**ADDISON AIRPORT
BUILDING REPORT**

Facility Information: **Facility Name:** 4400 Glenn Curtiss Drive
Facility Contact: Lisa Pyles **Contact Phone:** 972-450-2878

Accessology Inspector Information:
Inspector: Karen Jackson **Date:** April 17, 2017
Email: kjackson@accessology.com

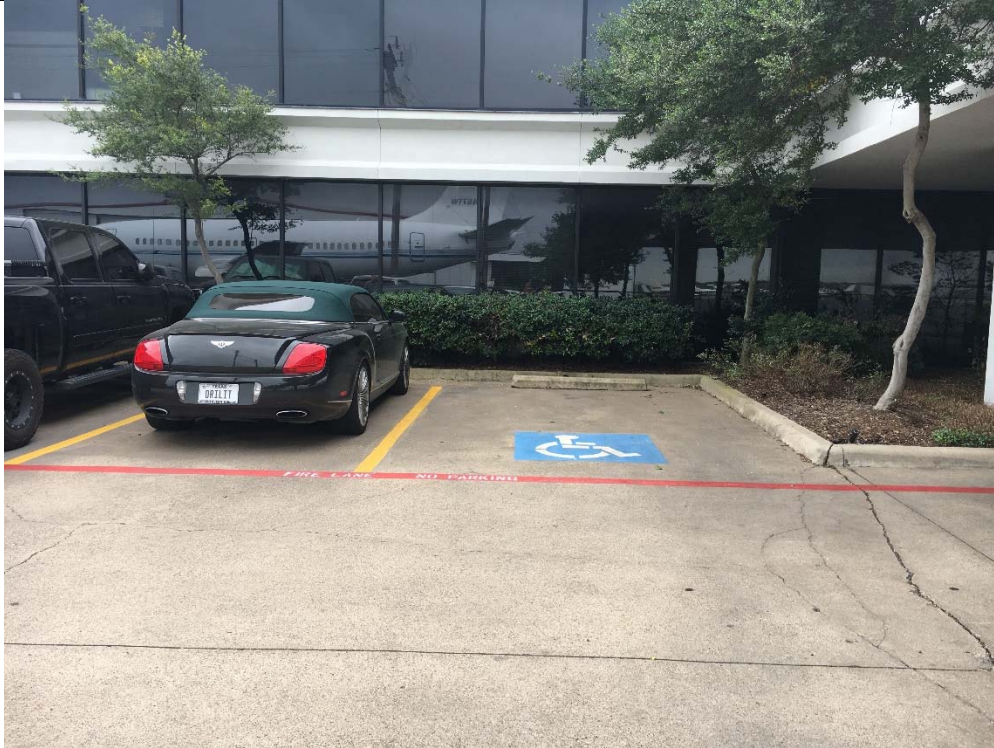
Violation #1: Only one accessible parking space is provided where two are required and one of the two is required to be van accessible.

Violation 1 - Only one accessible parking space is provided where two are required and one of the two is required to be van accessible.

Possible Solutions: Create one additional accessible parking space with an access aisle and accessible signage.

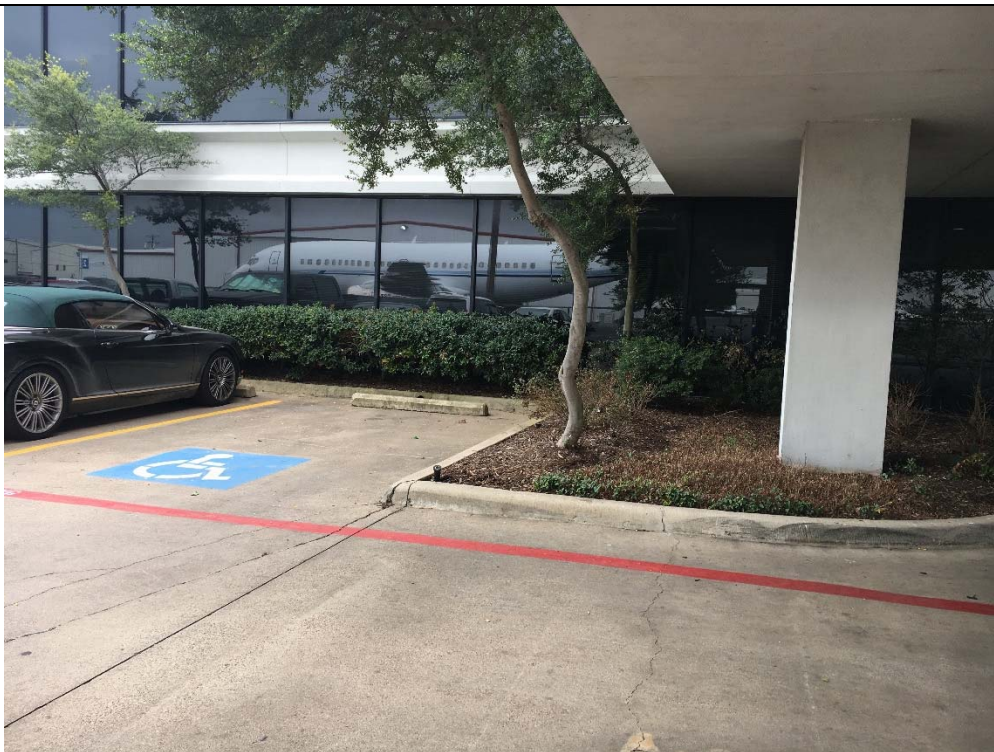
Violation #2: The existing accessible parking space is not served by the required access aisle.

Violation 2 - Only one accessible parking space is provided where two are required and one of the two is required to be van accessible.

Possible Solutions: Add an access aisle that can be shared with the additional parking space being added. Price is included in Violation #1.

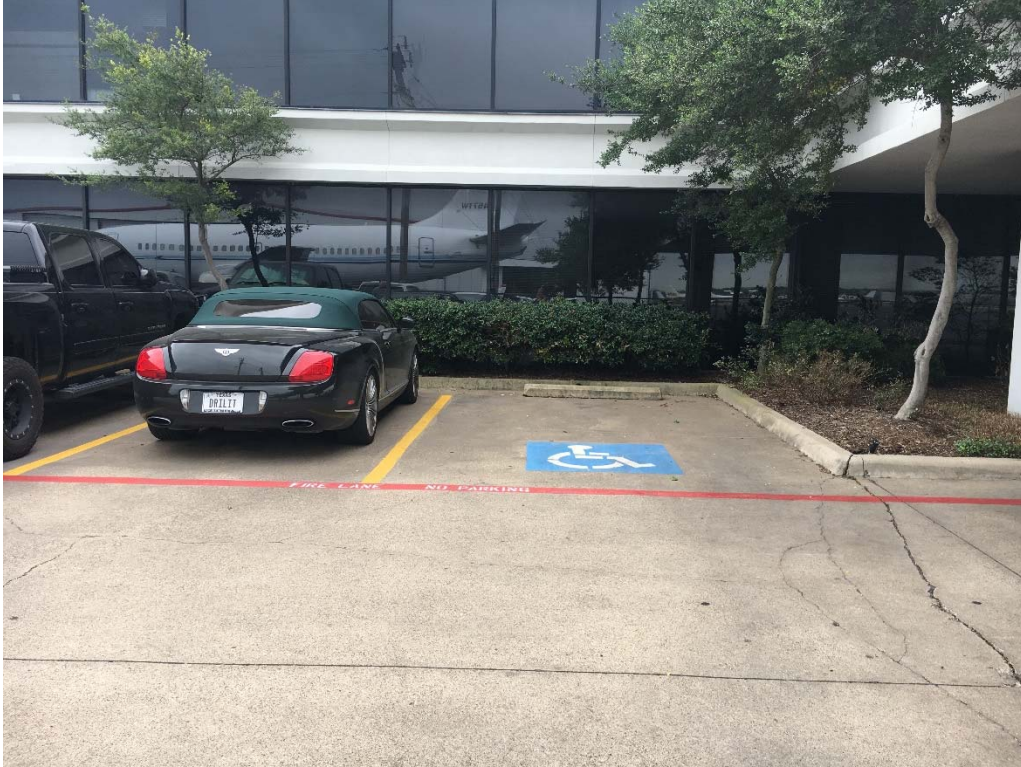
Violation #3: There is no accessible parking signage provided.

Violation 3 – There is no accessible parking signage provided.

Possible Solutions: Provide an accessible parking sign to serve the existing space.

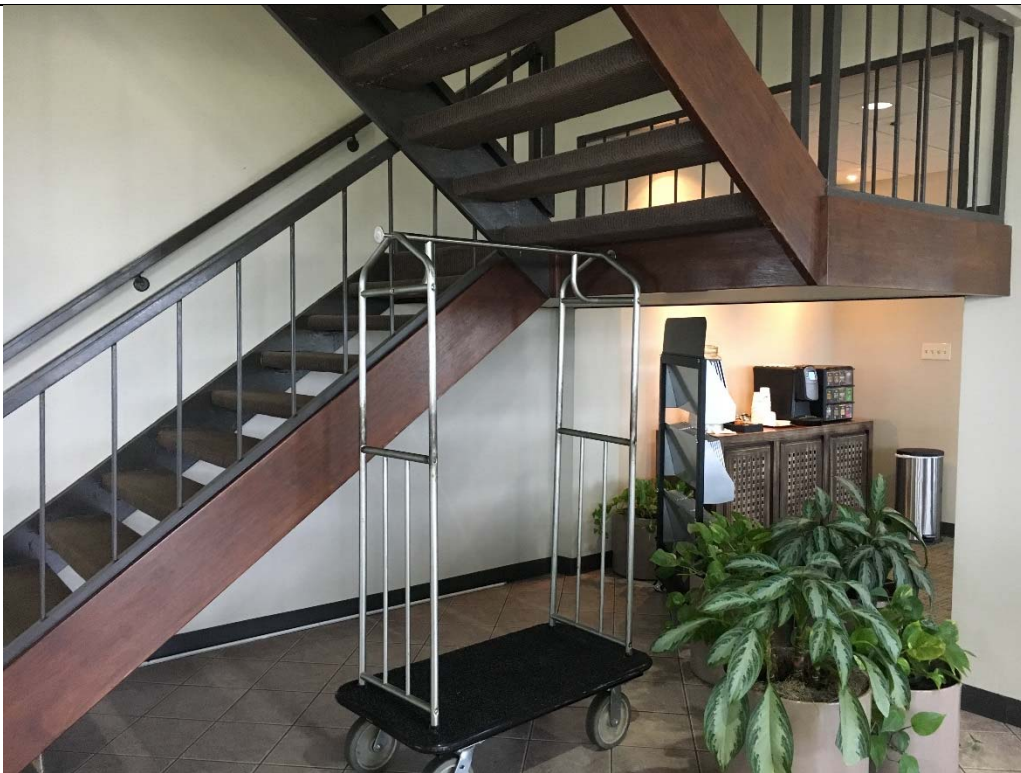
Violation #4: There is no accessible route leading to the second floor.

Violation 4 - There is no accessible route leading to the second floor.

Possible Solutions: Add a fully compliant elevator when needed to accommodate an employee if an accommodation can not be made in a more accessible location. Until the elevator is needed, it's a low priority.

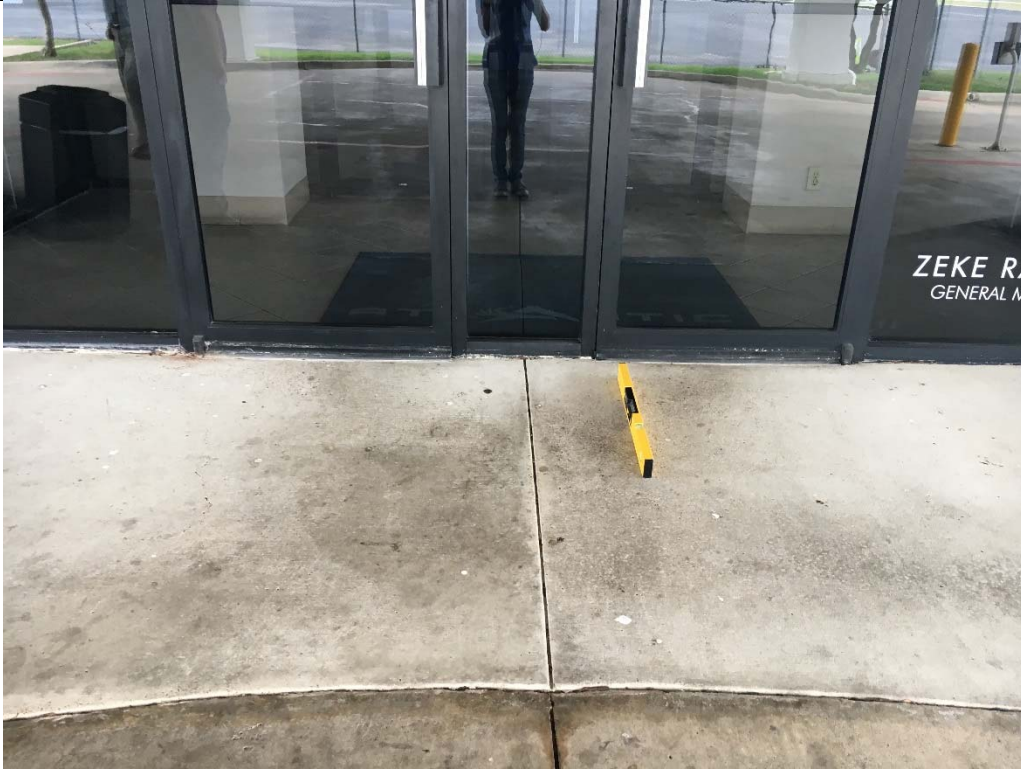
Violation #5: The landing at the building's main entrance has a 6.9% running slope.

Violation 5 - The landing at the building's main entrance has a 6.9% running slope.

Possible Solutions: Remove and replace pavement at entrance door to achieve a level landing at the door with slopes no greater than 1:48 in all directions.

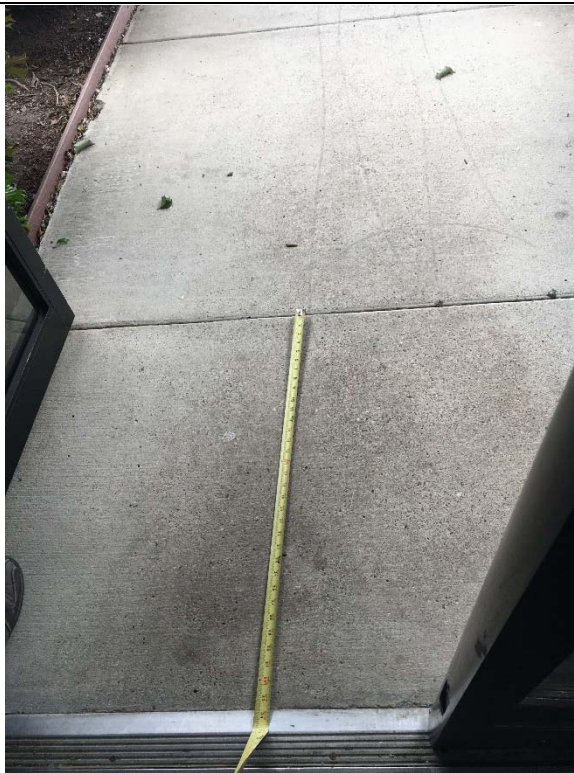
Violation #6: There is only a 33-1/2" deep level landing/maneuvering clearance at the side door that leads to the runway area. The maneuvering clearance at this door should be a minimum of 60" deep.

Violation 6 - There is only a 33-1/2" deep level landing/maneuvering clearance at the side door that leads to the runway area. The maneuvering clearance at this door should be a minimum of 60" deep.

Remove and replace pavement at entrance door to achieve a level landing with slopes no greater than 1:48 in all directions for a minimum of 60" deep.

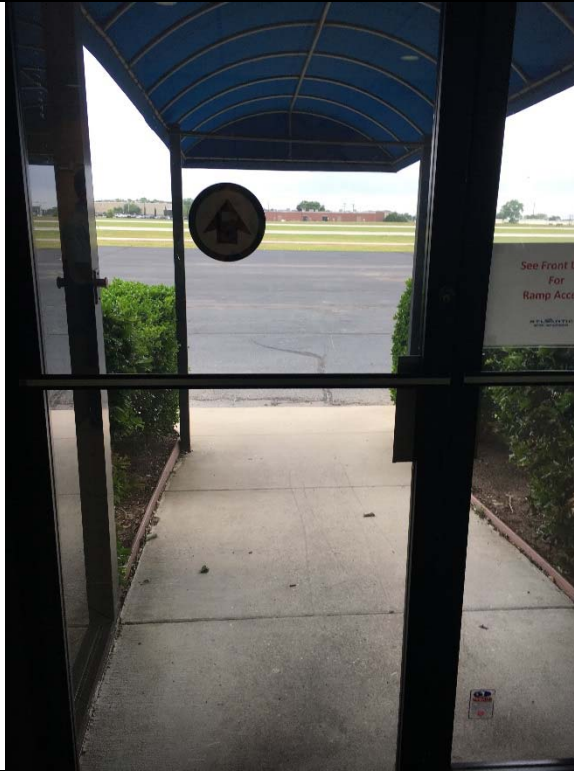
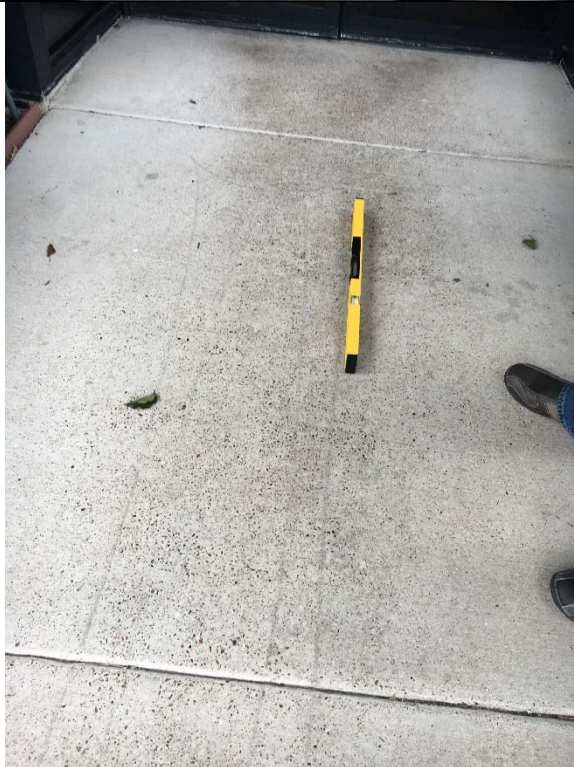
The sidewalk leading up to the side entrance from the runway area has a 10.7% running slope.

Violation 7 - The sidewalk leading up to the side entrance from the runway area has a 10.7% running slope.

Reconstruct this area and provide a fully accessible ramp with compliant handrails.

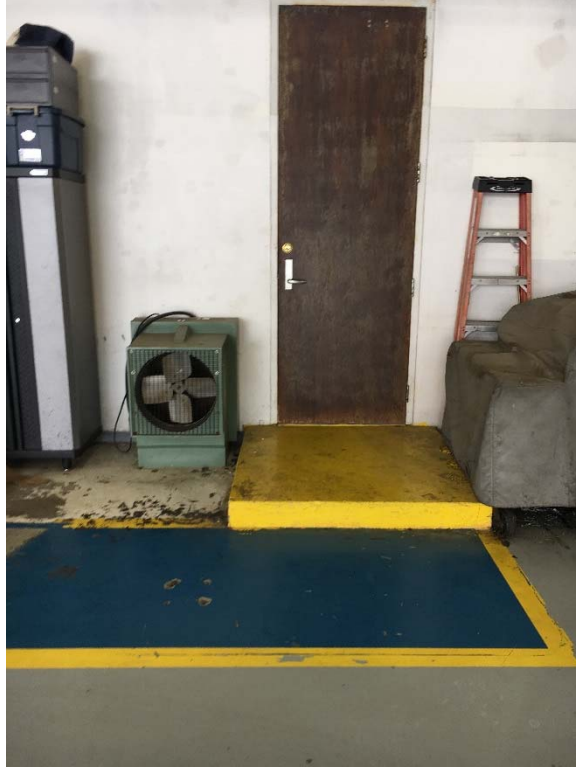
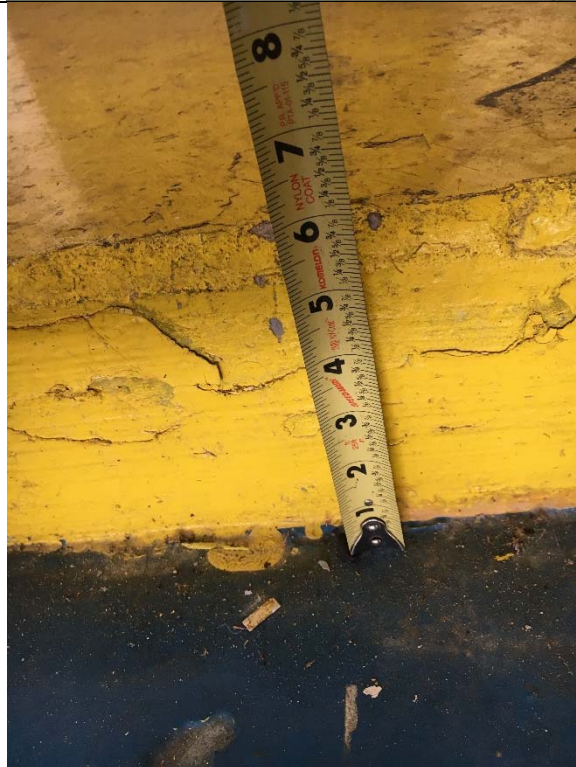
There are 5 doors leading into the building from the warehouse that have a 6" step up onto a platform.

Violation 8 - There are 5 doors leading into the building from the warehouse that have a 6" step up onto a platform.

Modify one door from the warehouse to provide an accessible connection to the building.

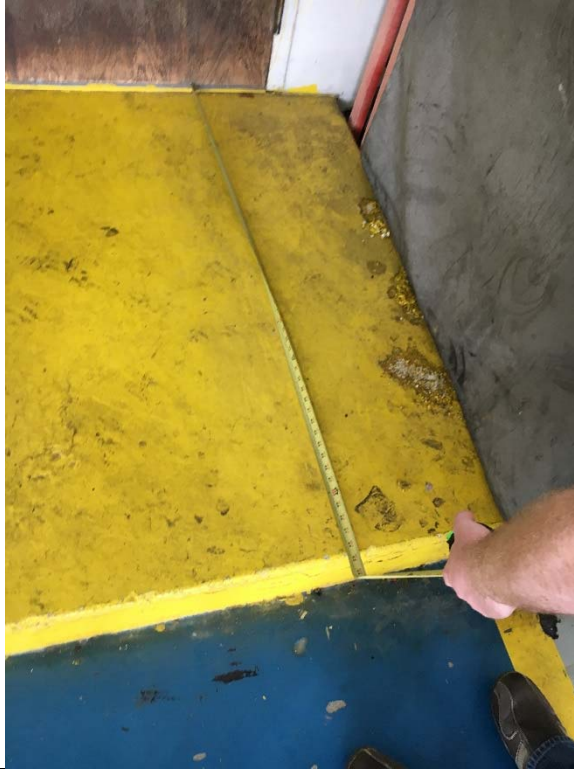
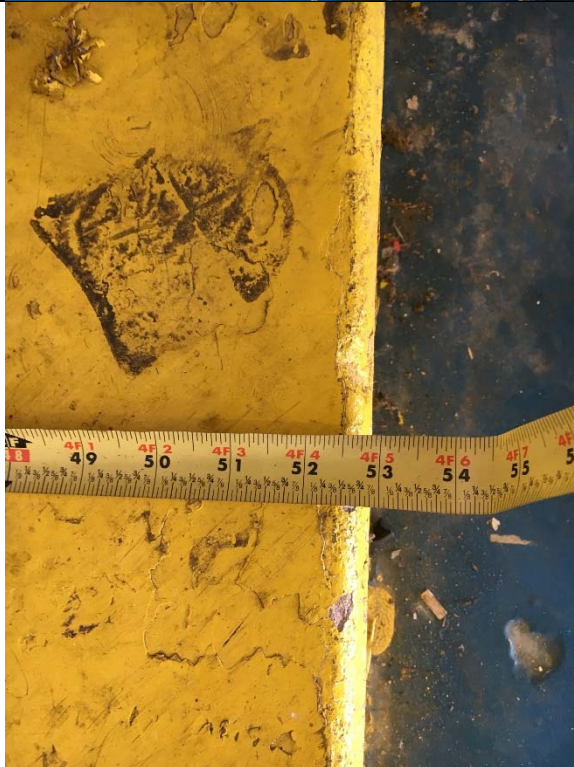
The warehouse doors only have a 53" deep maneuvering clearance where a minimum of 60" is required.

Violation 9 - The warehouse doors only have a 53" deep maneuvering clearance where a minimum of 60" is required.

Modify one door from the warehouse to provide the required 60" deep maneuvering clearance. Cost included in Violation #8.

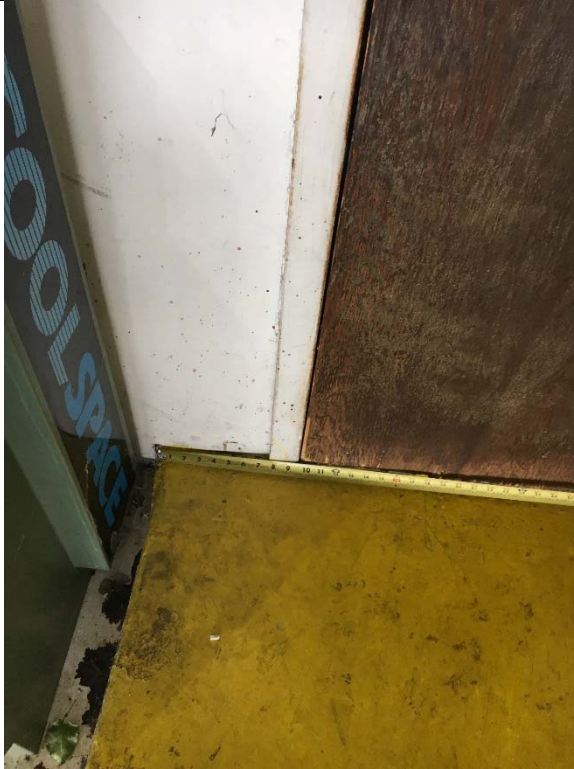
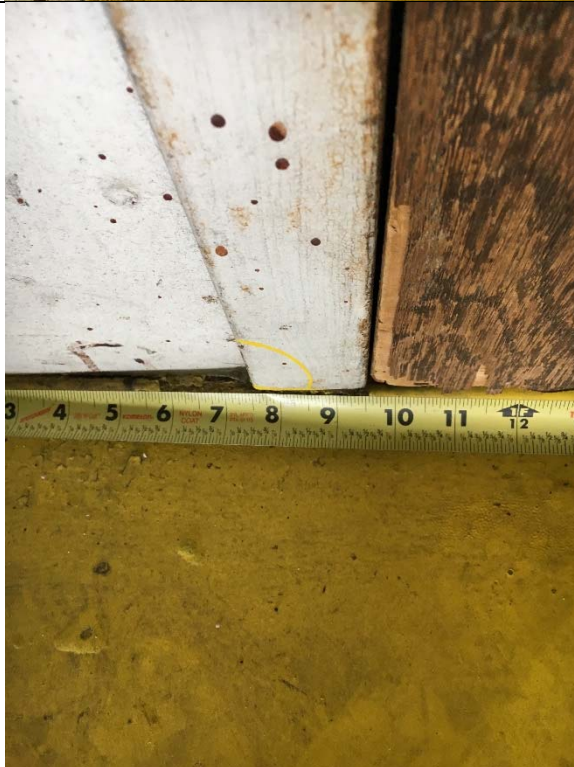
Doors leading into the building from the warehouse only have a 9-1/2" maneuvering clearance on the pull side where a minimum of 18" is required.

Violation 10 - Doors leading into the building from the warehouse only have a 9-1/2" maneuvering clearance on the pull side where a minimum of 18" is required.

Modify one door from the warehouse to provide 18" minimum clearance on the pull side of the door. Cost included in Violation #8.

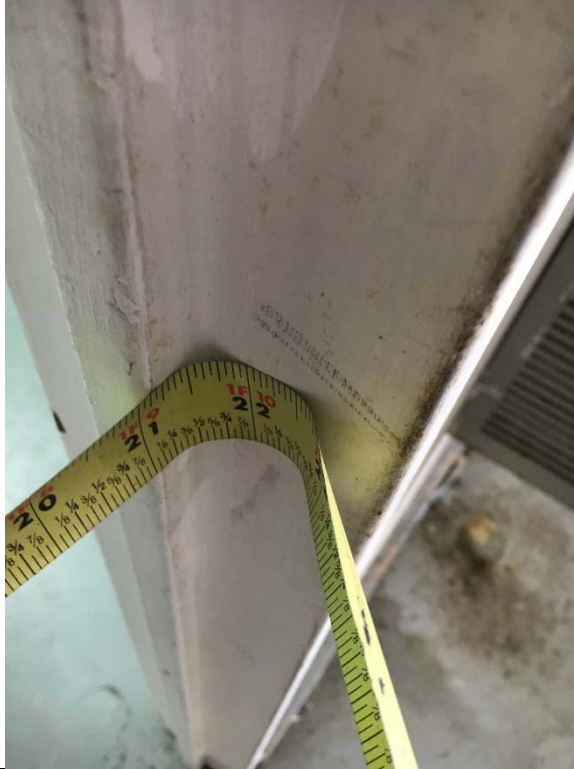
Doors leading into the building from the warehouse do not have a minimum width of 32".

Violation 11 - Doors leading into the building from the warehouse do not have a minimum width of 32".

Replace one door with unit that provides 32" minimum clear width. Cost included in Violation #8.

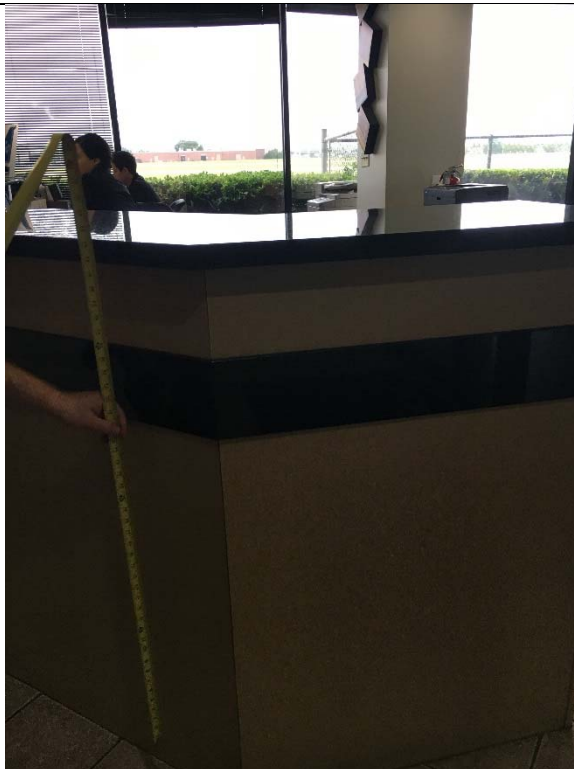
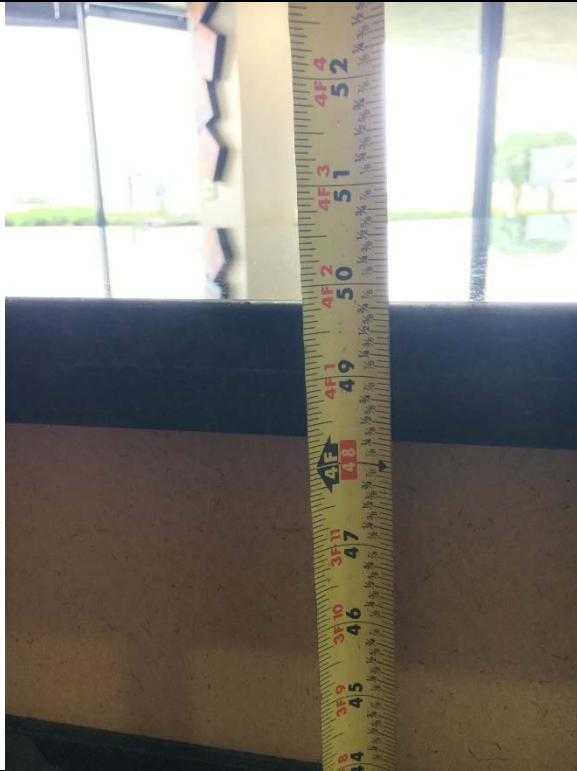
The information desk is at 49-3/4" to the top where a maximum of 36" is required.

Violation 12 - The information desk is at 49-3/4" to the top where a maximum of 36" is required.

Lower a 36" wide portion of the counter to 36" maximum. Clear floor space for a side approach is already provided.

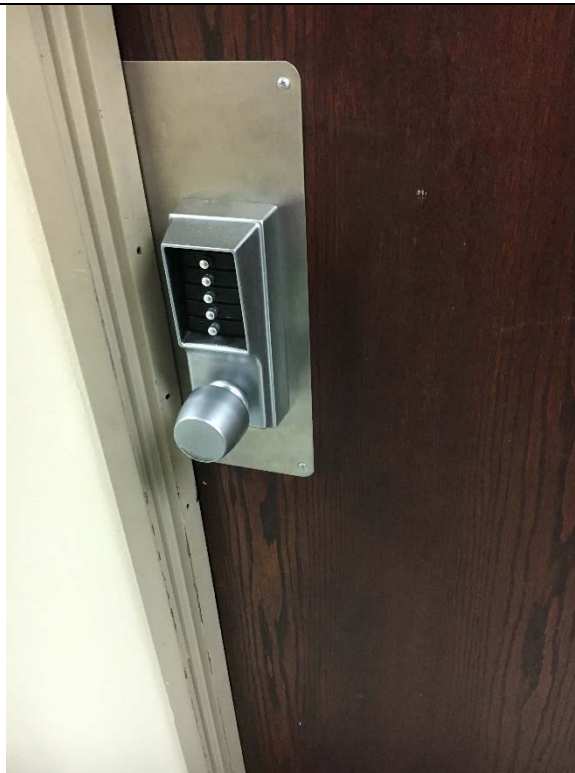
Approximately 15 doors throughout the facility have door hardware that requires grasping and twisting to operate.

Violation 13 - Approximately 15 doors throughout the facility have door hardware that requires grasping and twisting to operate.

Replace with lever style door hardware.

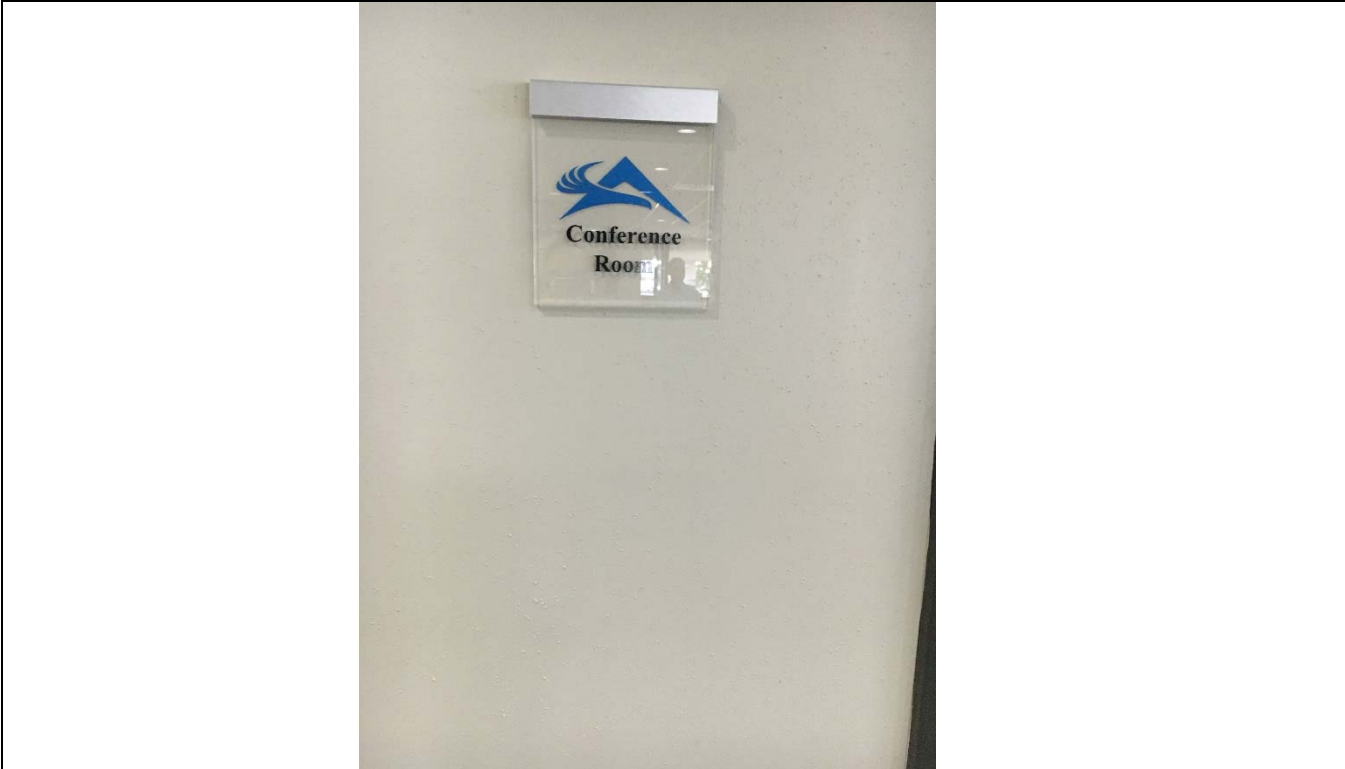
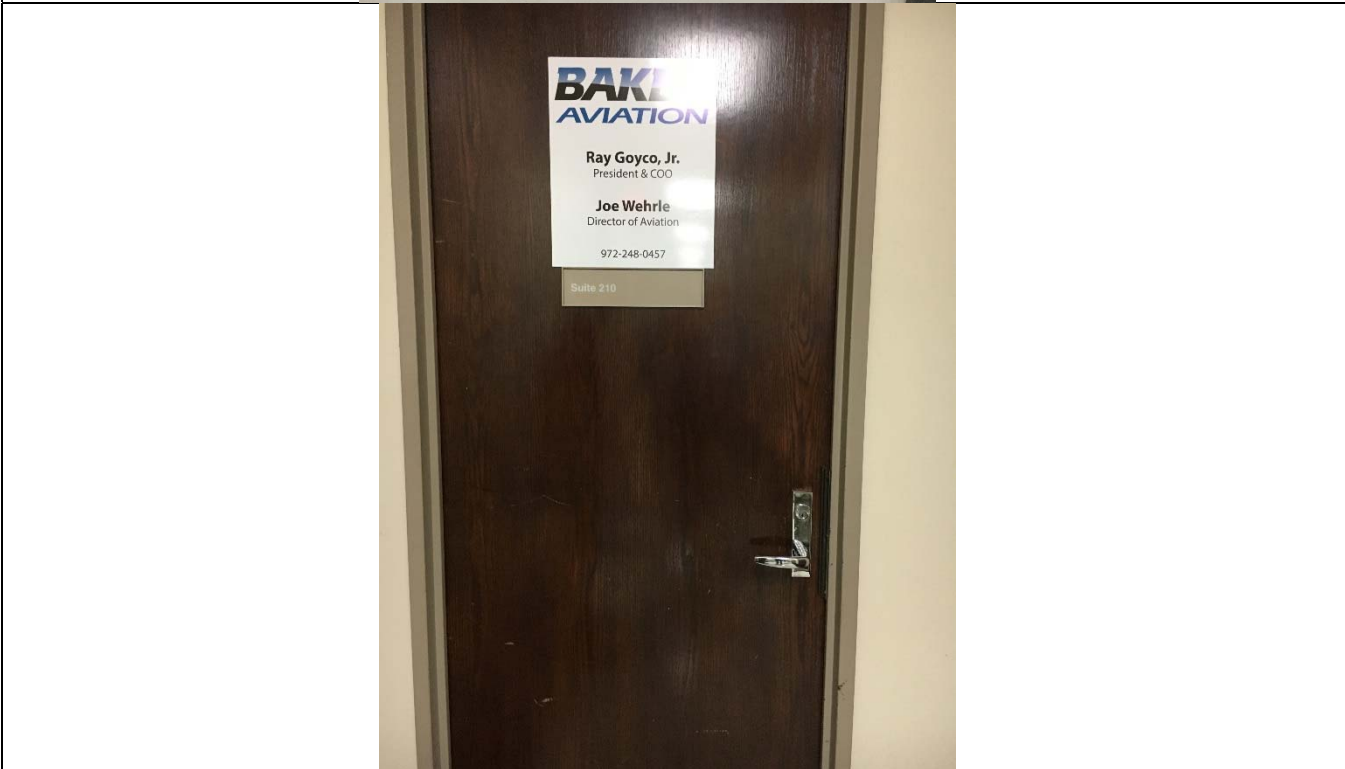
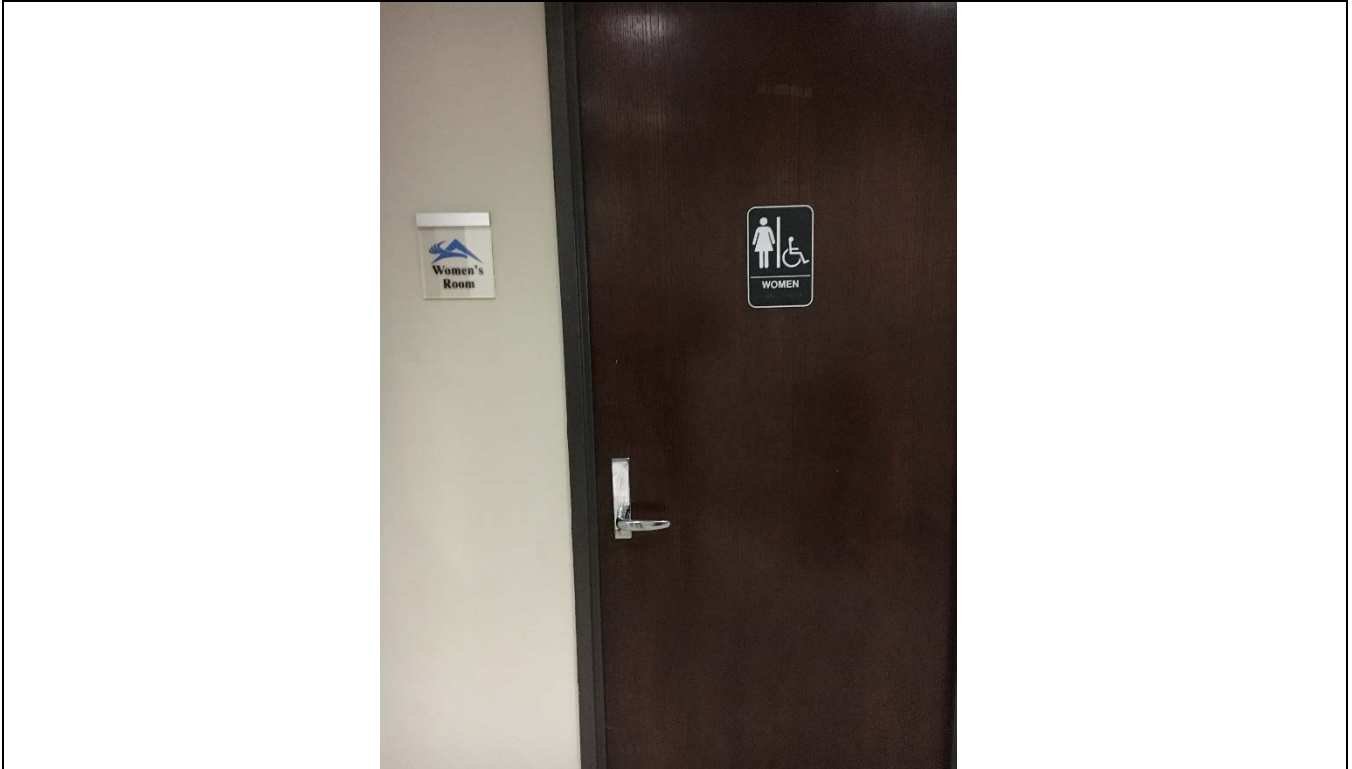
There are approximately 25 room signs throughout the building that have no compliant features, some of which are mounted on the doors.

Violation 14 - There are approximately 25 room signs throughout the building that have no compliant features, some of which are mounted on the doors.

Provide new compliant signs for all permanent rooms and install on them on the latch side of the doors.

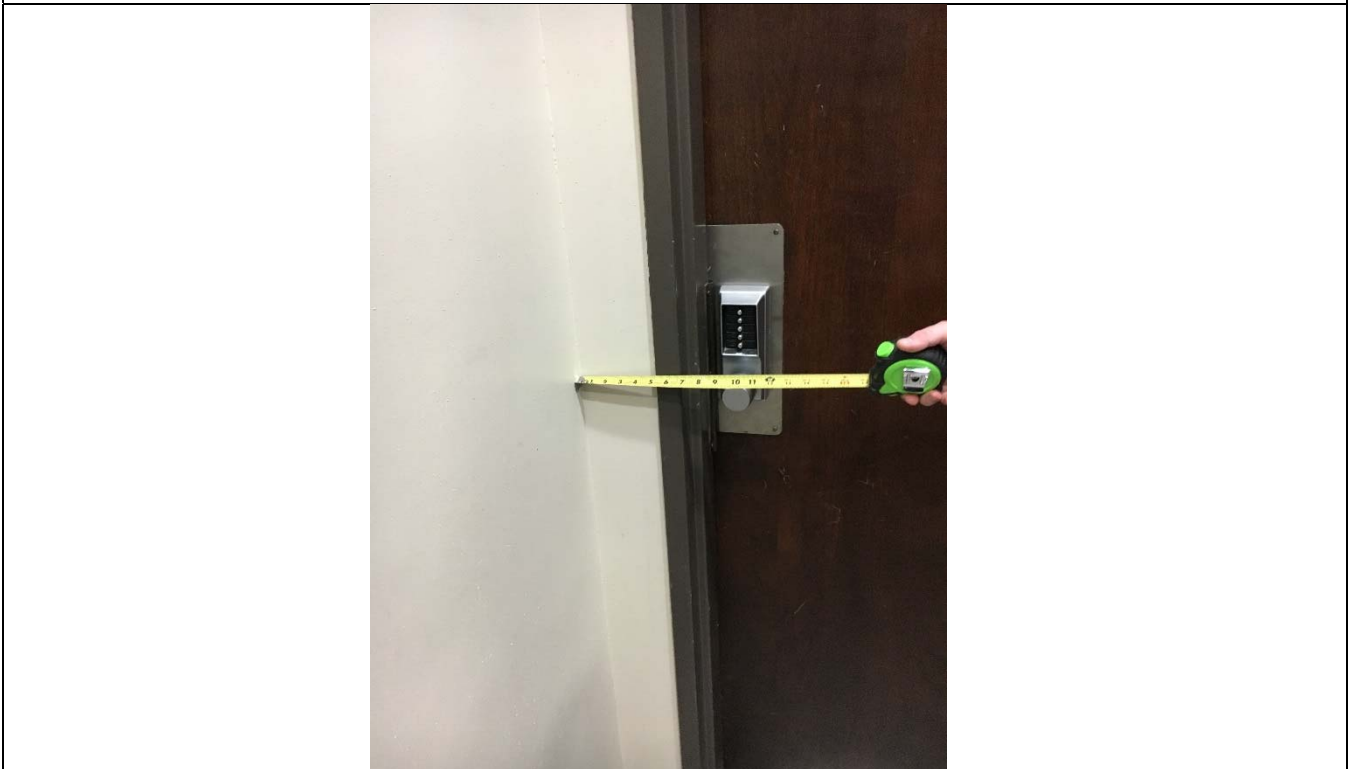
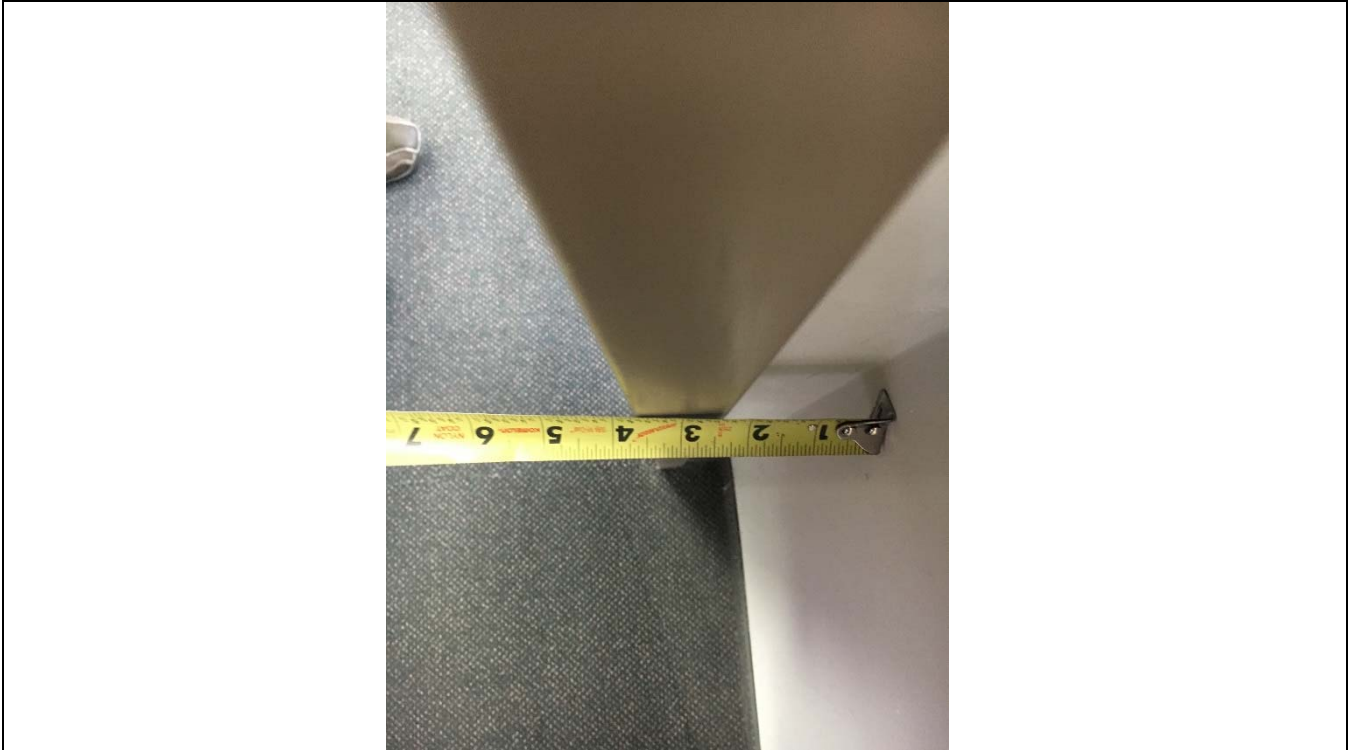
There are approximately 8 doors throughout the building (including private offices) that do not have a minimum of 18" maneuvering clearance on the pull side.

Violation 15 - There are approximately 8 doors throughout the building (including private offices) that do not have a minimum of 18" maneuvering clearance on the pull side.

Possible Solutions: Modify doors to provide an 18" minimum maneuvering clearance.

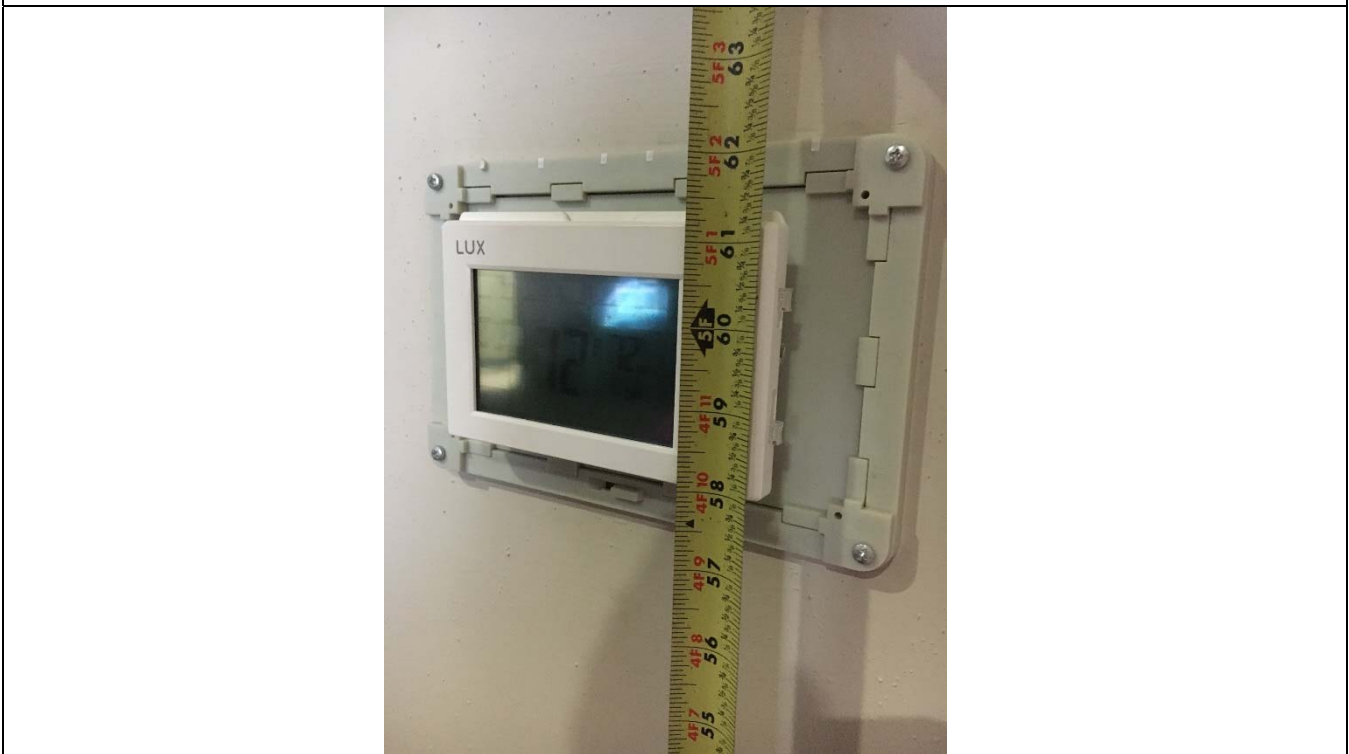
Violation #16: The controls for the thermostat provided in the lounge area are at 60" above finished floor.

Violation 16 - The controls for the thermostat provided in the lounge area are at 60" above finished floor.

Possible Solutions: Lower thermostat so the highest operable part is at 48" above finished floor.

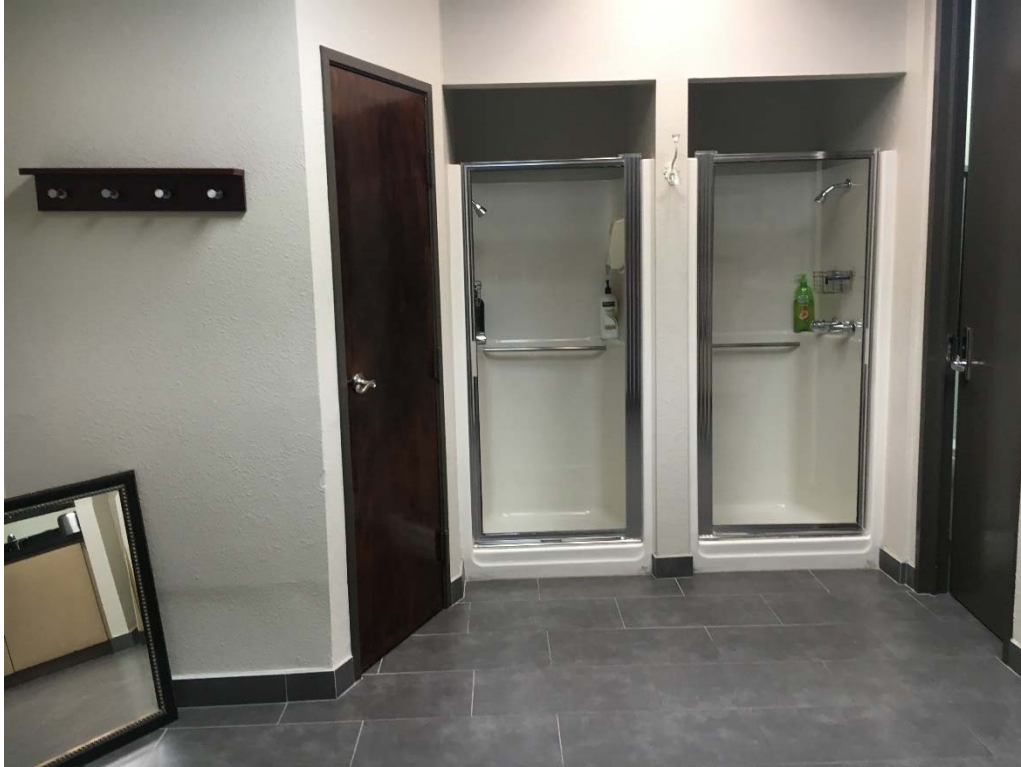
Violation 17 - There are two showers in the lounge restroom, neither of which are compliant.

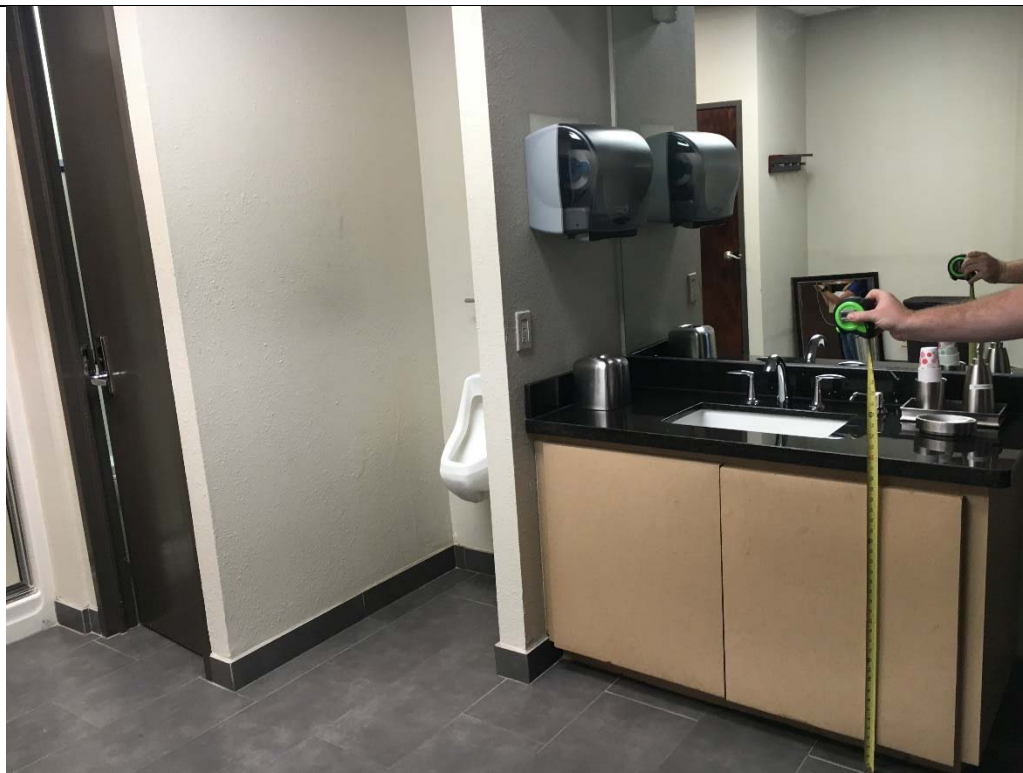
Violation 18 - The lavatory in the lounge restroom does not have the required toe and knee clearance provided.

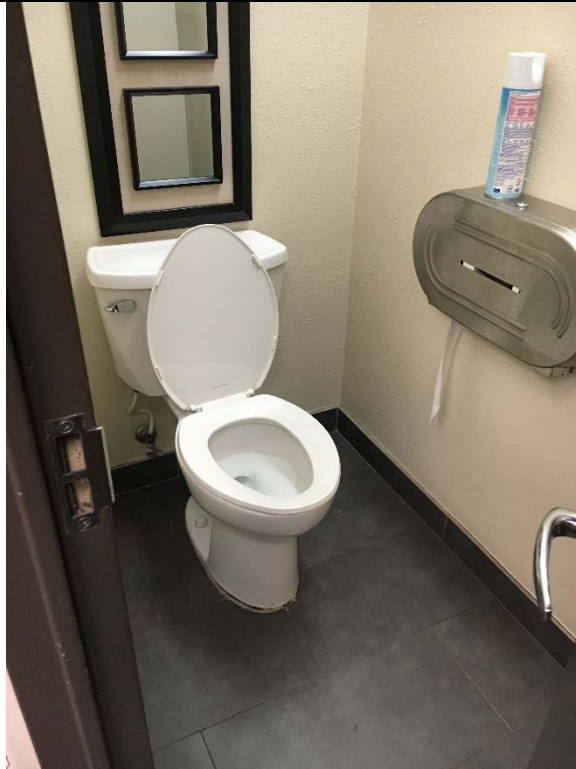
Violation 19 - The lounge restroom does not have an accessible stall provided.

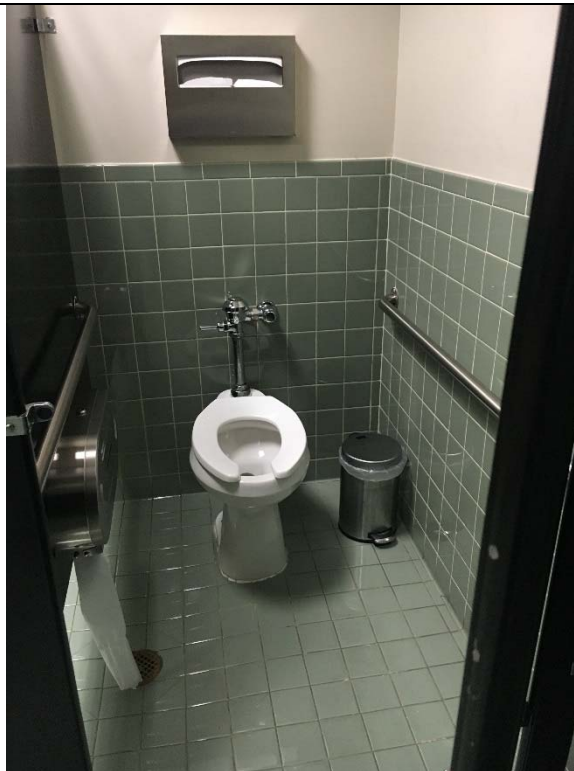
Violation 20 - First Floor Men's room - Does not have an accessible stall provided.

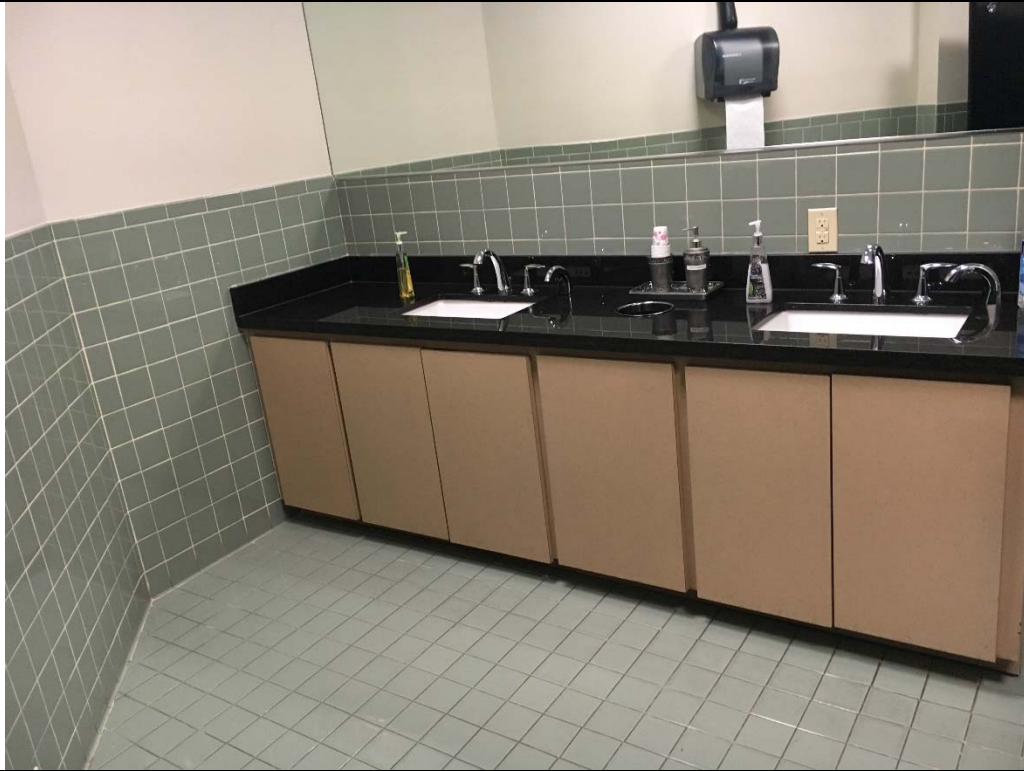
Violation #21: First Floor Men's room - Lavatory does not have the required toe and knee clearance provided.

Violation 21 - First Floor Men's room - Lavatory does not have the required toe and knee clearance provided.

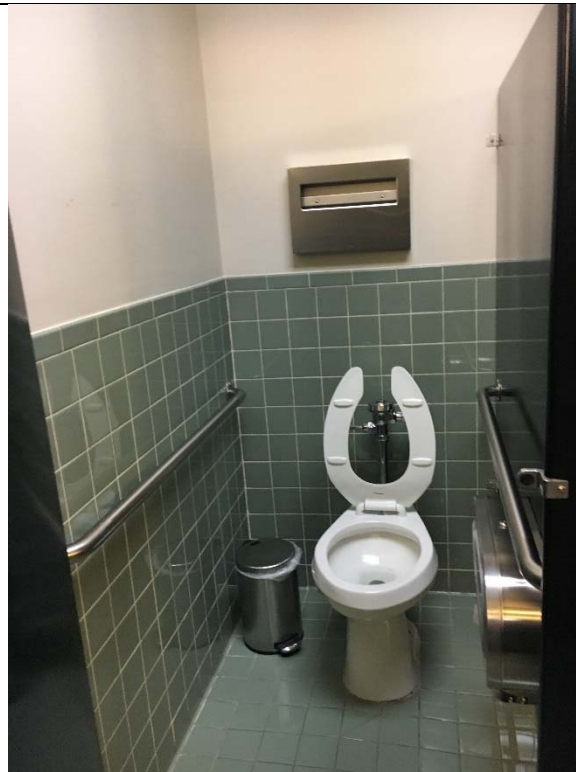
Violation #22: First Floor Women's room - Does not have an accessible stall provided.

Violation 22 - First Floor Women's room - Does not have an accessible stall provided.

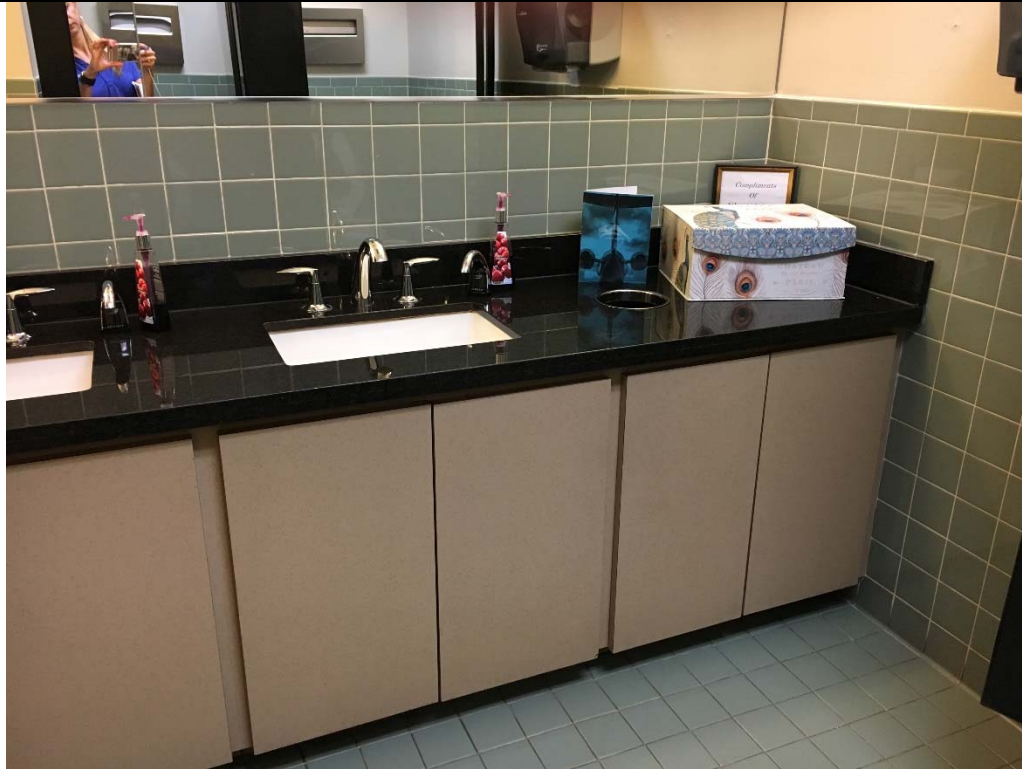
Violation 23 - First Floor Women's room - Lavatory does not have the required toe and knee clearance provided.

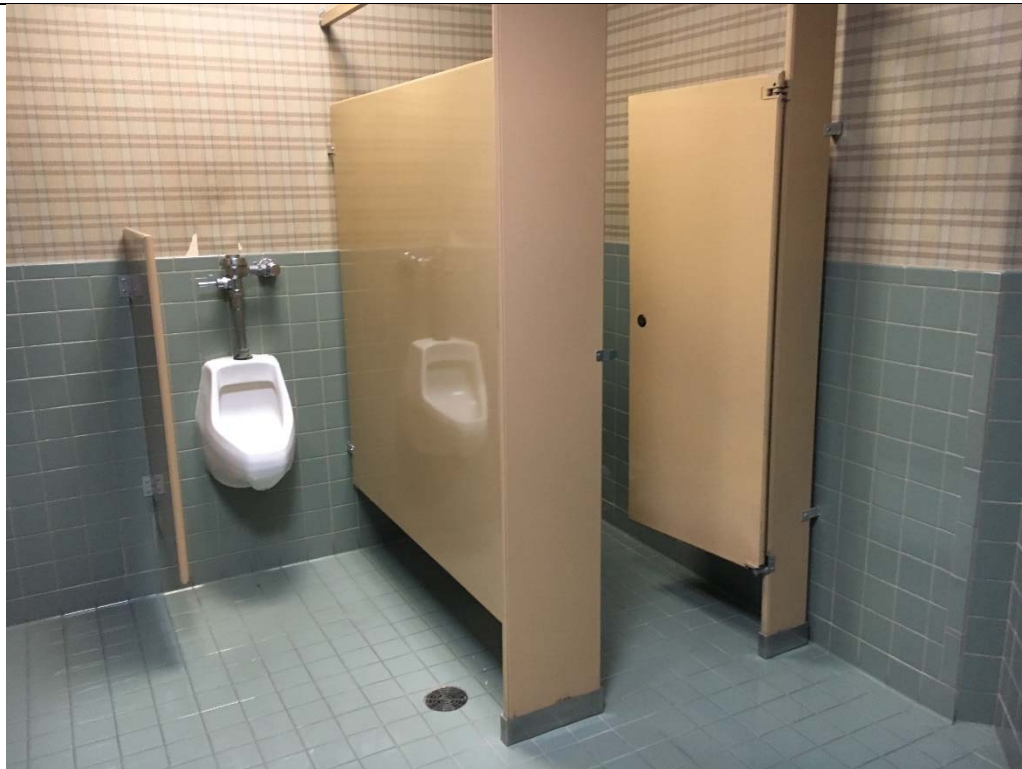
Violation 24 - Second Floor Men's room - Does not have an accessible stall provided.
