**ADDISON AIRPORT
BUILDING REPORT**

Facility Information: **Facility Name:** 4400 Glenn Curtiss Drive
Facility Contact: Lisa Pyles **Contact Phone:** 972-450-2878

Accessology Inspector Information:
Inspector: Karen Jackson **Date:** April 17, 2017
Email: kjackson@accessology.com

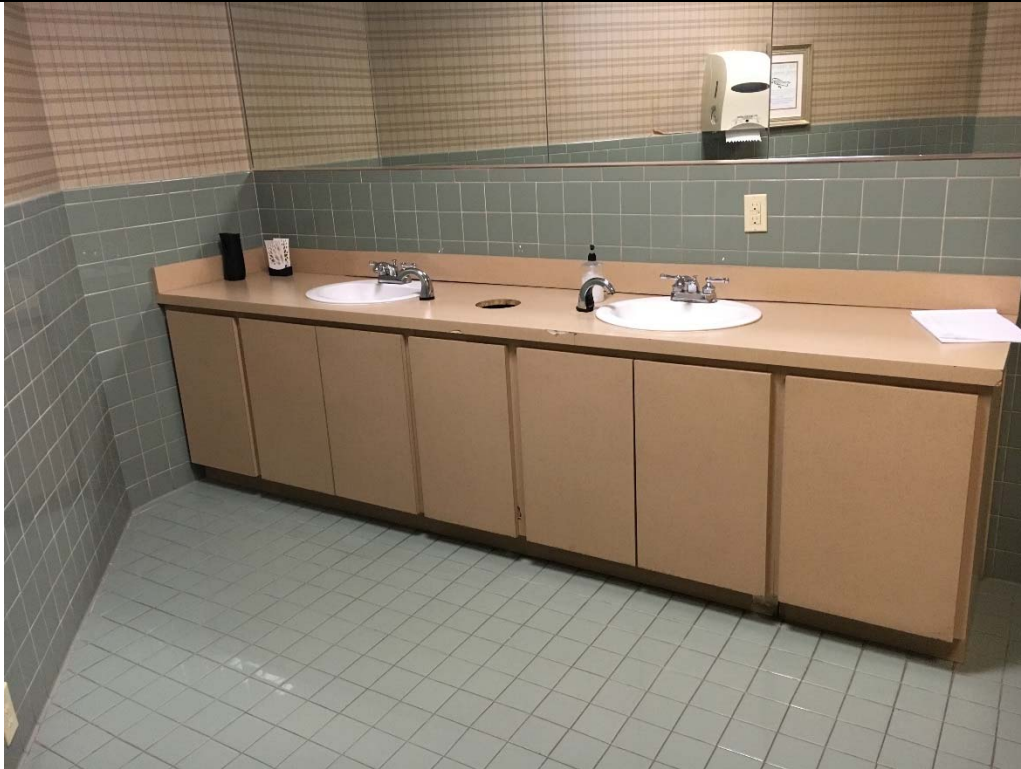
Violation 25 - Second Floor Men's room - Lavatory does not have the required toe and knee clearance provided.

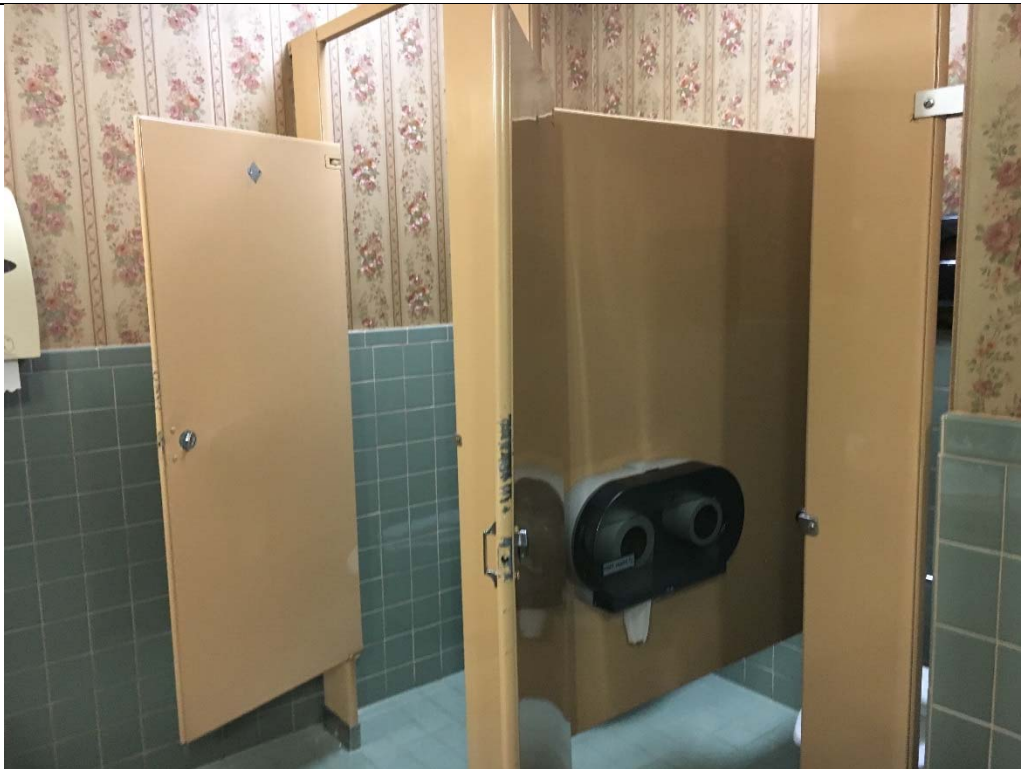
Violation 26 - Second Floor Women's room - Does not have an accessible stall provided.

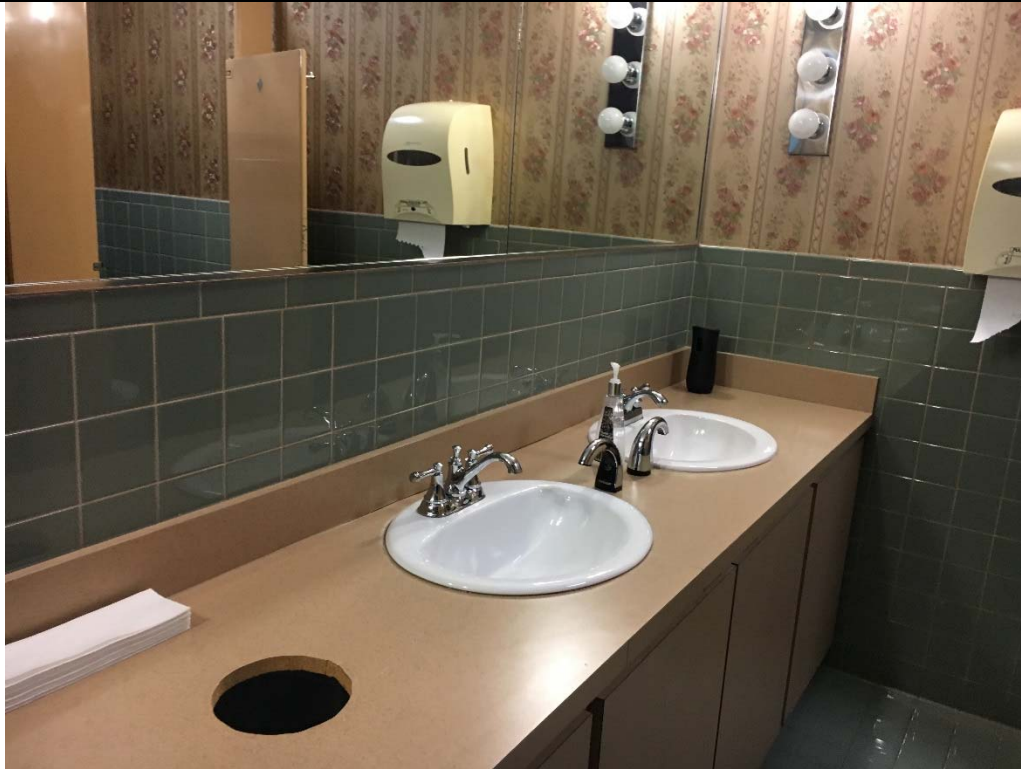
Violation 27 - Second Floor Women's room - Lavatory does not have the required toe and knee clearance provided.

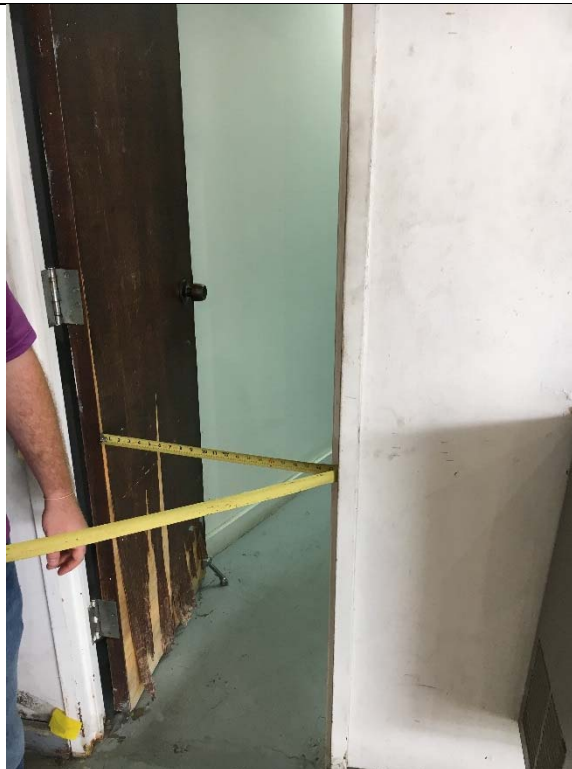
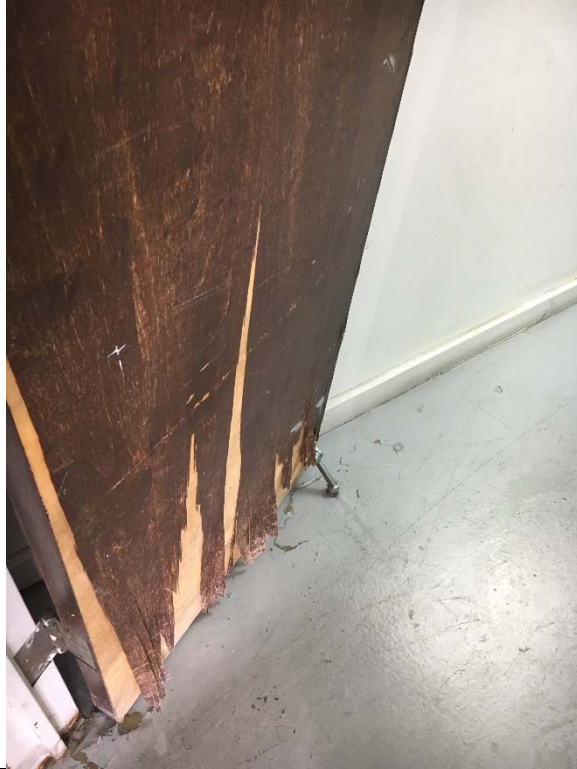
Violation 28 - Warehouse restroom door opening is only 22" wide and the door is shredded at the bottom with a door stop.

Replace door with unit that provides 32" minimum clear width and that has a smooth surface.

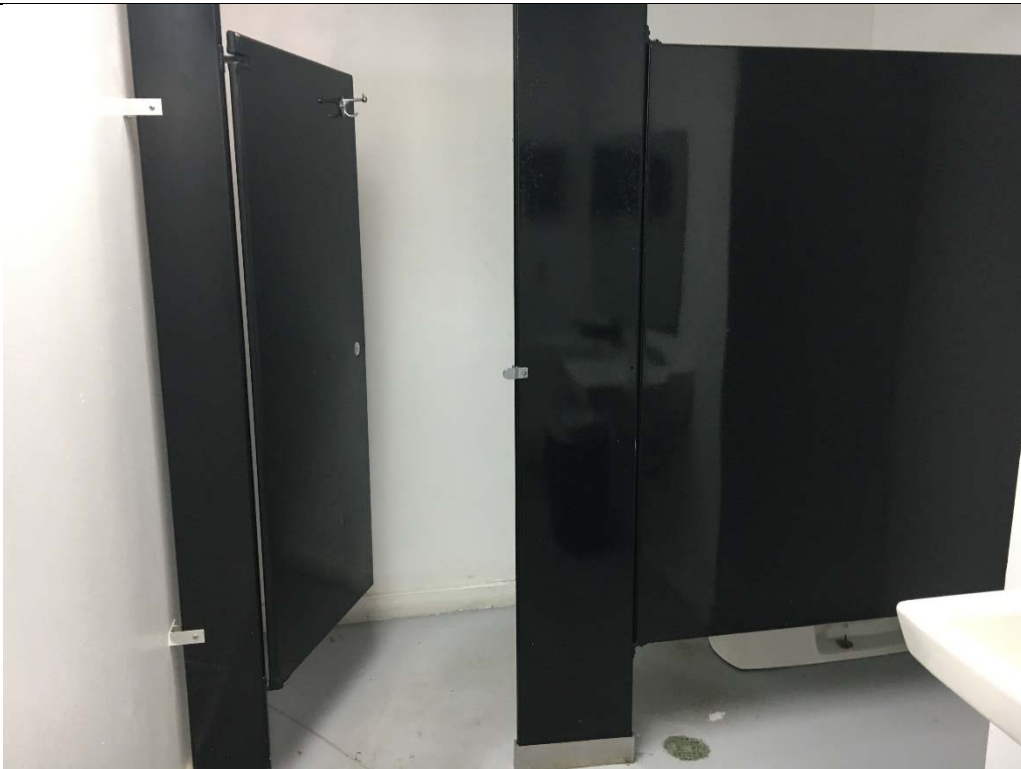
Violation 29 - The warehouse restroom does not have an accessible stall.

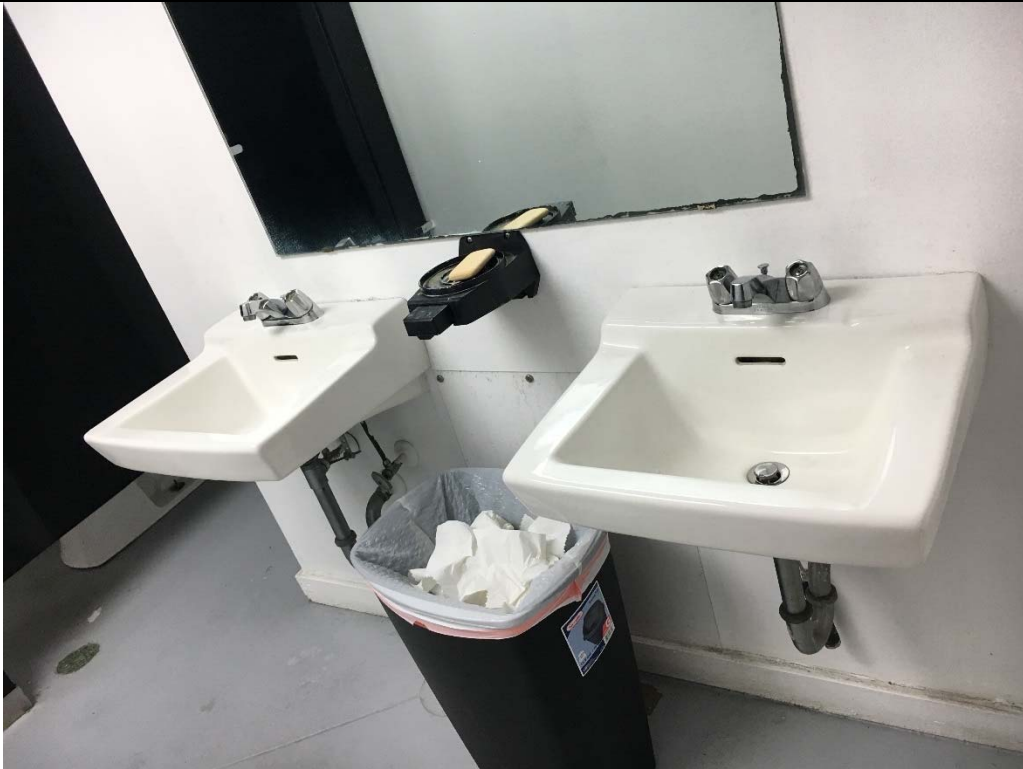
Violation #30: The warehouse restroom does not have an accessible lavatory provided.

Violation 30 - The warehouse restroom does not have an accessible lavatory provided.

Possible Solutions: Lower one of the lavatories to 34" with a 27" knee clearance, wrap pipes and replace controls with lever style controls.

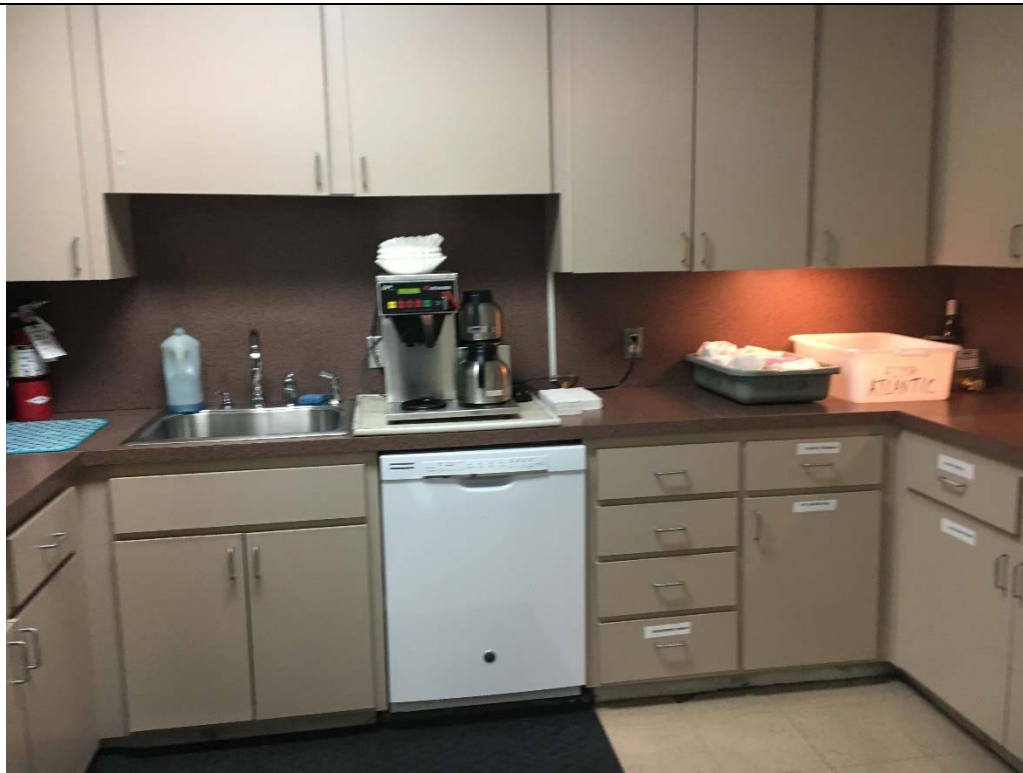
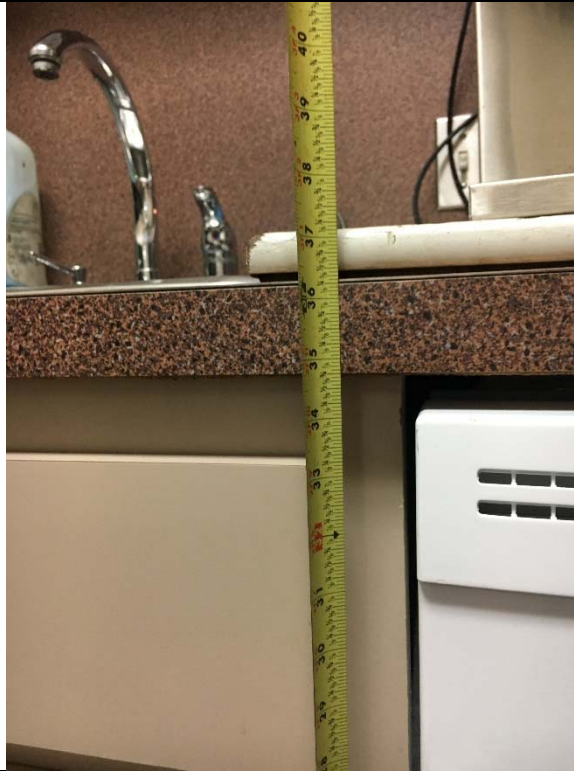
Violation #31: The counter in the first floor break room is 36-5/16" above finished floor to the top of the counter at the sink where a maximum of 34" is required.

Violation 31 - The counter in the first floor break room is 36-5/16" above finished floor to the top of the counter at the sink where a maximum of 34" is required.

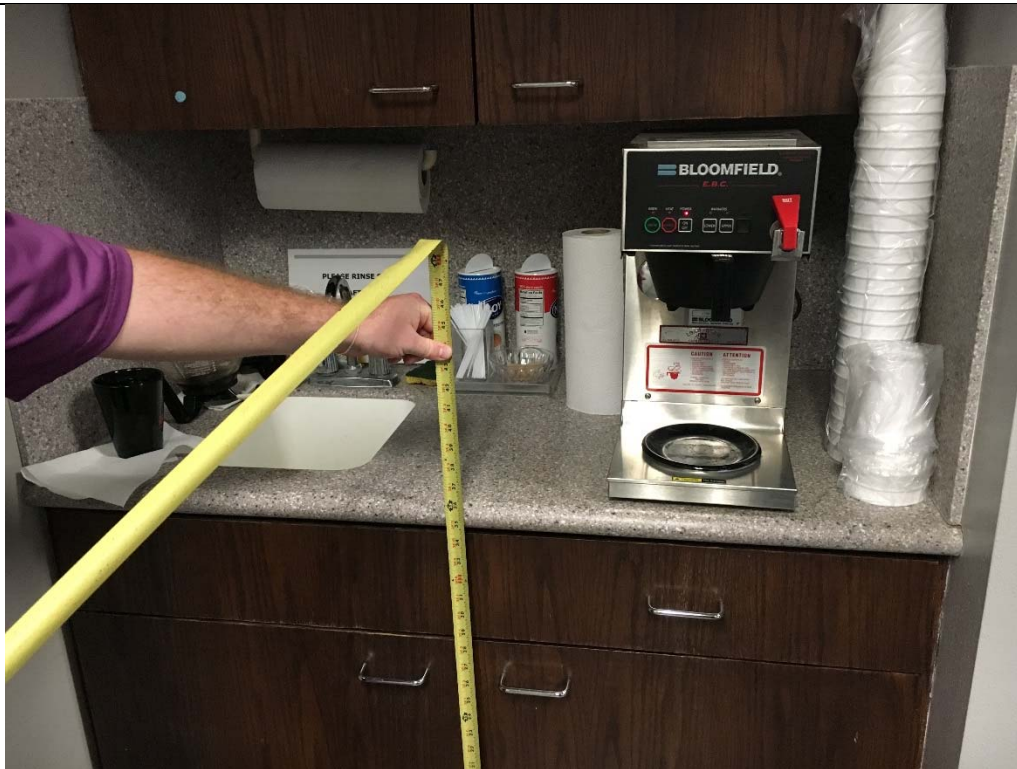
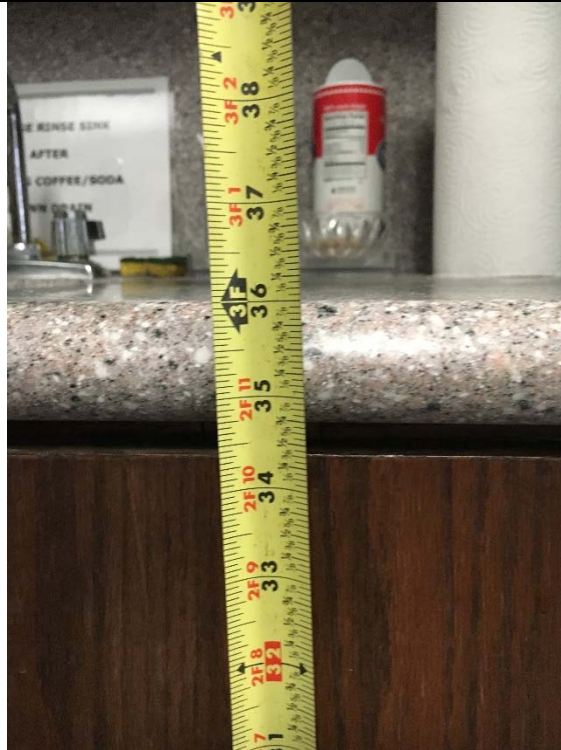
Violation 32 - There is a coffee bar in the AmeriStar Human Resources office (suite 100) with a sink that is mounted at 36" above finished floor where 34" maximum is required.

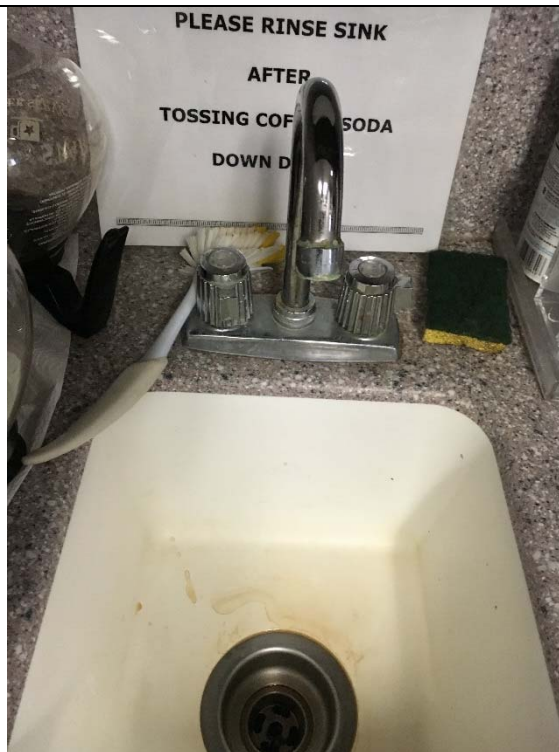
Violation 33 - The sink controls at the coffee bar in AmeriStar's Human Resources office require grasping and twisting of the wrist to operate.

Replace with lever style handles.

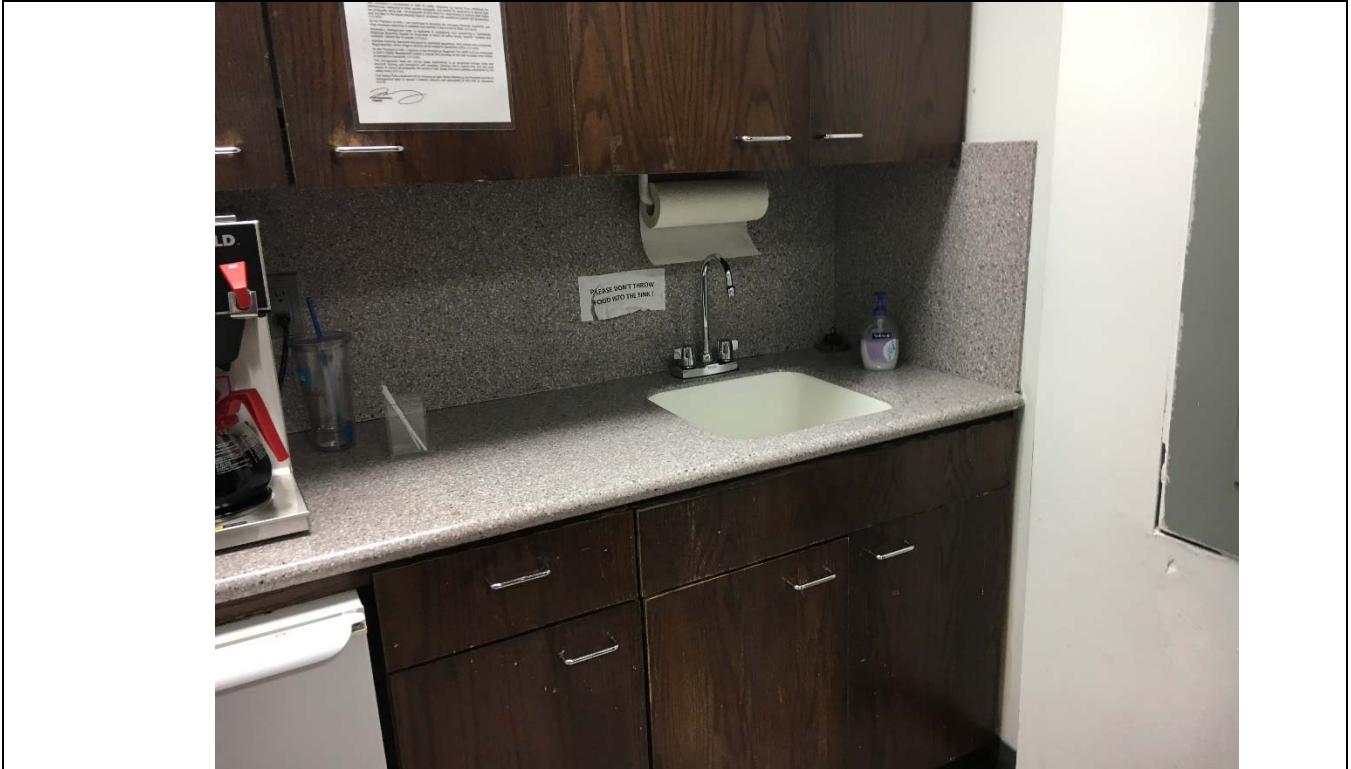
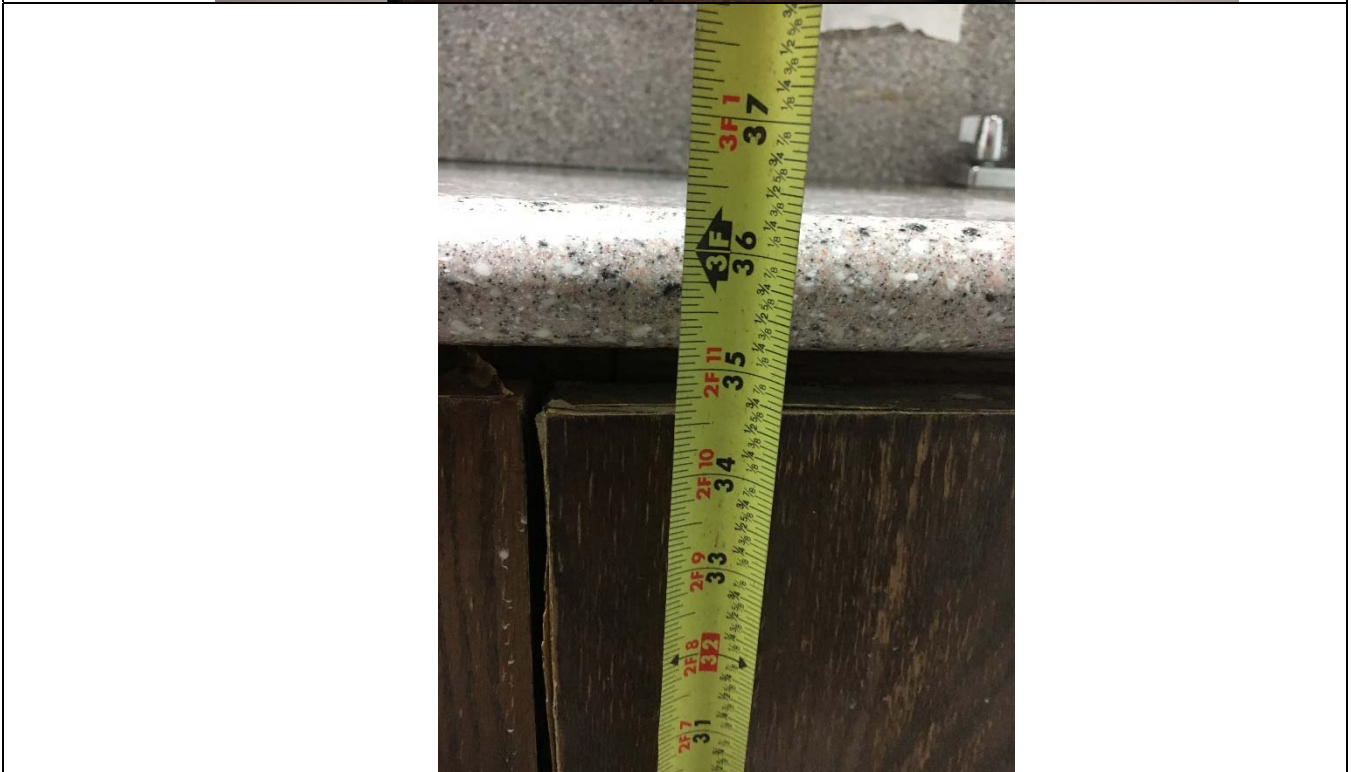
Violation 34 - The counter in the second floor break room is at 36-3/8" high where 34" maximum is required.

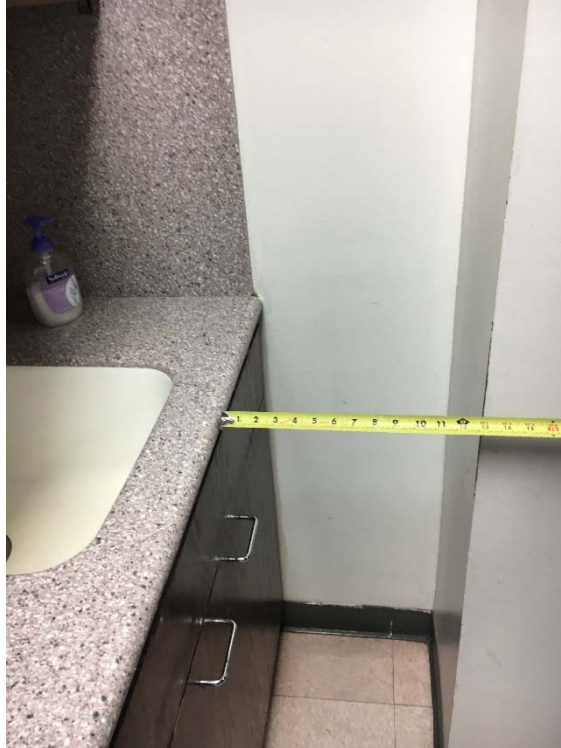
Violation 35 - The 2nd floor break room sink clear floor space is blocked by a wing wall leaving only a 13" deep clear floor space.

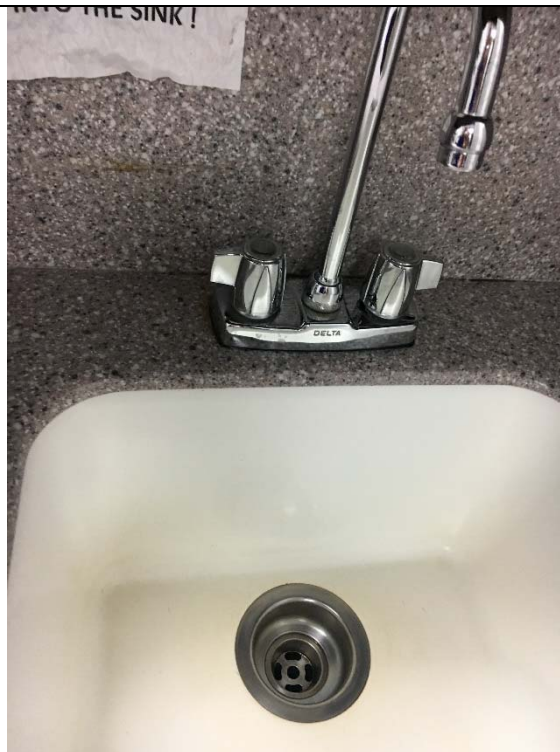
Violation 36 - The 2nd floor break room faucet controls require grasping and twisting of the wrist to operate.

Replace faucet with lever style handles.

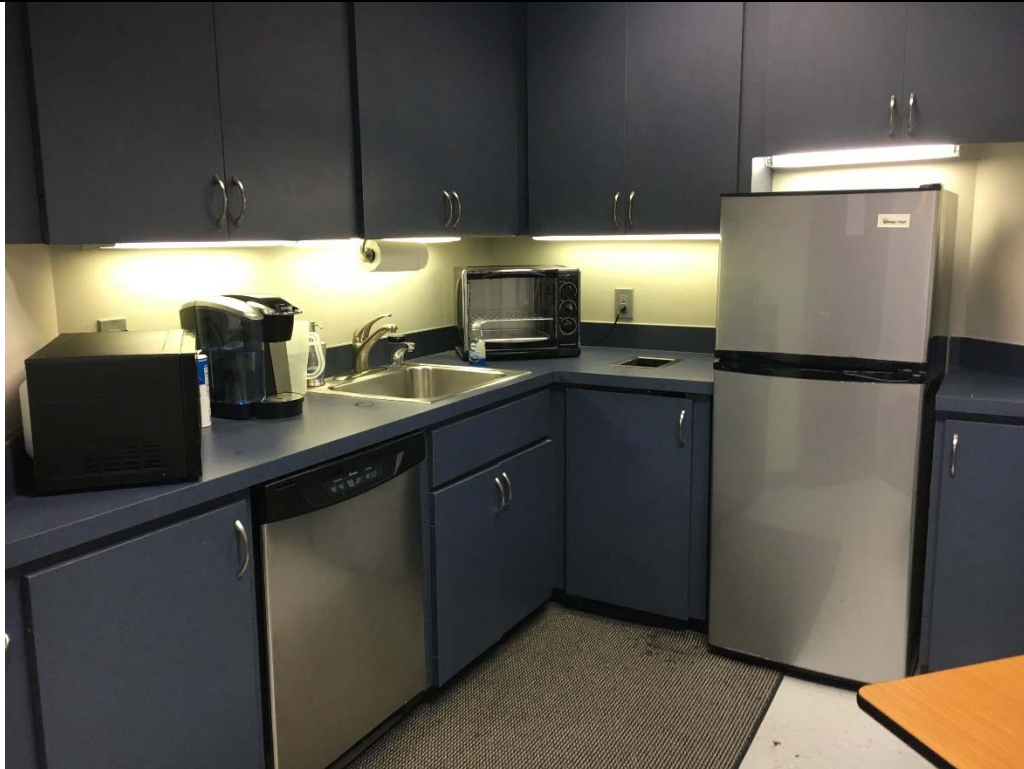
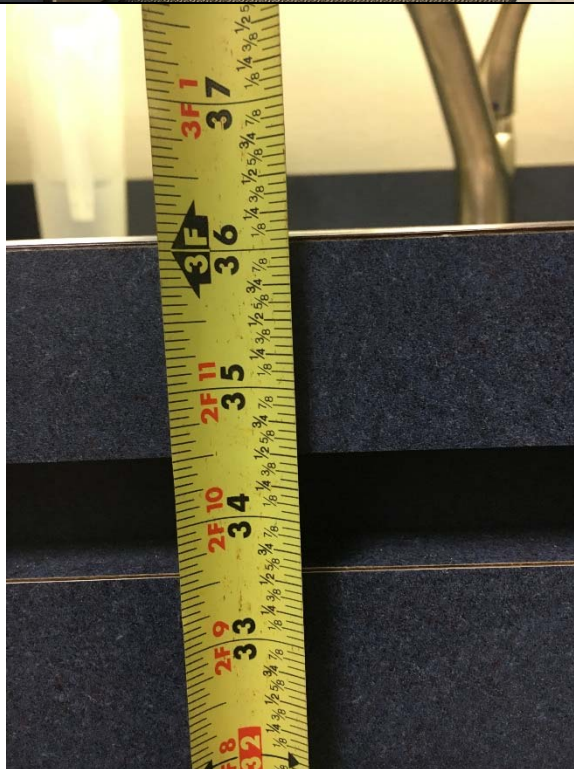
Violation #37: The counter in the 2nd floor break room in the AmeriStar office is 36-1/8" high where a maximum height of 34" is required.

Violation 37 - The counter in the 2nd floor break room in the AmeriStar office is 36-1/8" high where a maximum height of 34" is required.

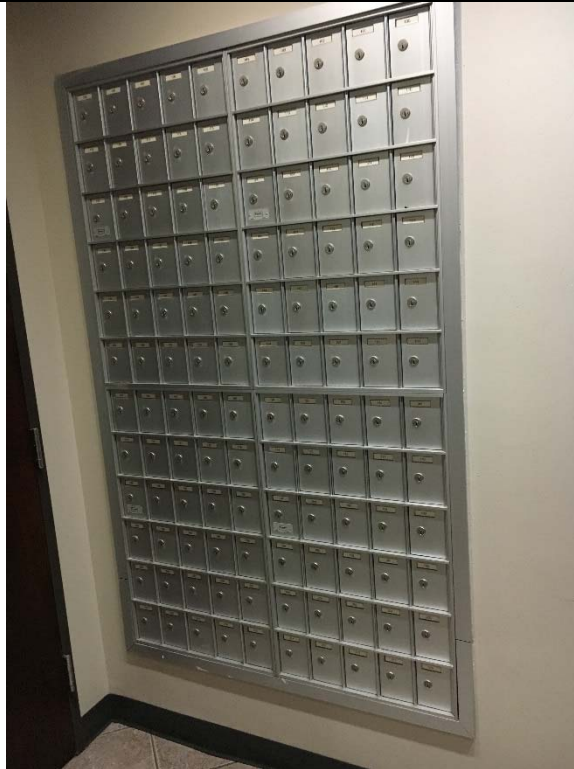
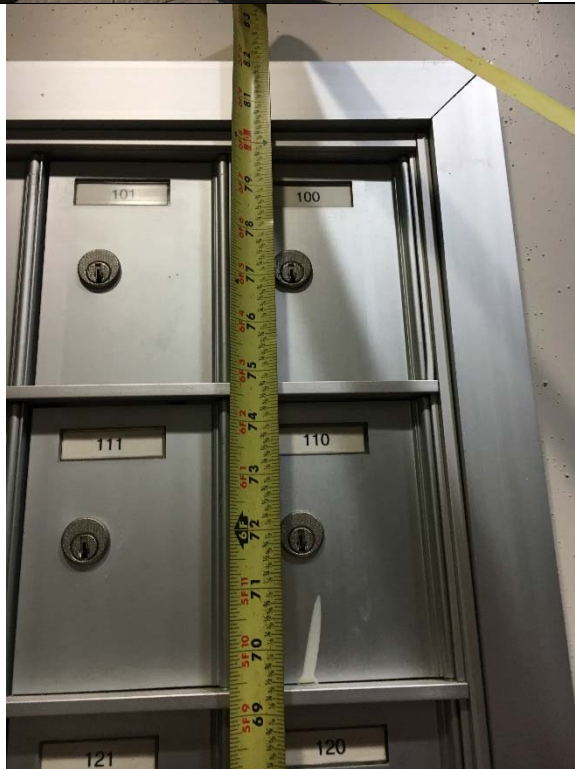
Violation 38 - The mailboxes provided for the tenant has the highest operable part at 77" above finished floor.

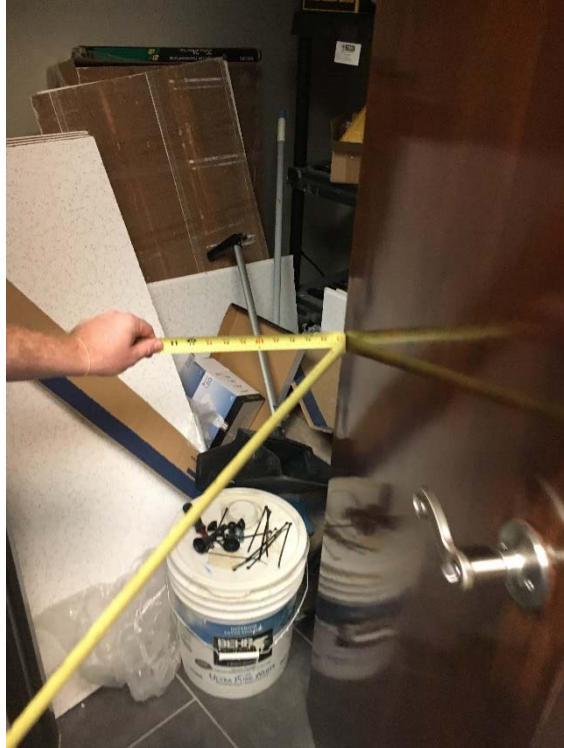
Violation 39 - The storage room in the restroom serving the lounge area has a door with a 21" opening. This storage room allows full access therefore the door width is required to have a 32" minimum opening for access.

Replace door with unit that provides 32" minimum clear width.

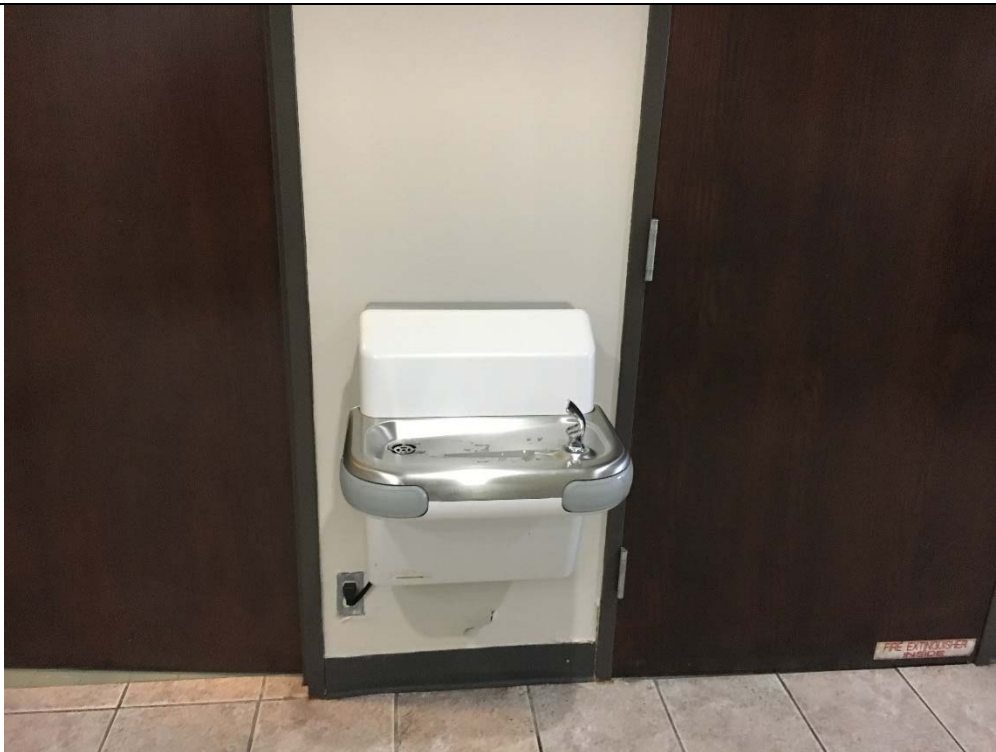
Violation 40 - There is only one drinking fountain provided on the first floor, where two are required.

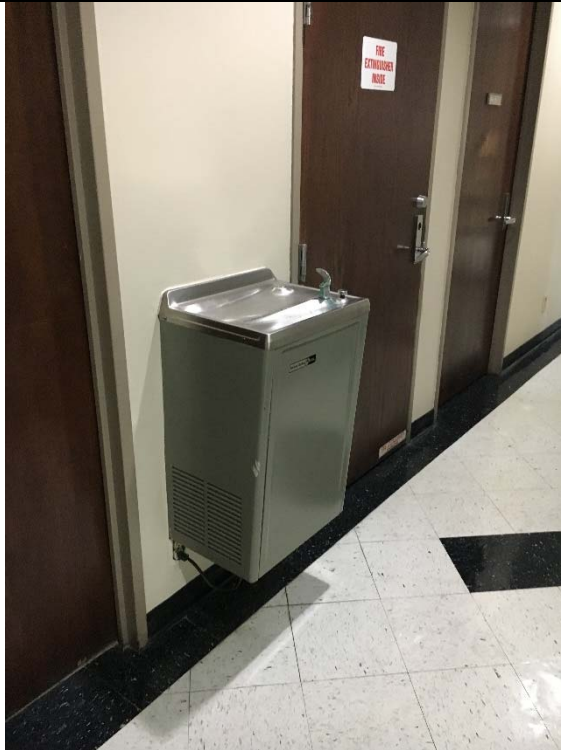
Violation 41 - There is only one drinking fountain provided on the second floor and it has no compliant features.

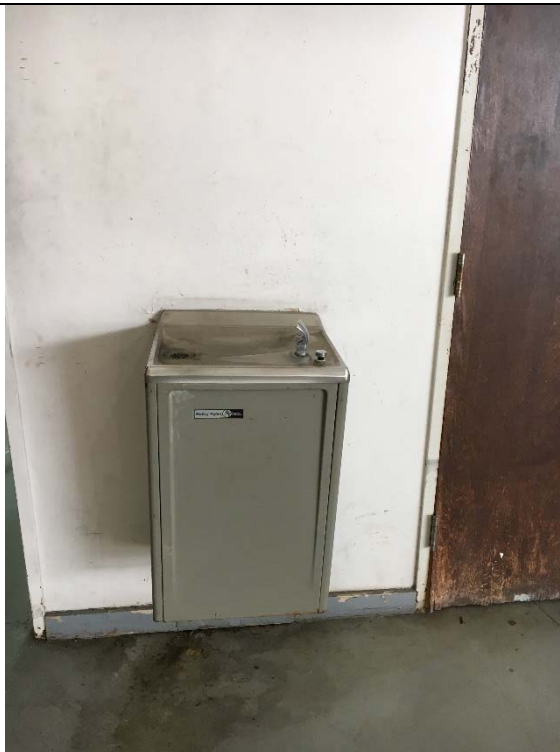
Violation 42 - There is only one drinking fountain provided in the warehouse and it has no compliant features.

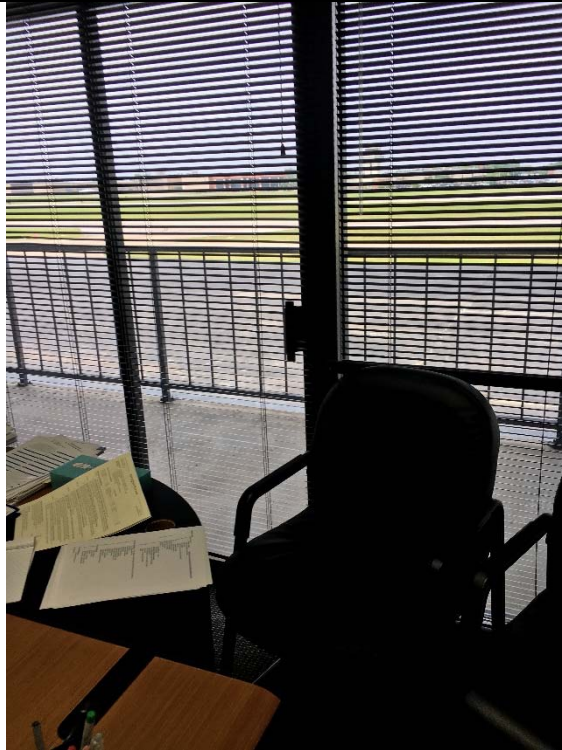
Violation 43 - One of the offices on the second floor office has sliding glass doors to go out on the balcony. The doors only have a 28" opening.

Replace door with unit that provides 32" minimum clear width.

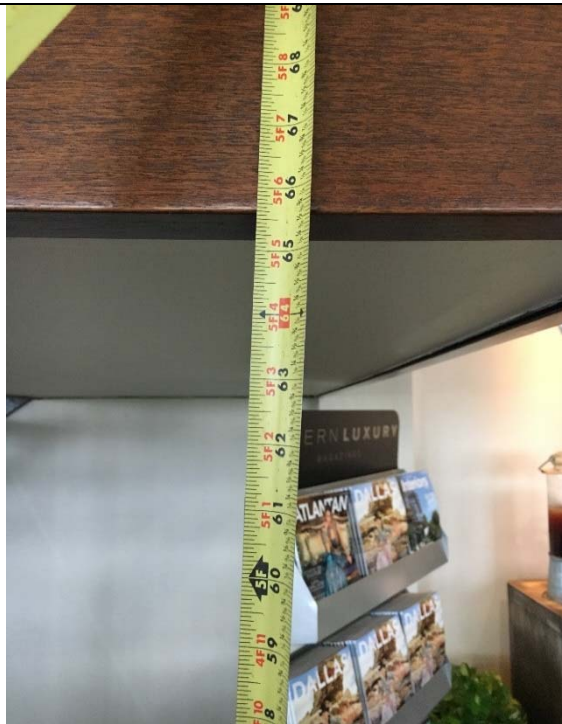
Violation 44 - The stairs in the lobby provide a vertical protrusion at 65-5/8" where a minimum of 80" clearance is required.
