## **Summary Sheet for 4551 Glenn Curtiss Drive**

## 4551 Glenn Curtiss Drive

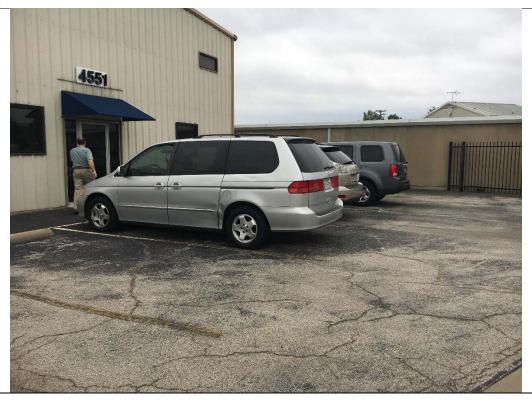
**Violation 1** - There are no accessible parking provided at this building.

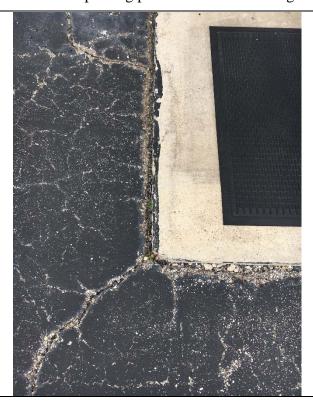
**Violation 2 -** The ground around the entrance is cracked and uneven with gaps up to 1-1/2" in some places.

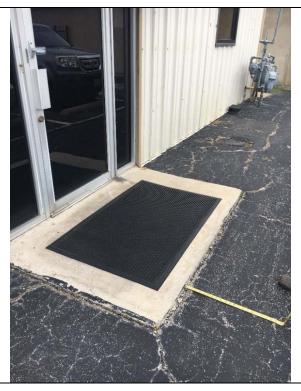
**Violation 3 -** There is not a 5' level maneuvering clearance on the pull side of the entrance door. The pavement drops off 1/2".

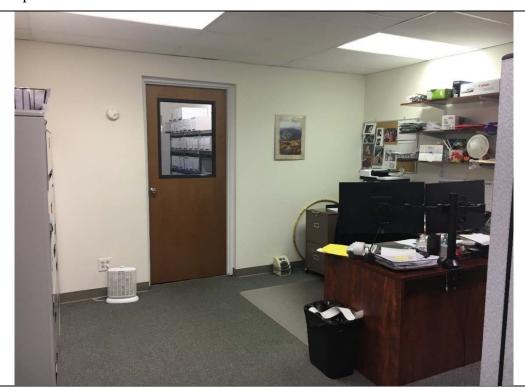
Standard:	2010 ADAAG 404.2.7 I	Door and Gate Hardware.		
Text:	Handles, pulls, latches, locks, and other operable parts on doors and gates shall comply with 309.4.			
Possible Solutions:	Replace door hardware with lever style door hardware.			
Violation #4 Cost:	\$3,150	Priority Level 2

**Violation 4 -** There are 8 interior doors with door hardware that requires grasping and twisting to operate.

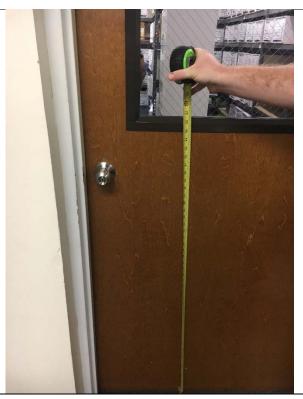
**Violation 5 -** The vision panel on the door leading into the storage room is at 46-3/8".

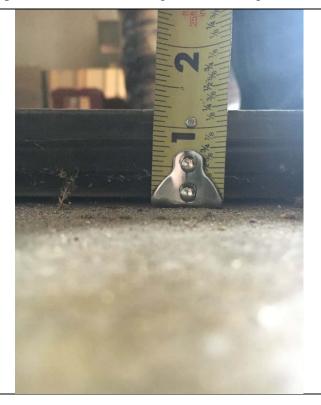
**Violation 6 -** The storage room in the warehouse has a 1-3/16" step to enter.

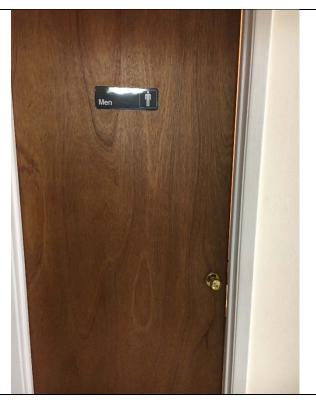
ADDISON AIRPORT BUILDING REPORT				
Facility Information:	Facility N	Name: 4551 Glenn Cu	artiss Drive	
Facility Contact: Lisa Pyles	Contact P	<b>Phone:</b> 972-450-2878		
Accessology Inspector Information	:			
Inspector: Karen Jackson@a		Da	te: May 3, 2017	
Latitude: 32.970644 Address: 4551 Glenn	9	itude: -96.833811 City: Addison	County: Dallas	
General Restroom Notes:				
	Ien's and a Women's single user r in substantial compliance.	restroom serving this fa	acility. Neither	
Is the door to the restroom substant Does the room have the required to Is the water closet substantially con Does the water closet have the required Is the lavatory substantially compliants the urinal substantially compliants the mirror substantially compliants.	urning radius? mpliant? uired clear floor space? iant? nt?		No	
Violation #7: The Men's re	estroom signage is mounted on th	ne door.		
Standard: 2010	ADAAG 703.1 General.

**Violation 7 -** The Men's restroom signage is mounted on the door.

Teyt: requi	s shall comply with 703. Where be red, either one sign with both vistate signs, one with visual, and or ided.	sual and tactile charact	ers, or two	
Possible Solutions: Insta	Il compliant signage on the wall	on the latch side of the	e door.	
Violation #7 Cost:	\$525 Prio	ority Level 6

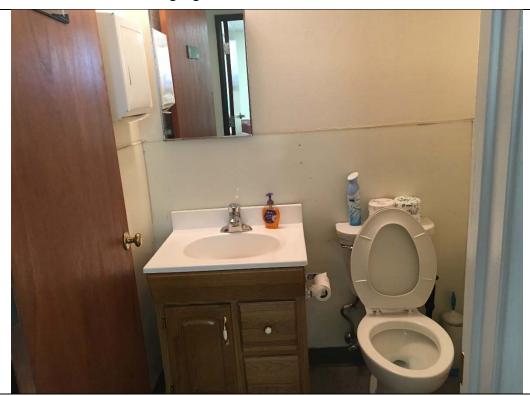
Violation #8: The Men's restroom is too small and does not have the required turning radius provided.

Standard: 2010 ADAAG 213.2 Toilet Rooms and Bathing Rooms.

**Text:** Where toilet rooms are provided, each toilet room shall comply with 603.

Violation 8 - The Men's restroom is too small and does not have the required turning radius provided.

Enlarge restroom to accommodate accessible water closet, lavatory and wheelchair turning space.

Violation #8 Cost: \$8,400 Priority Level 4

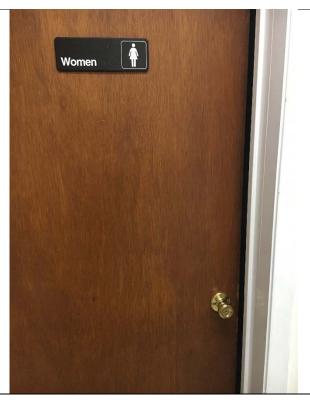
**Violation #9:** The Women's restroom signage is mounted on the door.

Standard: 2010 ADAAG 703.1 General.

Signs shall comply with 703. Where both visual and tactile characters are required, either one sign with both visual and tactile characters, or two separate signs, one with visual, and one with tactile characters, shall be provided.

**Violation 9 -** The Women's restroom signage is mounted on the door.

**Possible Solutions:** Install compliant signage on the wall on the latch side of the door.

Violation #9 Cost: \$525 Priority Level 6

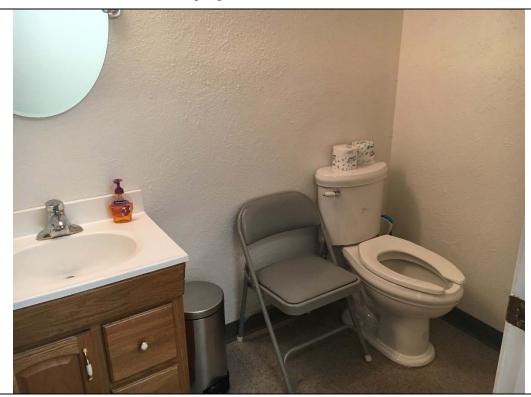
Violation #10: The Women's restroom is too small and does not have the required turning radius provided.

Standard: 2010 ADAAG 213.2 Toilet Rooms and Bathing Rooms.

$oldsymbol{Violation 10}$  - The Women's restroom is too small and does not have the required turning radius provided.

ADDISON AIRPORT - 4551 Glenn Curtiss Drive Restrooms - Page 3	
Text:	Where toilet rooms are provided, each toilet room shall comply with 603.	
Possible Solutions:	Enlarge restroom to accommodate accessible water closet, lavatory and wheelchair turning space.	
Violation #10 Cost:	\$8,400 Priority Level 4	
	High Priority 1-4	
Restrooms Total	\$17,850 Medium Priority 5-8	
	Low Priority 9-12

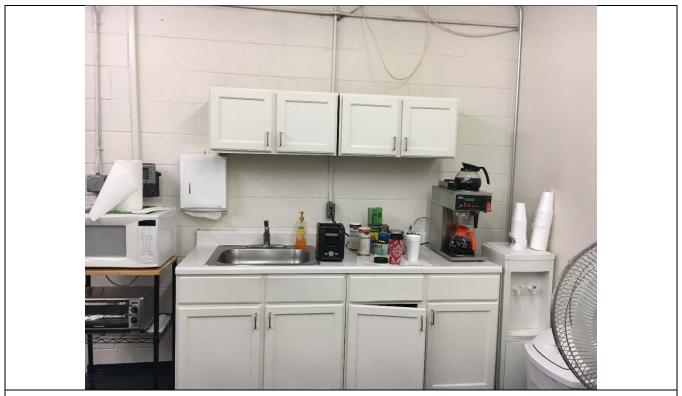
DISON AIRPORT LDING REPORT	
Facility Information:		Facility Name: 4551 Glenn C	Curtiss Drive
Facility Contact: Lisa	a Pyles	<b>Contact Phone:</b> 972-450-2878	3
Accessology Inspector Info	ormation:		
<b>Inspector:</b> Kar <b>Email:</b> Kja	en Jackson ckson@accessology.com	D	ate: May 3, 2017
Latitude: 32.9	970644	<b>Longitude:</b> -96.833811	
Address: 455	1 Glenn Curtiss Drive	City: Addison	County: Dallas
General Break Room Note The	ere is one break room that se	erves this facility.	
Does the facility have a breast list here a stove or cooktop. Is there a sink? Is the sink substantially cooker the counters at 34" aff	? mpliant?		Yes No Yes No No
Violation #11:	breakroom sink is at 35-1/2	2" high where 34" maximum is req	uired.
Standard:	2010 ADAAG 606.3 La	avatories and Sinks Height.	
Text:		all be installed with the front of the 4 inches maximum above the finish	_
Possible Solutions:	Modify sink to provide	34" maximum height.

**Violation 11 -** The breakroom sink is at 35-1/2" high where 34" maximum is required.

Violation #11 Cost:	\$2,100	Priority Level 4	
Break Rooms Total	\$2,100	High Priori Medium Prio Low Priori	5-8
