**ADDISON AIRPORT
BUILDING REPORT**

Facility Information: Facility Name: 4553 Glenn Curtiss Drive
Facility Contact: Lisa Pyles Contact Phone: 972-450-2878

Accessology Inspector Information:
Inspector: Karen Jackson Date: May 3, 2017
Email: Kjackson@accessology.com

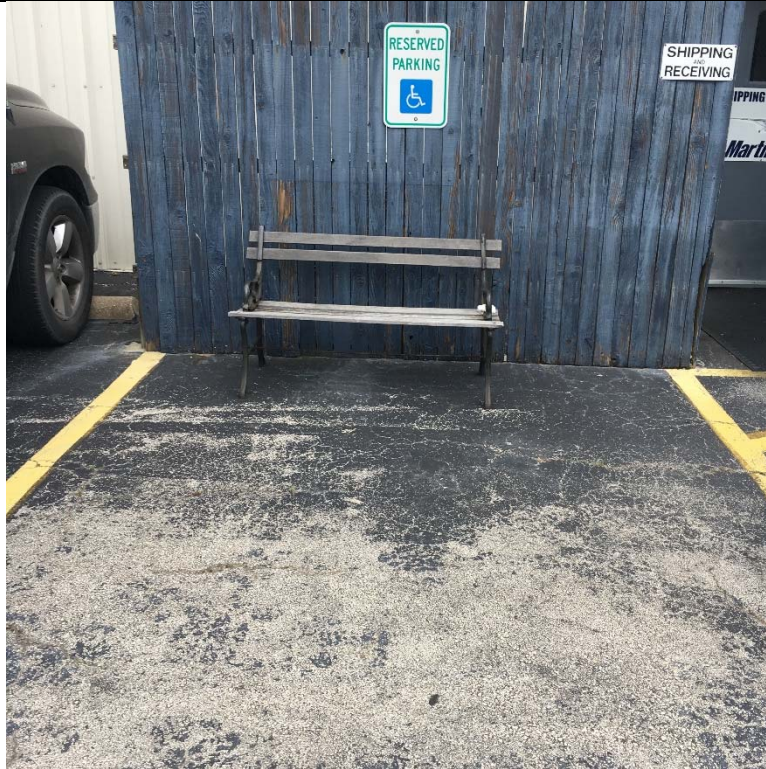
Violation #1: The left accessible space has a bench sitting in it blocking access for a vehicle to park.

Standard: 2010 ADAAG 502.7 Relationship to Accessible Routes.

Violation 1 - The left accessible space has a bench sitting in it blocking access for a vehicle to park.

Possible Solutions: Remove from the accessible parking space.

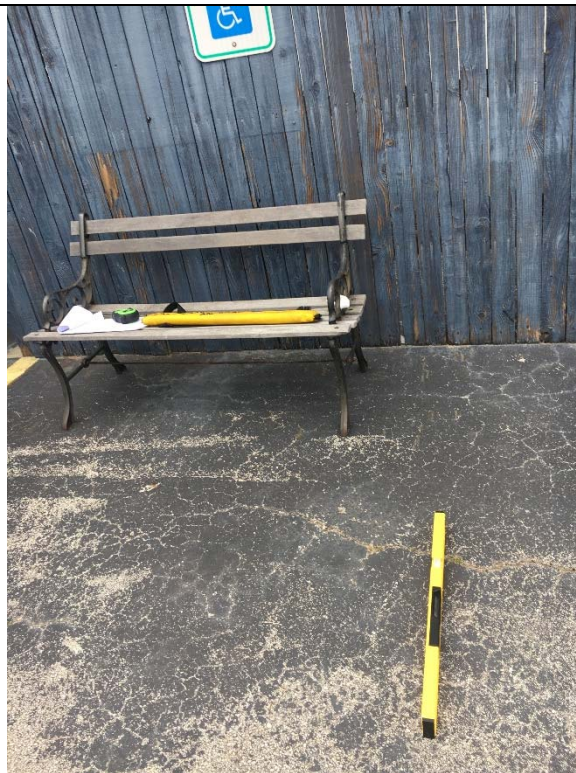
Violation #2: The left accessible space has a 3.5% running slope.

Standard: **2010 ADAAG 502.4 Floor or Ground Surfaces.**

Violation 2 - The left accessible space has a 3.5% running slope.

Possible Solutions: Regrade accessible parking space to achieve 1:48 (2.08%) maximum slope in all directions.

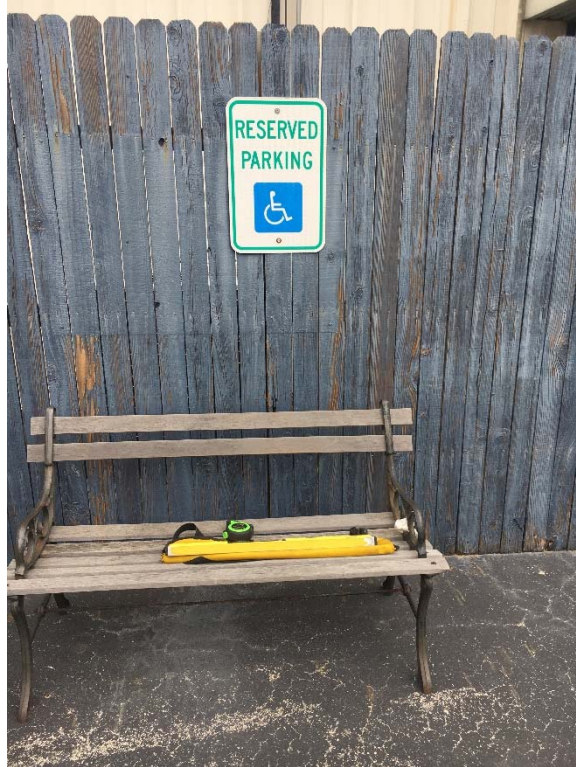
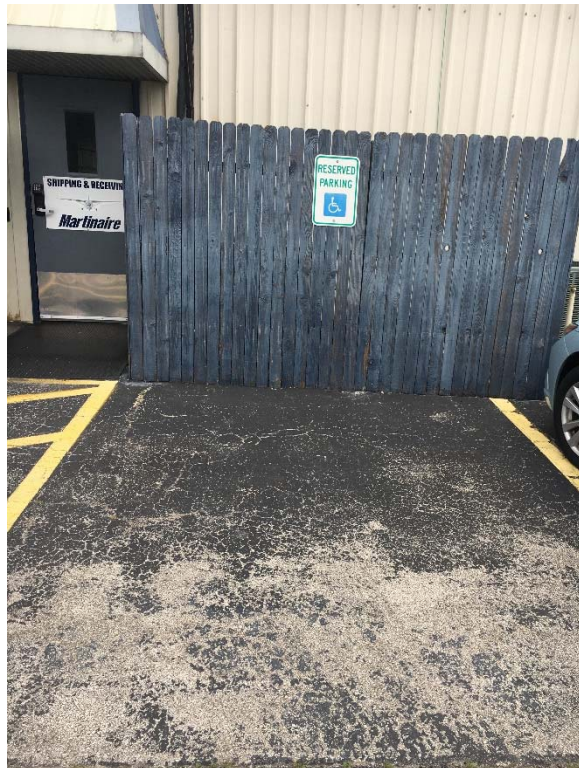
Violation #3: There are no "van Accessible" parking spaces provided.

Standard: **2010 ADAAG 502.6 Identification.**

Violation 3 - There are no "van Accessible" parking spaces provided.

Possible Solutions: Install van accessible signage.

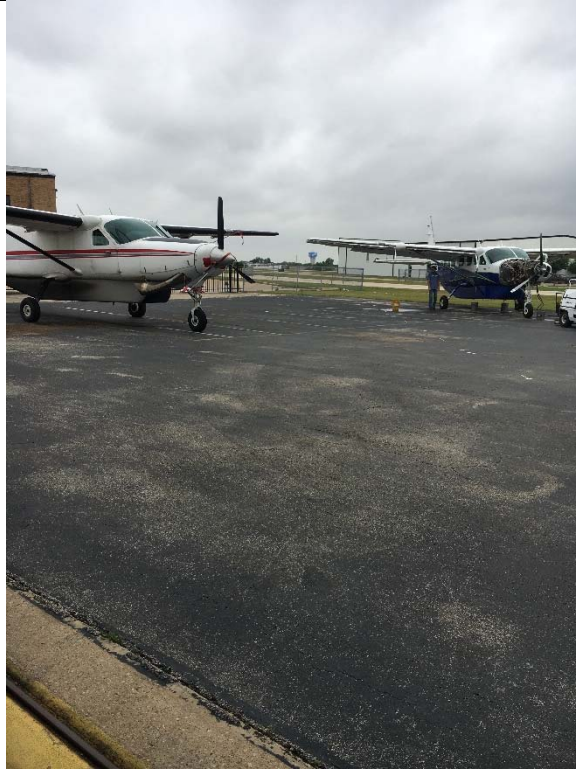
Violation #4: The exterior hangar area has 7 parking spaces provided, none of which are accessible. Airplanes are parked in the spaces.

Standard: **2010 ADAAG 208.1 General.**

Violation 4 - The exterior hangar area has 7 parking spaces provided, none of which are accessible. Airplanes are parked in the spaces.

Provide an accessible parking space with a compliant access aisle and signage.

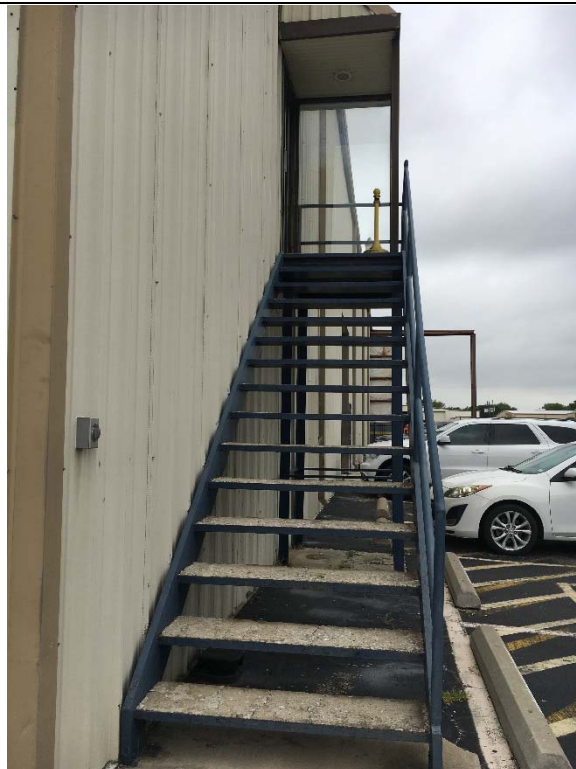
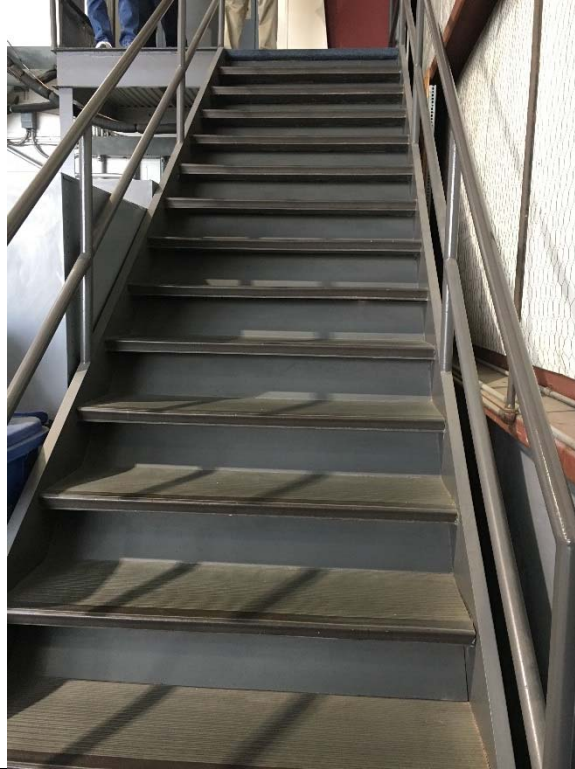
Violation #5: There is no accessible route to the 2nd floor of the building.

Standard: 2010 ADAAG 206.2.3 Multi-Story Buildings and Facilities.

Violation 5 - There is no accessible route to the 2nd floor of the building.

Possible Solutions: Add a fully compliant elevator when needed to accommodate an employee if an accommodation can not be made in a more accessible location. Until the elevator is needed, it's a low priority.

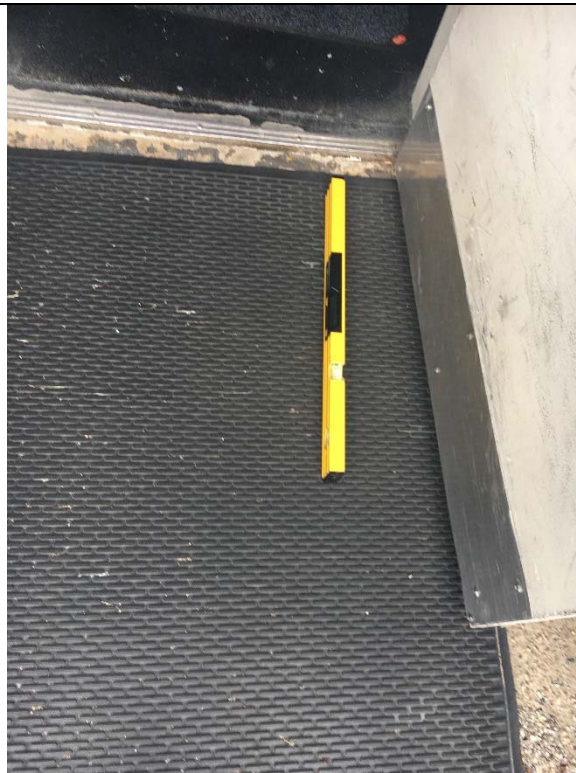
Violation #6: The landing at the main entrance into the building has a 4% slope.

Standard: 2010 ADAAG 404.2.4.4 Floor or Ground Surface.

Violation 6 - The landing at the main entrance into the building has a 4% slope running up to it.

Possible Solutions: Remove and replace paving to achieve slopes no greater than 2% in all directions.

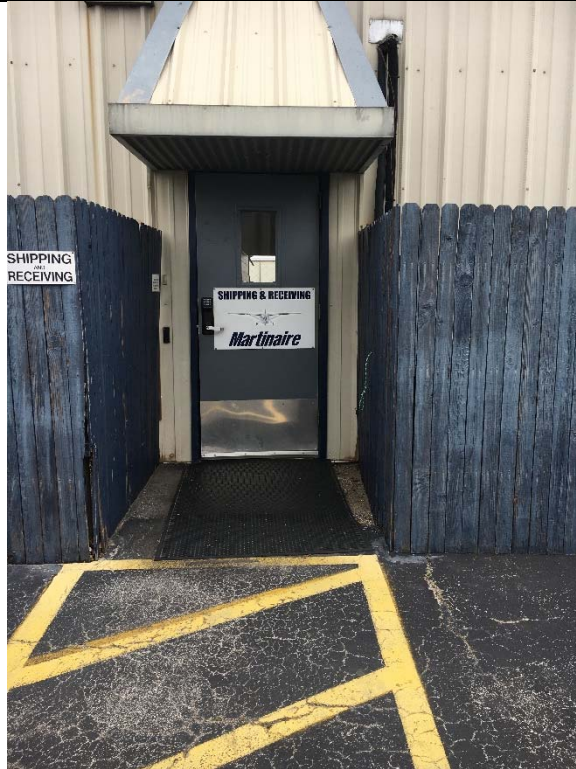
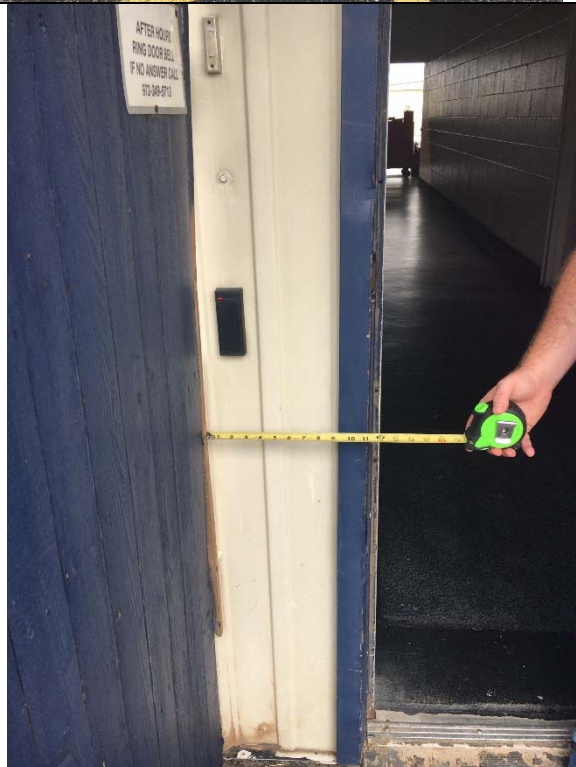
Violation #7: There is only an 11" maneuvering clearance on the pull side at the entrance door.

Standard: 2010 ADAAG 404.2.4.1 Swinging Doors and Gates

Violation 7 - There is only an 11" maneuvering clearance on the pull side at the entrance door.

Modify entrance to provide the 18" minimum required maneuvering clearance.

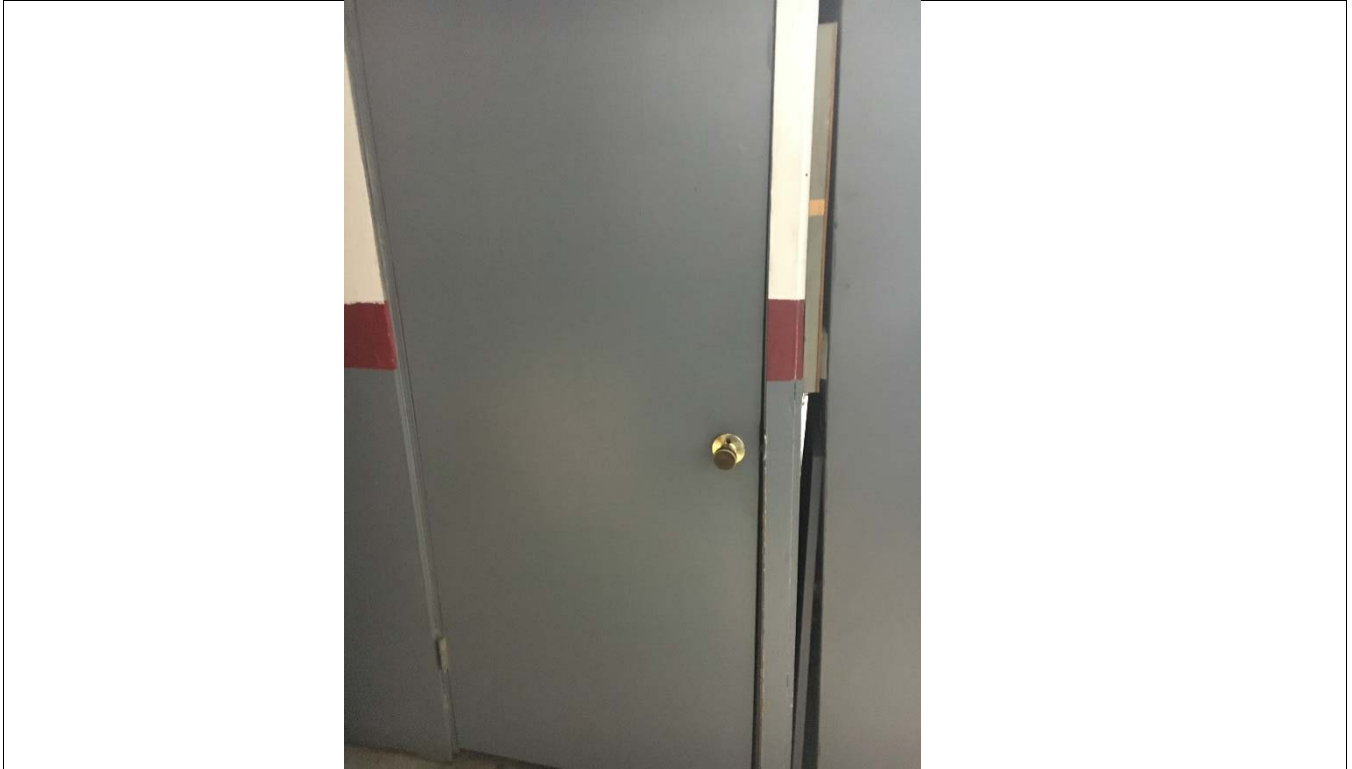
There are approximately 10 doors throughout the facility that have door hardware that requires twisting and grasping to operate.

2010 ADAAG 404.2.7 Door and Gate Hardware.

Violation 8 - There are approximately 10 doors throughout the facility that have door hardware that requires twisting and grasping to operate.

Replace door hardware with lever type hardware.

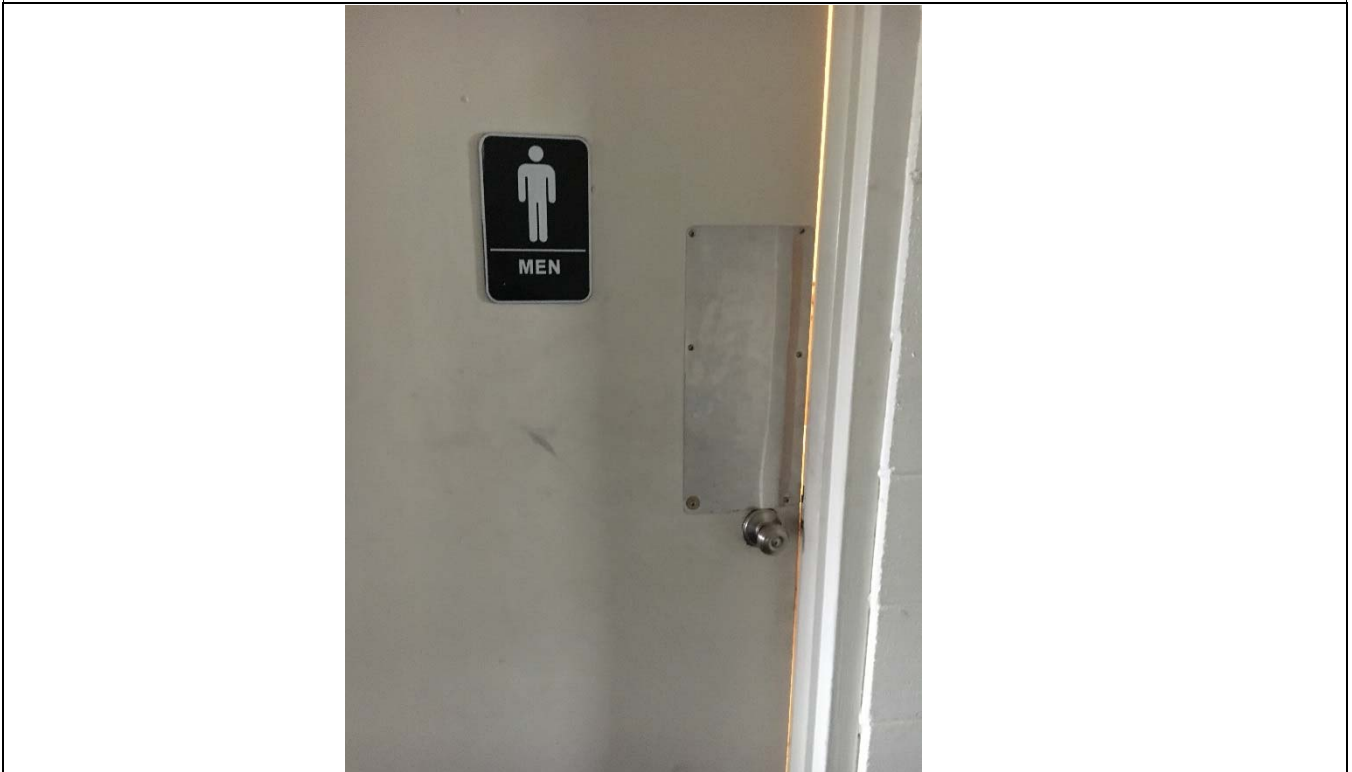
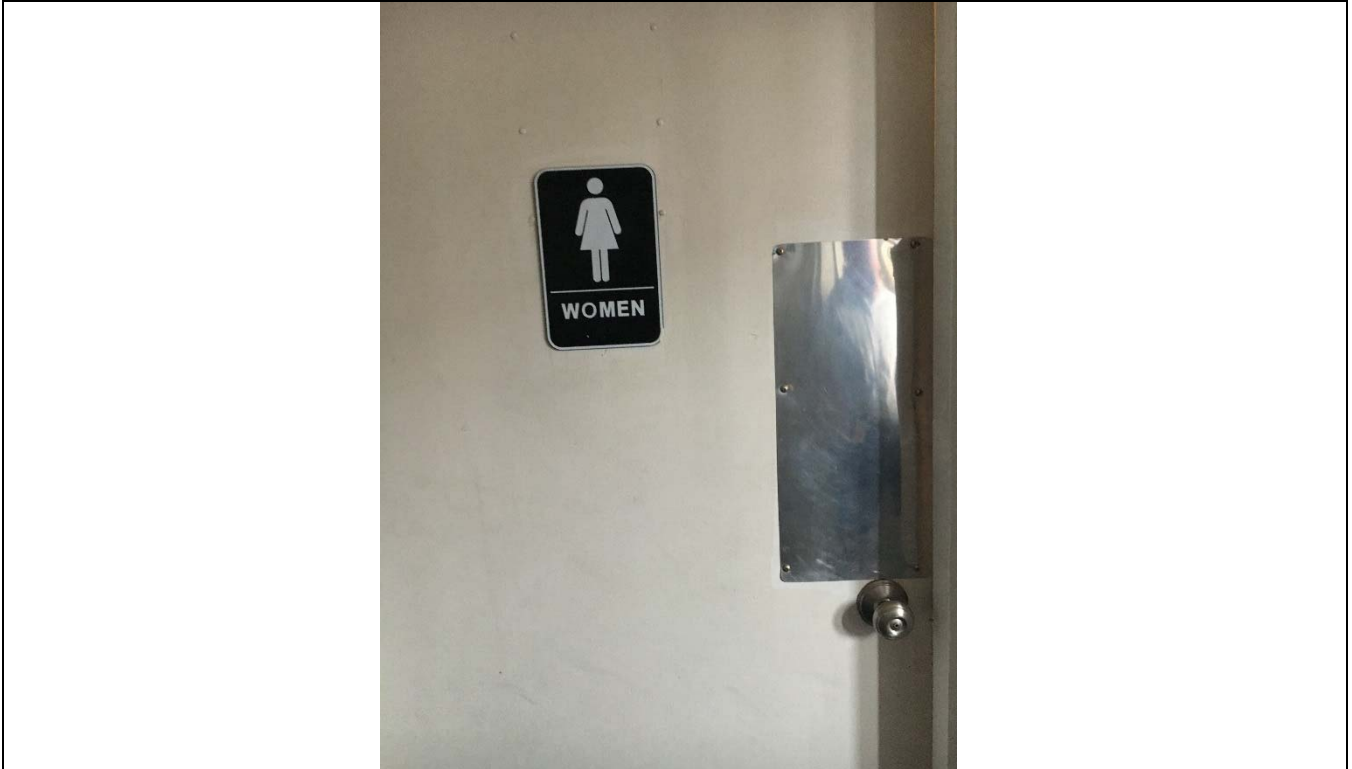
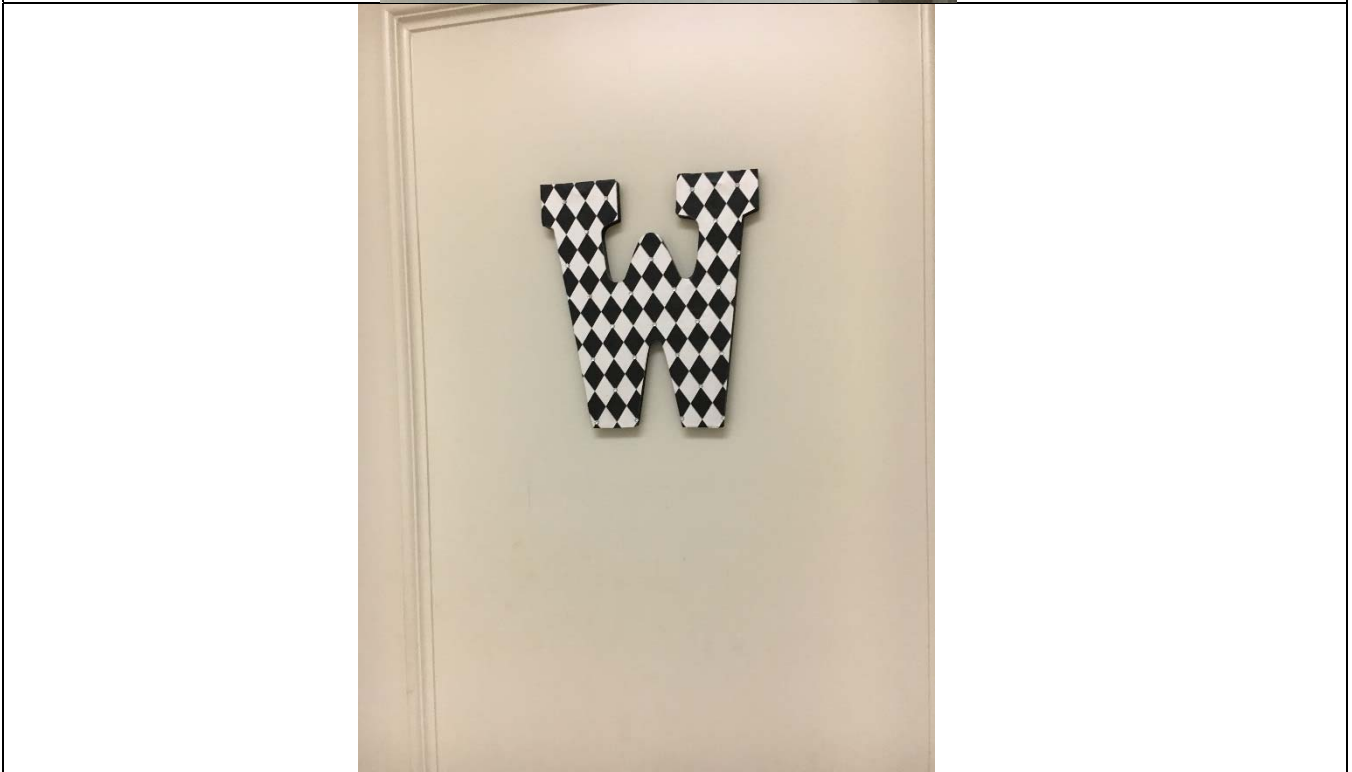
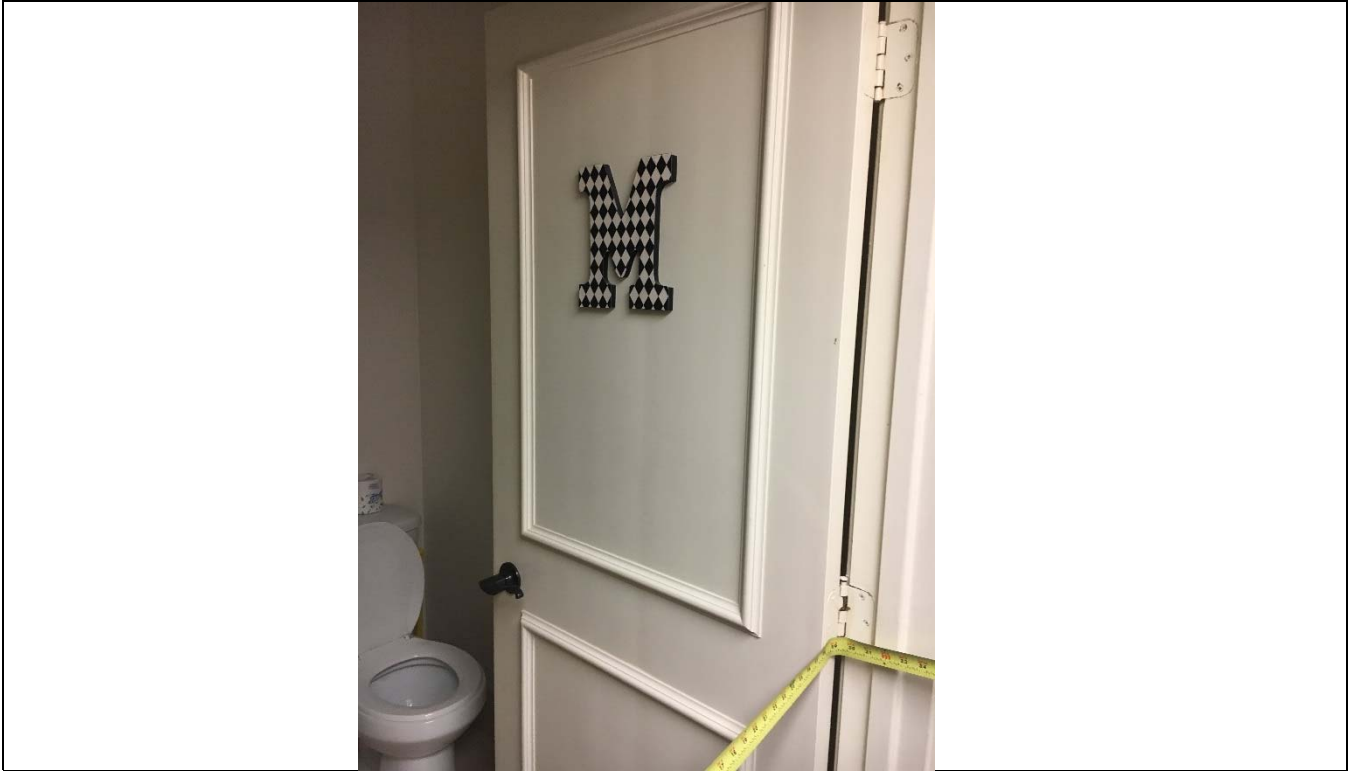
Restroom signage on both the first and second floors are not compliant.

2010 ADAAG 216.2 Designations.

Violation 9 - Restroom signage on both the first and second floors are not compliant.

Provide new compliant signs for the men's and women's restrooms and install on the latch side of the door.

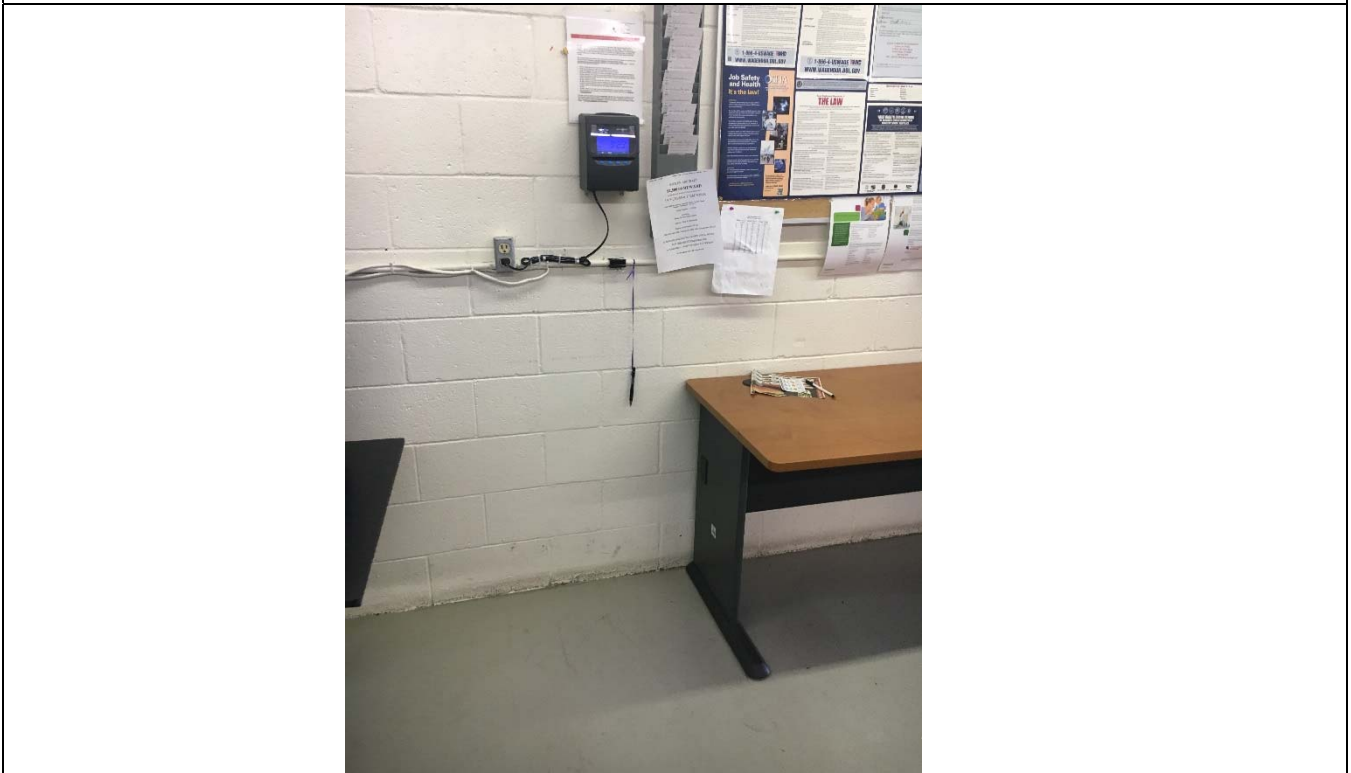
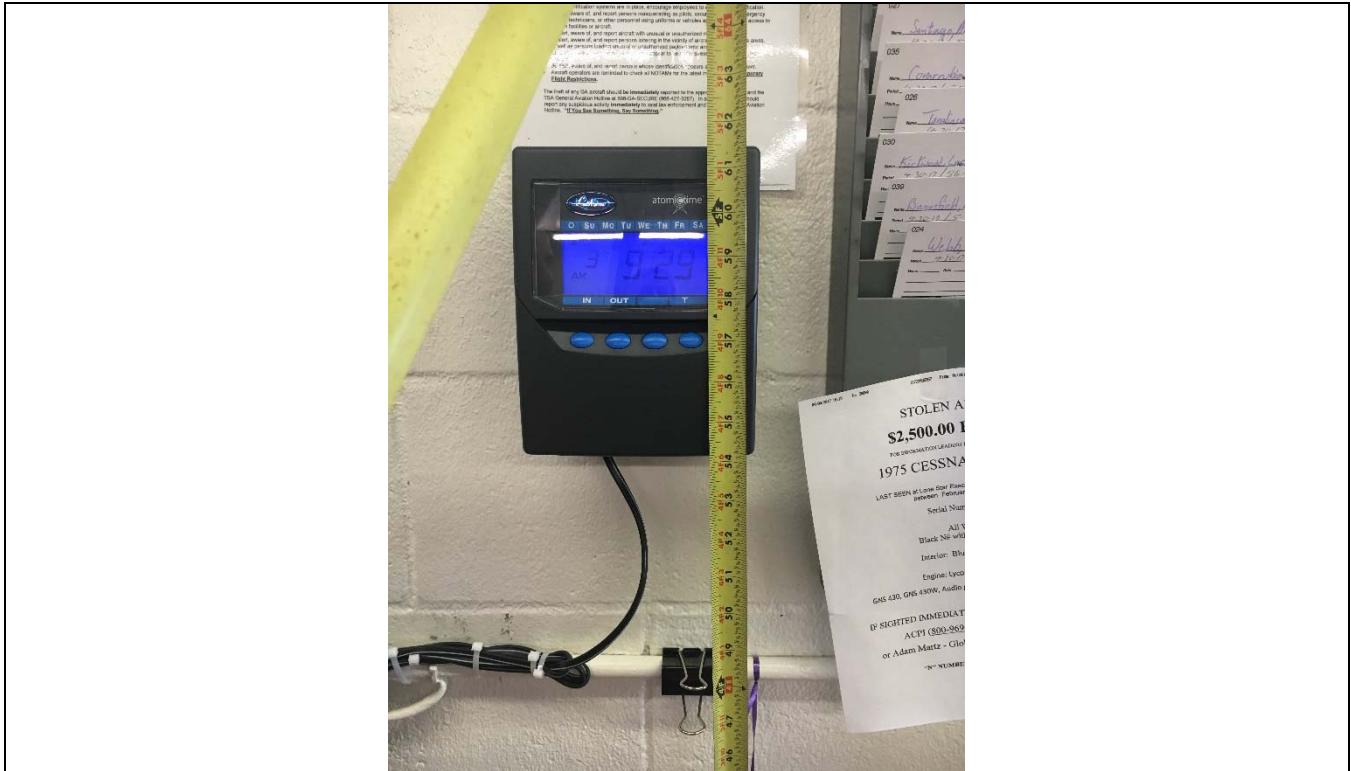
The time clock located in the break room is mounted with the highest operable part at 57" above finished floor where 48" maximum is required.

2010 ADAAG 308.2.1 Unobstructed.

Violation 10 - The time clock located in the break room is mounted with the highest operable part at 57" above finished floor where 48" maximum is required.

Lower the time clock so the highest operable part is no more than 48" above finished floor.

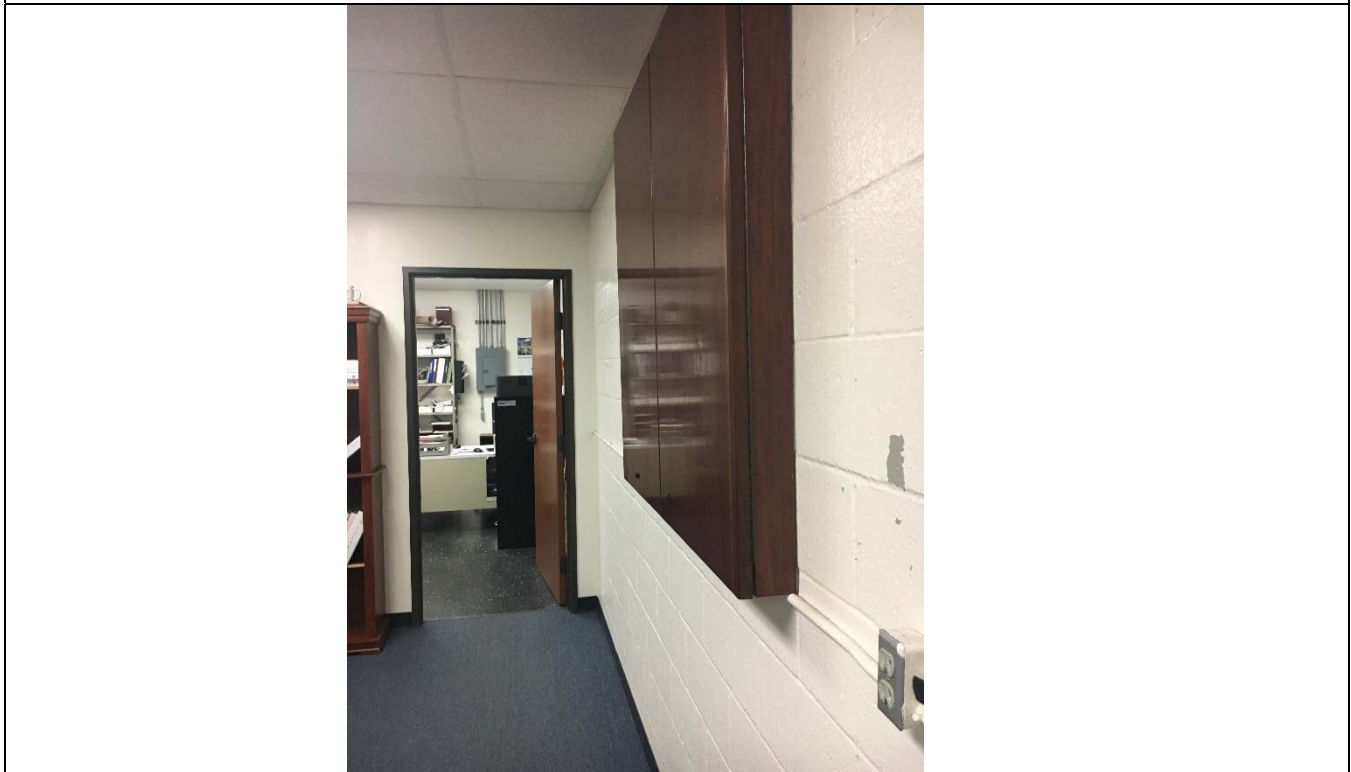
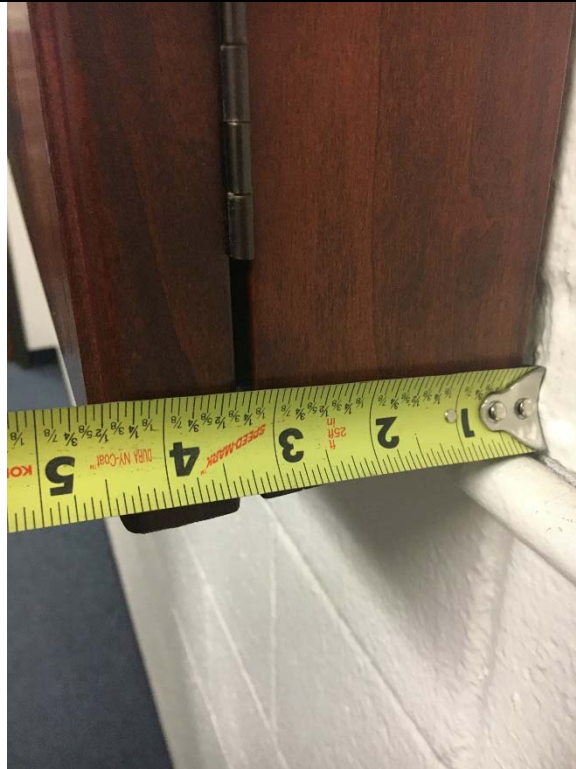
The white board cabinet provided in the conference room protrudes into the path of travel 4-5/8".

2010 ADAAG 307.2 Protrusion Limits.

Violation 11 - The white board cabinet provided in the conference room protrudes into the path of travel 4-5/8".

Remove whiteboard cabinet or relocate so that its leading edge is 27" maximum above the floor.

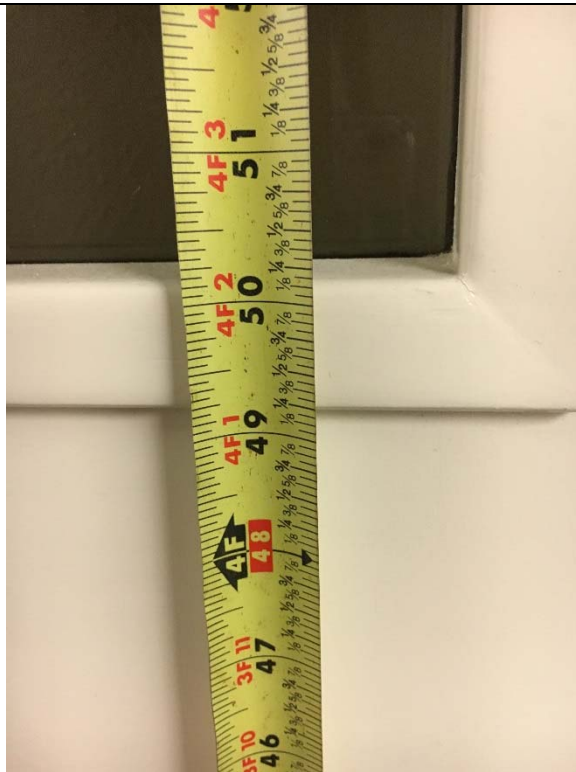
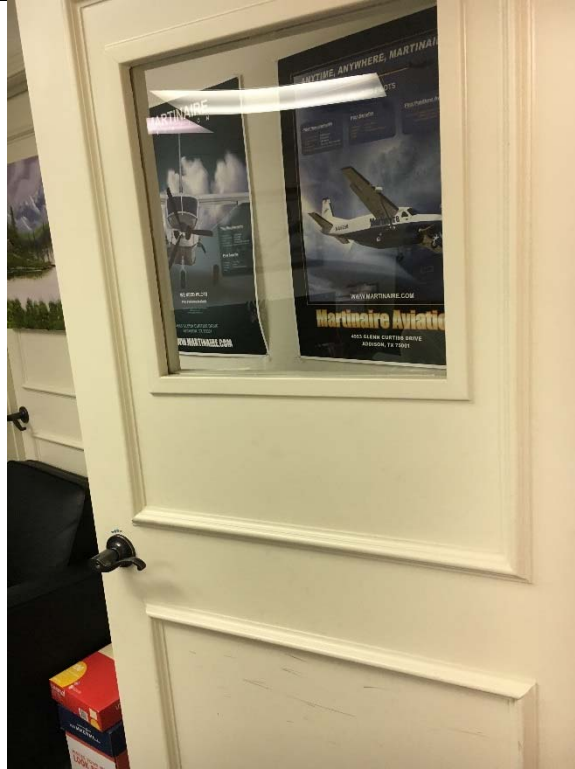
There are 4 office doors on the 2nd floor with vision lights that are above the required 43" above finished floor.

2010 ADAAG 404.2.11 Vision Lights.

Violation 12 - There are 4 office doors on the 2nd floor with vision lights that are above the required 43" above finished floor.

Replace doors with vision panels that are 43" maximum high.

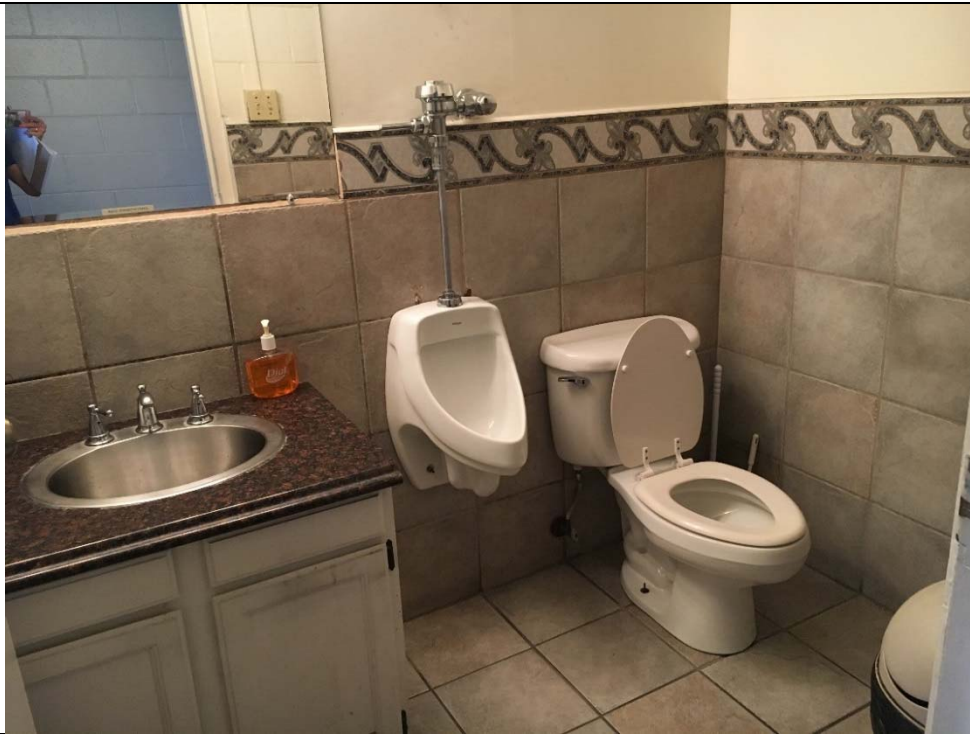
The Men's restroom on the first floor is too small and does not have the required turning radius provided.

2010 ADAAG 213.2 Toilet Rooms.

Violation 13 - The Men's restroom on the first floor is too small and does not have the required turning radius provided.

Remove urinal and lavatory base cabinet to provide the required clear floor space.

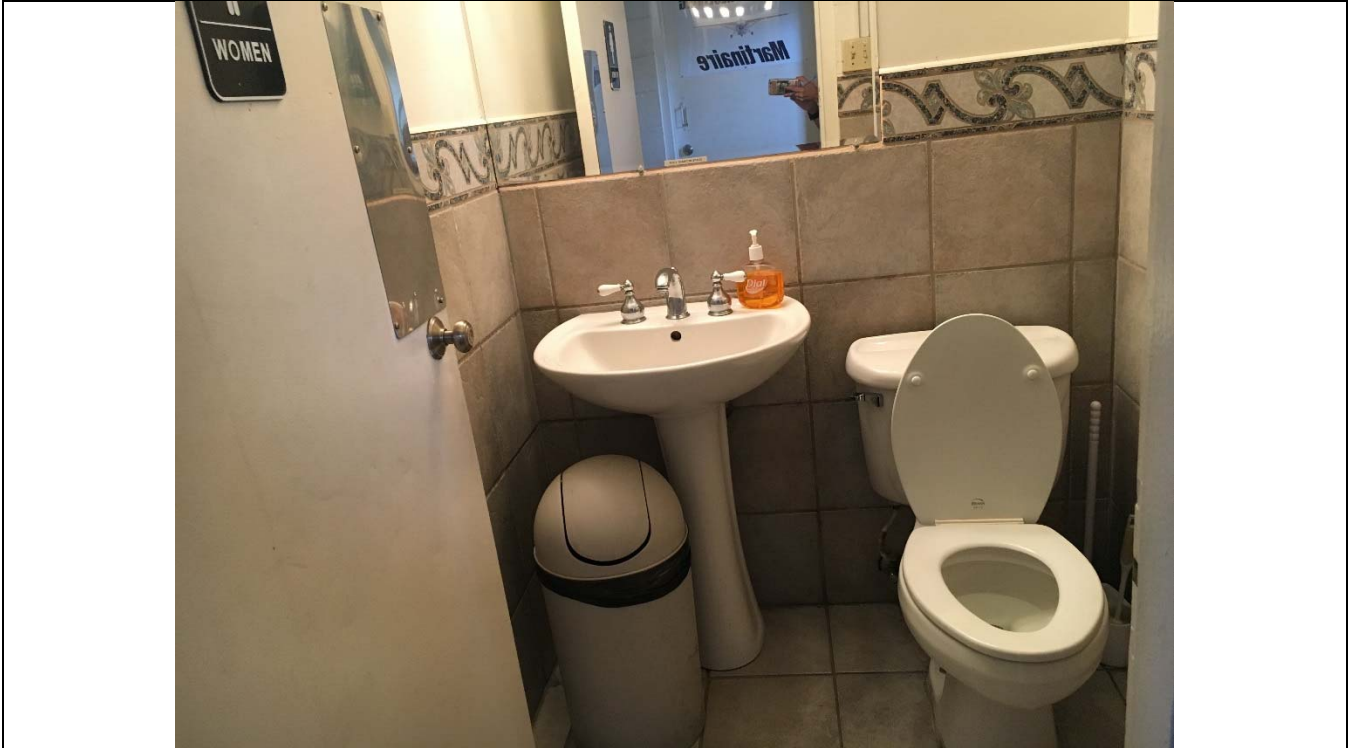
The Women's restroom on the first floor is too small and does not have the required turning radius provided.

Violation 14 - The Women's restroom on the first floor is too small and does not have the required turning radius provided.

Enlarge restroom to accommodate accessible water closet, lavatory and wheelchair turning space.

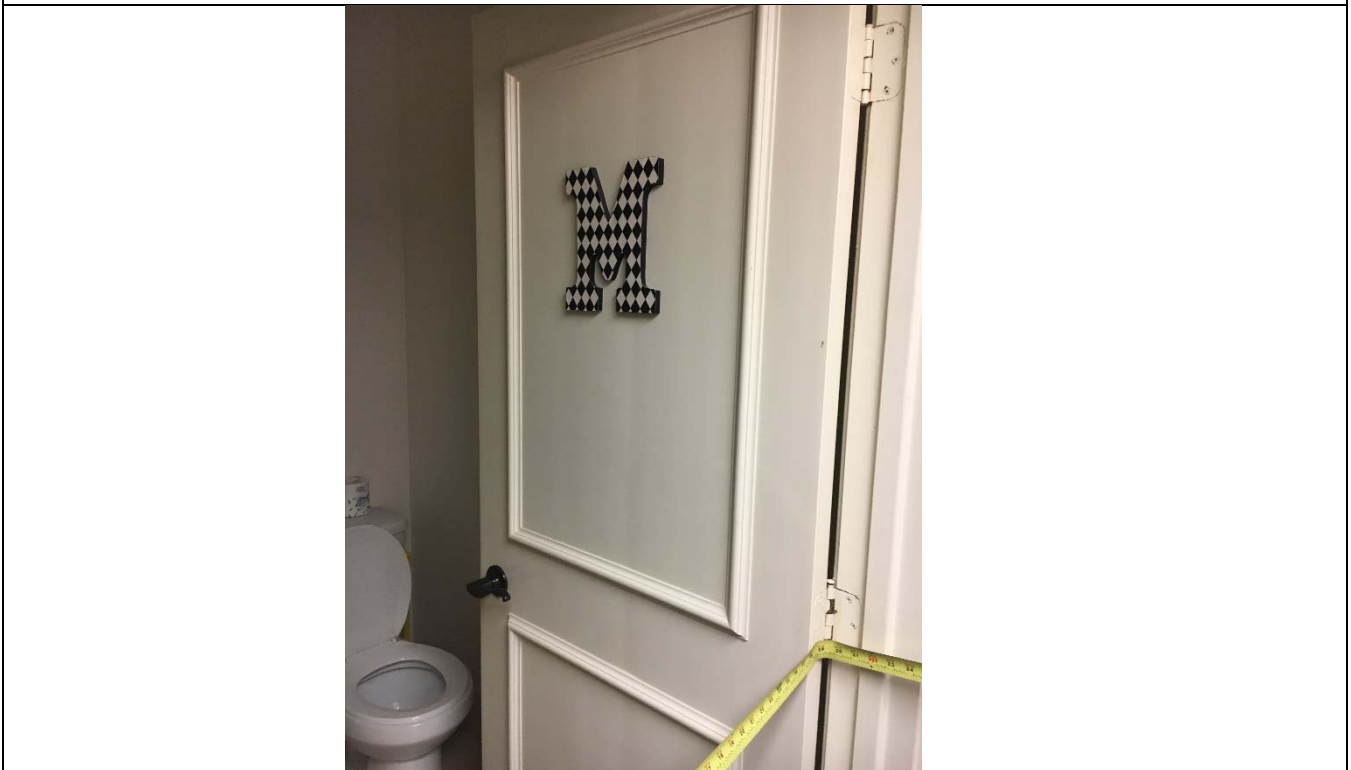
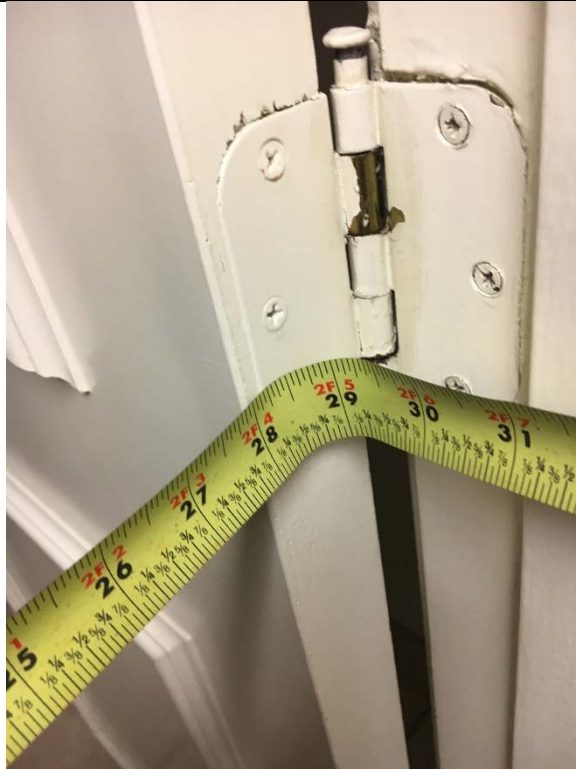
Men's and Women's restroom doors on the 2nd floor only have a 28" opening.

2010 ADAAG 404.2.3 Clear Width.

Violation 15 - Men's and Women's restroom doors on the 2nd floor only have a 28" opening.

Replace doors to achieve 32" minimum clear width and swing doors outward.

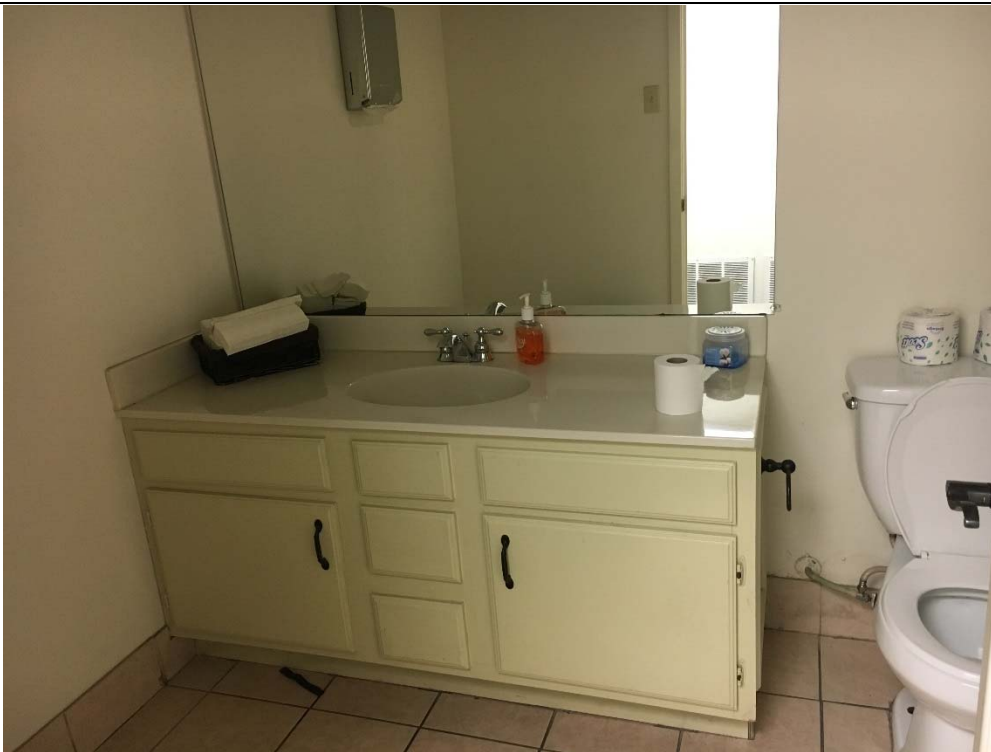
The Men's restroom on the second floor is too small and does not have the required turning radius provided.

Violation 16 - The Men's restroom on the second floor is too small and does not have the required turning radius provided.

Possible Solutions: Enlarge restroom to accommodate accessible water closet, lavatory and wheelchair turning space.

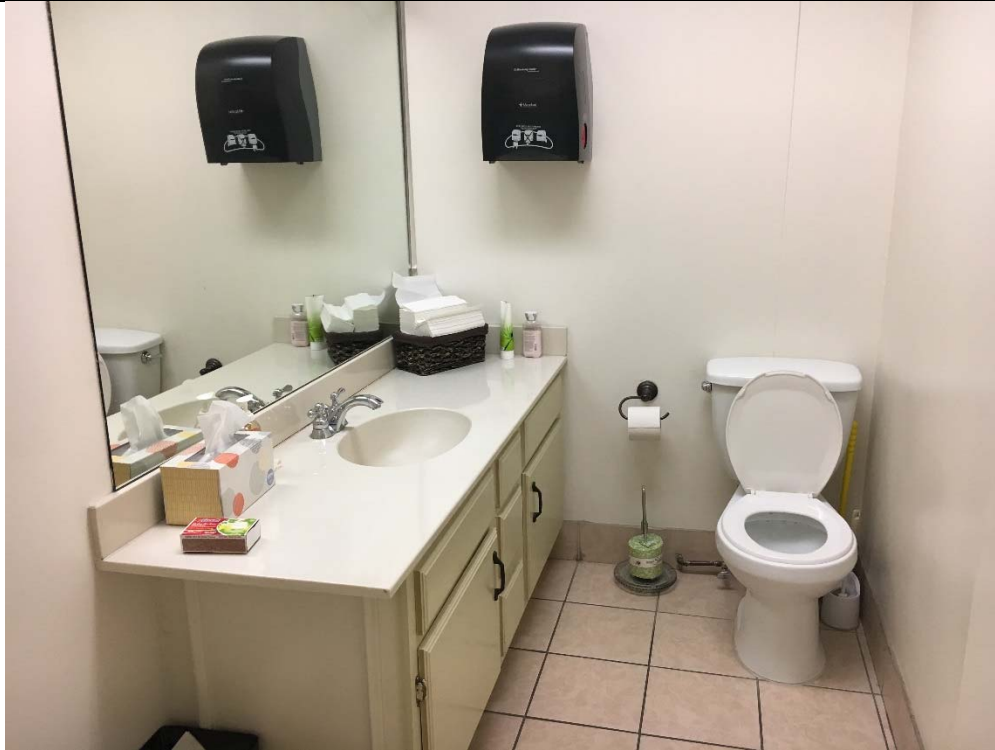
Violation #17: The Women's restroom on the second floor is too small and does not have the required turning radius provided.

Violation 17 - The Women's restroom on the second floor is too small and does not have the required turning radius provided.

Possible Solutions: Enlarge restroom to accommodate accessible water closet, lavatory and wheelchair turning space.

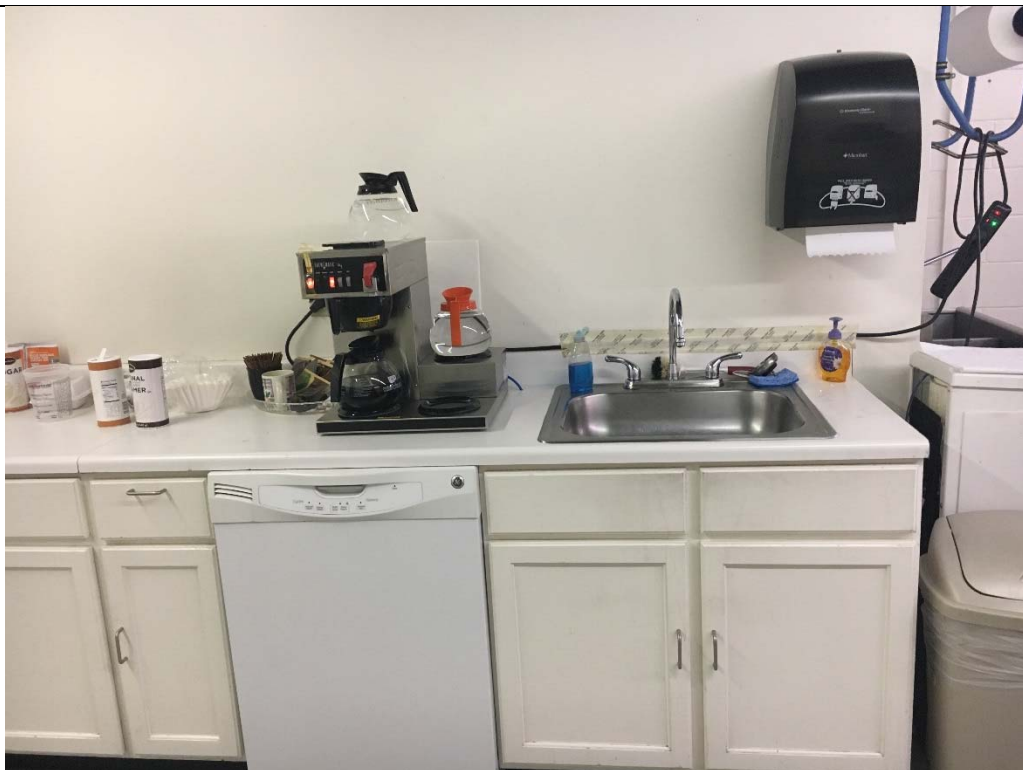
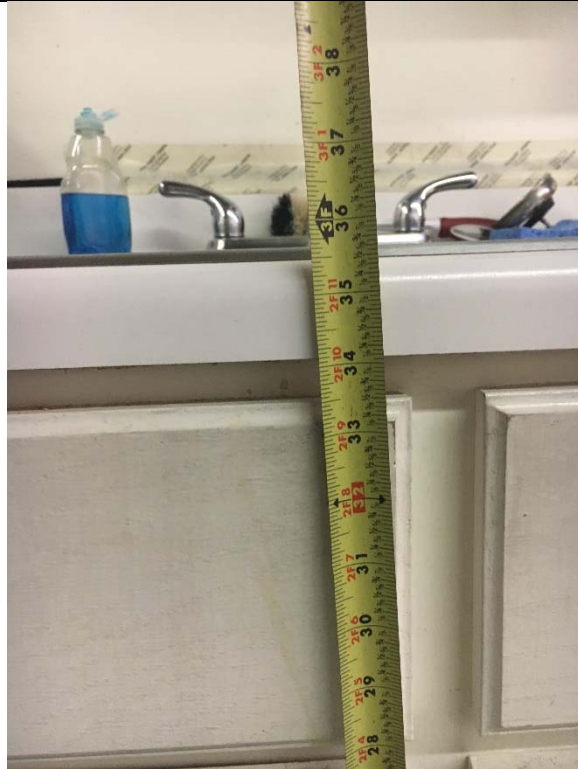
Violation #18: The break room sink on the first floor is at 35-1/2" where a maximum of 34" is required.

Standard: **2010 ADAAG 606.3 Lavatories and Sinks Height.**

Violation 18 - The break room sink on the first floor is at 35-1/2" where a maximum of 34" is required.

Possible Solutions: Modify sink to provide 34" maximum height.
