**ADDISON AIRPORT
BUILDING REPORT**

Facility Information: Facility Name: 4553 Glenn Curtiss Drive
Facility Contact: Lisa Pyles Contact Phone: 972-450-2878

Accessology Inspector Information:
Inspector: Karen Jackson Date: May 3, 2017
Email: Kjackson@accessology.com

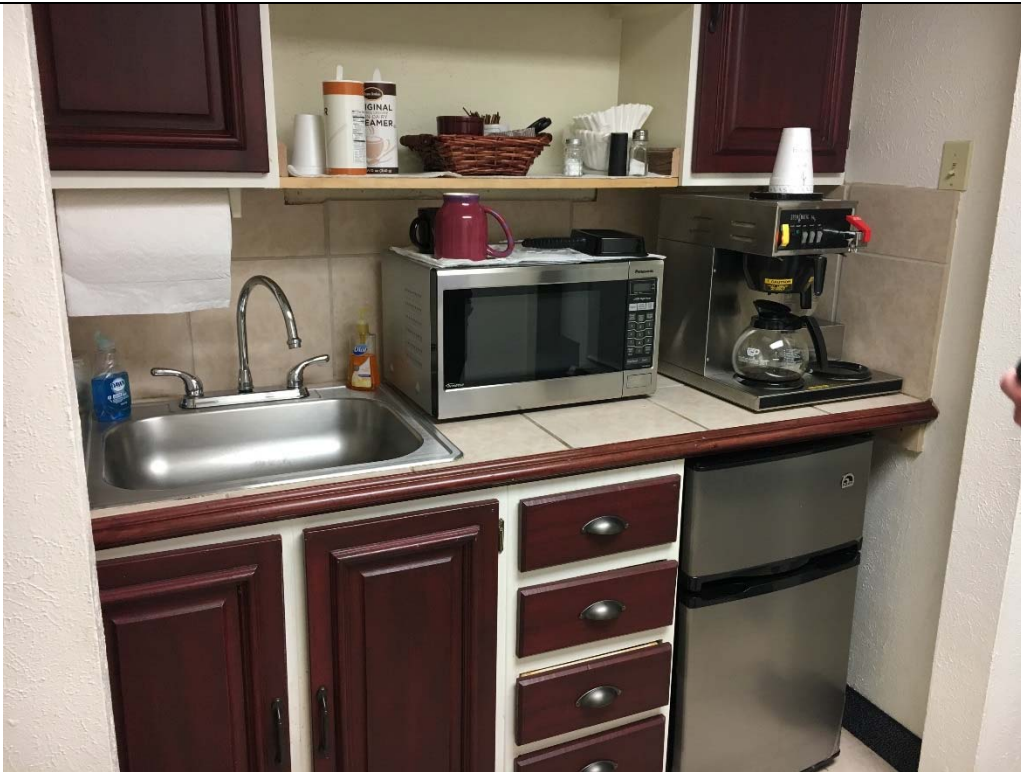
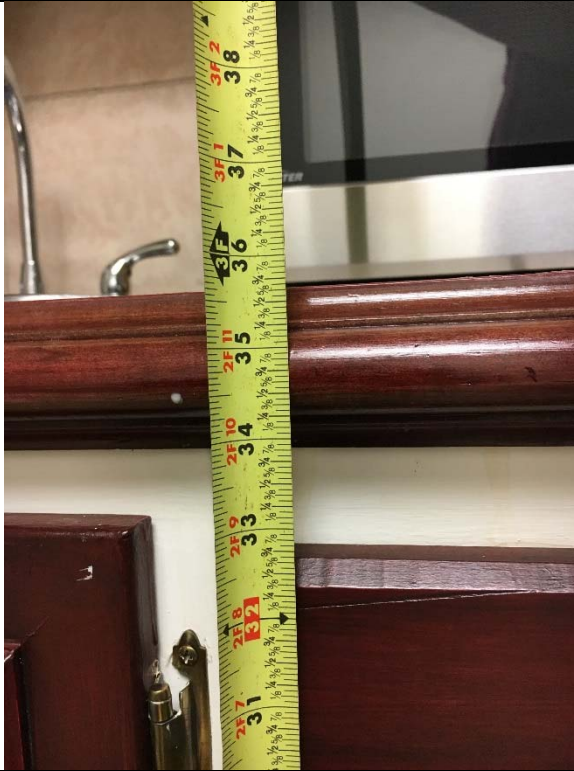
Violation #19: The sink in the break room on the second floor is at 35-5/8" where a maximum of 34" is required.

2010 ADAAG 606.3 Lavatories and Sinks Height.

Violation 19 - The sink in the break room on the second floor is at 35-5/8" where a maximum of 34" is required.

Modify sink to provide 34" maximum height.
