**ADDISON AIRPORT
BUILDING REPORT**

Facility Information: **Facility Name:** 4555 Glenn Curtiss Drive

Accessology Inspector Information:

Inspector: Karen Jackson **Date:** May 3, 2017

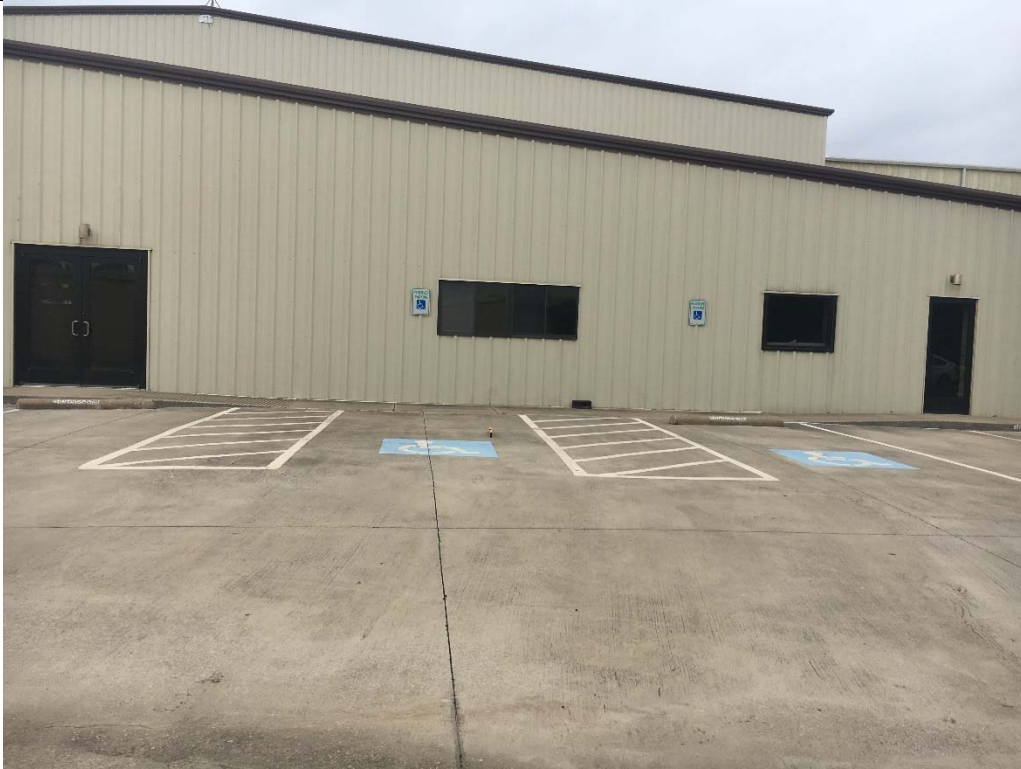
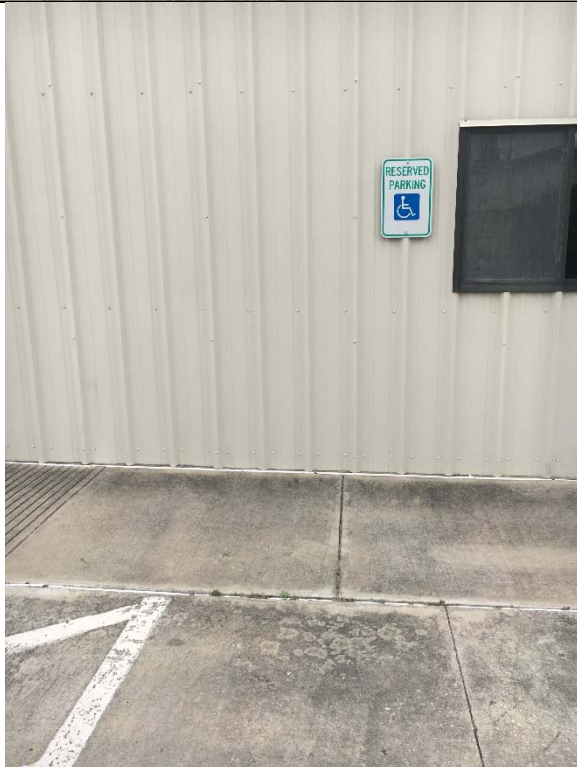
There are two accessible parking spaces provided at the side of the building, neither of them are designated as van accessible.

2010 ADAAG 502.2 Vehicle Spaces.

Car parking spaces shall be 96" wide min. and van parking spaces shall be 132" wide min., shall be marked to define the width, and shall have an adjacent access aisle complying with 502.3. EXCEPTION: Van parking spaces shall be permitted to be 96" wide minimum where the access aisle is 96" wide min.

Violation 1 - There are two accessible parking spaces provided at the side of the building, neither of them are designated as van accessible.

Add van accessible signage to the right accessible space. Restripe the access aisles so it is 96" wide to serve the accessible parking space that will be designated as "van accessible."

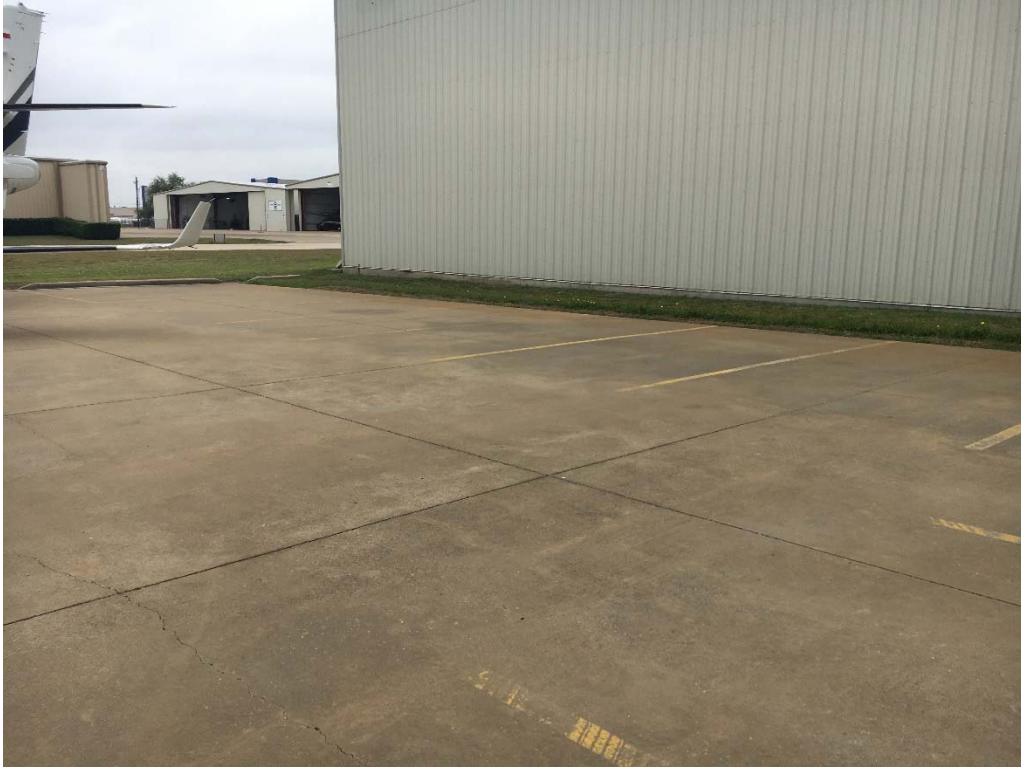
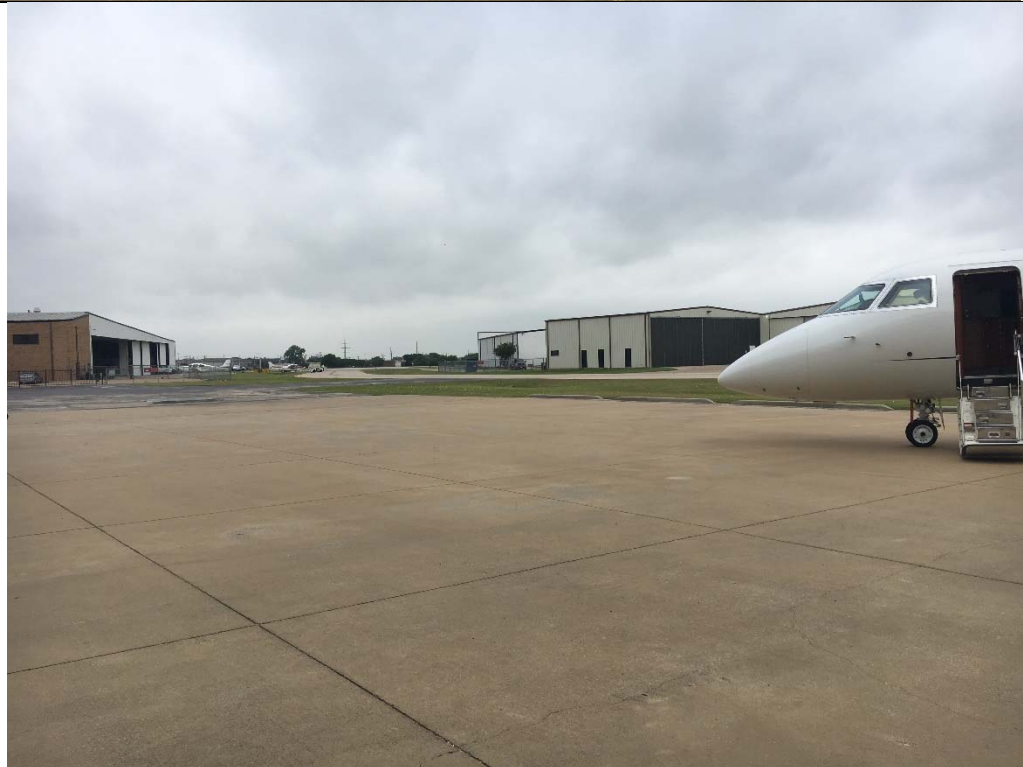
There are no accessible parking spaces provided in the back hangar parking area.

2010 ADAAG 208.1 General.

Violation 2 - There are no accessible parking spaces provided in the back hangar parking area.

Add a van accessible parking space, access aisle and complaint parking signage.

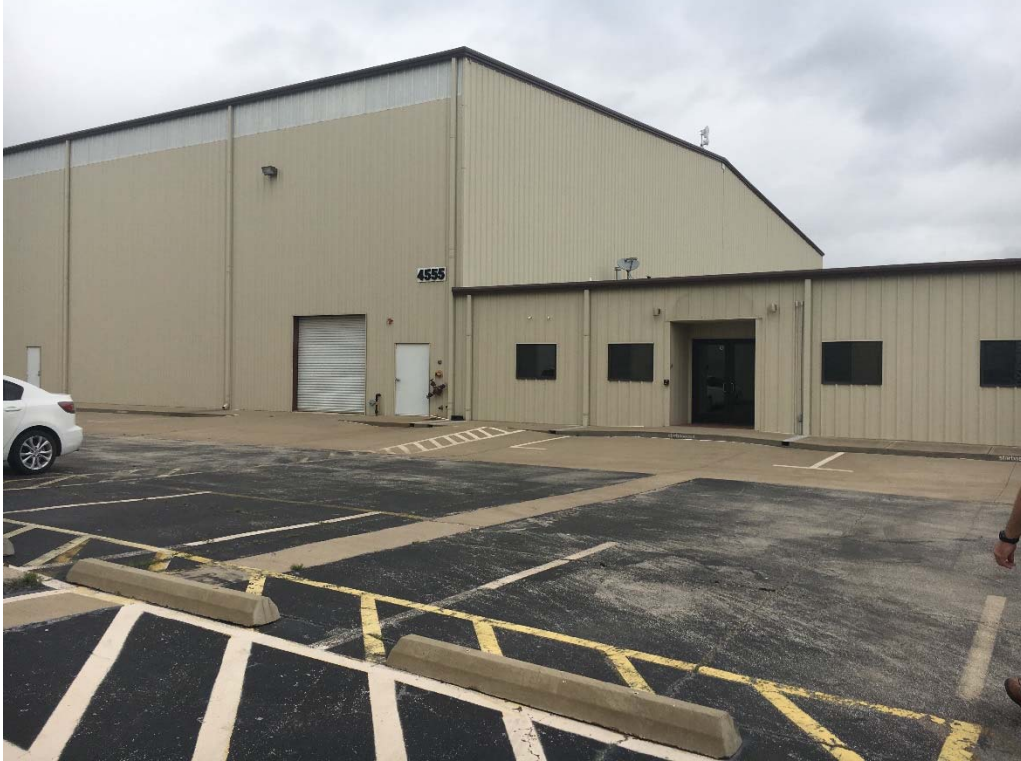
The accessible parking is not located on the shortest accessible route to the main entrance. There are no accessible spaces in the front lot to serve the main building entrance.

2010 ADAAG 208.3.1 General.

Parking spaces complying with 502 that serve a particular building or facility shall be located on the shortest accessible route from parking to an entrance complying with 206.4.

Violation 3 - The accessible parking is not located on the shortest accessible route to the main entrance. There are no accessible spaces in the front lot to serve the main building entrance.

Add accessible parking, access aisle and parking signage to the front parking area.

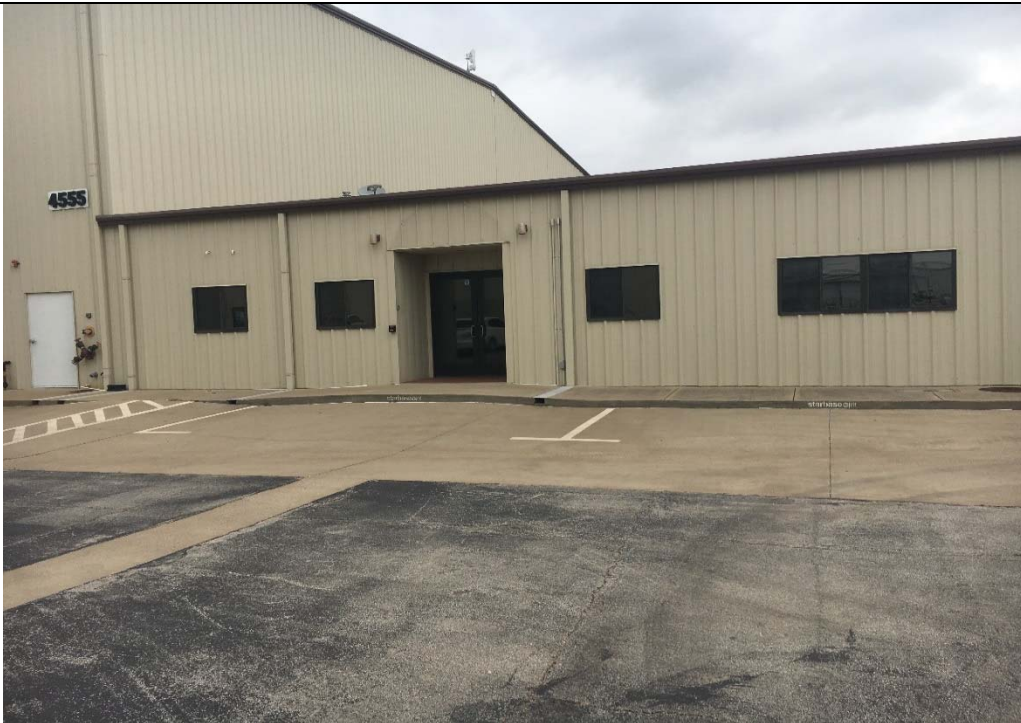
The route from the front parking lot to the building is not compliant. The parking lot as well as the sidewalk leading to the main building entrance has excessive slopes.

2010 ADAAG 403.3 Slope.

The running slope of walking surfaces shall not be steeper than 1:20 (5%).
The cross slope of walking surfaces shall not be steeper than 1:48 (2%).

Violation 4 - The route from the front parking lot to the building is not compliant. The parking lot as well as the sidewalk leading to the main building entrance has excessive slopes.

Repave that path of travel leading from the front parking area (where accessible parking should be provided) to the building entrance.

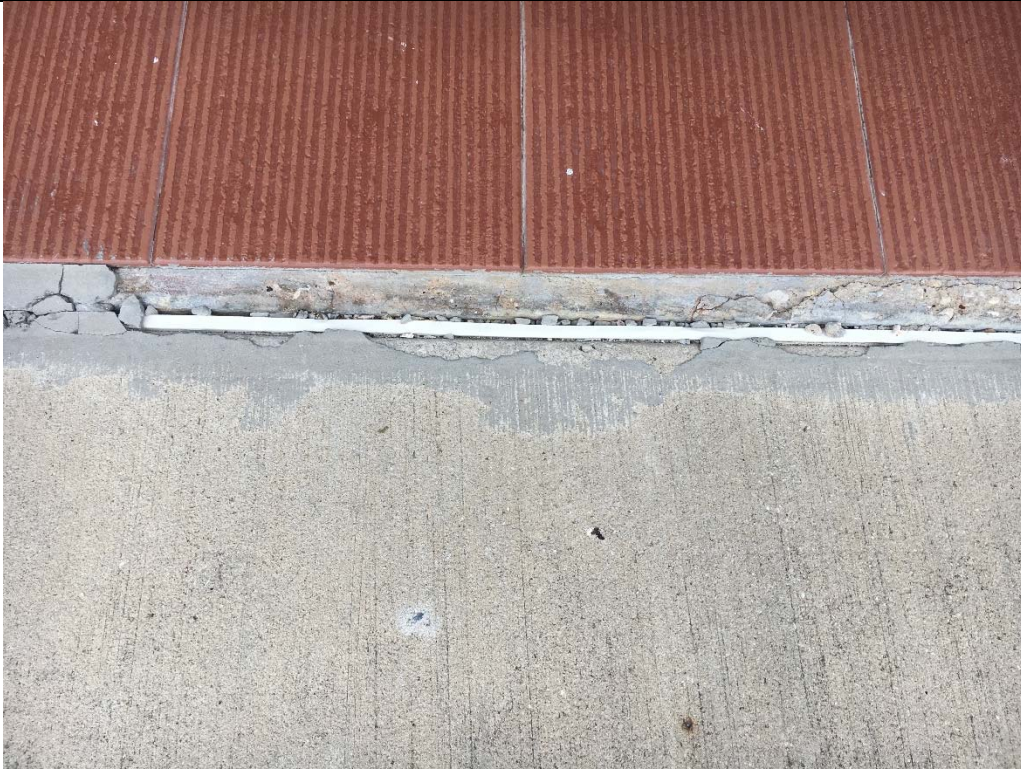
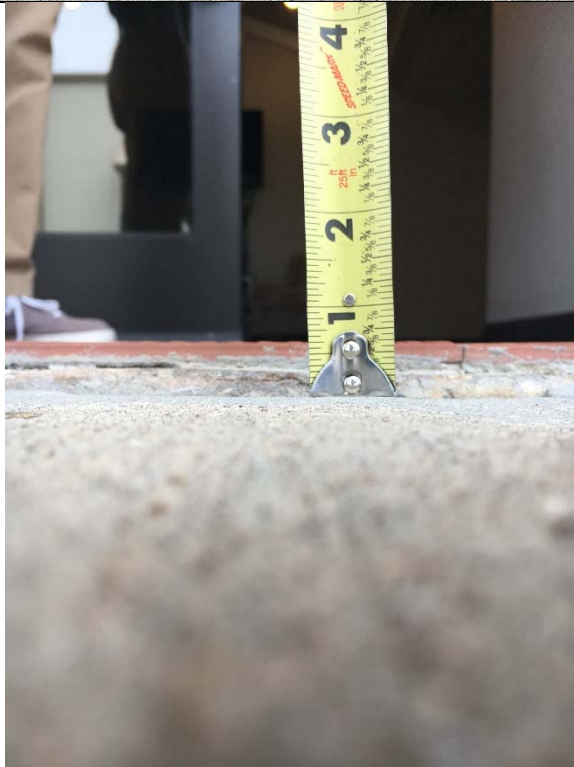
The main entrance has a broken concrete resulting in a change in level greater than 1/4".

Floor or ground surface within required maneuvering clearances shall comply with 302. Changes in level are not permitted. EXCEPTIONS: Slopes not steeper than 1:48 shall be permitted.

Violation 5 - The main entrance has a broken concrete resulting in a change in level greater than 1/4".

Remove and patch the broken concrete at the front entrance to achieve a smooth, level transition.

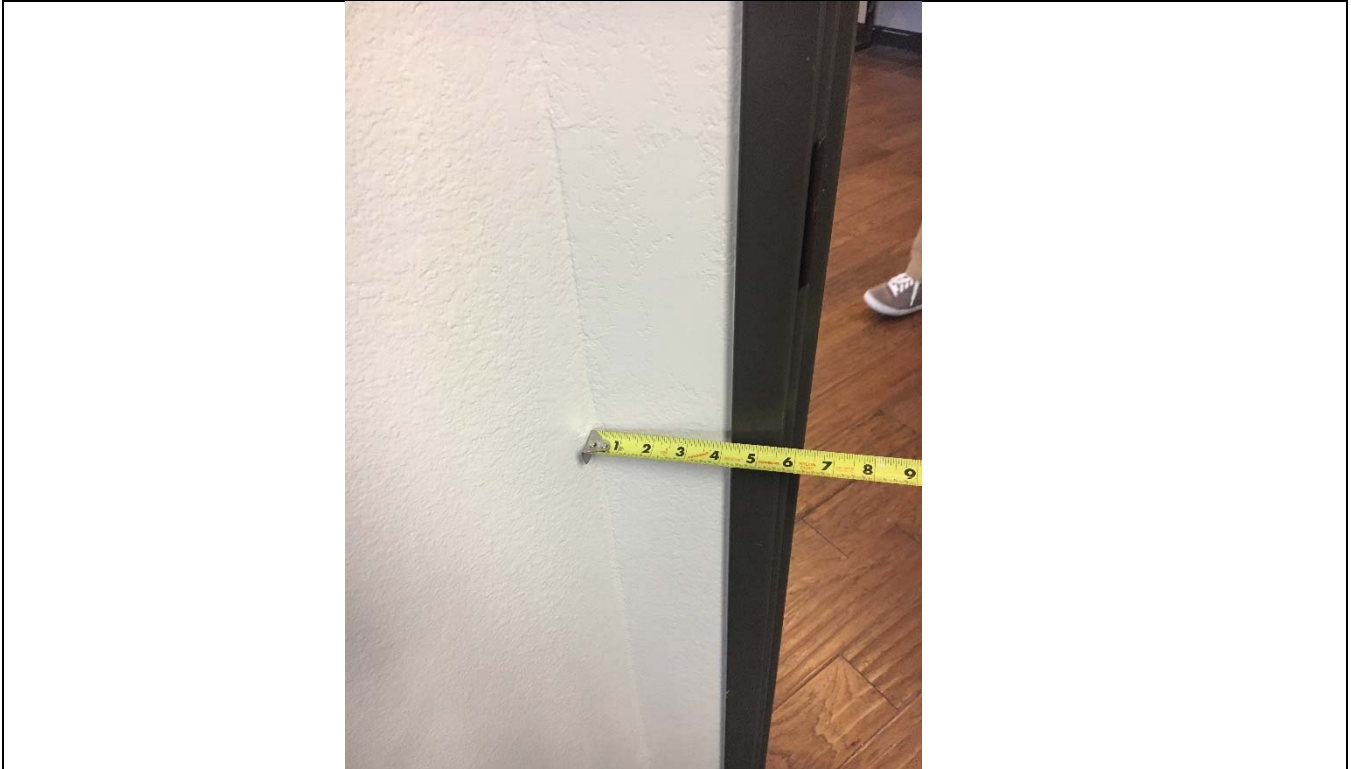
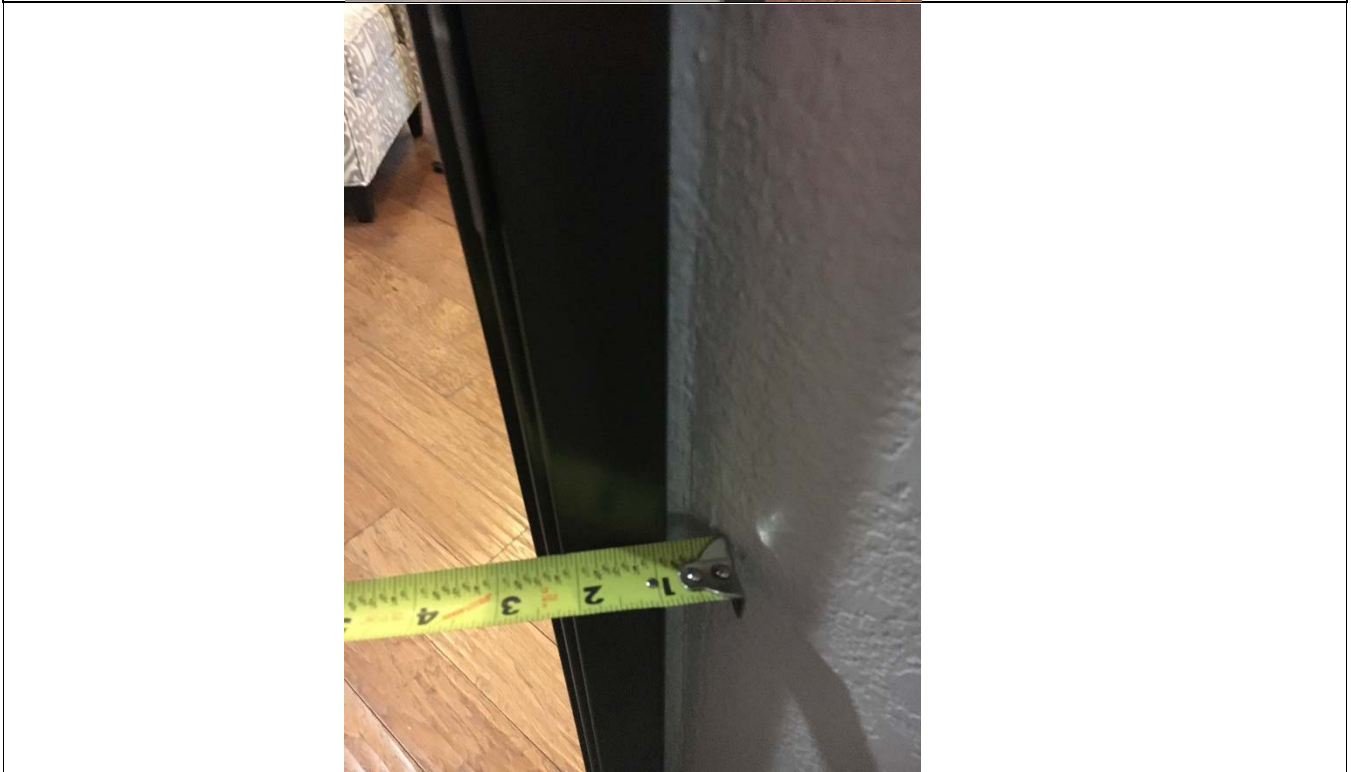
The two front offices do not have a minimum of 18" maneuvering clearance on the pull side of the doors.

2010 ADAAG 404.2.4.1 Swinging Doors and Gates.
--

Violation 6 - The two front offices do not have a minimum of 18" maneuvering clearance on the pull side of the doors.

Reverse the swing of the doors.

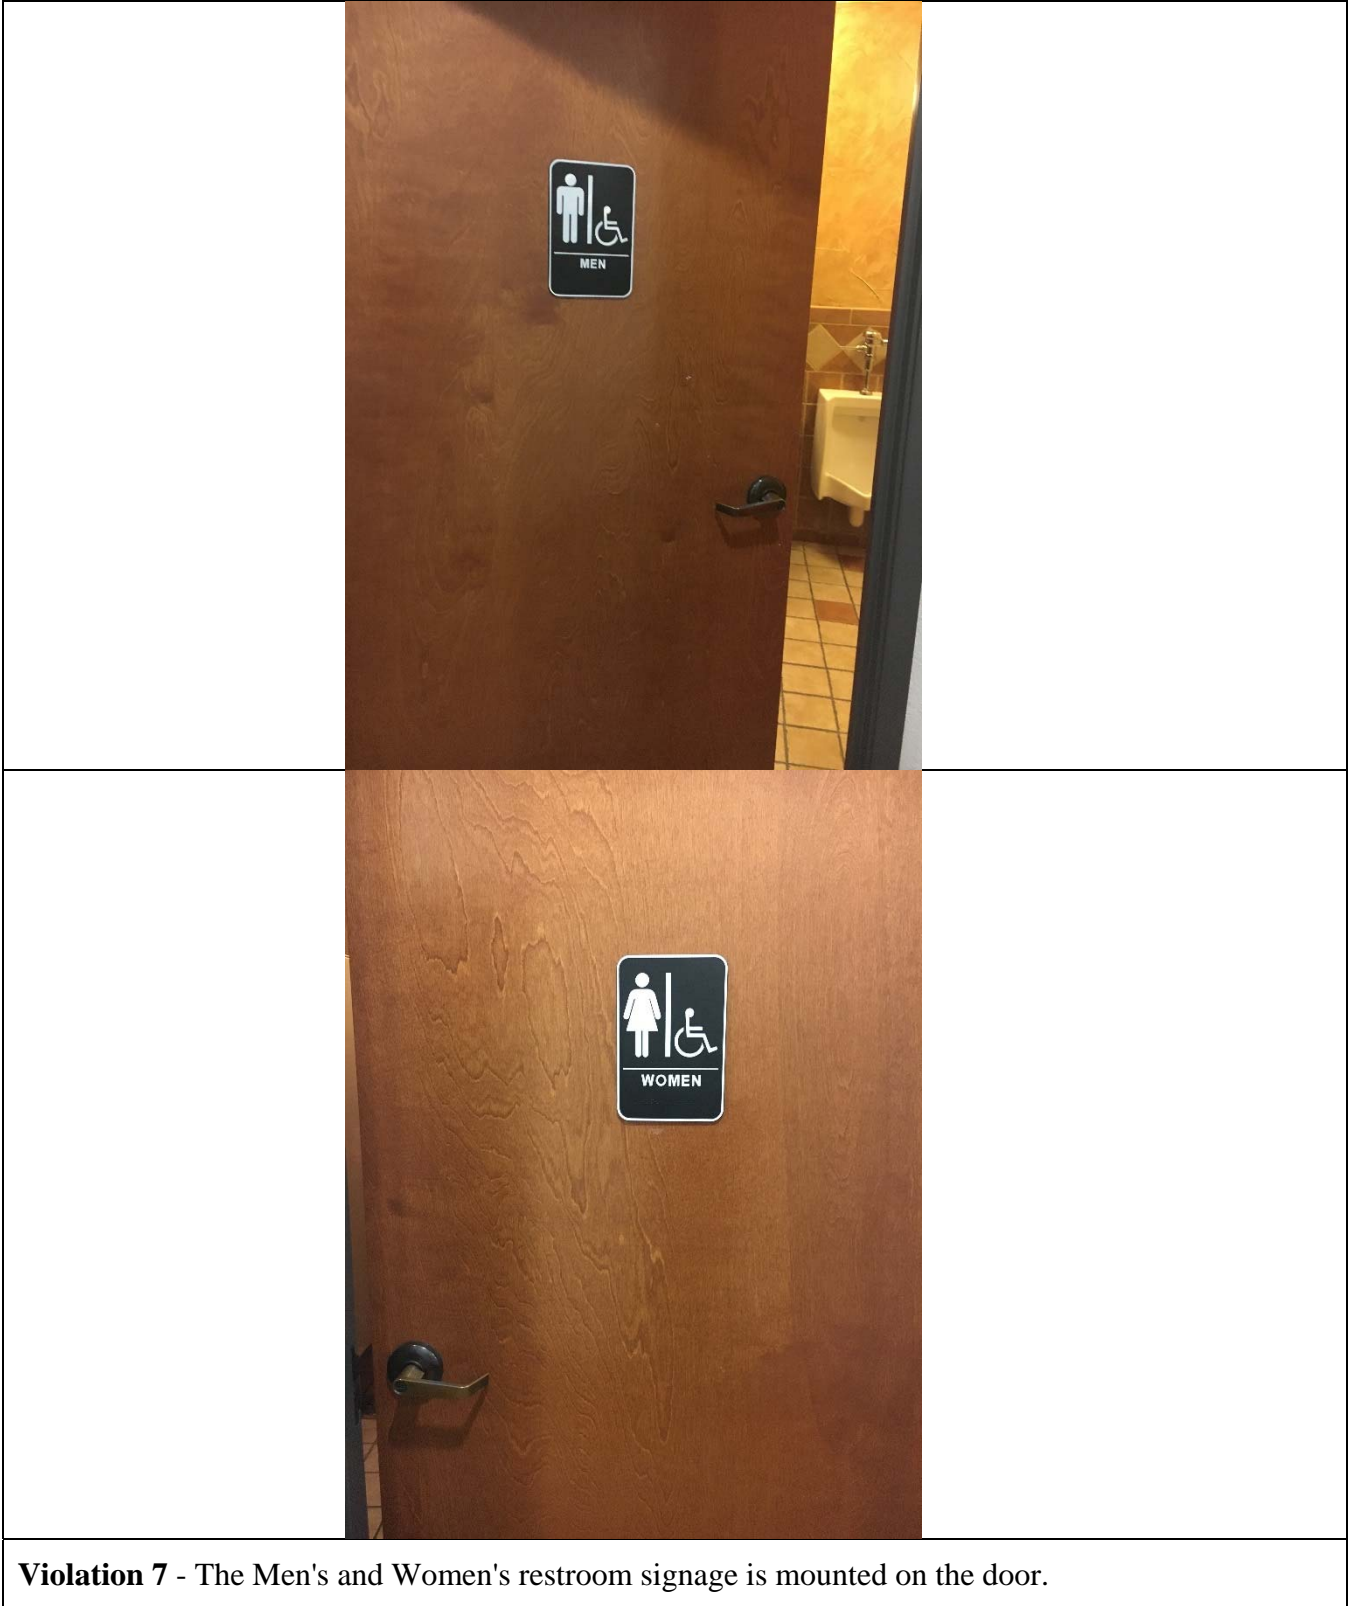
The Men's and Women's restroom signage is mounted on the door.

2010 ADAAG 703.4.2 Installation Height and Location.

Where a tactile sign is provided at a door, the sign shall be located alongside the door at the latch side.

Violation 7 - The Men's and Women's restroom signage is mounted on the door.

Remove the signs and relocate them to the latch side of the doors.

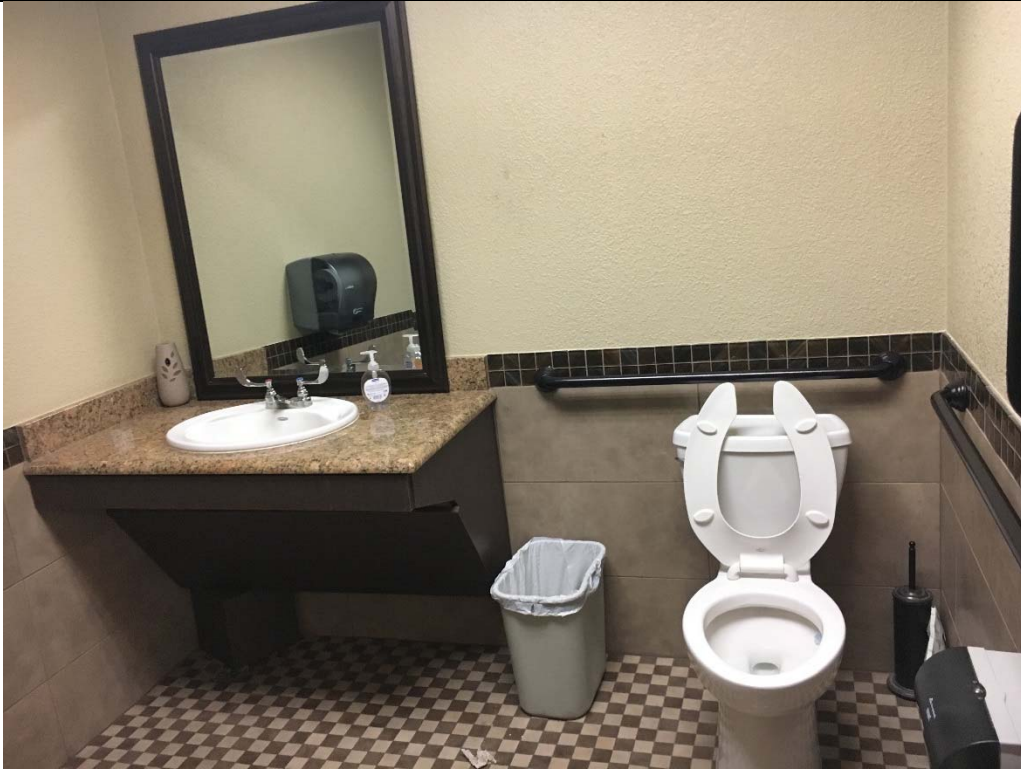
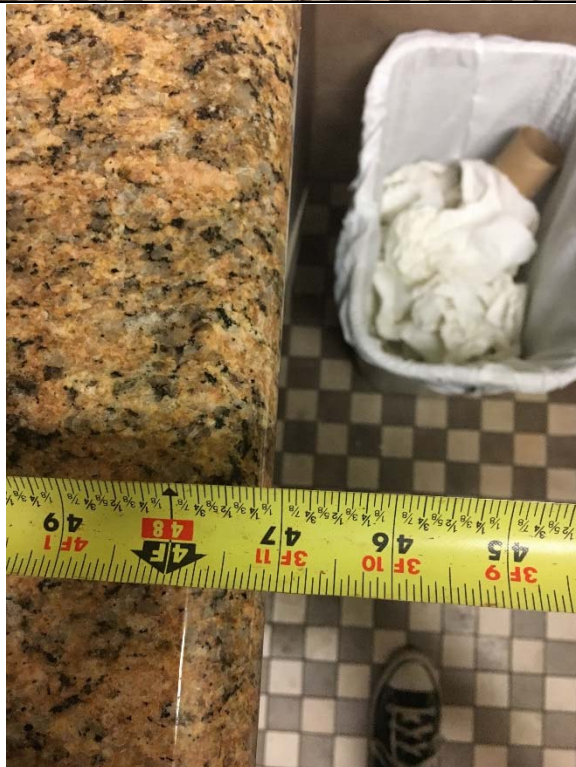
The water closet in the unisex toilet room only has a 47" wide clear floor space. The sink encroaches on the required clear floor space.

2010 ADAAG 604.3.1 Size.

Clearance around a water closet shall be 60 inches minimum measured perpendicular from the side wall and 56 inches minimum measured perpendicular from the rear wall.

Violation 8: - The water closet in the unisex toilet room only has a 47" wide clear floor space. The sink encroaches on the required clear floor space.

Modify toilet room to achieve the required clear floor space for the water closet.

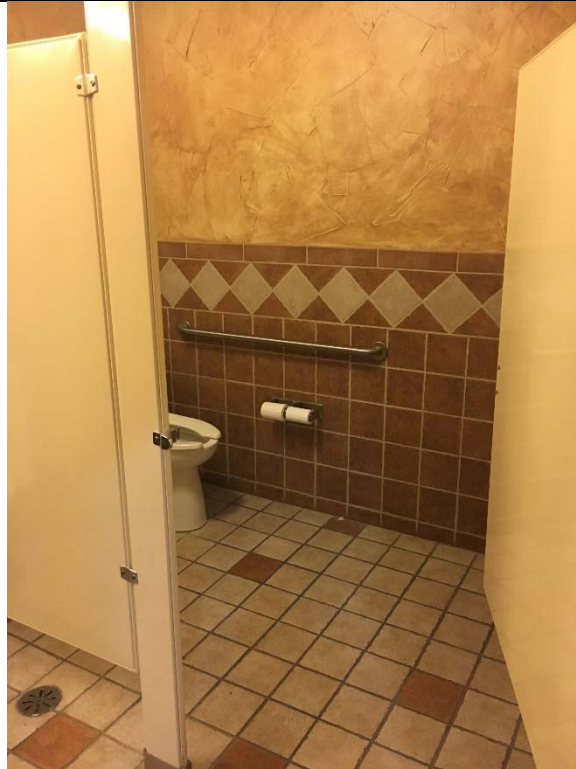
Men's Restroom: Stall door is not self-closing and does not have door hardware.

2010 ADAAG 604.8.1.2 Doors.

The door shall be self-closing. A door pull complying with 404.2.7 shall be placed on both sides of the door near the latch.

Violation 9 - Men's Restroom: Stall door is not self-closing and does not have door hardware.

Adjust closer to self-close and add door pulls.

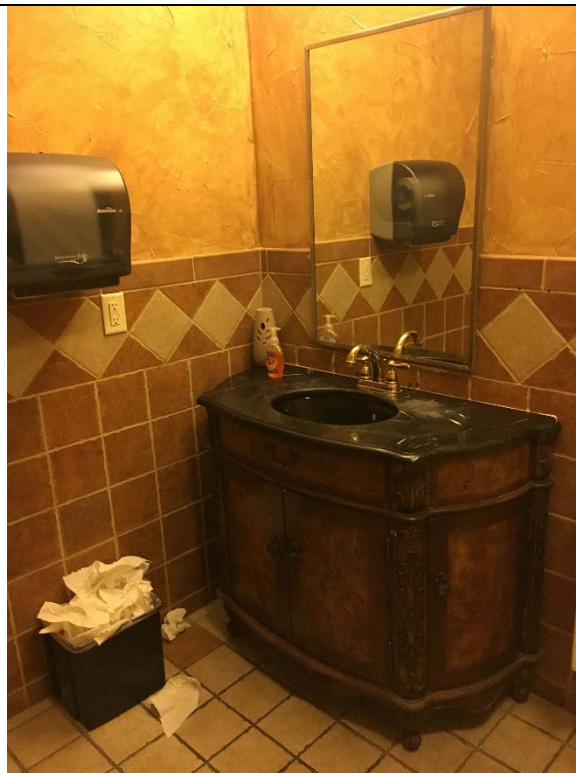
Men's Restroom: The lavatory does not have the required toe and knee clearance provided.

2010 ADAAG 606.2 Clear Floor Space.

Violation 10 - Men's Restroom: The coat hook is mounted at 55" above finished floor to the highest operable part.

Replace or modify lavatory to provide the required toe and knee clearance.

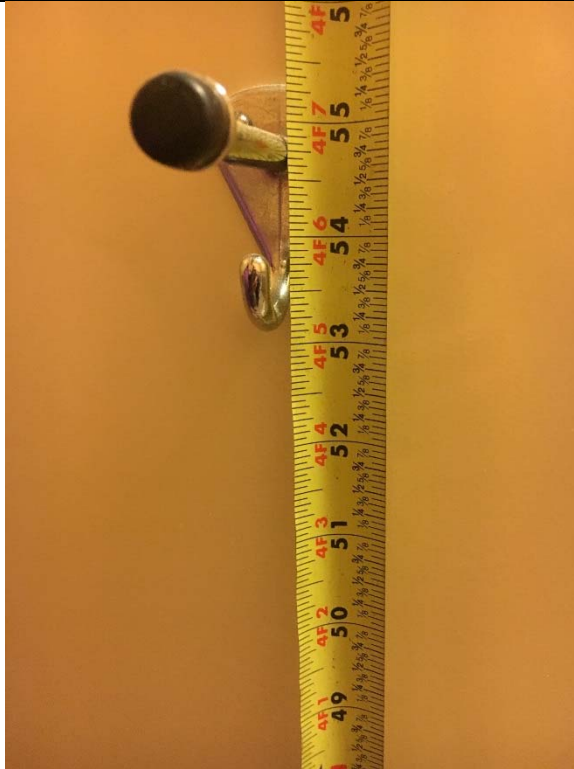
Men's Restroom: The coat hook is mounted at 55" above finished floor to the highest operable part.

2010 ADAAG 308.3.1 Unobstructed.

Where a clear floor or ground space allows a parallel approach to an element and the side reach is unobstructed, the high side reach shall be 48" max. and the low side reach shall be 15" min. above the finish floor.

Violation 11 - Men's Restroom: The coat hook is mounted at 55" above finished floor to the highest operable part.

Install a coat hook so its highest operable part is at 48" above finished floor.

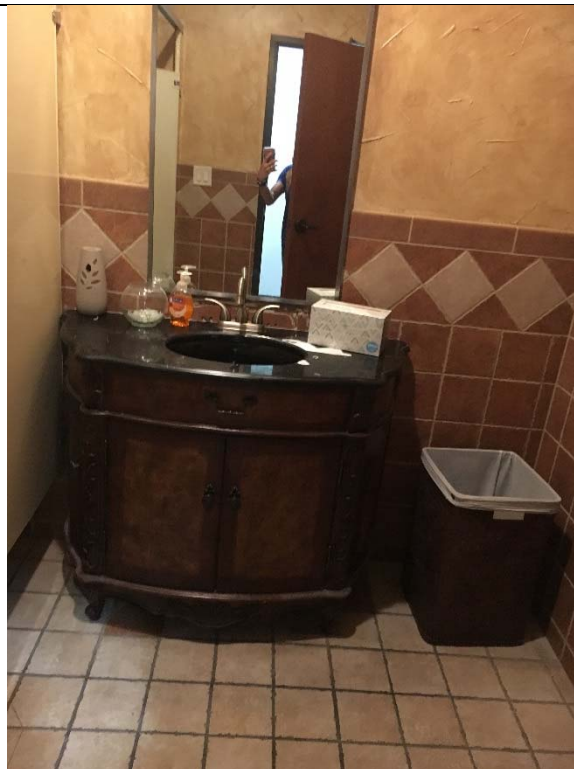
Women's Restroom: Lavatory does not have the required toe and knee clearance.

2010 ADAAG 606.2 Clear Floor Space.

Violation 12 - Women's Restroom: Lavatory does not have the required toe and knee clearance.

Replace or modify lavatory to provide the required toe and knee clearance.

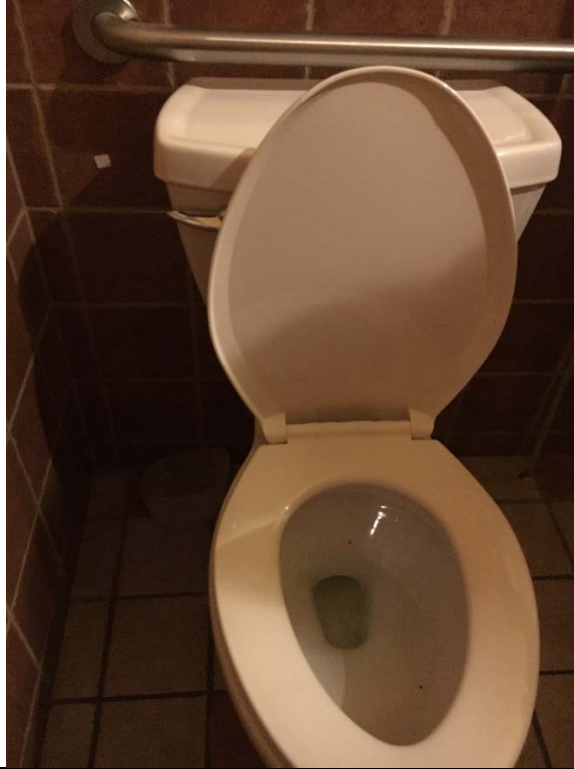
Violation #13: Women's Restroom: The flush control is on the closed side of the water closet.

Standard: 2010 ADAAG 604.6 Flush Controls.

Text: Flush controls shall be located on the open side of the water closet.

Violation 13 - Women's Restroom: The flush control is on the closed side of the water closet.

Possible Solutions: Replace flush valve to approach/open side of water closet.

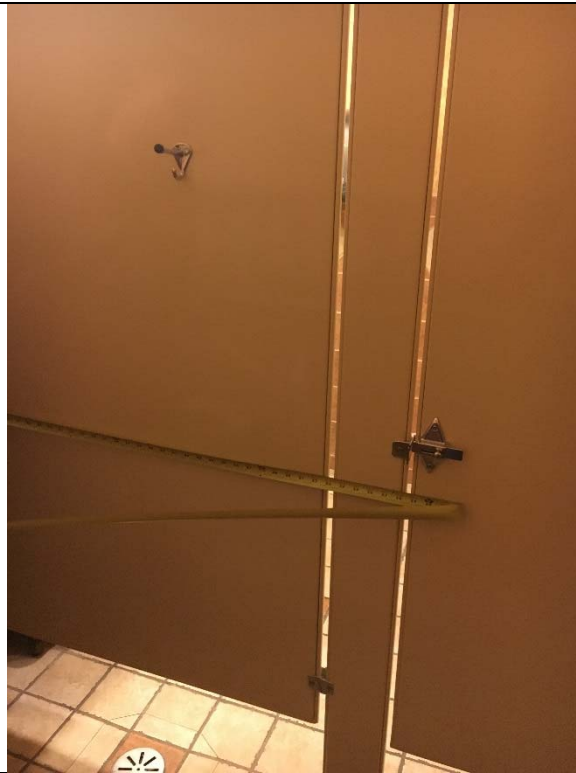
Violation #14: Women's Restroom: The stall door does not have any door hardware.

Standard: 2010 ADAAG 604.8.1.2 Doors.

Text: A door pull complying with 404.2.7 shall be placed on both sides of the door near the latch.

Violation 14 - Women's Restroom: The stall door does not have any door hardware.

Possible Solutions: Add door pulls.

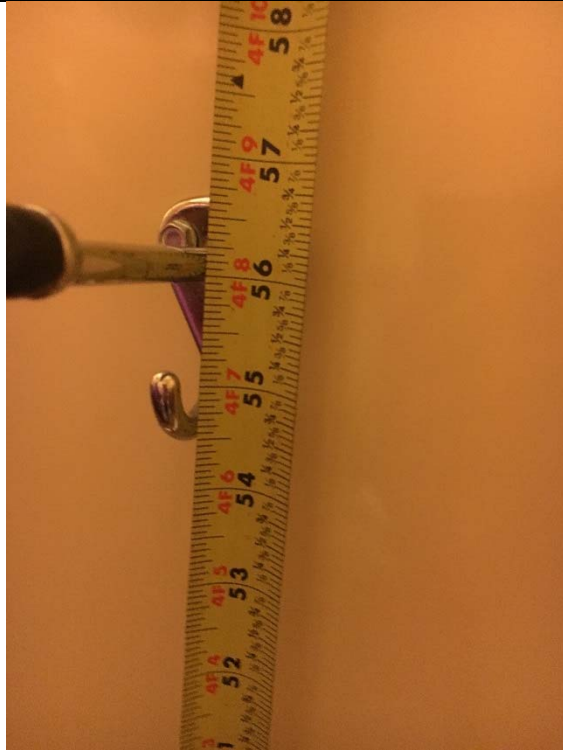
Violation #15: Women's Restroom: The coat hook is mounted at 56" above finished floor to the highest operable part.

Standard: 2010 ADAAG 308.3.1 Unobstructed.

Where a clear floor or ground space allows a parallel approach to an element and the side reach is unobstructed, the high side reach shall be 48" max. and the low side reach shall be 15" min. above the finish floor.

Violation 15 - Women's Restroom: The coat hook is mounted at 56" above finished floor to the highest operable part.

Install a coat hook so its highest operable part is at 48" above finished floor.

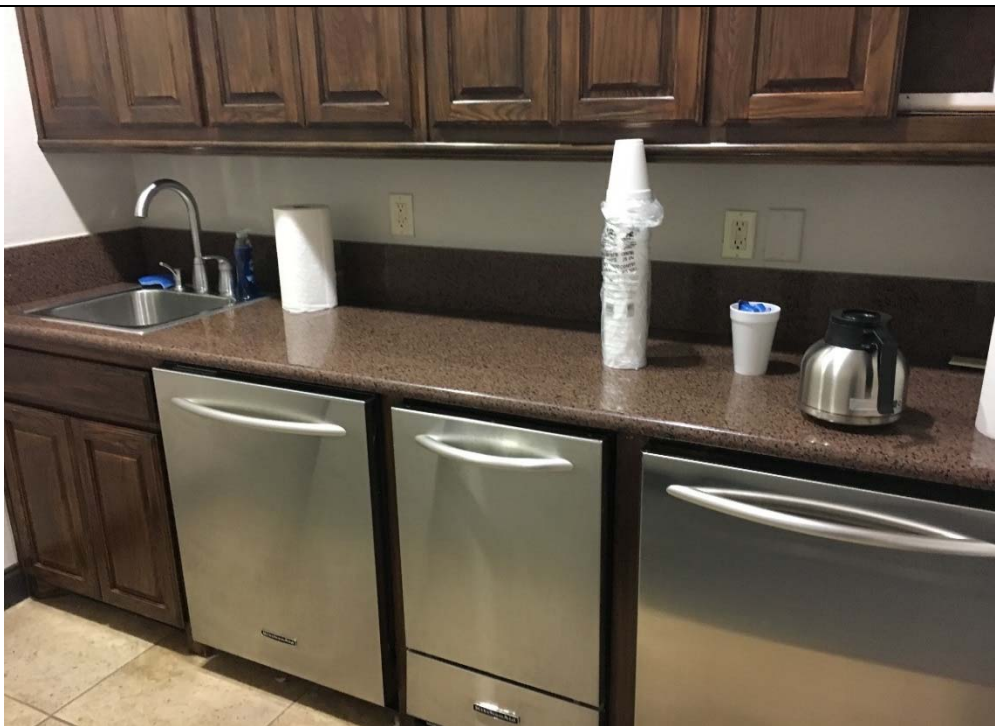
The small breakroom near the front of the facility sink is 36" high where 34" maximum is required.

2010 ADAAG 606.3 Lavatories and Sinks Height.

Lavatories and sinks shall be installed with the front of the higher of the rim or counter surface 34 inches maximum above the finish floor or ground.

Violation 16 - The small breakroom near the front of the facility sink is 36" high where 34" maximum is required.

Modify sink to provide 34" maximum height.
