**ADDISON AIRPORT
BUILDING REPORT**

Facility Information: Facility Name: 4666 Glenn Curtiss Drive
Facility Contact: Lisa Pyles Contact Phone: 972-450-2878

Accessology Inspector Information:
Inspector: Karen Jackson Date: May 3, 2017
Email: Kjackson@accessology.com

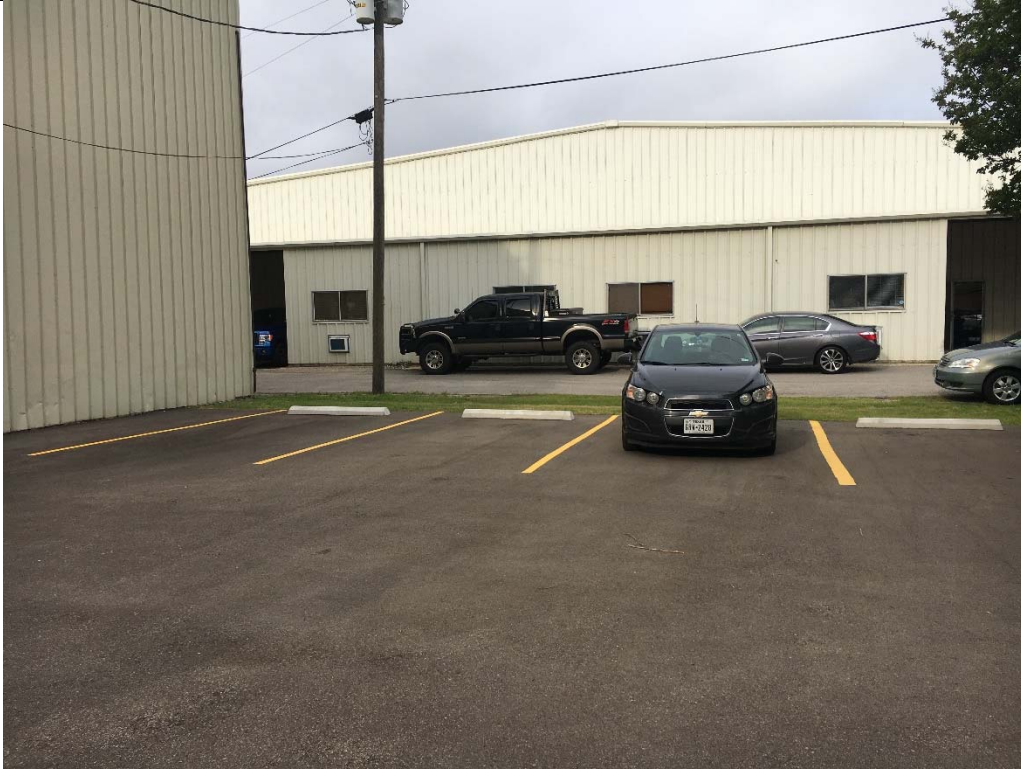
Violation #1: Four parking spaces serve this building, none of which are accessible.

Standard: 2010 ADAAG 208.1 General.

Level 3

Violation 1 - Four parking spaces serve this building, none of which are accessible.

Possible Solutions: Provide one van accessible parking space, an access aisle and compliant signage.

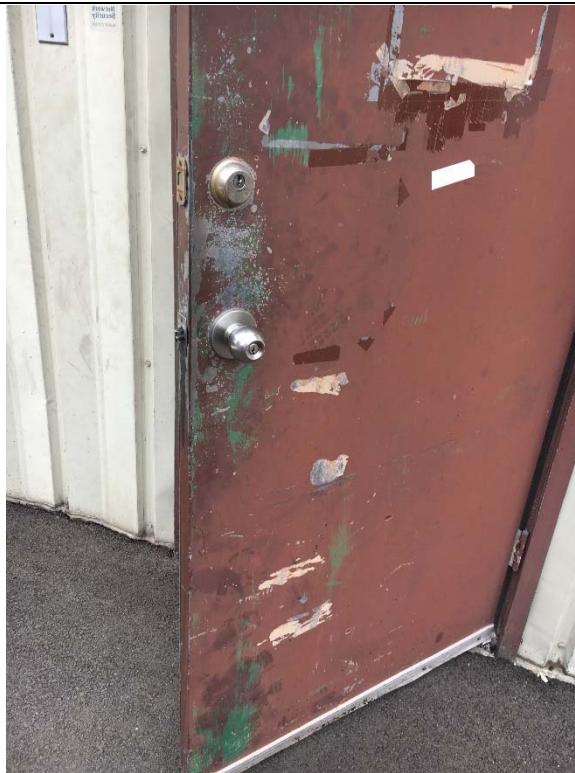
The main entrance door into the building has knob door hardware requiring grasping and twisting to operate.

2010 ADAAG 404.2.7 Door and Gate Hardware.

Level 5

Violation 2 - The main entrance door into the building has knob door hardware requiring grasping and twisting to operate.

Replace door hardware with lever style hardware.

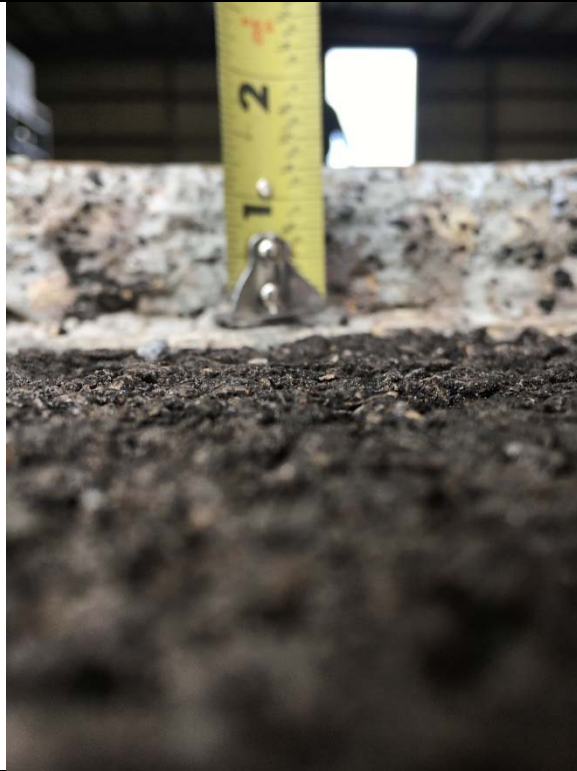
There is a 1-1/4" step to get into the building.

2010 ADAAG 303.2 Vertical.

Level 3

Violation 3 - There is a 1-1/4" step to get into the building.

Modify entrance to provide a transition no more than 1/4" high.

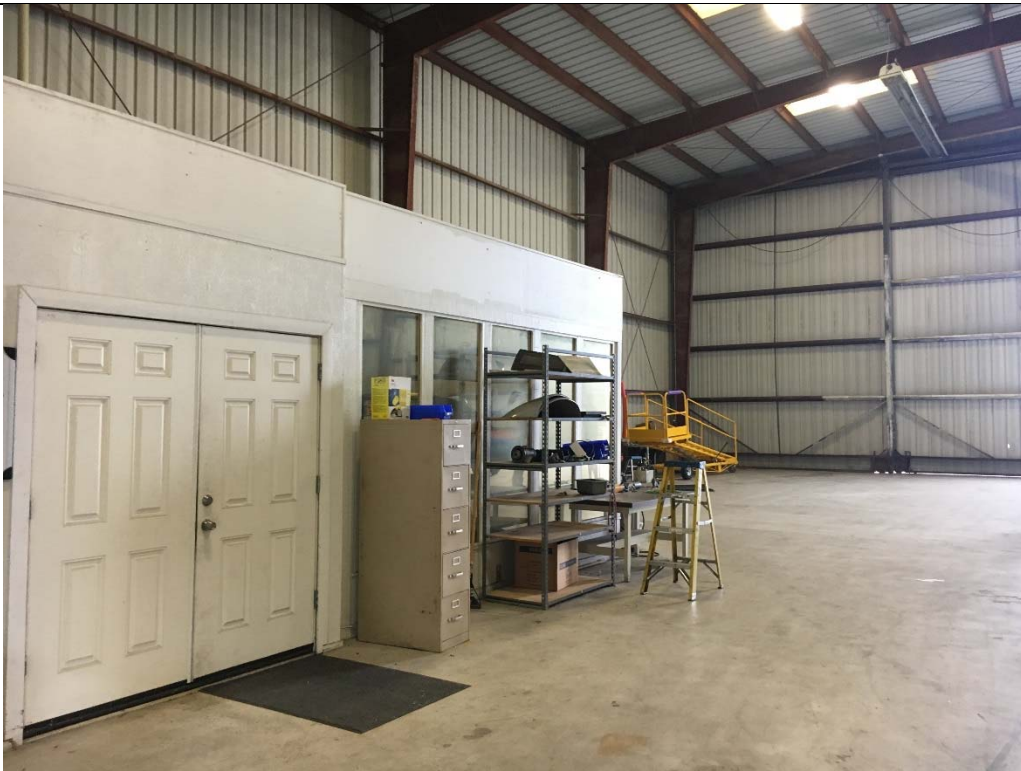
The entrance door into the storage portion of the office pod has knob style door hardware requiring grasping and twisting to operate.

2010 ADAAG 404.2.7 Door and Gate Hardware.

Level 5

Violation 4 - The entrance door into the storage portion of the office pod has knob style door hardware requiring grasping and twisting to operate.

Replace door hardware with lever style hardware.

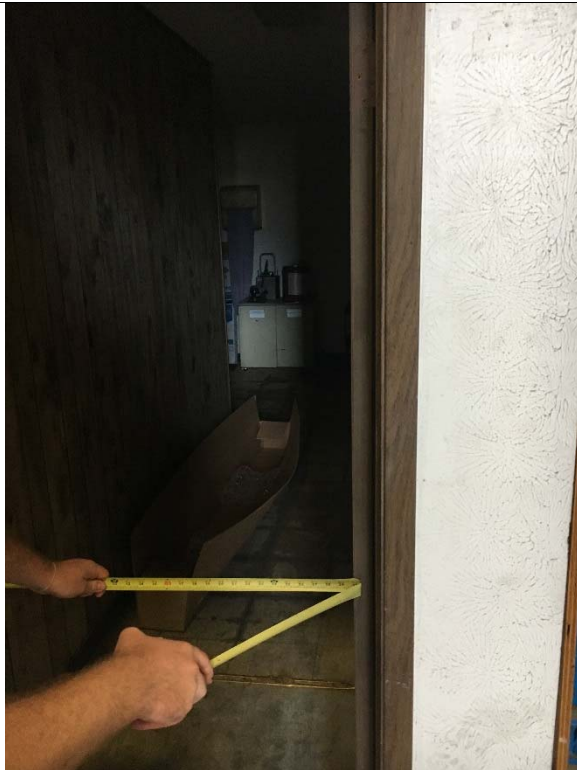
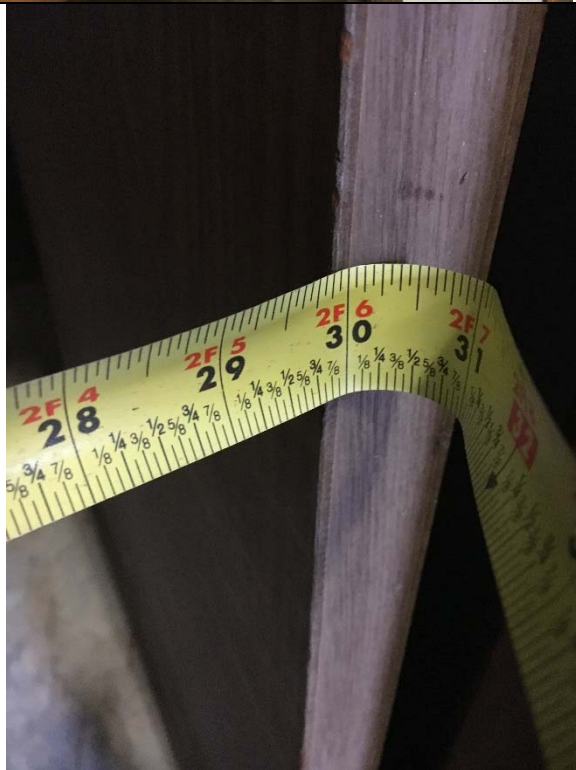
The entrance door into the storage portion of the office pod only has a 30" opening.

2010 ADAAG 404.2.3 Door and Gate Clear Width.

Level 2

Violation 5 - The entrance door into the storage portion of the office pod only has a 30" opening.

Replace door to achieve 32" minimum clear width and swing door outward.

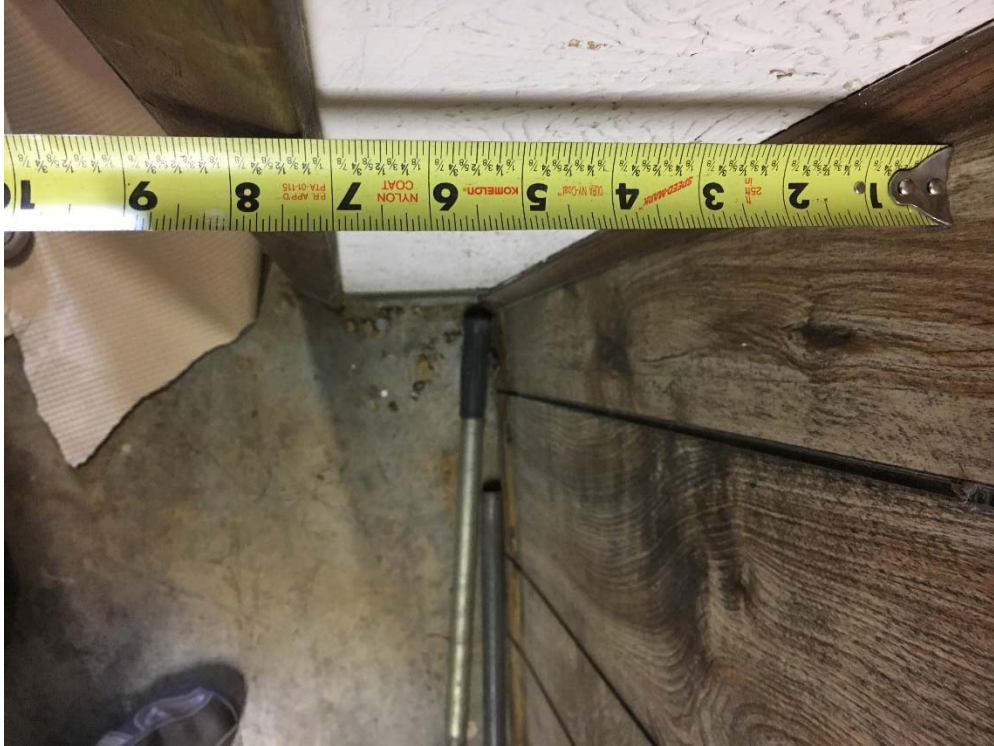
The door exiting from the storage portion of the office pod only has a 8.5" maneuvering clearance on the pull side.

2010 ADAAG 404.2.4.1 Swinging Doors and Gates.

Level 4

Violation 6 - The door exiting from the storage portion of the office pod only has a 8-1/2" maneuvering clearance on the pull side.

Modify the door to provide 18" minimum clearance.

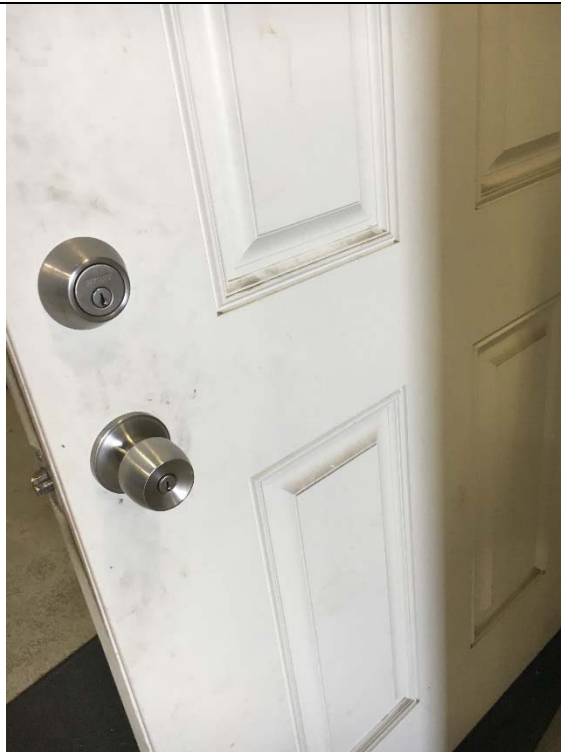
The entrance into the main portion of the office pod has door hardware that requires grasping and twisting to operate.

2010 ADAAG 404.2.7 Door and Gate Hardware.

Level 5

Violation 7 - The entrance into the main portion of the office pod has door hardware that requires grasping and twisting to operate.

Replace door hardware with lever style hardware.

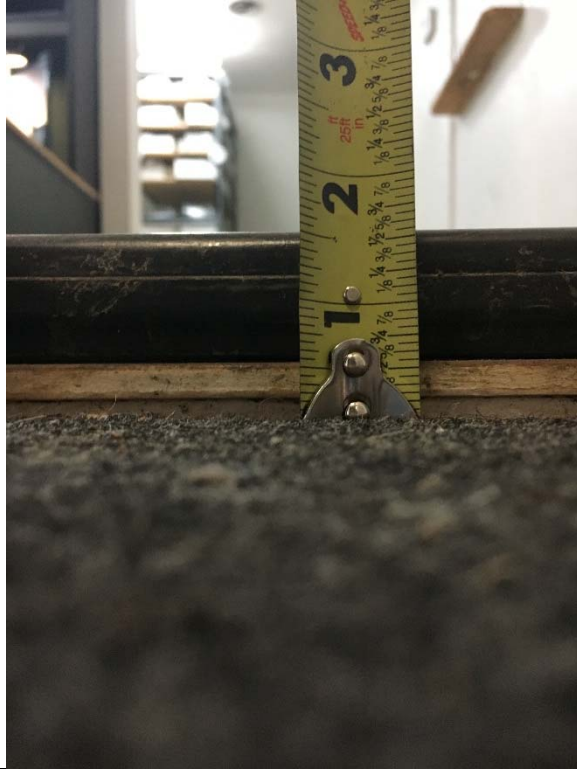
The entrance into the main portion of the office pod requires a 1-1/2" step up to enter.

2010 ADAAG 303.2 Vertical.

Level 3

Violation 8 - The entrance into the main portion of the office pod requires a 1-1/2" step up to enter.

Modify entrance to provide a transition no more than 1/4" high.

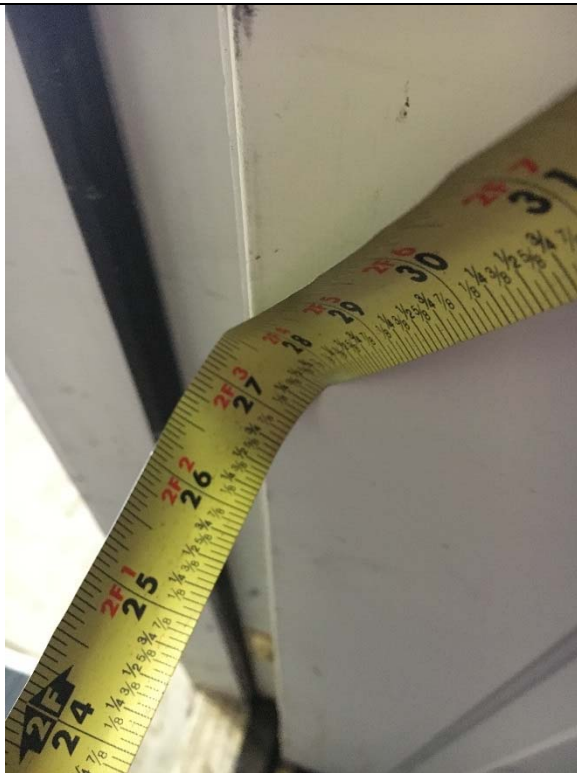
The entrance door into the main portion of the office only has a 27" wide opening.

2010 ADAAG 404.2.3 Door and Gate Clear Width.

Level 3

Violation 9 - The entrance door into the main portion of the office only has a 27" wide opening.

Replace door to achieve 32" minimum clear width and swing door outward.

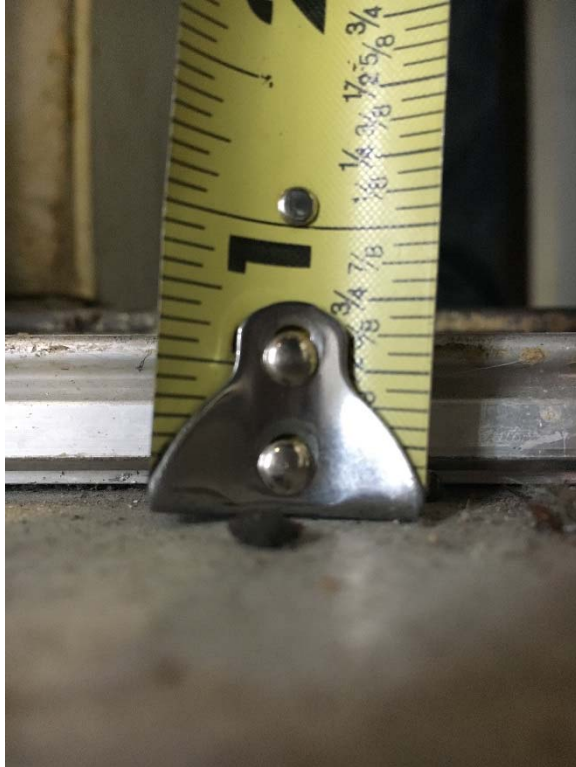
The third entrance into the office pod has a 5/8" high change in level.

2010 ADAAG 303.2 Vertical.

Level 3

Violation 10 - The third entrance into the office pod has a 5/8" high change in level.

Modify entrance to provide a transition no more than 1/4" high.

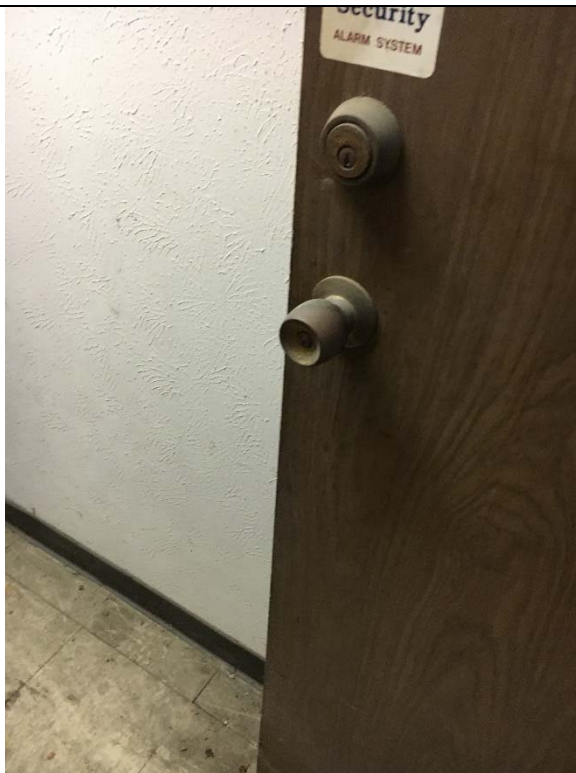
Two doors inside the office pod have door knob hardware that requires grasping and twisting to operate.

2010 ADAAG 404.2.7 Door and Gate Hardware.

Level 5

Violation 11 - Two doors inside the office pod have door knob hardware that requires grasping and twisting to operate.

Replace all knob hardware with lever hardware that doesn't require tight grasping or twisting to operate.

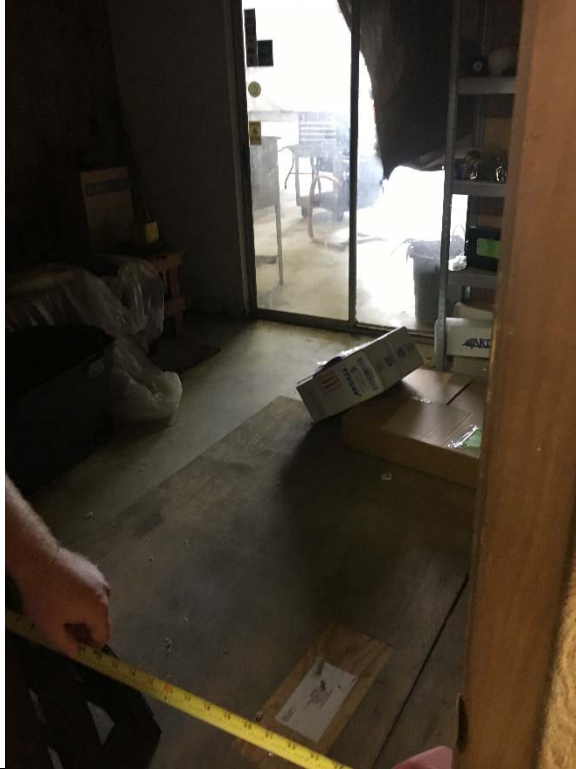
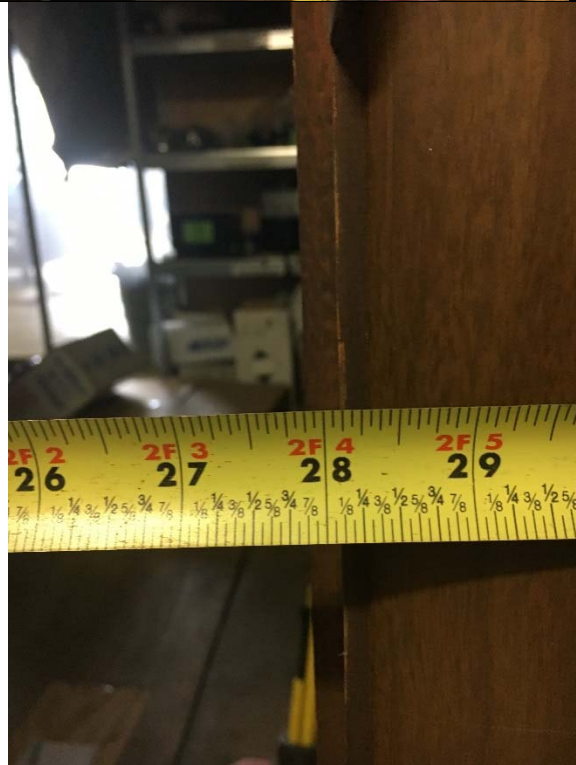
The entrance into the storage room has an opening of only 28" wide.

2010 ADAAG 404.2.3 Door and Gate Clear Width.

Level 7

Violation 12 - The entrance into the storage room has an opening of only 28" wide.

Replace door to achieve 32" minimum clear width and swing door outward.

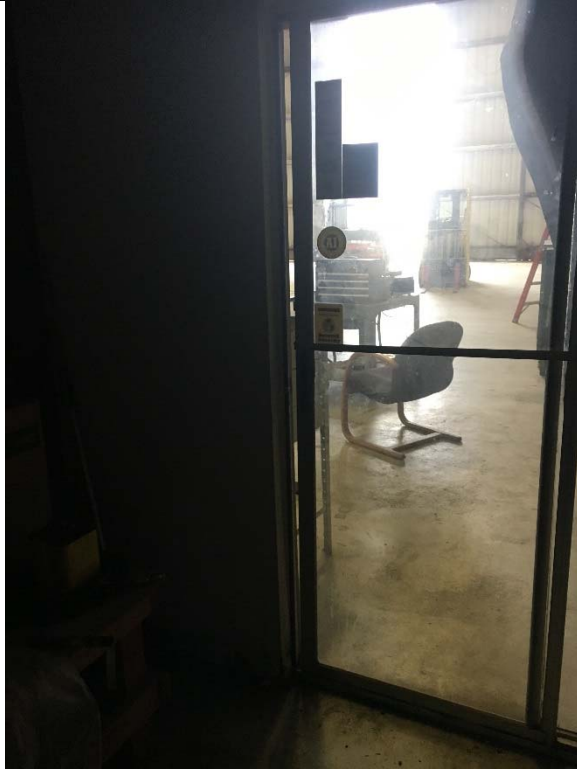
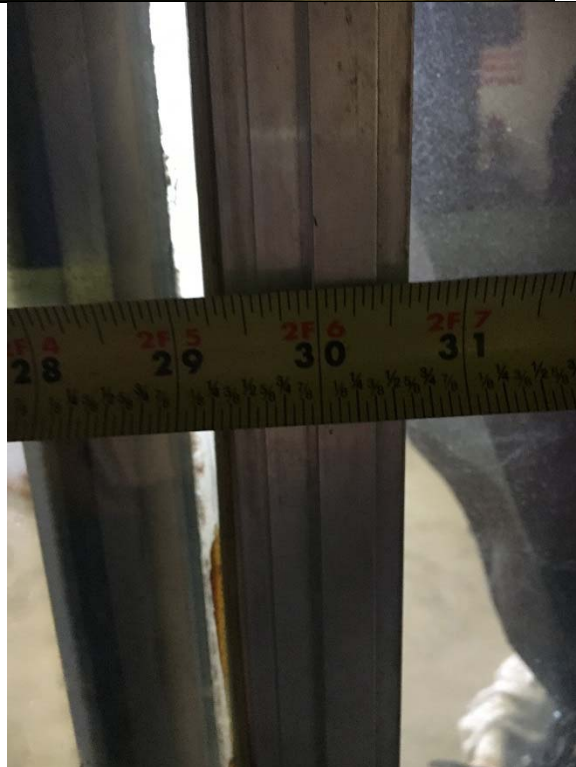
Sliding glass doors exiting the storage room only have a 30" opening.

2010 ADAAG 404.2.4.2 Doorways without Doors or Gates, Sliding Doors, and Folding Doors.

Level 10

Violation 13 - Sliding glass doors exiting the storage room only have a 30" opening.

Replace doors to achieve a 32" minimum opening.

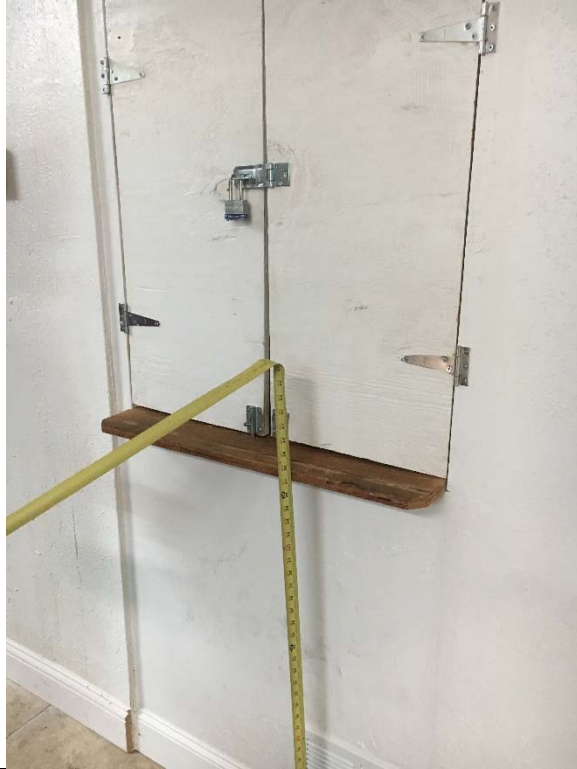
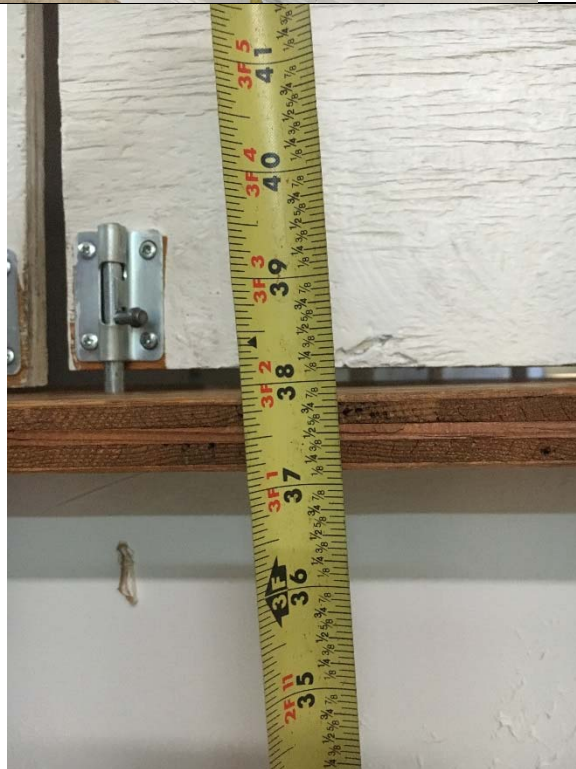
There is a counter that is 38" to the top where 36" is the maximum allowed.

2010 ADAAG 904.4.1 Parallel Approach.

Level 12

Violation 14 - There is a counter that is 38" to the top where 36" is the maximum allowed.

Modify counter so it is no higher than 36" above finished floor.

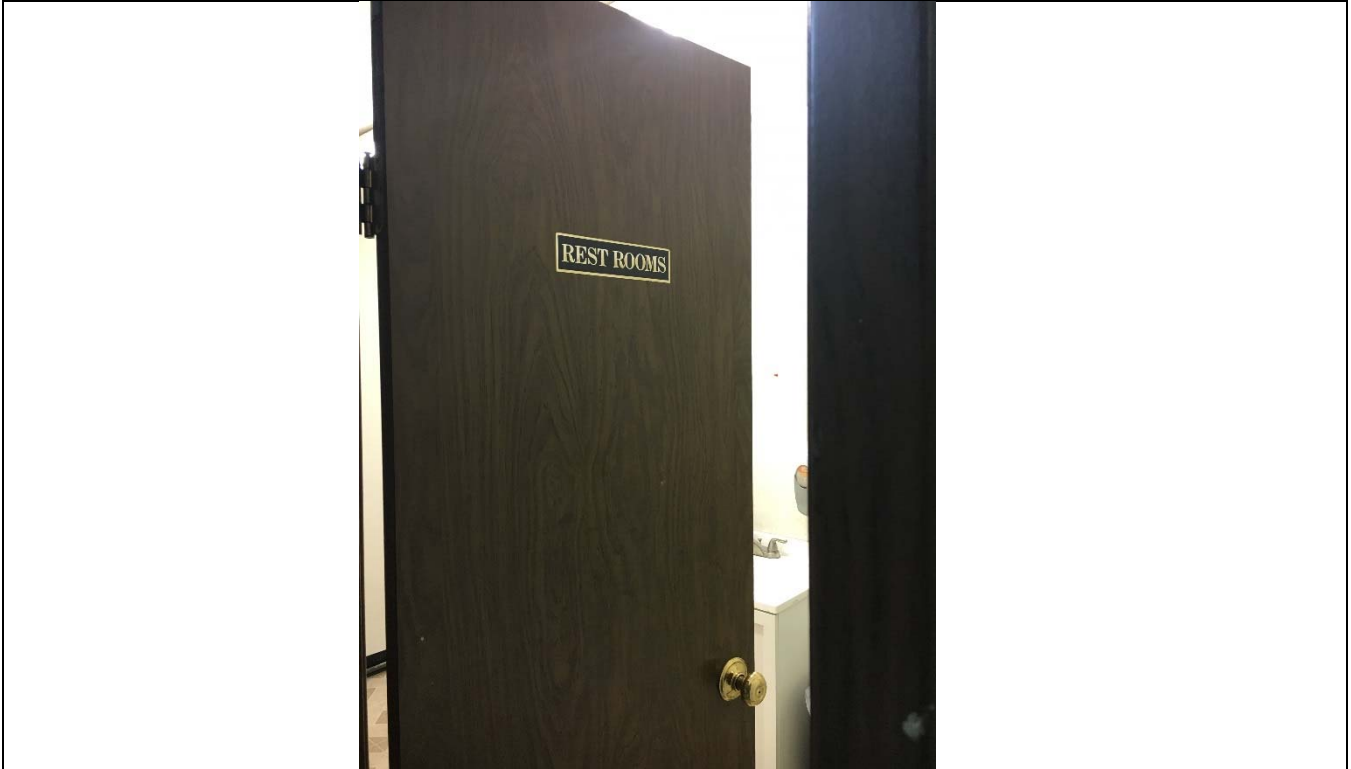
The restroom door has knob style door hardware requiring grasping and twisting to operate.

2010 ADAAG 404.2.7 Door and Gate Hardware.

Level 5

Violation 15 - The restroom door has knob style door hardware requiring grasping and twisting to operate.

Replace door hardware with lever type hardware.

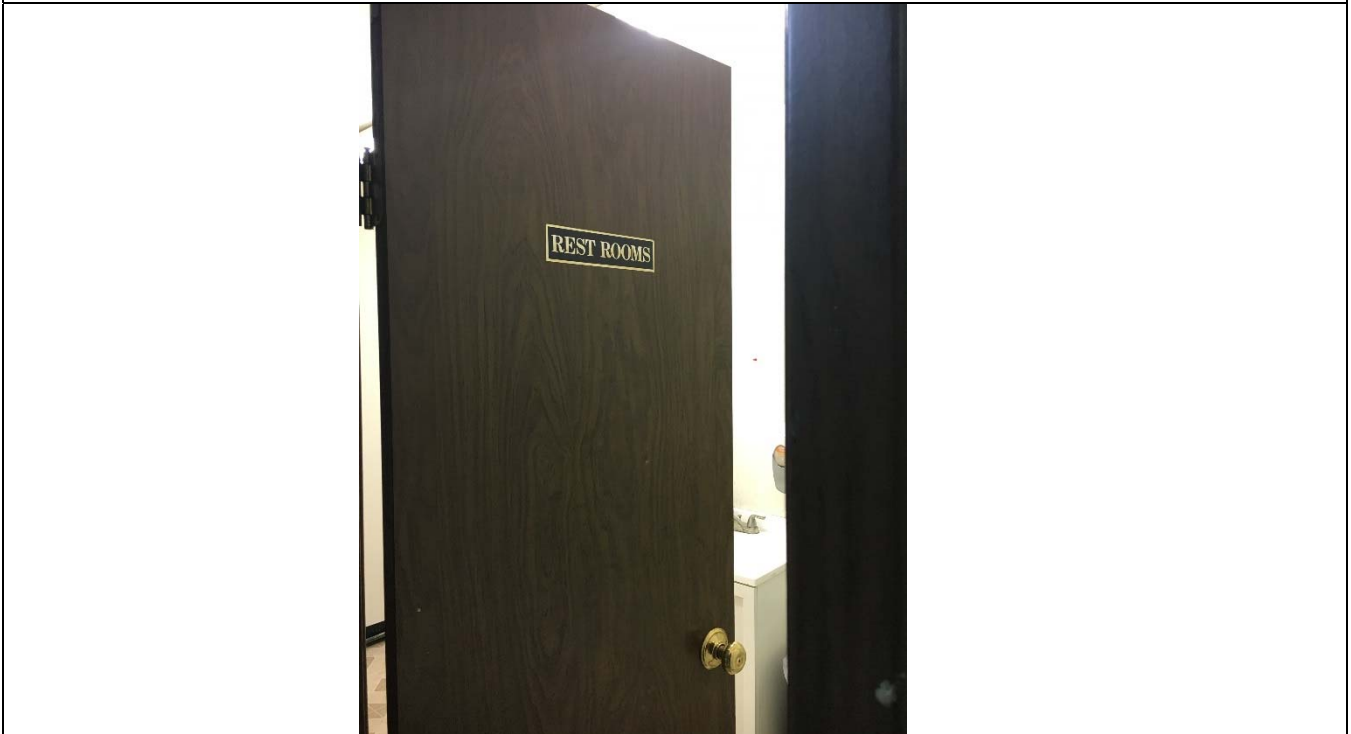
Restroom signage is mounted on the door and does not provide tactile characters or braille.

2010 ADAAG 216.2 Designations.

Level 6

Violation 16 - Restroom signage is mounted on the door and does not provide tactile characters or braille.

Provide a new compliant sign and install on the latch side of the door.

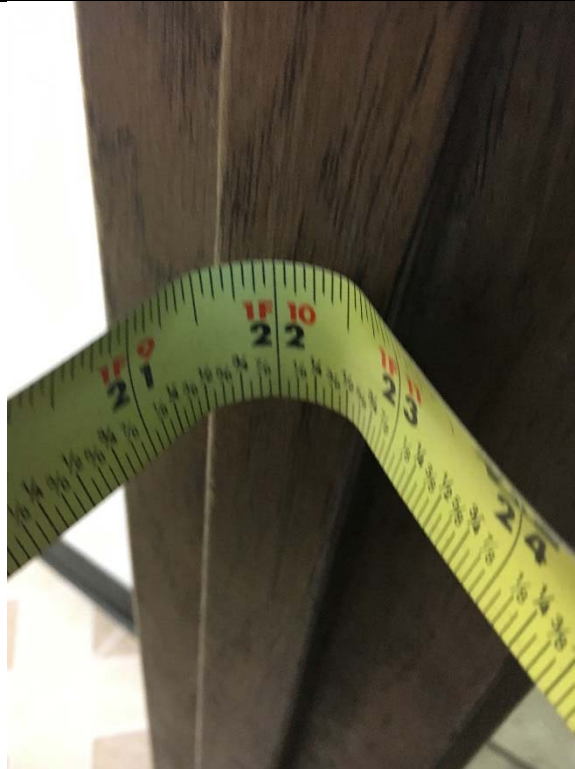
The restroom door only provides 22" clear width where 32" minimum is required.

2010 ADAAG 404.2.3 Door and Gate Clear Width.

Level 2

Violation 17 - The restroom door only provides 22" clear width where 32" minimum is required.

Replace door with unit that provides 32" minimum clear width.

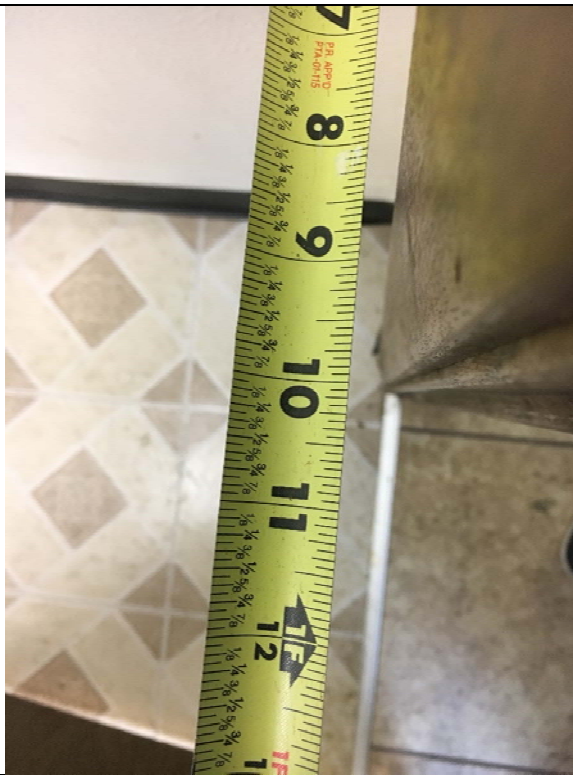
The restroom door only has a 10" maneuvering clearance on the pull side of the door.

2010 ADAAG 404.2.4.1 Swinging Doors and Gates.

Level 3

Violation 18 - The restroom door only has a 10" maneuvering clearance on the pull side of the door.

Swing door out. Price included under violation #17.

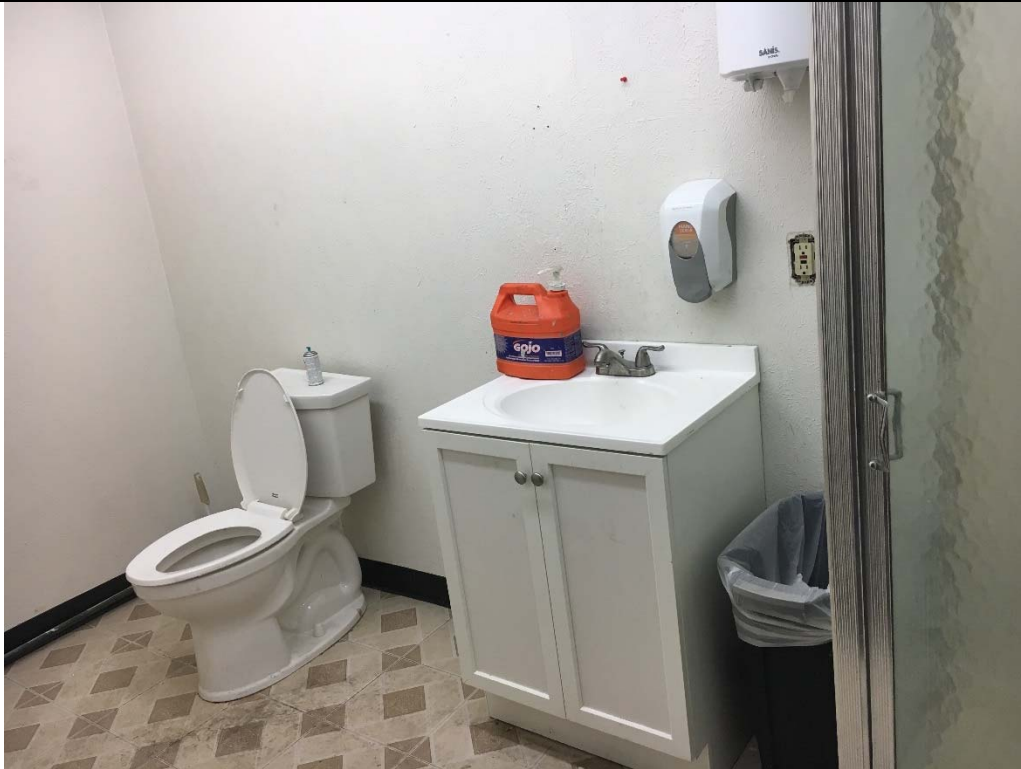
The restroom does not include any accessible features and the room is not large enough to accommodate accessible fixtures and wheelchair turning space.

2010 ADAAG 213.2 Toilet Rooms and Bathing Rooms.

Level 2

Violation 19 - The restroom does not include any accessible features and the room is not large enough to accommodate accessible fixtures and wheelchair turning space.

Enlarge restroom to accommodate accessible water closet, lavatory and wheelchair turning space.

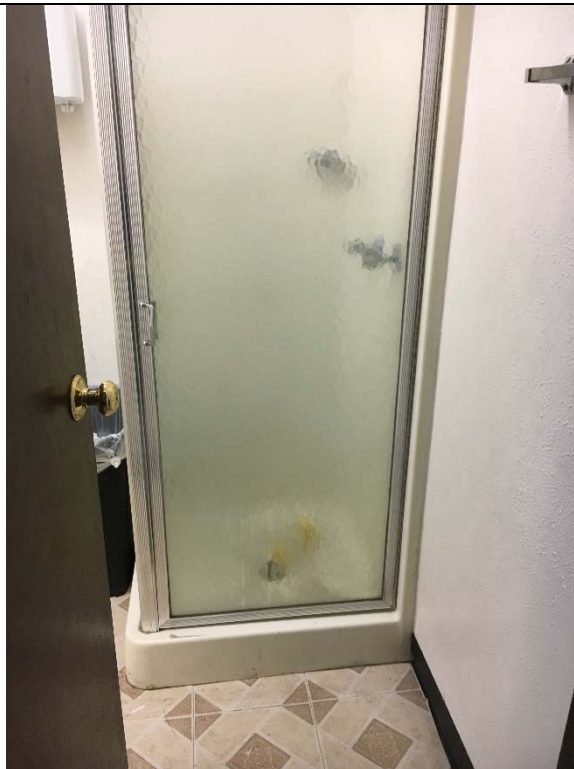
There is a shower provided in the restroom that has no accessible features.

2010 ADAAG 213.2 Toilet Rooms and Bathing Rooms.

Level 2

Violation 20 - There is a shower provided in the restroom that has no accessible features.

Enlarge restroom to accommodate accessible water closet, lavatory and wheelchair turning space. Cost include in violation #19.

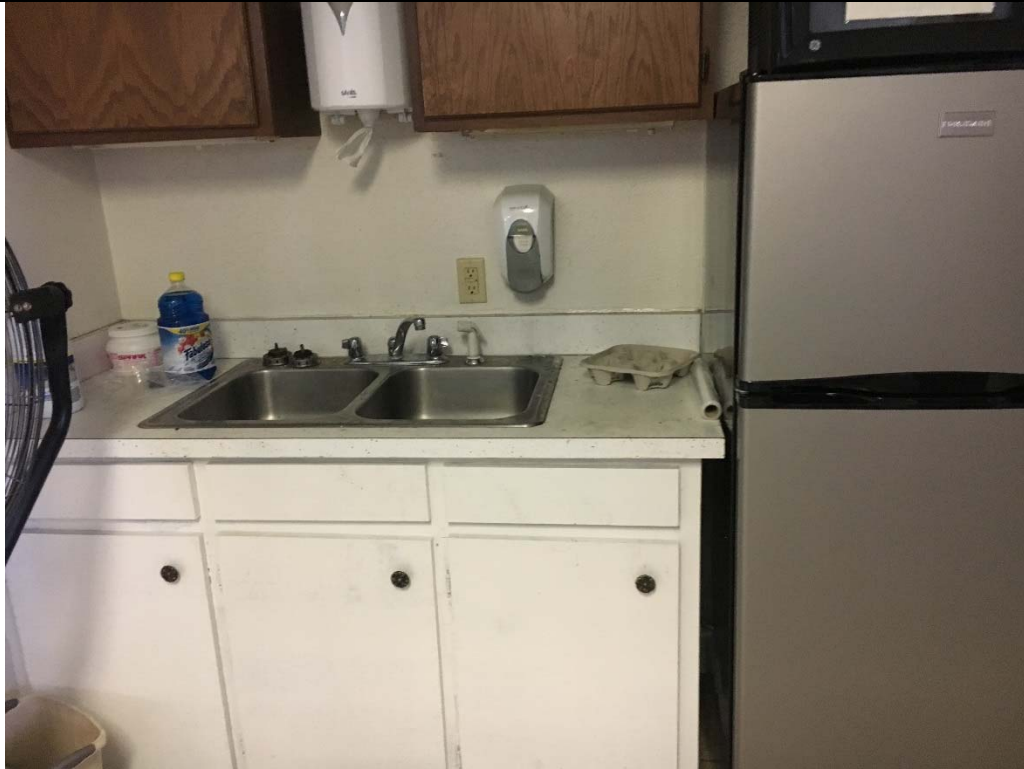
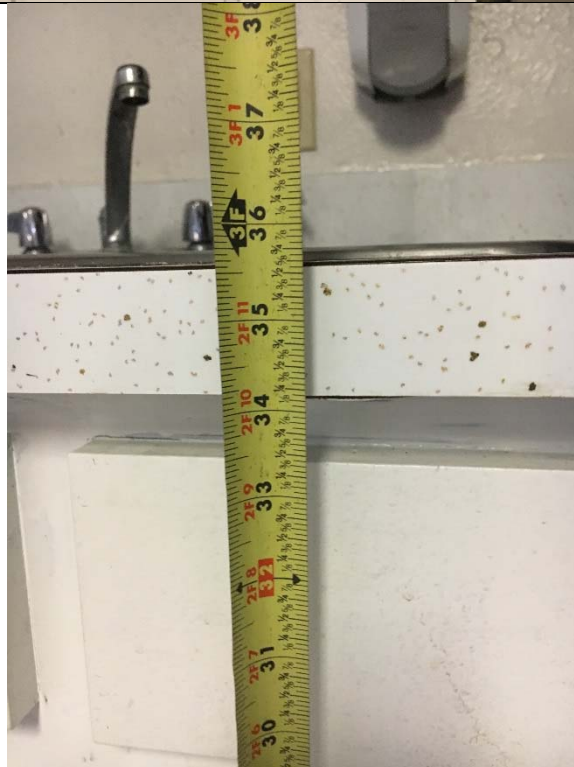
The break room sink is 35-3/4" high where 34" maximum is required.

2010 ADAAG 606.3 Lavatories and Sinks Height.

Level 4

Violation 21 - The break room sink is 35-3/4" high where 34" maximum is required.

Modify break room sink and counter to provide 34" maximum height.

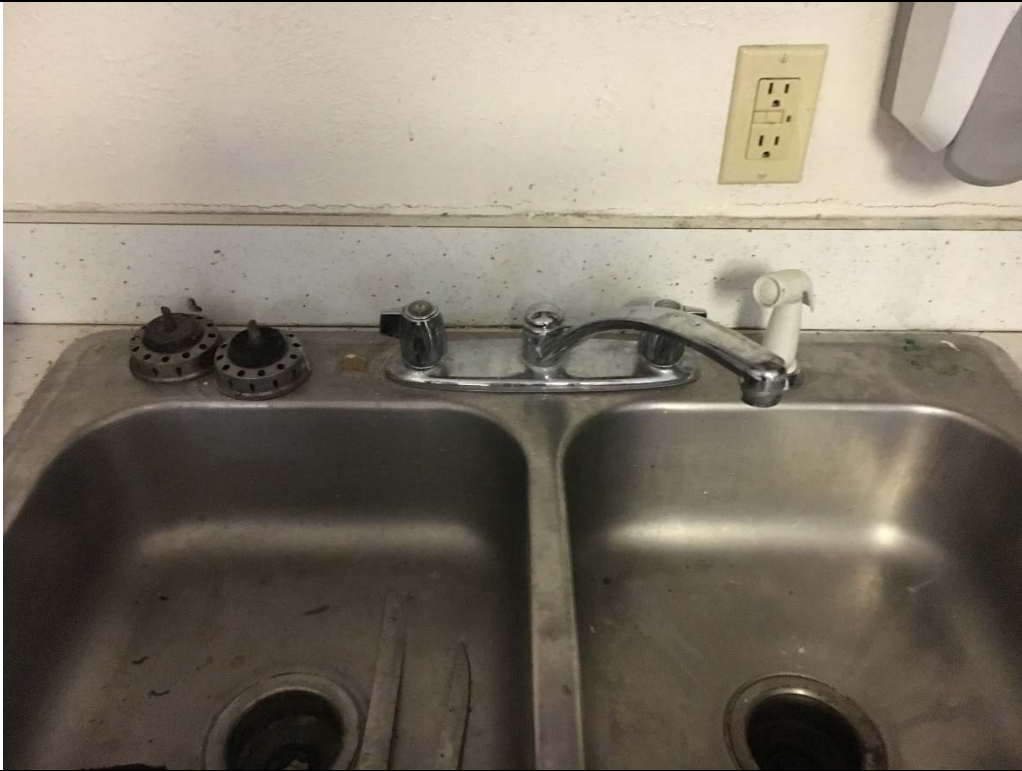
Breakroom sink faucets require grasping and twisting to operate.

2010 ADAAG 606.4 Faucets.

Level 4

Violation 22 - Breakroom sink faucets require grasping and twisting to operate.

Replace faucet with lever style handles.
