**ADDISON AIRPORT
BUILDING REPORT**

Facility Information: **Facility Name:** 4680 Glenn Curtiss Drive
Facility Contact: Lisa Pyles **Contact Phone:** 972-450-2878

Accessology Inspector Information:
Inspector: Karen Jackson **Date:** May 3, 2017
Email: Kjackson@accessology.com

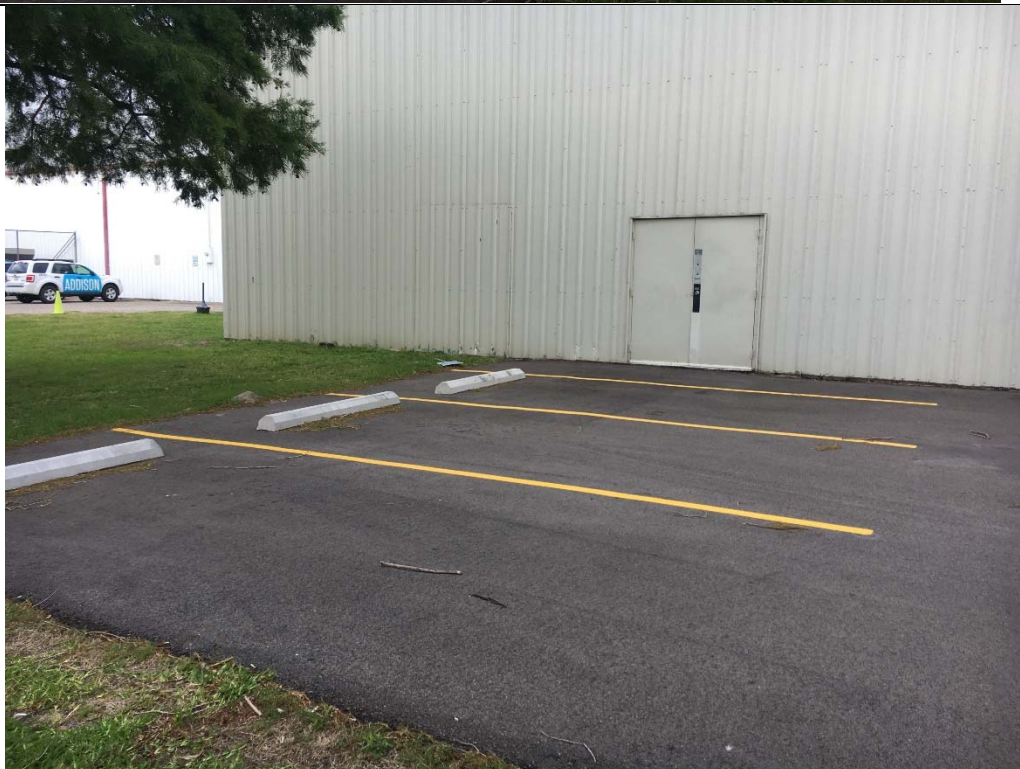
Violation #1: Eight parking spaces serve this building and none are accessible.

Standard: 2010 ADAAG 208.1 General.

Violation 1 – Eight parking spaces serve this building and none are accessible.

Possible Solutions: Provide one van accessible parking space, an access aisle and compliant signage.

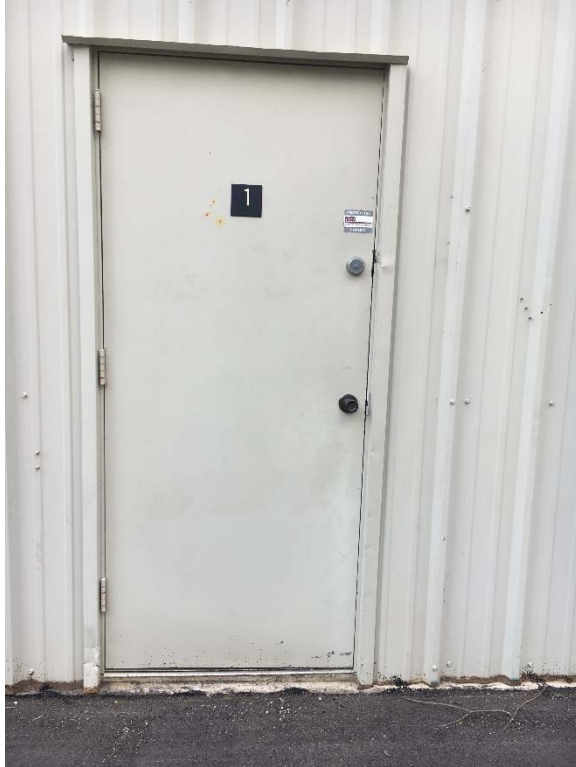
Violation #2: The entrance door into the building has knob door hardware requiring grasping and twisting to operate.

Standard: 2010 ADAAG 404.2.7 Door and Gate Hardware.

Violation 2 - The entrance door into the building has knob door hardware requiring grasping and twisting to operate.

Possible Solutions: Replace door hardware with lever style hardware.

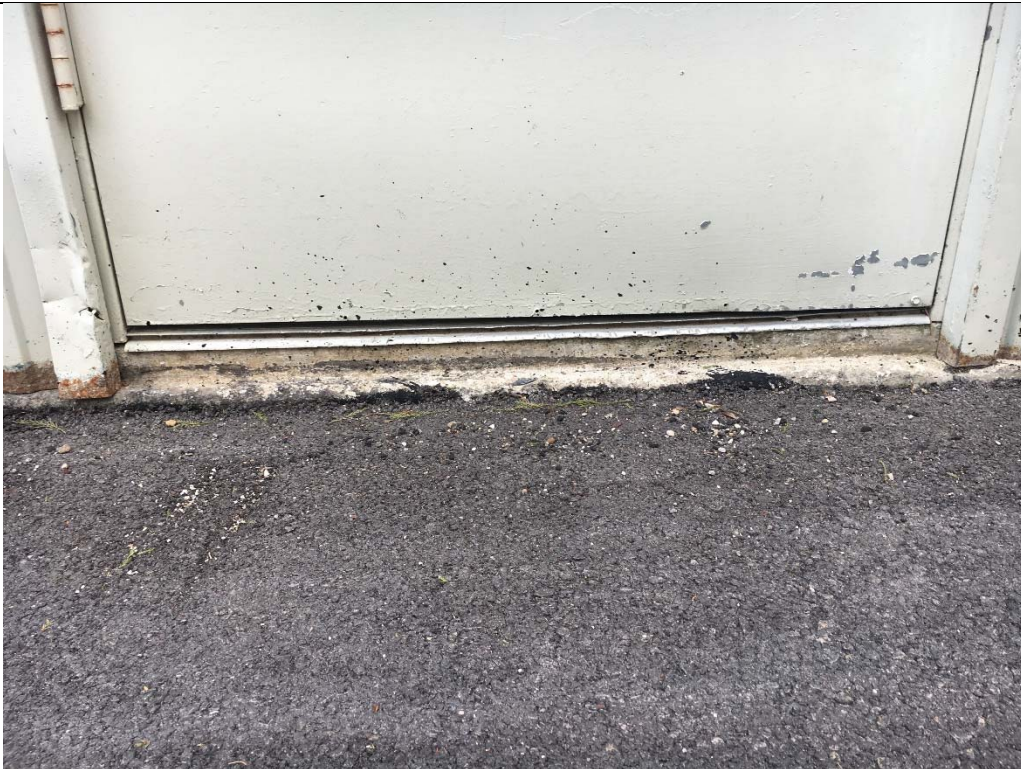
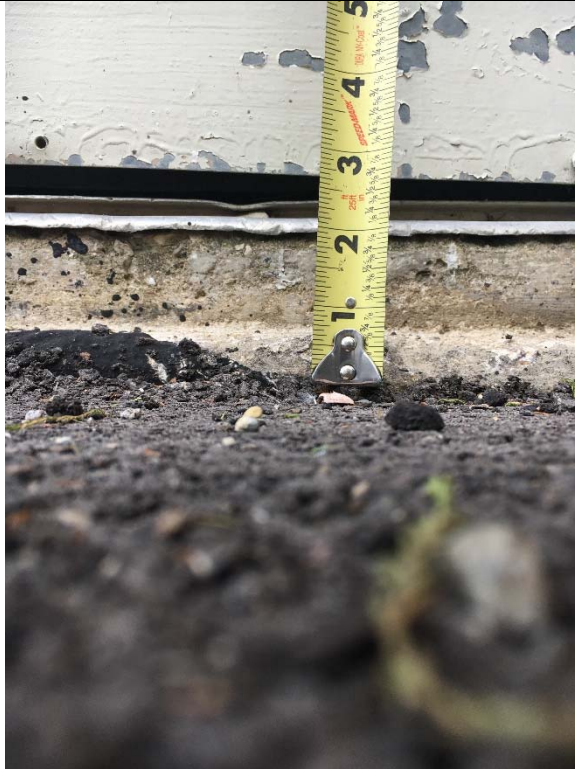
Violation #3: There is a 2-1/2" step to get into the building.

Standard: 2010 ADAAG 303.2 Vertical.

Violation 3 - There is a 2-1/2" step to get into the building.

Modify entrance to provide a transition no more than 1/4" high.

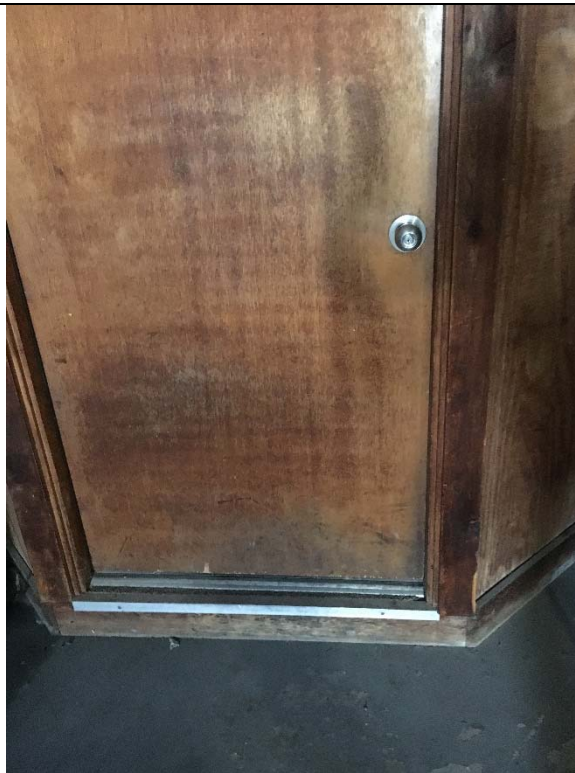
The door at the entrance into the office pod has knob style door hardware requiring grasping and twisting to operate.

2010 ADAAG 404.2.7 Door and Gate Hardware.

Violation 4 - The door at the entrance into the office pod has knob style door hardware requiring grasping and twisting to operate.

Replace door hardware with lever style hardware.

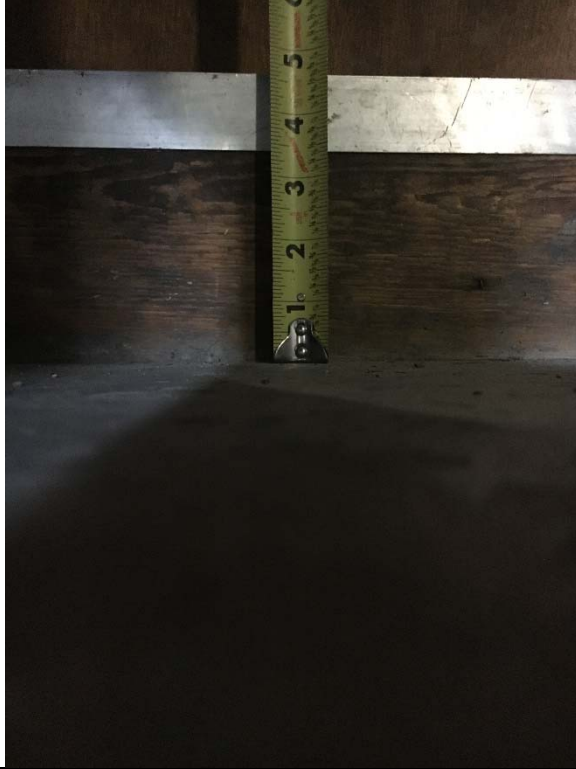
There is a 5" step up to enter the office pod.

2010 ADAAG 303.2 Vertical.

Violation 5 - There is a 5" step up to enter the office pod.

Modify entrance to provide a transition no more than 1/4" high.

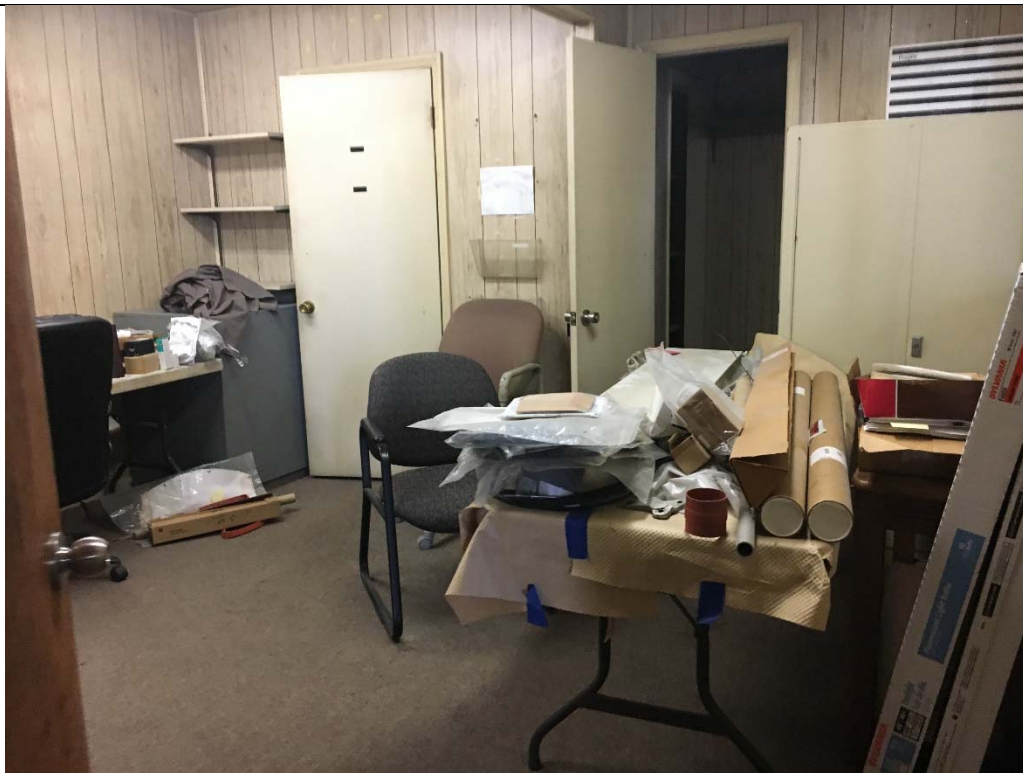
The two interior doors have door hardware that requires grasping and twisting to operate.

2010 ADAAG 404.2.7 Door and Gate Hardware.

Violation 6 - The two interior doors have door hardware that requires grasping and twisting to operate.

Replace all knob hardware with lever hardware that doesn't require tight grasping or twisting to operate.

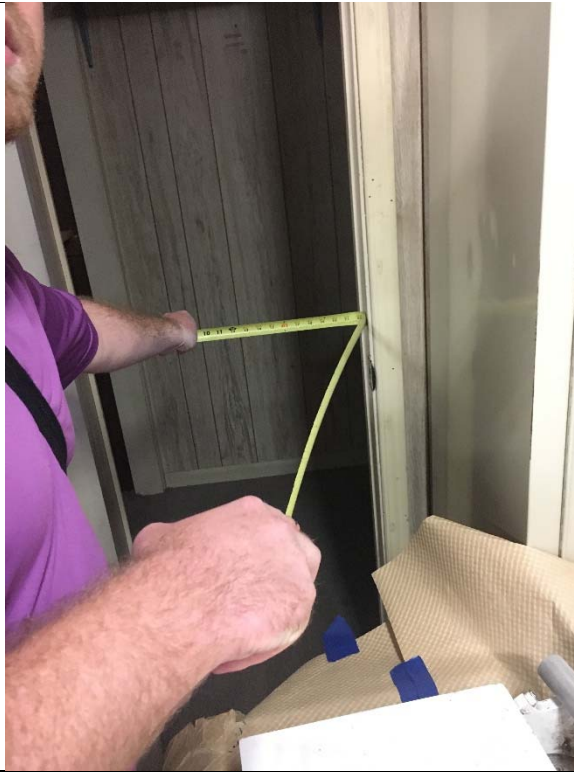
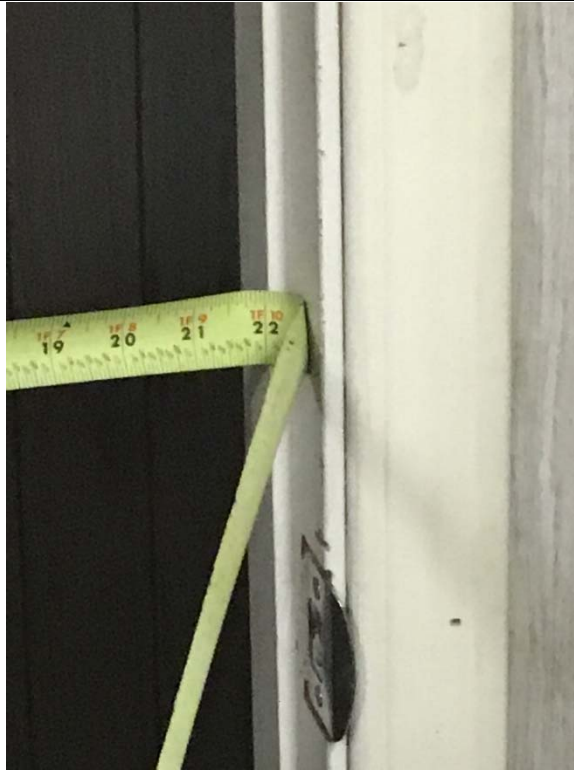
The storage area has an opening of only 22" wide where a minimum of 32" wide opening is required.

2010 ADAAG 404.2.3 Door and Gate Clear Width.

Violation 7 - The storage area has an opening of only 22" wide where a minimum of 32" wide opening is required.

Replace door to achieve 32" minimum clear width and swing door outward.

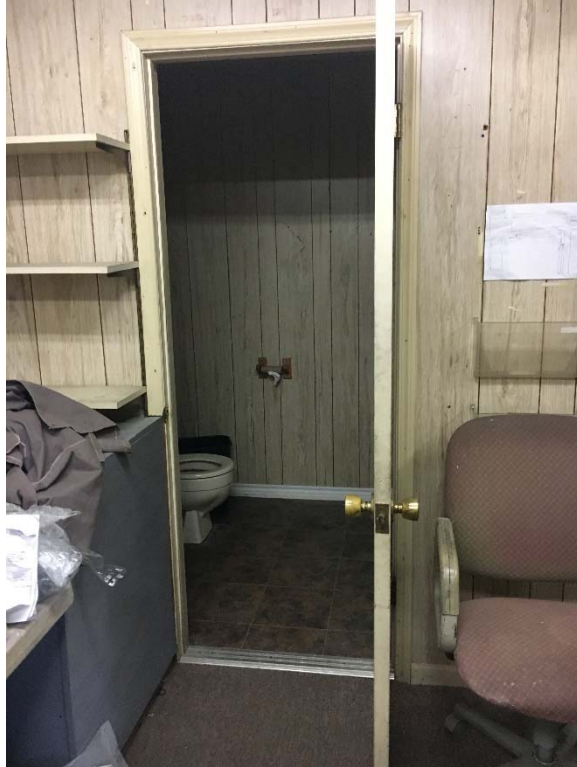
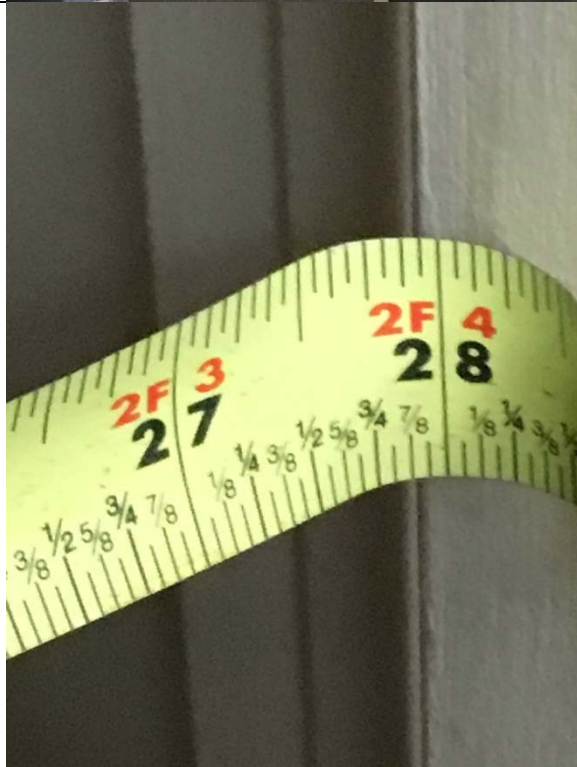
The door to the restroom only has a 28" wide opening where a minimum of 32" wide opening is required.

2010 ADAAG 404.2.3 Door and Gate Clear Width.

Violation 8 - The door to the restroom only has a 28" wide opening where a minimum of 32" wide opening is required.

Replace door. Ensure clear opening of 32 inches minimum

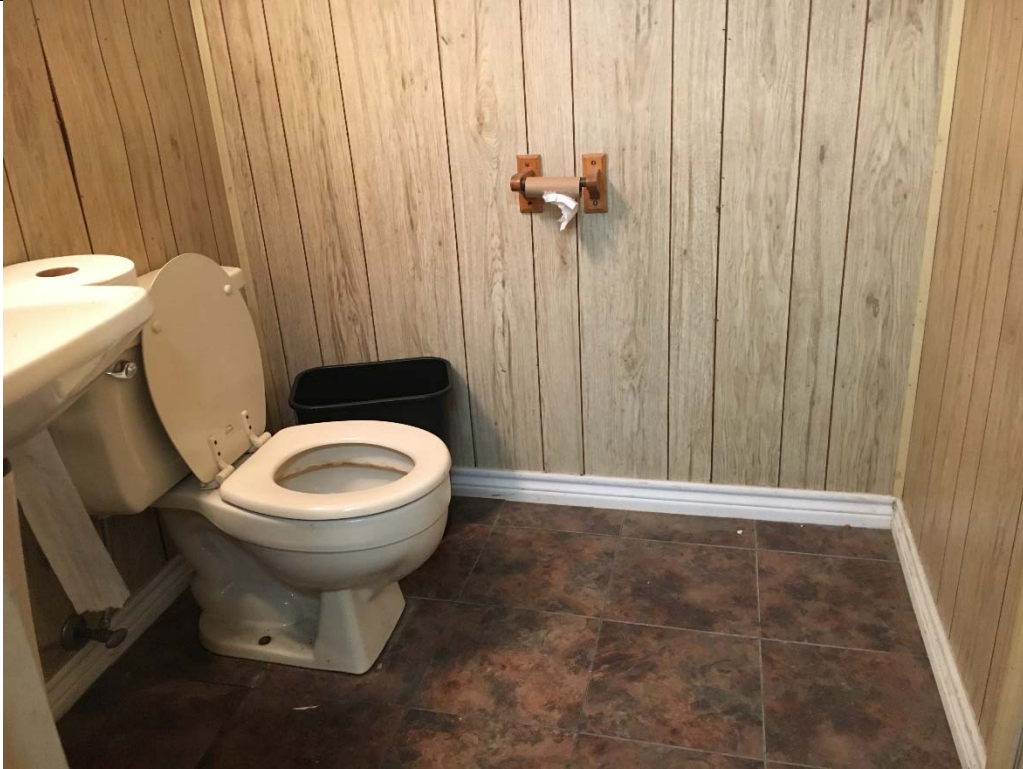
The restroom does not include any accessible features and the room is not large enough to accommodate accessible fixtures and wheelchair turning space.

2010 ADAAG 213.2 Toilet Rooms and Bathing Rooms.

Violation 9 - The restroom does not include any accessible features and the room is not large enough to accommodate accessible fixtures and wheelchair turning space.

Enlarge restroom to accommodate accessible water closet, lavatory and wheelchair turning space.
