**ADDISON AIRPORT
BUILDING REPORT**

Facility Information: **Facility Name:** 4726 George Haddaway Dr.
Facility Contact: Lisa Pyles **Contact Phone:** 972-450-2878

Accessology Inspector Information:
Inspector: Karen Jackson **Date:** April 17, 2017
Email: Kjackson@accessology.com

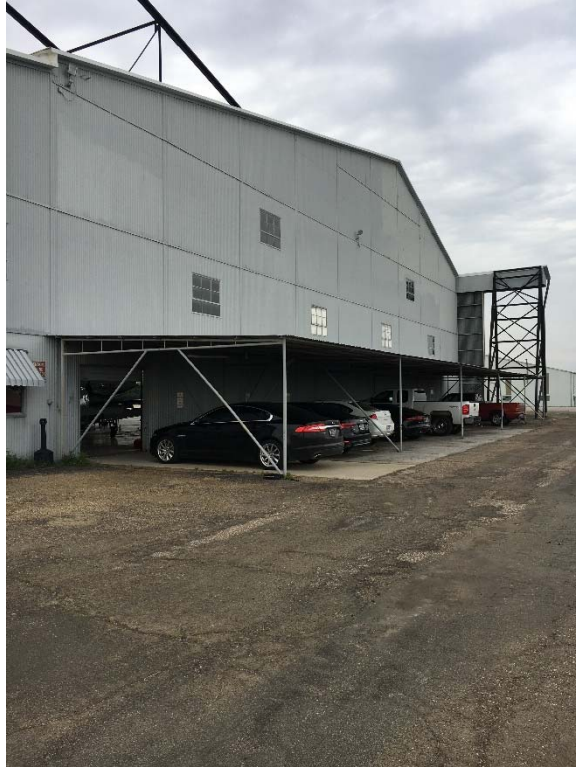
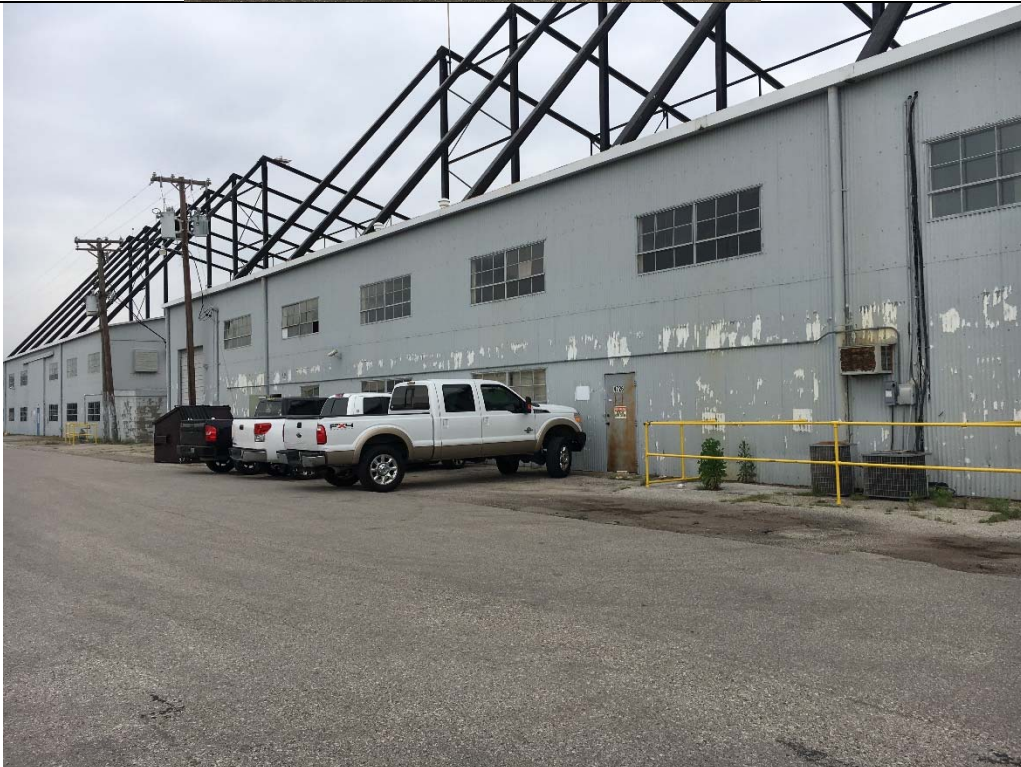
Violation #1: There are no accessible parking spaces provided.

Standard: 2010 ADAAG 208.1 General.

Violation 1 - There are no accessible parking spaces provided.

Possible Solutions: Add one van accessible parking space, an access aisle and compliant van parking signage.

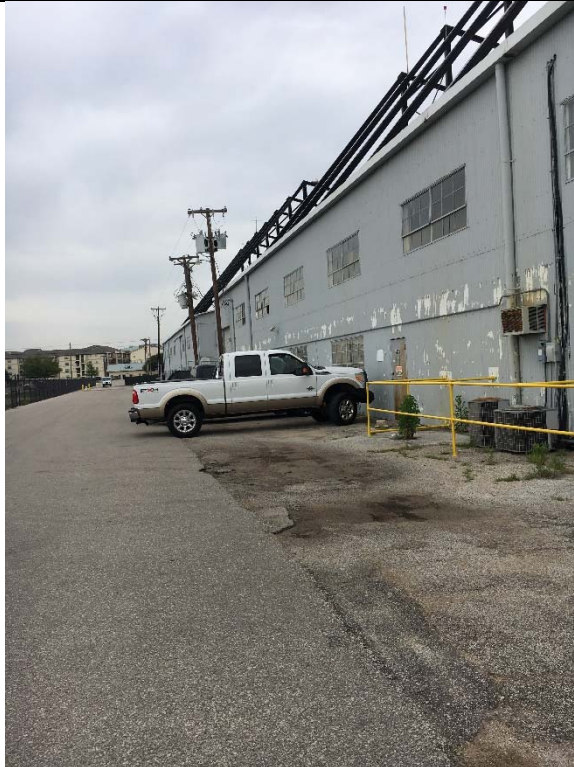
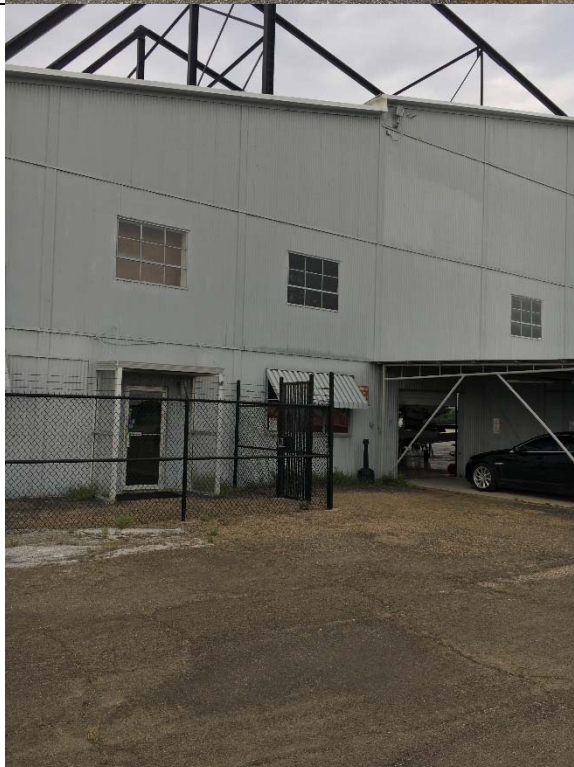
Violation #2: The ground surface in the parking area is broken, uneven and unstable.

Standard: 2010 ADAAG 302.1 General.

Violation 2 - The ground surface in the parking area is broken, uneven and unstable.

Possible Solutions: Repave the area where accessible parking spaces will be added. Cost is included in Violation #1.

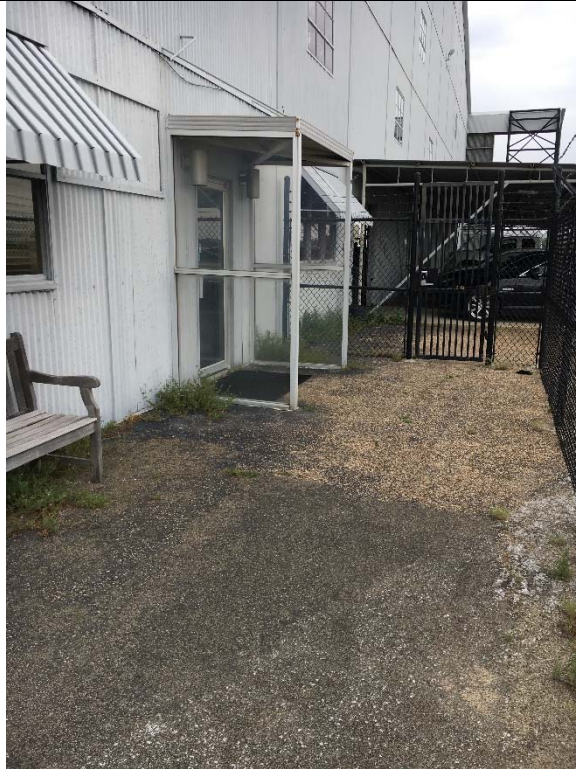
Violation #3: The ground surface around the building is broken, uneven and unstable.

Standard: 2010 ADAAG 302.1 General.

Violation 3 - The ground surface around the building is broken, uneven and unstable.

Possible Solutions: Repave the accessible route leading to the building's main entrance.

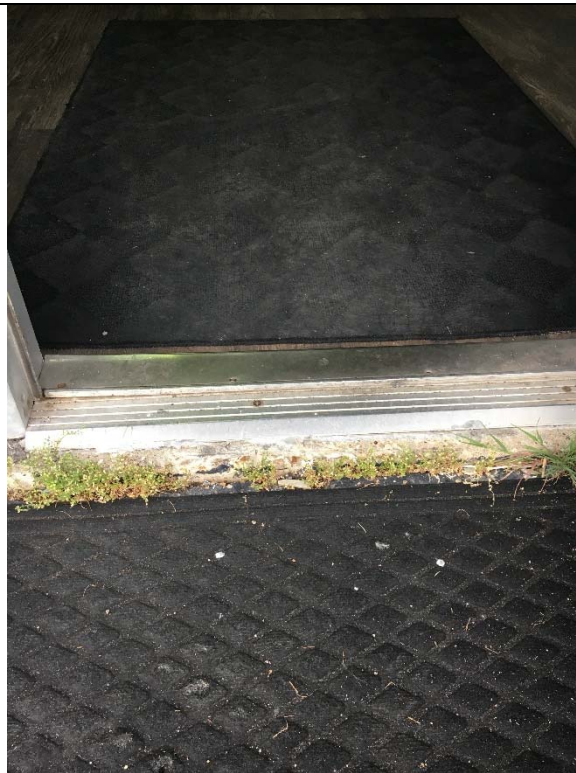
Violation #4: The main entrance has a threshold that is greater than 1/2" and there is not a smooth transition from the porch area.

Standard: 2010 ADAAG 404.2.5 Thresholds.

Violation 4 - The main entrance has a threshold that is greater than 1/2" and there is not a smooth transition from the porch area.

Possible Solutions: Modify threshold.

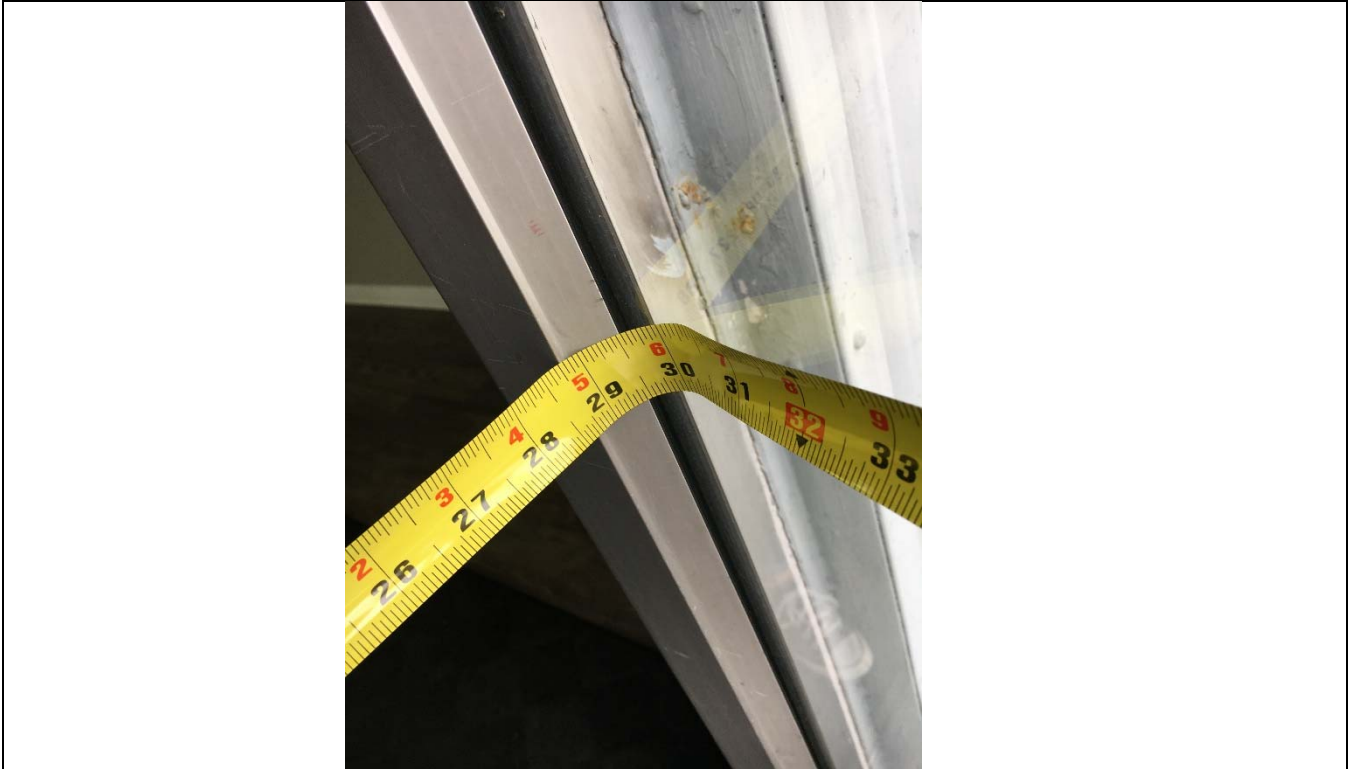
Violation #5: The entrance door is only 28-1/2" wide where a minimum of 32" is required.

Standard: 2010 ADAAG 404.2.3 Clear Width.

Violation 5 - The entrance door is only 28-1/2" wide where a minimum of 32" is required.

Replace door to achieve 32" minimum clear width.

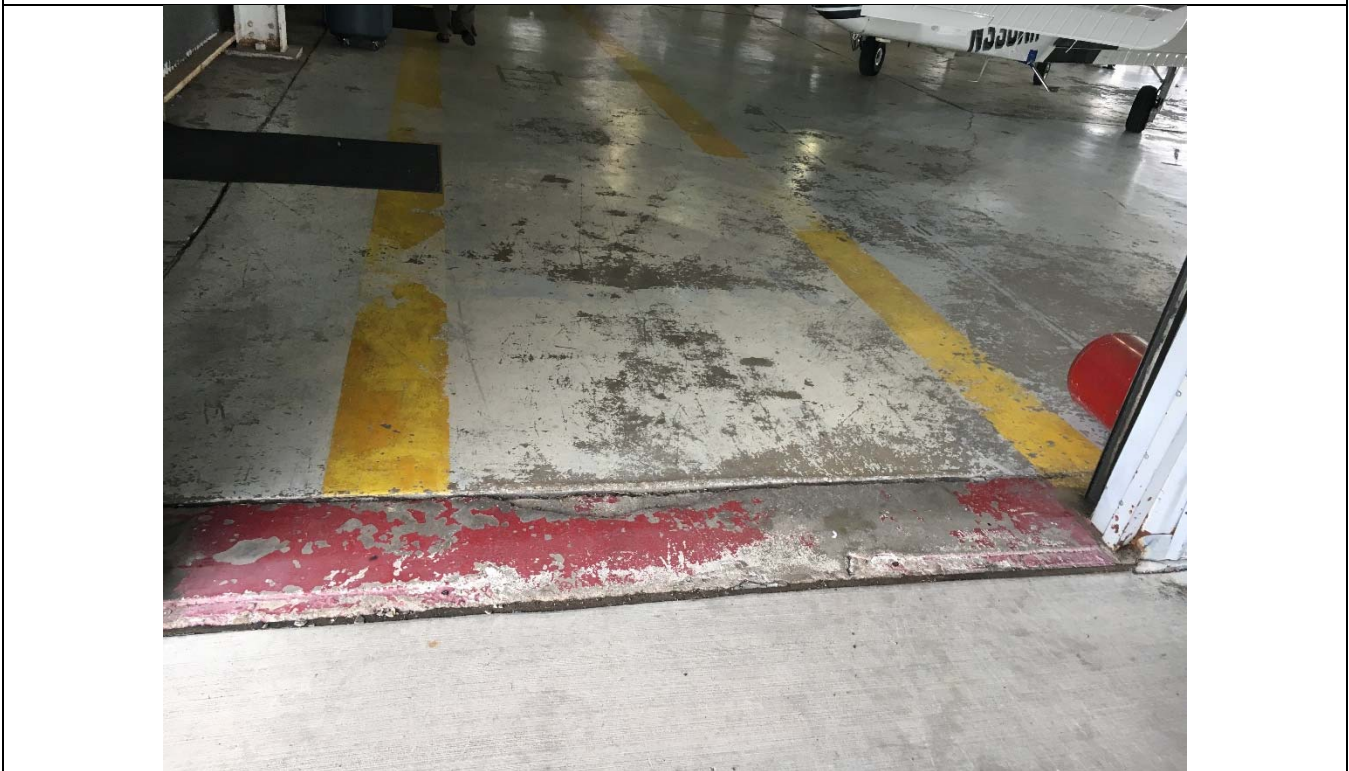
The entrance into the airplane hangar area from outside has broken, uneven pavement.

2010 ADAAG 302.1 General.

Violation 6 - The entrance into the airplane hangar area from outside has broken, uneven pavement.

Repair broken pavement.

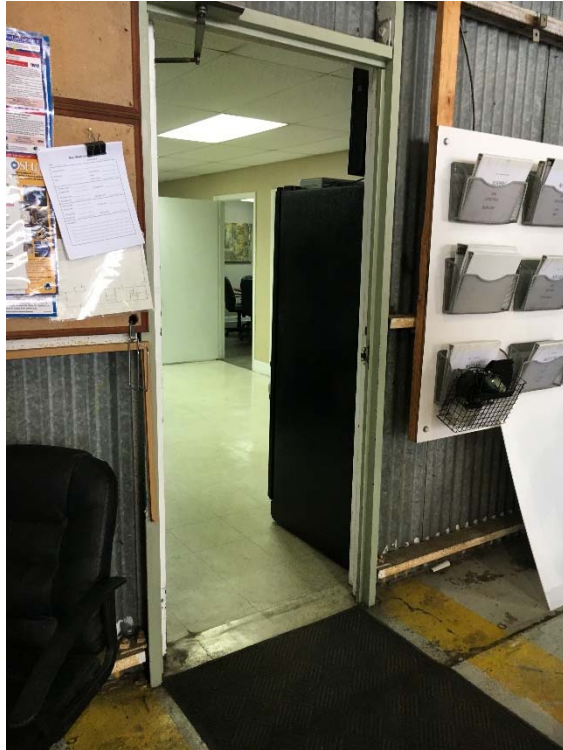
The entrance into the office from the hangar area has uneven pavement that appears to have dropped.

2010 ADAAG 404.2.4.4 Floor or Ground Surface.

Violation 7 - The entrance into the office from the hangar area has uneven pavement that appears to have dropped.

Remove and replace pavement in the area in front of the door to achieve a smooth transition.

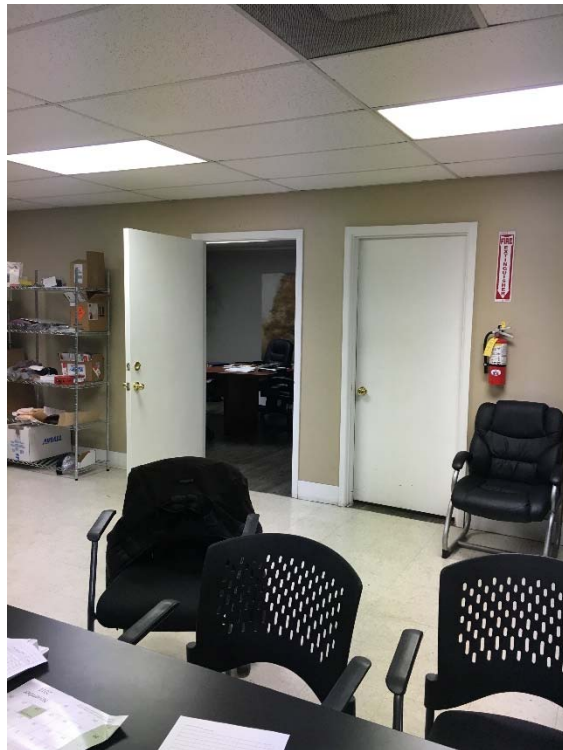
There are 9 interior doors with door hardware that requires grasping and twisting to operate.

2010 ADAAG 404.2.7 Door and Gate Hardware.

Violation 8 - There are 9 interior doors with door hardware that requires grasping and twisting to operate.

Replace all knob hardware with lever hardware that doesn't require tight grasping or twisting to operate.

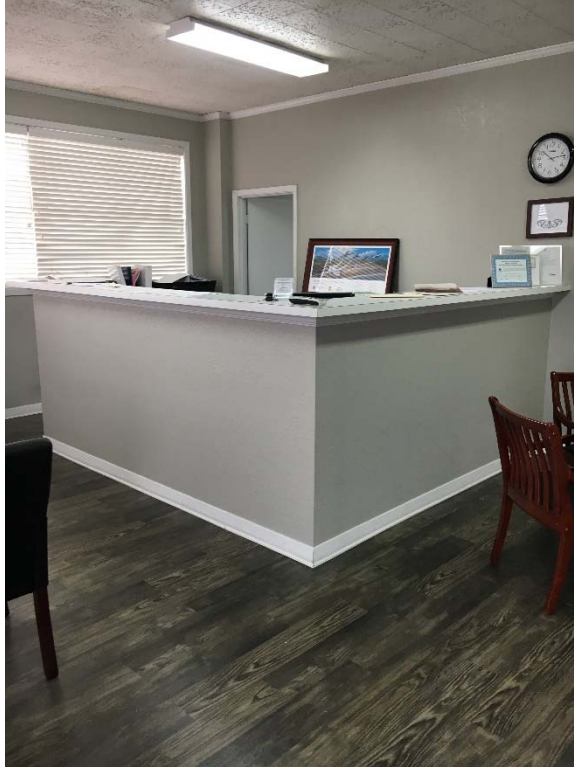
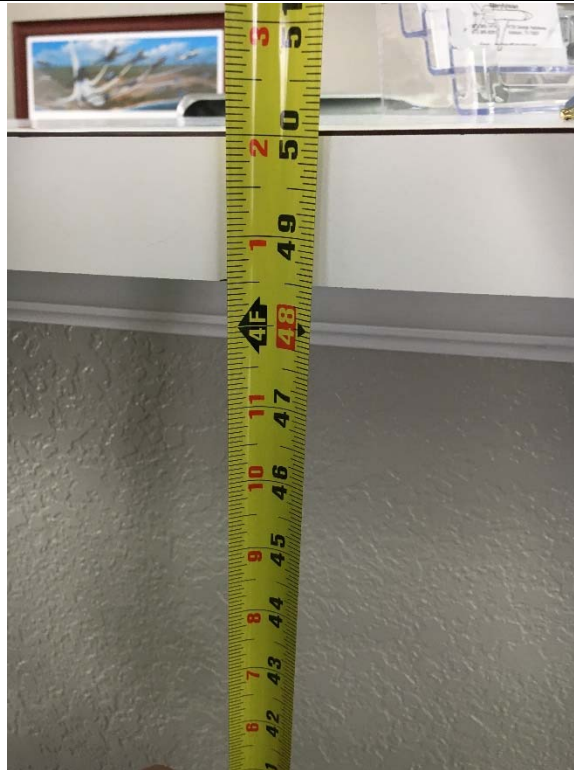
The reception desk is mounted at 50" above finished floor to the top of the counter.

2010 ADAAG 904.4.1 Parallel Approach.

Violation 9 - The reception desk is mounted at 50" above finished floor to the top of the counter.

Lower a 36" portion of the counter to 36" above finished floor to the top of the counter.

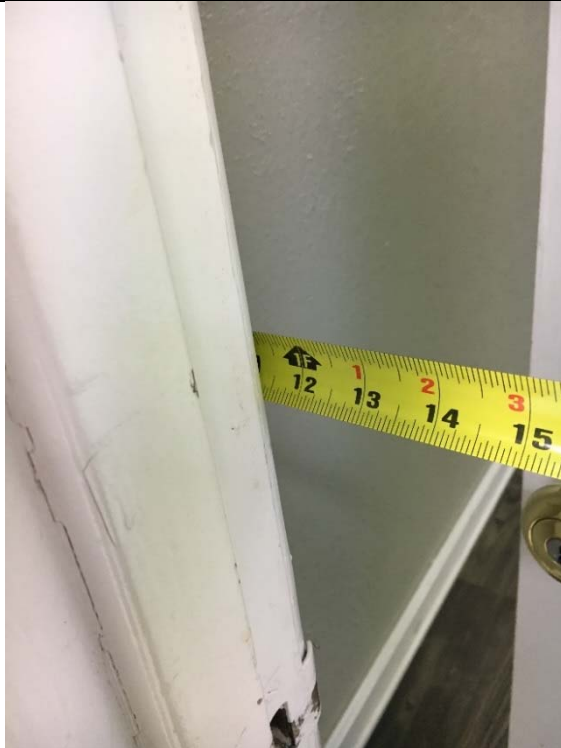
Office door only has an 11-1/2" maneuvering clearance on the pull side where a minimum of 18" is required.

2010 ADAAG 404.2.4.1 Swinging Doors and Gates.

Violation 10 - Office door only has an 11-1/2" maneuvering clearance on the pull side where a minimum of 18" is required.

Reverse the swing of the door.

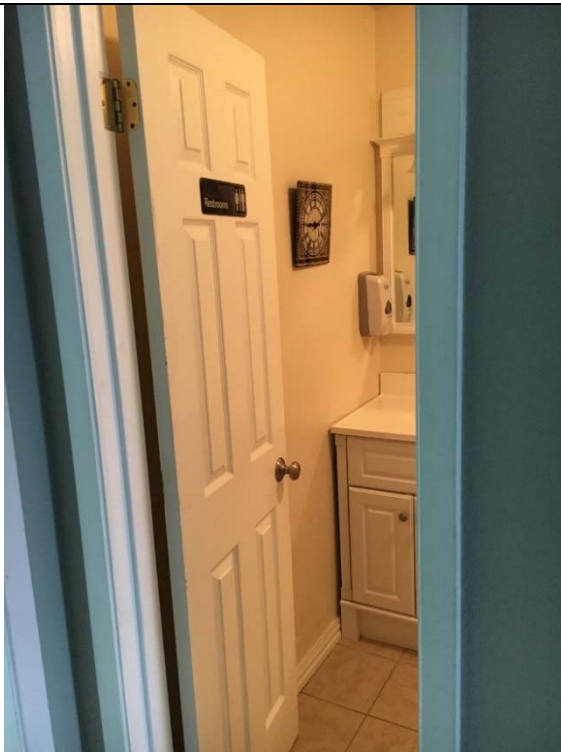
Restroom signage is mounted on the door and does not have Braille or tactile characters.

2010 ADAAG 216.2 Designations.

Violation 11 - Restroom signage is mounted on the door and does not have Braille or tactile characters.

Install compliant signage on the wall on the latch side of the door.

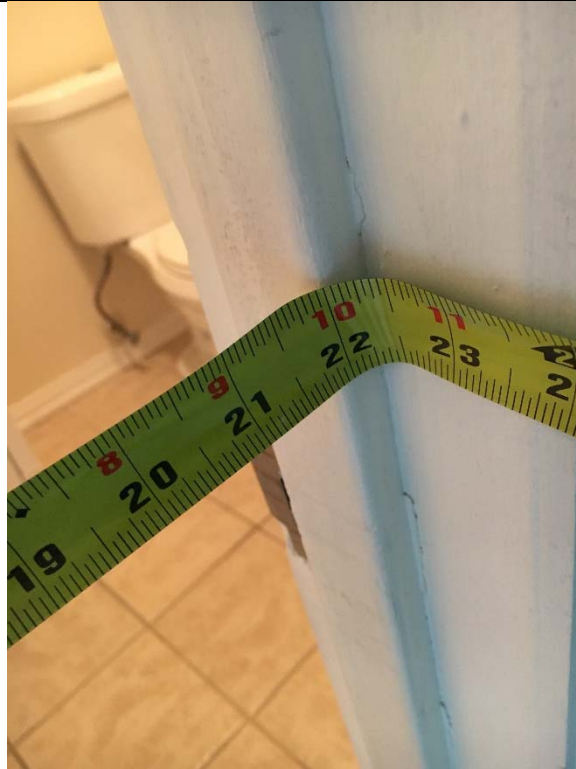
The door to the restroom is only 22" wide where a minimum of 32" is required.

2010 ADAAG 404.2.3 Clear Width.

Violation 12 - The door to the restroom is only 22" wide where a minimum of 32" is required.

Replace door to achieve 32" minimum clear width and reverse the swing of the door.

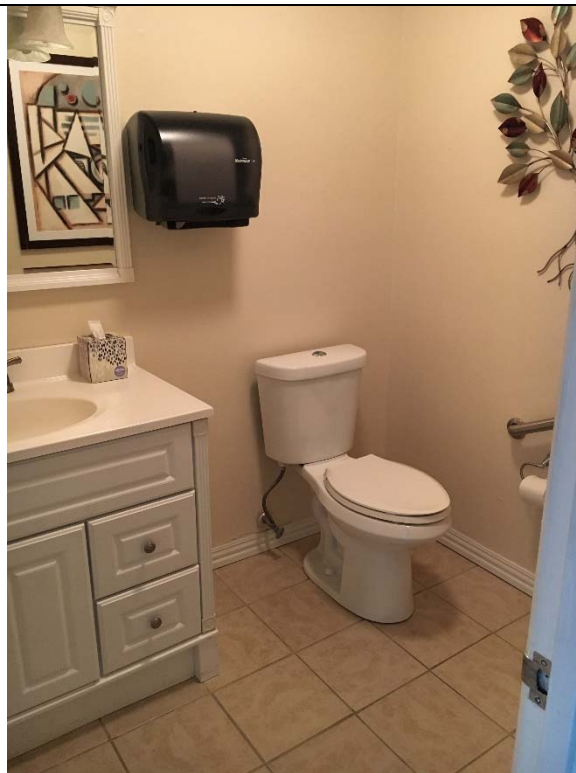
The single user restroom is not large enough to accommodate a wheelchair turning space and could not be considered an accessible restroom.

2010 ADAAG 213.2 Toilet Rooms and Bathing Rooms.

Violation 13 - The single user restroom is not large enough to accommodate a wheelchair turning space and could not be considered accessible restrooms.

Enlarge restroom to accommodate accessible water closet and lavatory and wheelchair turning space.

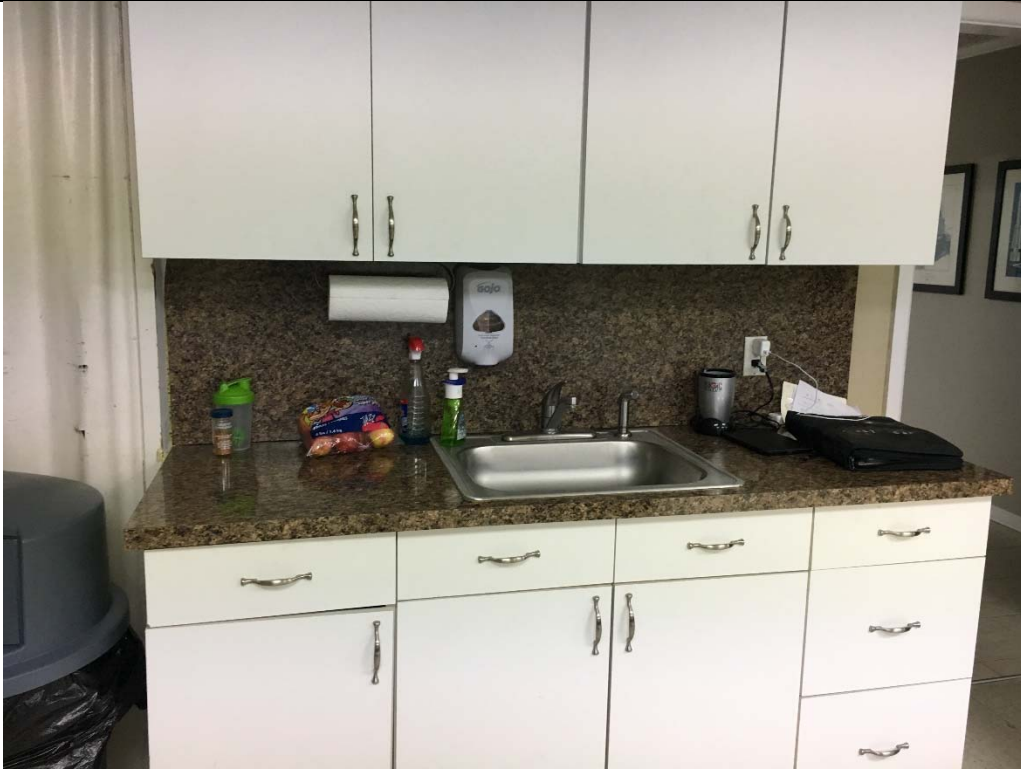
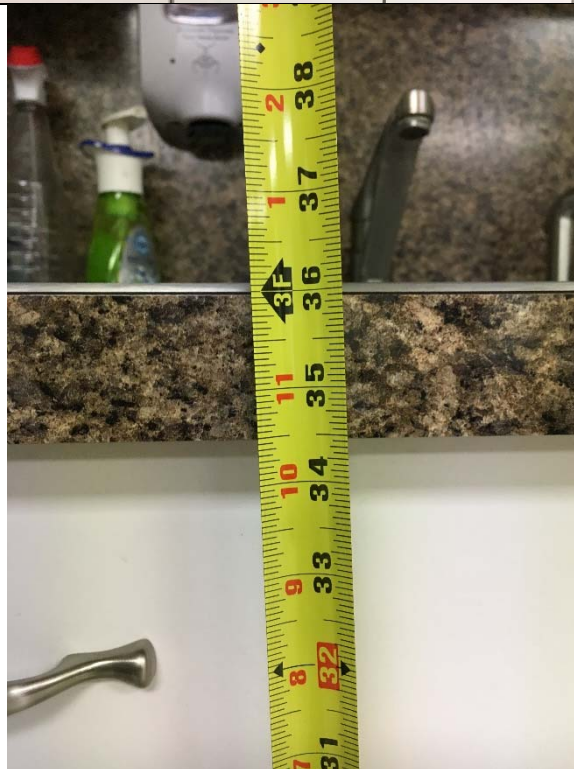
Violation #14: The sink in the break room is at 36" where a maximum of 34" is required.

Standard: 2010 ADAAG 606.3 Lavatories and Sinks Height.

Violation 14 - The sink in the break room is at 36" where a maximum of 34" is required.

Possible Solutions: Modify sink to provide 34" maximum height.
