**ADDISON AIRPORT
BUILDING REPORT**

Facility Information: **Facility Name:** Cavanaugh Flight Museum - Hangar 4
Facility Contact: Lisa Pyles **Contact Phone:** 972-450-2878

Accessology Inspector Information:
Inspector: Karen Jackson **Date:** April 17, 2017
Email: Kjackson@accessology.com

Latitude: 32.973154 **Longitude:** -96.834302
Address: 4572 Clair Chennault Street **City:** Addison **County:** Dallas

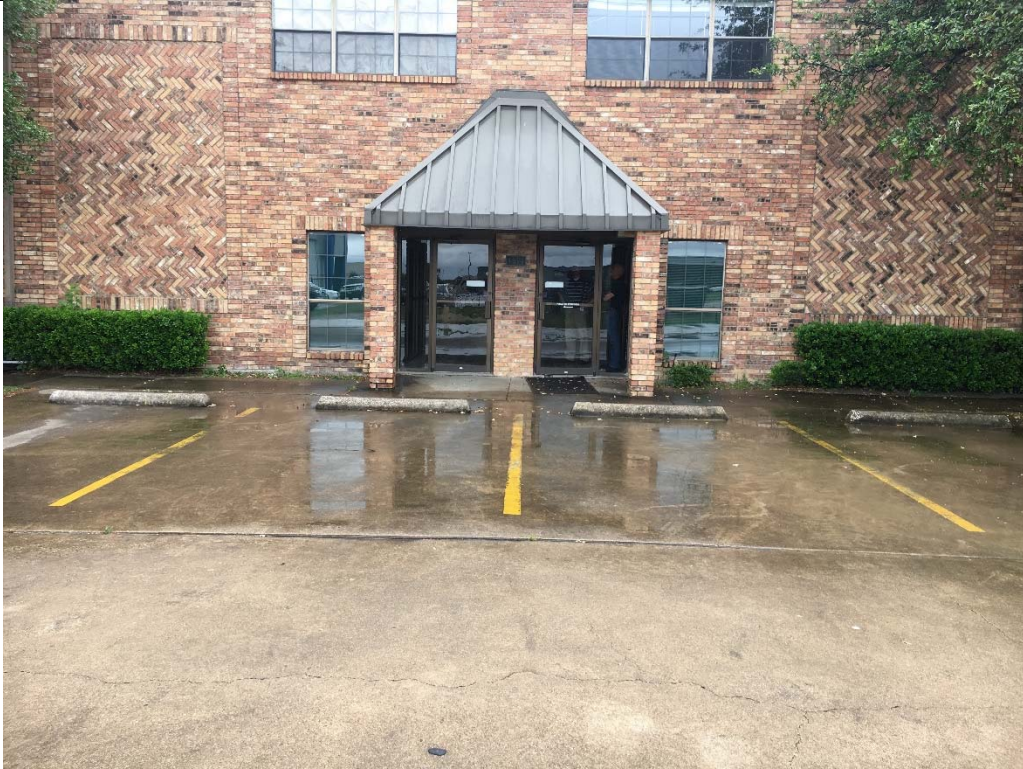
Violation #1: There are no accessible parking spaces provided.

Standard: 2010 ADAAG 208.1 General.

Text: Where parking spaces are provided, parking spaces shall be provided in accordance with 208

Violation 1 - There are no accessible parking spaces provided.

Possible Solutions: Provide a van accessible parking space with an access aisle and compliant signage.

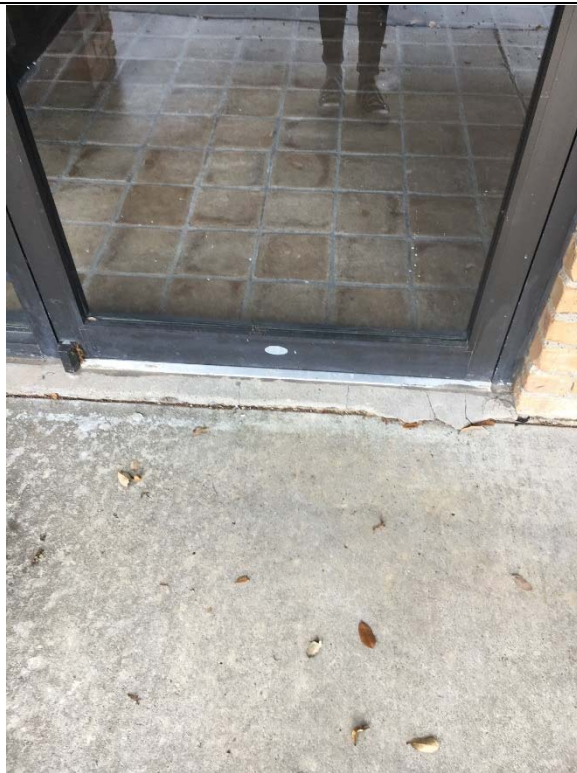
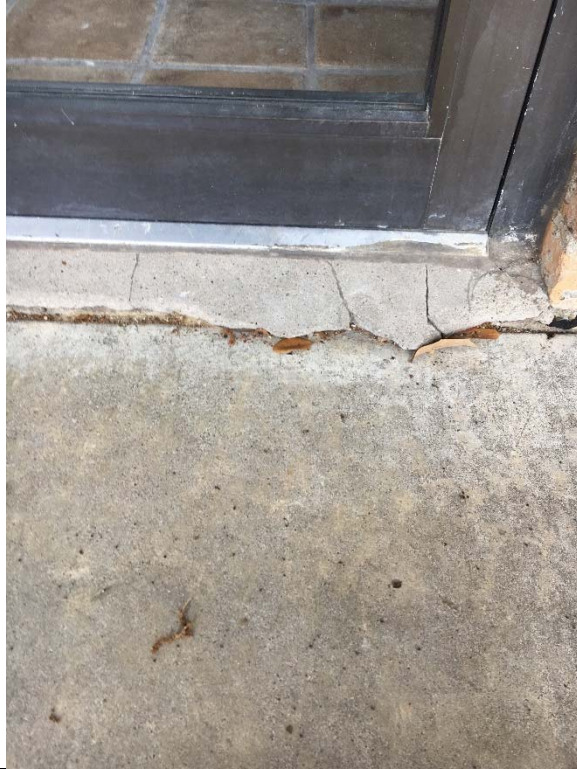
The pavement at the main entrance door is broken.

Standard:**2010 ADAAG 404.2.4.4 Floor or Ground Surface.****Text:**

Floor or ground surface within required maneuvering clearances shall comply with 302. Changes in level are not permitted.

Violation 2 - The pavement at the main entrance door is broken.

Remove and replace the broken pavement.

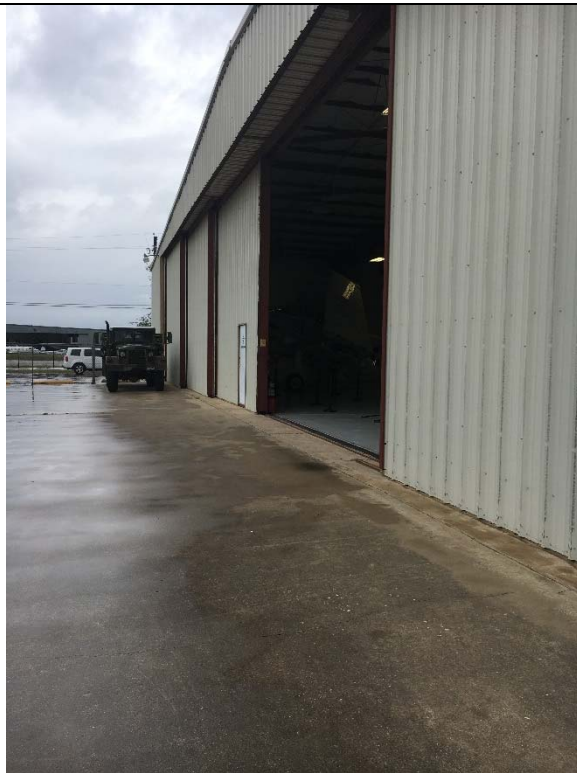
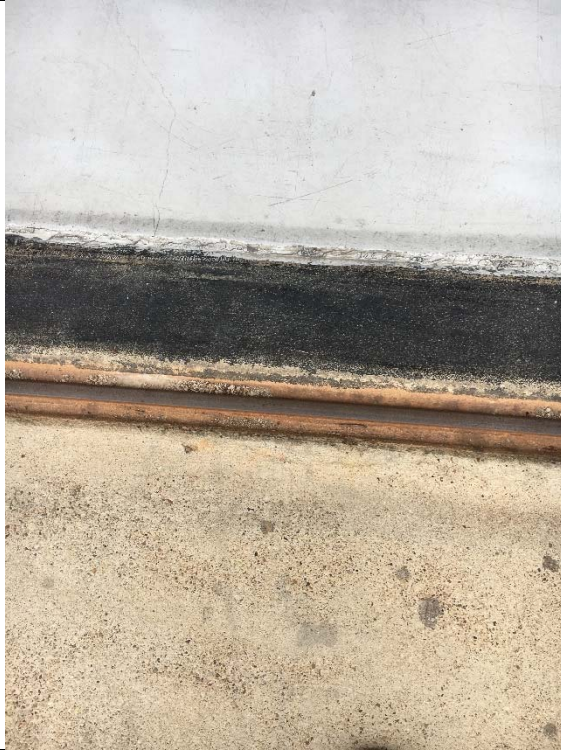
The public entrance into the hangar that is used during tours requires travel over the door tracks which is not a stable surface.

Standard:**2010 ADAAG 302.1 Floor and Ground Surfaces General**

The floor and ground surfaces shall be stable, firm, and slip resistant and shall comply with 302.

Violation 3 - The public entrance into the hangar that is used during tours requires travel over the door tracks which is not a stable surface.

Provide an accessible route into the hangar.

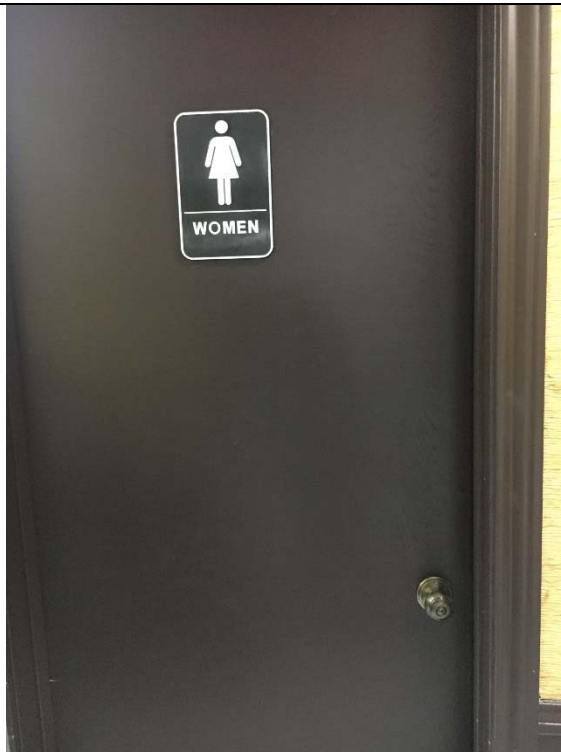
There are 6 doors in the building with knob style door hardware requiring grasping and twisting to operate.

2010 ADAAG 404.2.7 Door and Gate Hardware.

Handles, pulls, latches, locks, and other operable parts on doors and gates shall comply with 309.4.

Violation 4 - There are 6 doors in the building with knob style door hardware requiring grasping and twisting to operate.

Replace with lever hardware.

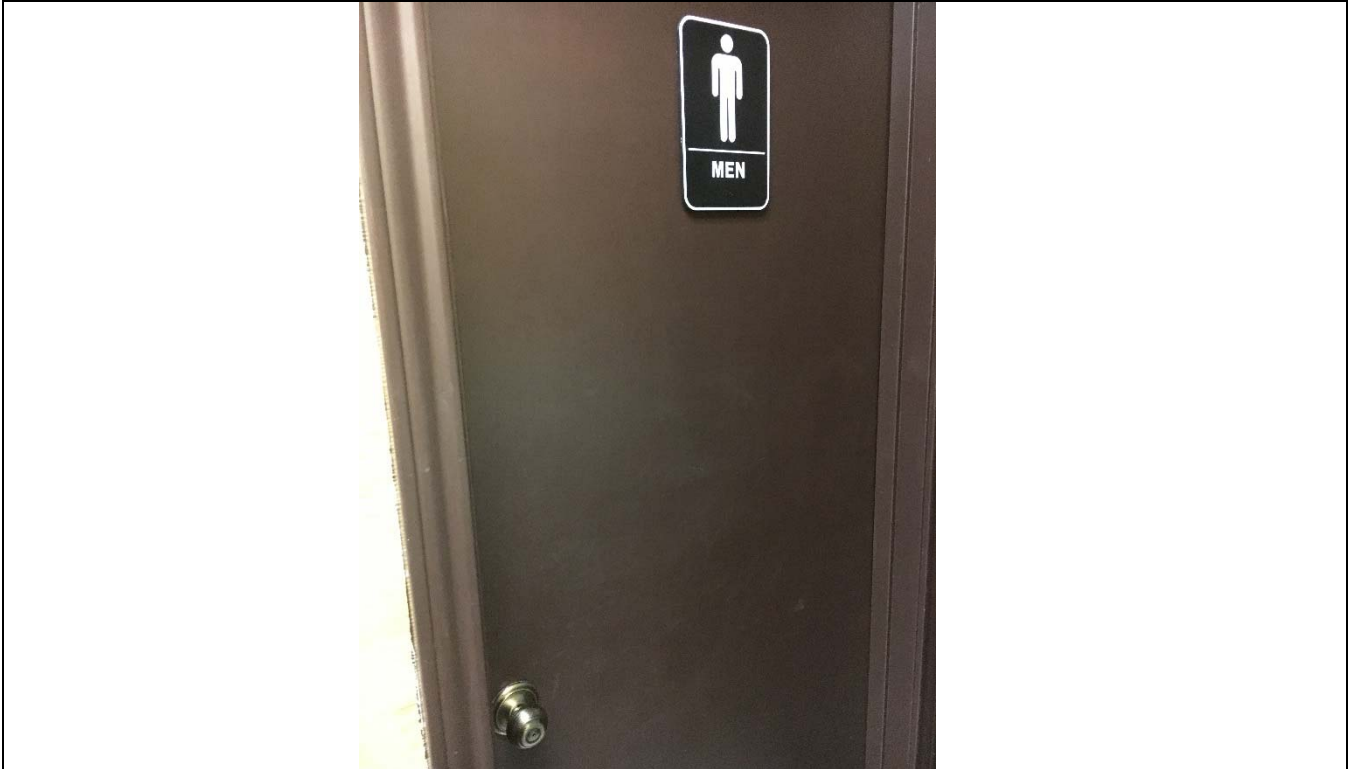
Signage for the restrooms in the office area is mounted on the door.

2010 ADAAG 703.4.2 Location.

Where a tactile sign is provided at a door, the sign shall be located alongside the door at the latch side.

Violation 5 - Signage for the restrooms in the office area is mounted on the door.

Install signage complying with Section 703.

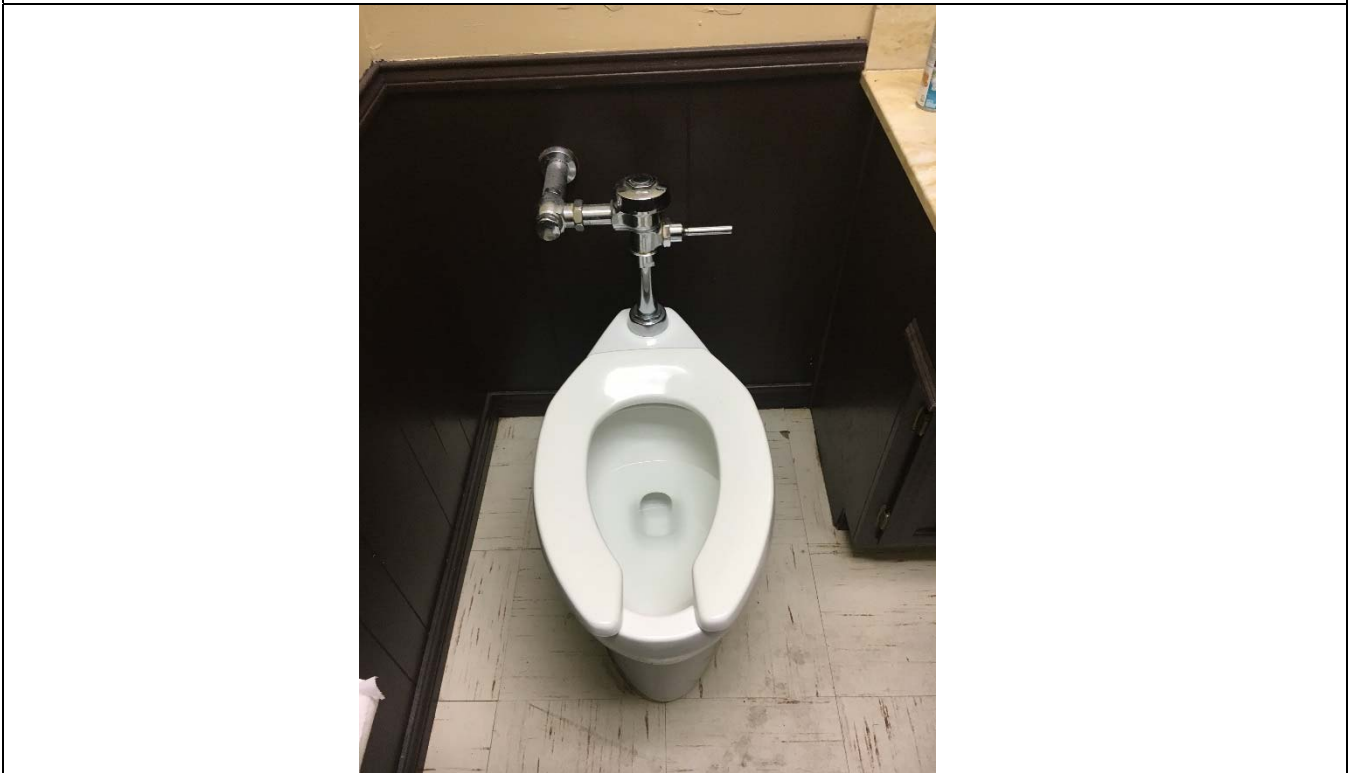
Office area Women's Room: The water closet does not have the required clear floor space.

2010 ADAAG 604.3.1 Size

Clearance around a water closet shall be 60" min. measured perpendicular from the side wall and 56" min. measured perpendicular from the rear wall.

Violation 6 - Office area Women's Room: The water closet does not have the required clear floor space.

Remodel restroom to provide the required clear floor space.

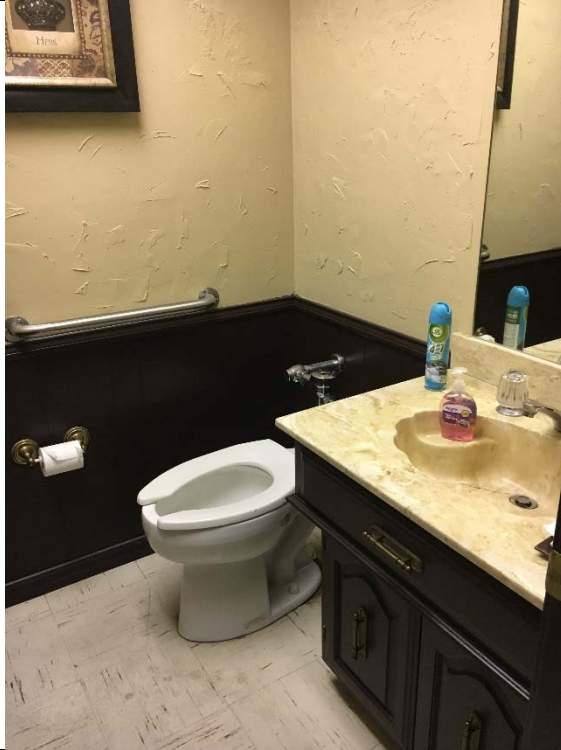
Office area Women's Room: No rear grab bar is provided and the side grab bar is only 24" long.

2010 ADAAG 604.5 Grab Bars.

Grab bars for water closets shall comply with 609. Grab bars shall be provided on the side wall closest to the water closet and on the rear wall.

Violation 7 - Office area Women's Room: No rear grab bar is provided and the side grab bar is only 24" long.

Install compliant grab bars.

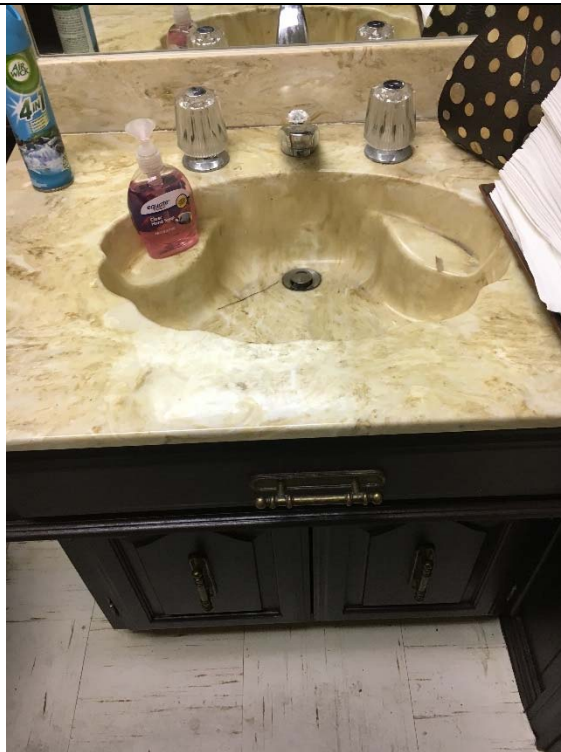
Office area Men's and Women's Rooms: The lavatories do not have the required knee clearance.

2010 ADAAG 606.2 Clear Floor Space.

A clear floor space complying with 305, positioned for a forward approach, and knee and toe clearance complying with 306 shall be provided.

Violation 8 - Office area Men's and Women's Rooms: The lavatories do not have the required knee clearance.

Modify lavatories to provide required toe and knee clearance.

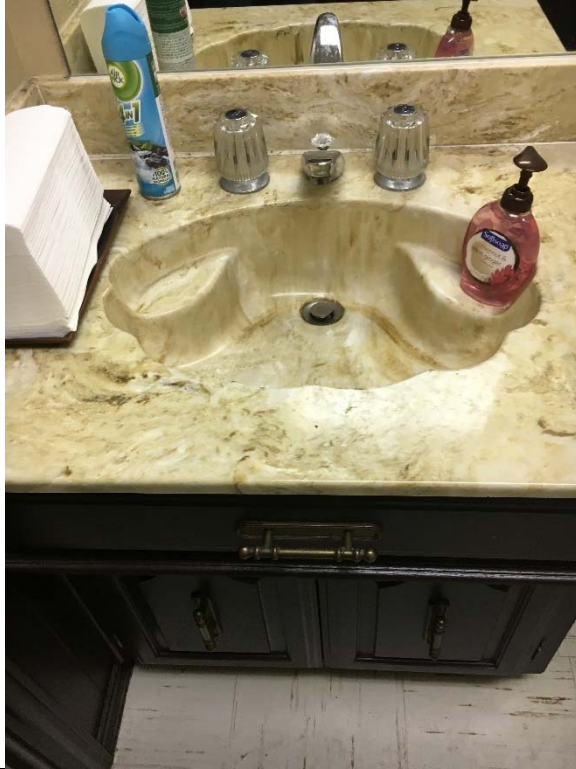
Office area Men's and Women's Rooms: The lavatory faucet controls require grasping and twisting to operate.

2010 ADAAG 606.4 Faucets.

Controls for faucets shall comply with 309. Hand-operated metering faucets shall remain open for 10 seconds min.

Violation 9 - Office area Men's and Women's Rooms: The lavatory faucet controls require grasping and twisting to operate.

Replace faucets with lever type.

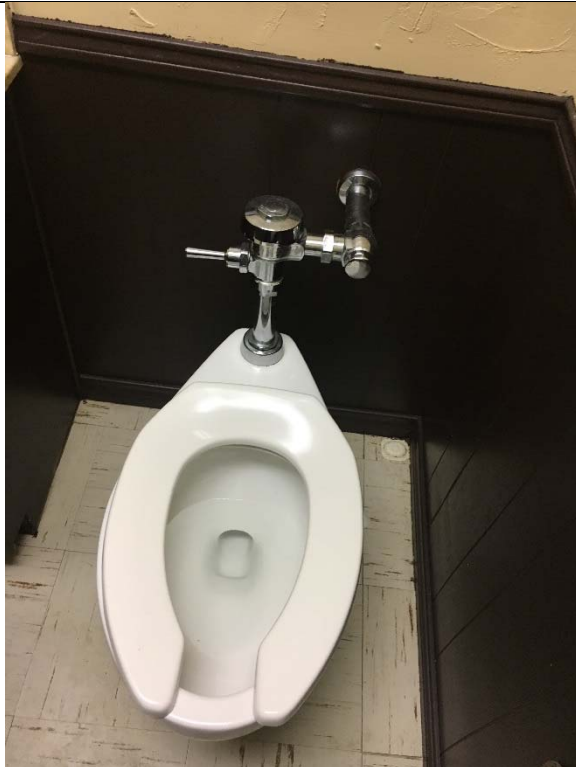
Office are Men's room: The water closet does not have the required clear floor space.

2010 ADAAG 604.3.1 Size

Clearance around a water closet shall be 60" min. measured perpendicular from the side wall and 56" min. measured perpendicular from the rear wall.

Violation 10 - Office are Men's room: The water closet does not have the required clear floor space.

Remodel restroom to provide the required clear floor space.

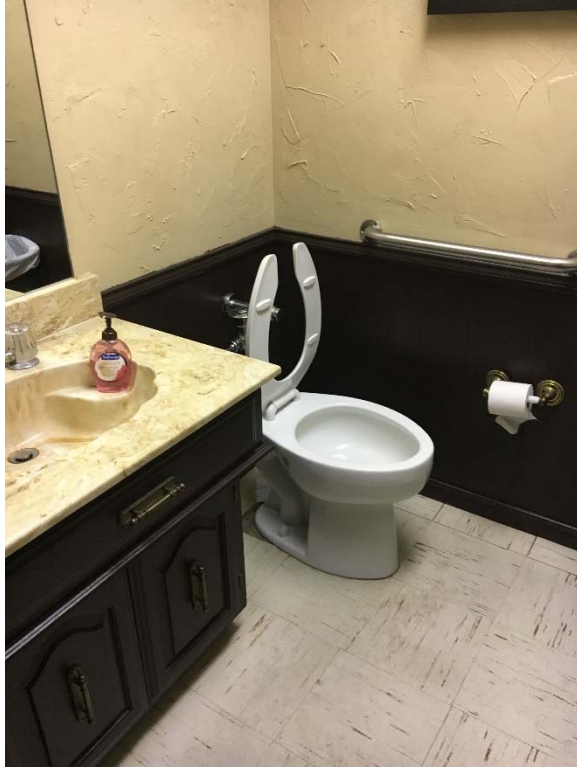
Office area Men's Room: No rear grab bar is provided and the side grab bar is only 24" long.

2010 ADAAG 604.5 Grab Bars.

Grab bars for water closets shall comply with 609. Grab bars shall be provided on the side wall closest to the water closet and on the rear wall.

Violation 11 - Office area Men's Room: No rear grab bar is provided and the side grab bar is only 24" long.

Install compliant grab bars.

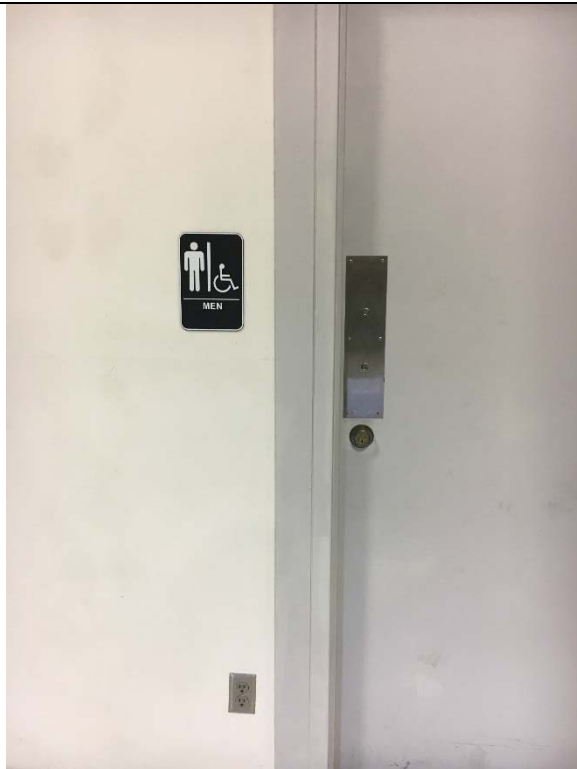
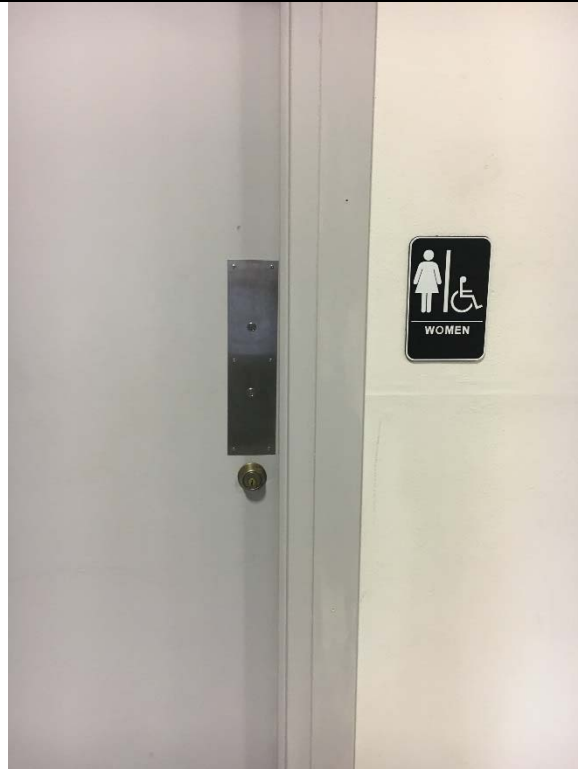
The Men's and Women's hangar restrooms require more than 5lbs of pressure to operate.

2010 ADAAG 404.2.9 Door and Gate Opening Force.

The force for pushing or pulling open an interior hinged doors and gates is 5 pounds maximum.

Violation 12 - The Men's and Women's hangar restrooms require more than 5lbs of pressure to operate.

Adjust door closers.

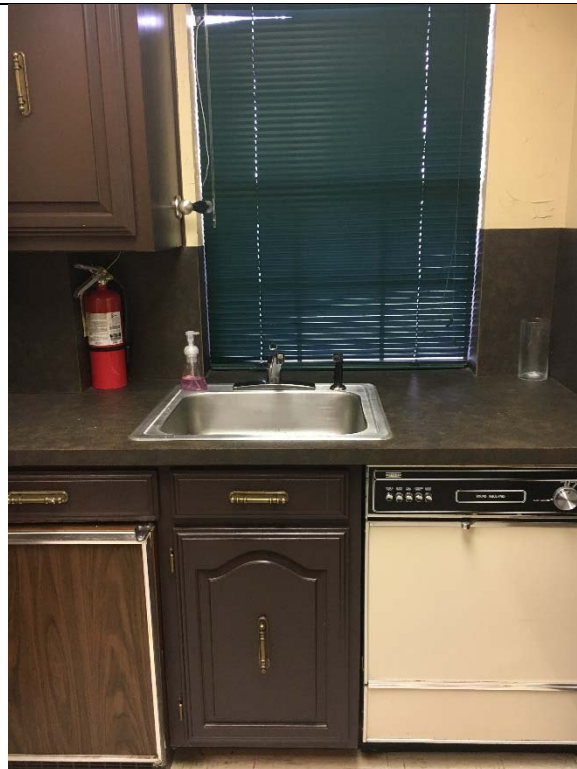
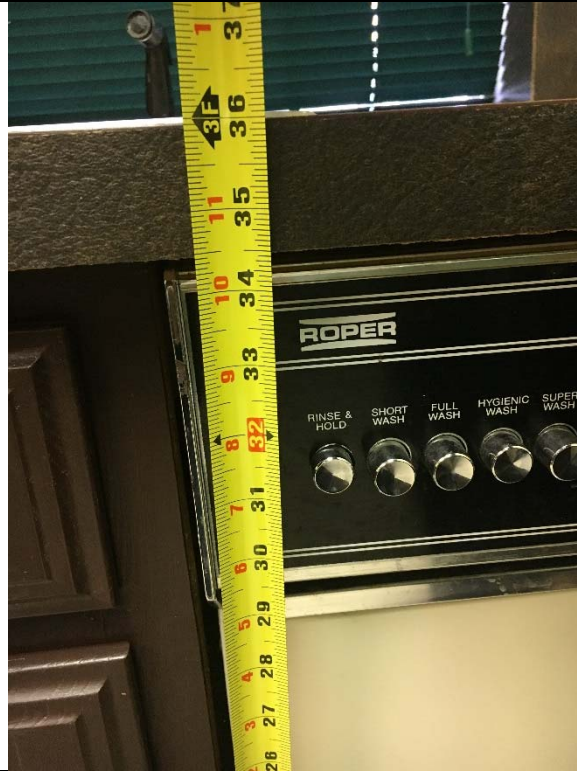
Violation #13: The sink in the break rea is 36" high where 34" maximum is required.

Standard: **2010 ADAAG 606.3 Lavatories and Sinks Height.**

Text: Lavatories and sinks shall be installed with the front of the higher of the rim or counter surface 34 inches maximum above the finish floor or ground.

Violation 13 - The sink in the break rea is 36" high where 34" maximum is required.

Possible Solutions: Modify sink to provide 34" maximum height.
