**ADDISON AIRPORT  
BUILDING REPORT**

**Facility Information:** **Facility Name:** Cavanaugh Flight Museum - Main Building  
**Facility Contact:** Lisa Pyles **Contact Phone:** 972-450-2878

**Accessology Inspector Information:**  
**Inspector:** Karen Jackson **Date:** April 17, 2017  
**Email:** Kjackson@accessology.com

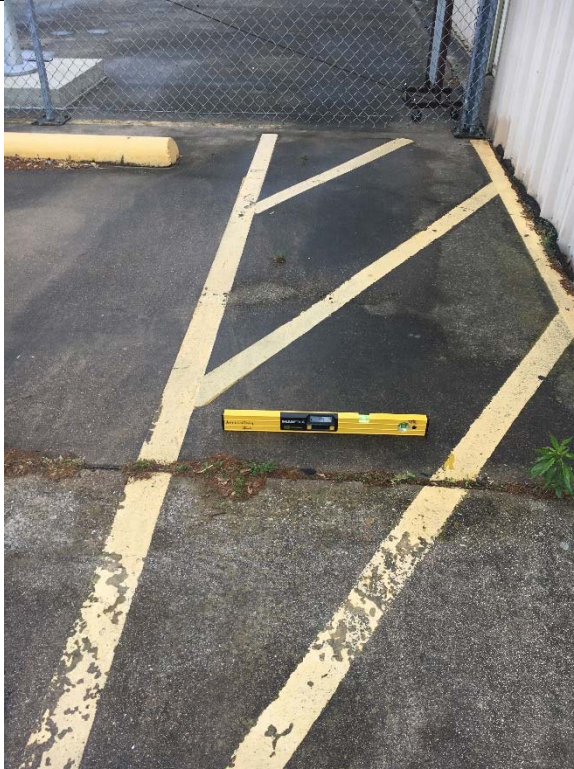
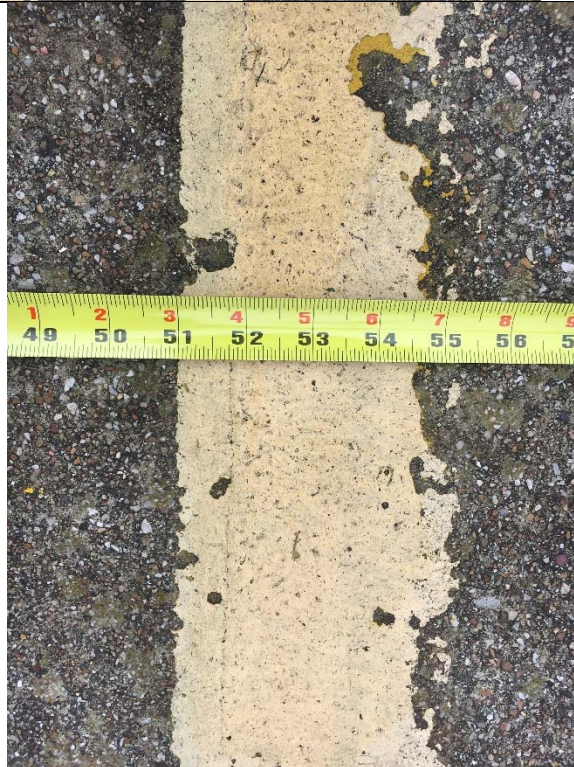
**Violation #1:** The access aisle is only 53" wide, where it is required to be a minimum of 60" wide.

**Standard:** 2010 ADAAG 502.3.1 Access Aisle Width.

**Violation 1** - The access aisle is only 53" wide, where it is required to be a minimum of 60" wide.

Restripe access aisle.

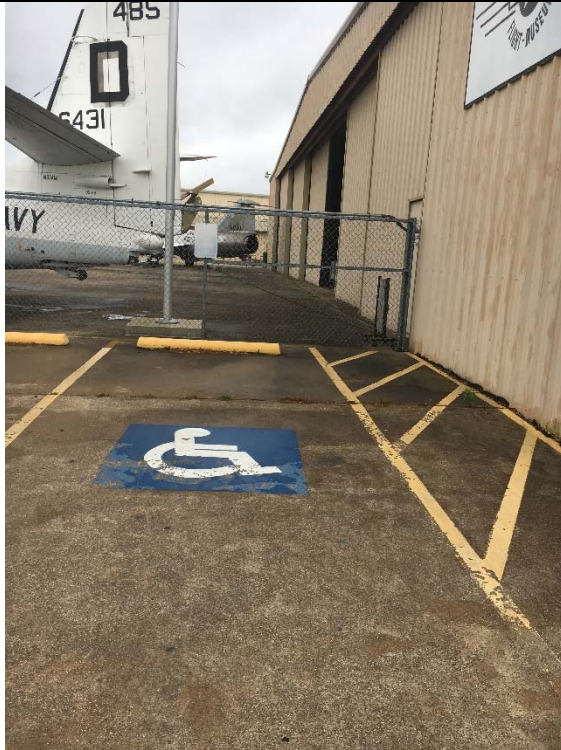
The accessible parking space is required to van accessible.

**2010 ADAAG 502.2 Vehicle Spaces.**

**Violation 2** - The accessible parking space is required to van accessible.

Restripe accessible parking space and access aisle so the accessible space and access aisles are each a minimum of 96" wide. Price included with Violation #1.

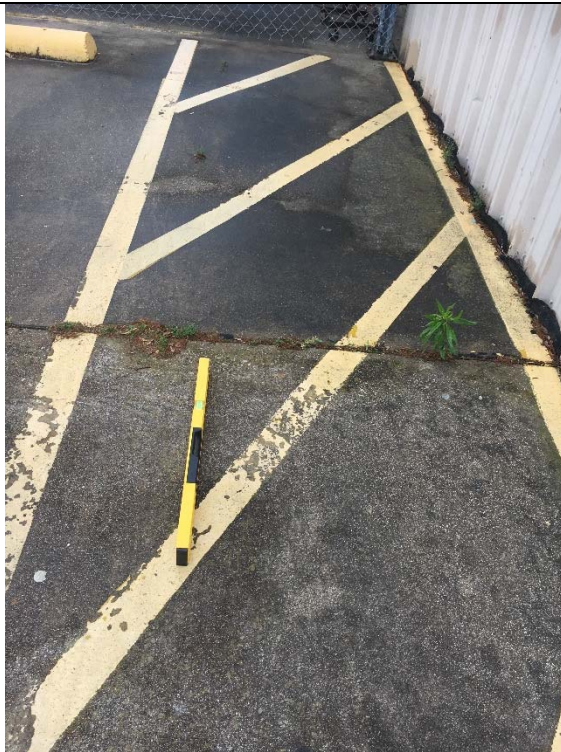
The expansion joint that runs from the parking space through the access aisle has grass growing up through it.

**2010 ADAAG 302.1 General.**

**Violation 3** - The expansion joint that runs from the parking space through the access aisle has grass growing up through it.

Clean out and caulk the expansion joint to achieve a smooth transition.

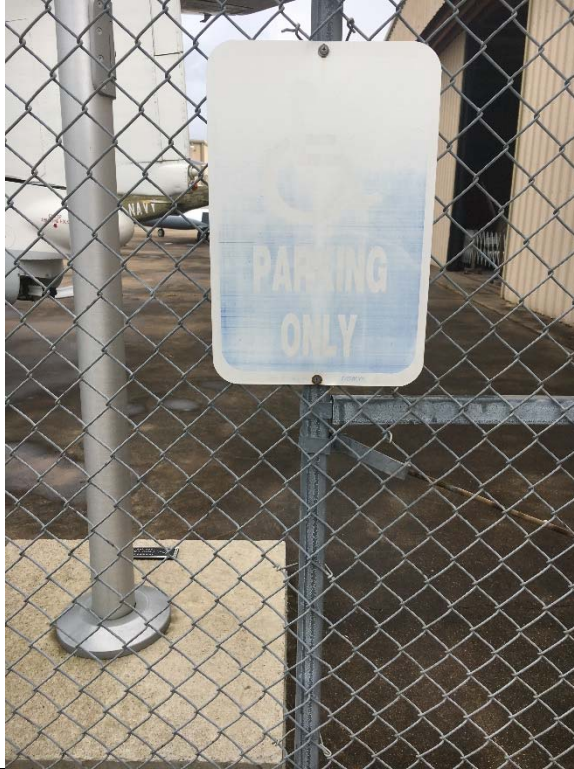
The parking sign is faded and illegible.

**2010 ADAAG 502.6 Identification.**

**Violation 4** - The parking sign is faded and illegible.

Replace with a compliant van accessible sign.

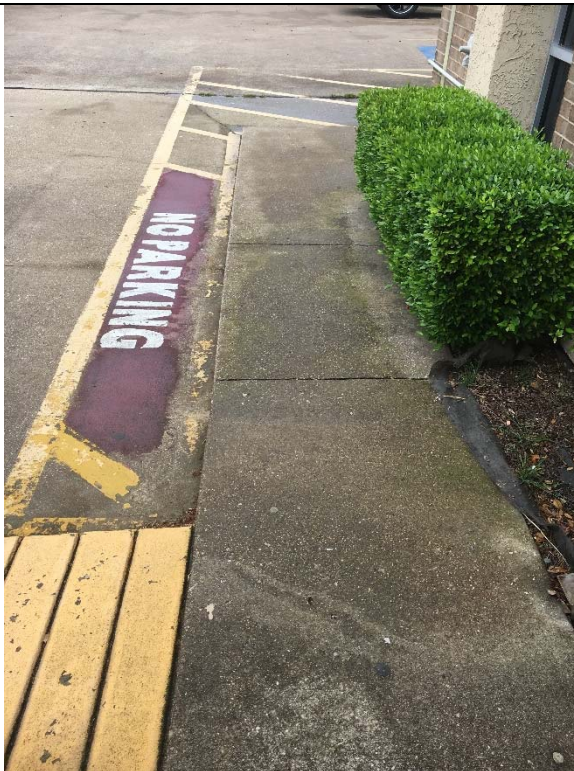
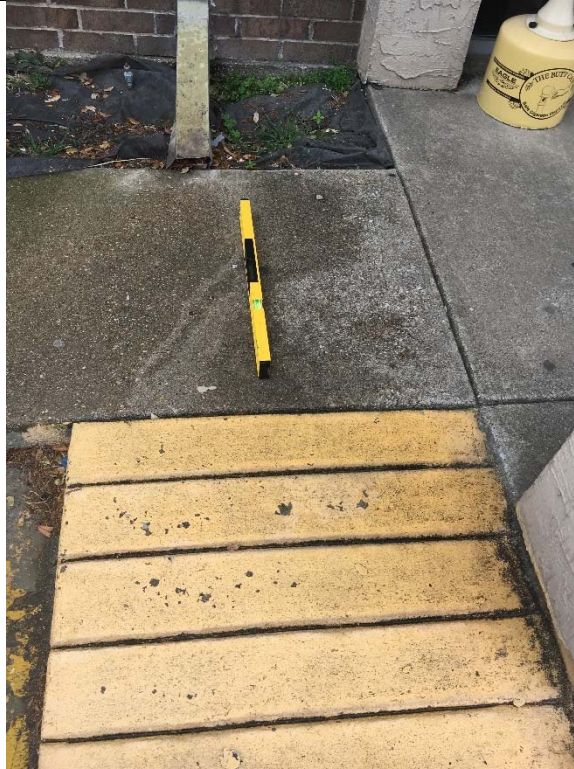
**Violation #5:** The sidewalk as well as the landing at the top of the curb ramp has a 5.4% cross slope.

**Standard:** 2010 ADAAG 405.3 Cross Slope.

**Violation 5** - The sidewalk as well as the landing at the top of the curb ramp has a 5.4% cross slope.

**Possible Solutions:** Replace the sidewalk to achieve a cross slope no greater than 1:48.

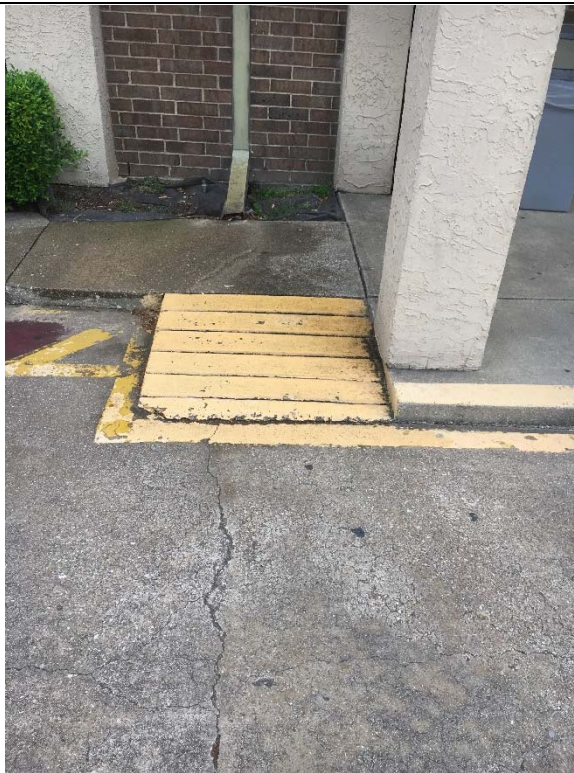
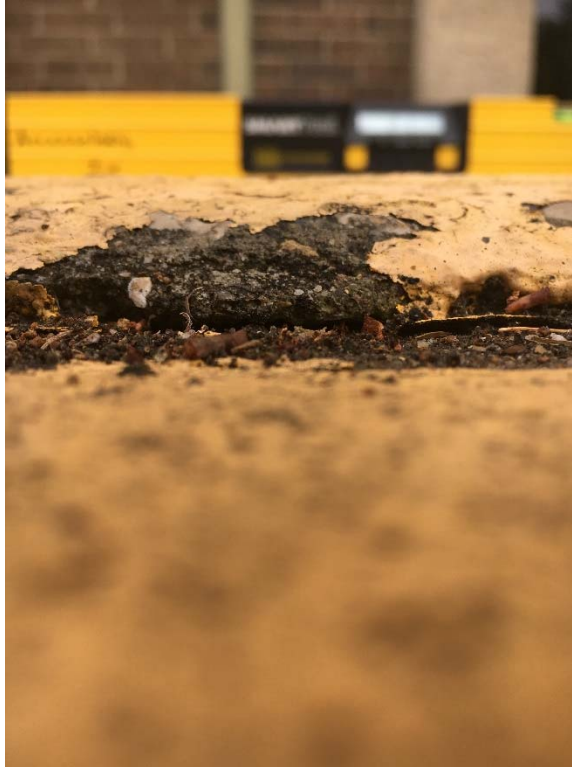
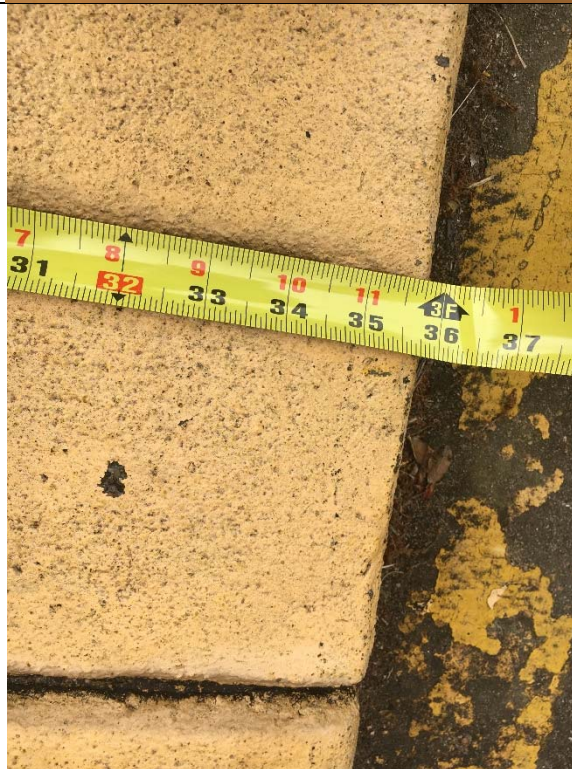
**Violation #6:** The curb ramp has a change in level greater than a 1/2" at the bottom and is 35-3/4" wide and has a drop off.

**Standard:** 2010 ADAAG 405.5 Clear Width.  
 2010 ADAAG 303.2 Vertical.

**Violation 6** - The curb ramp has a change in level greater than a 1/2" at the bottom and is 35-3/4" wide and has a drop off.

Install new compliant curb ramp at the end of the sidewalk next to the access aisle to provide a

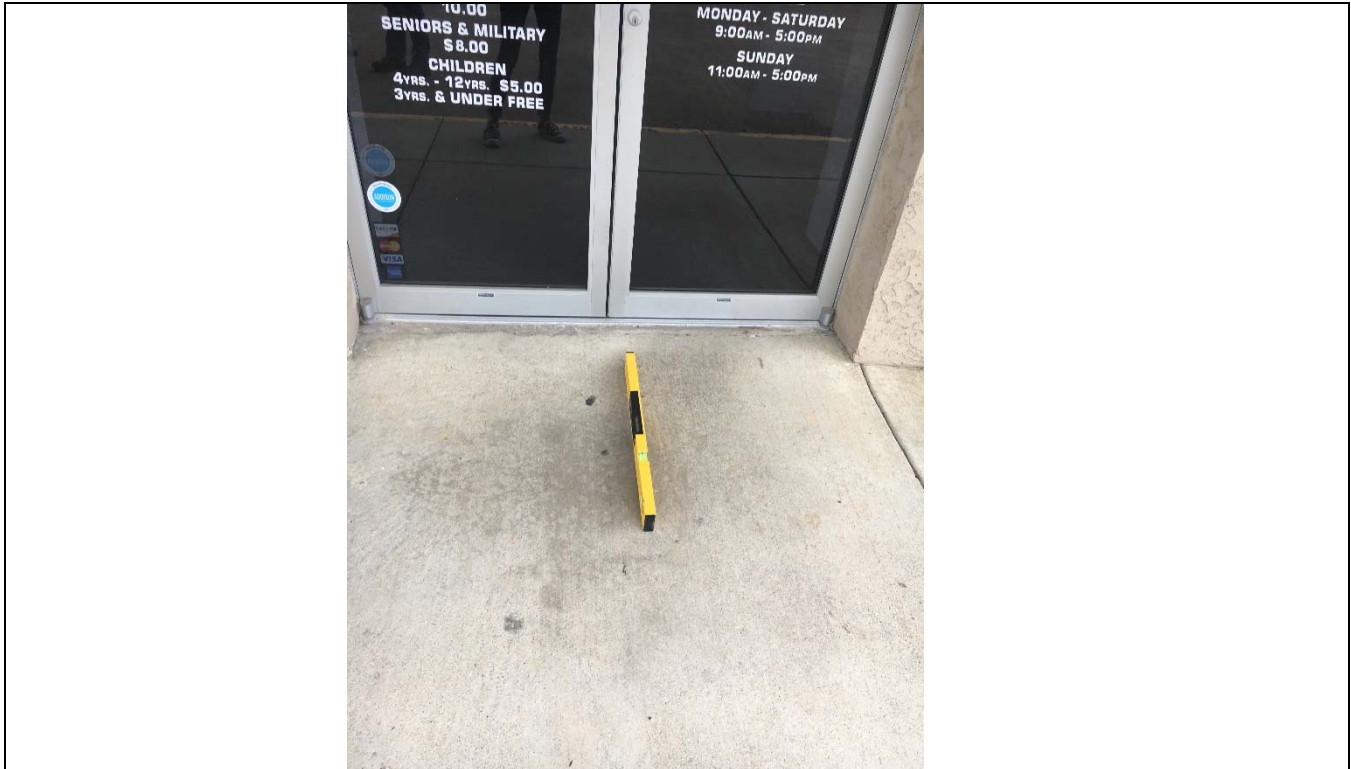
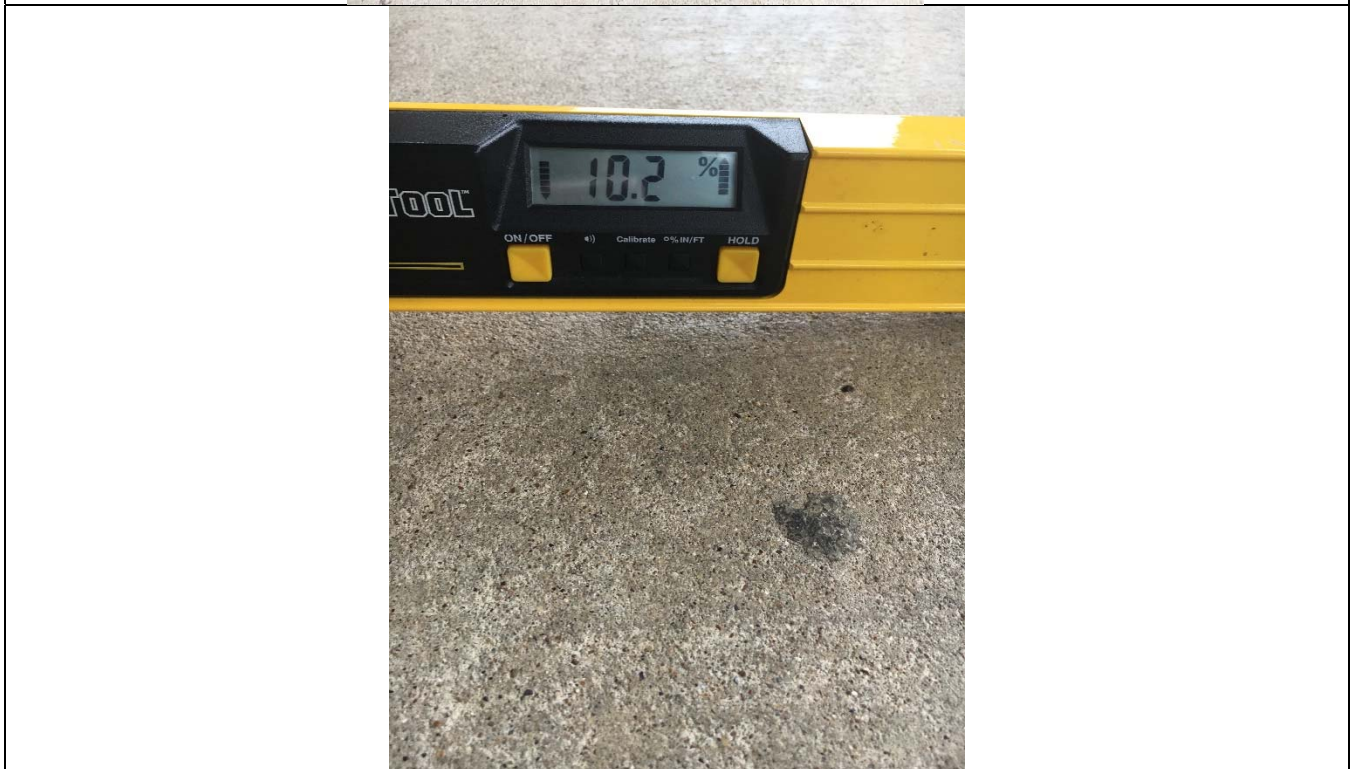
**Violation #7:** There is a 10.2% slope at the main entrance door.

**Standard:** **2010 ADAAG 404.2.4.4 Floor or Ground Surface.**

**Violation 7** - There is a 10.2% slope at the main entrance door.

**Possible Solutions:** Remove and re-pour concrete to achieve slopes no greater than 1:48.

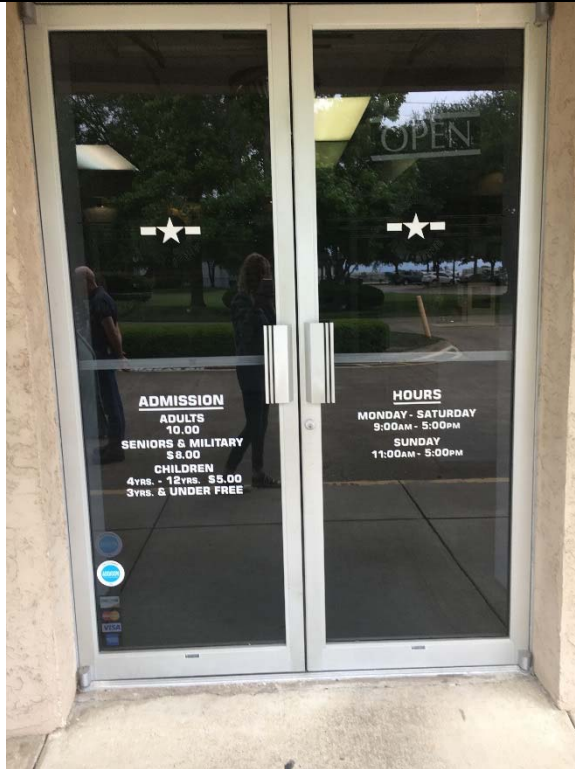
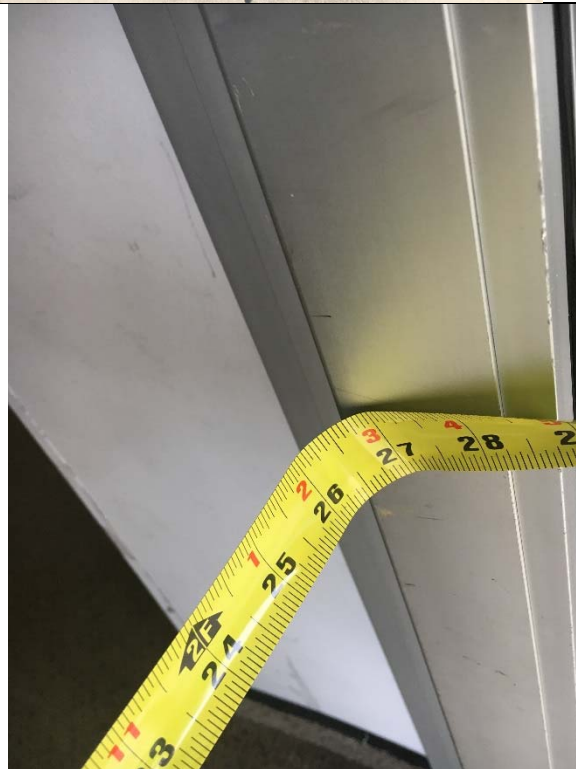
**Violation #8:** The entrance door opening is only 27" wide where a minimum of 32" is required.

**Standard:** **2010 ADAAG 404.2.2 Double-Leaf Doors and Gates.**

**Violation 8** - The entrance door opening is only 27" wide where a minimum of 32" is required.

Modify doors so one of the door openings is a minimum of 32" opening.

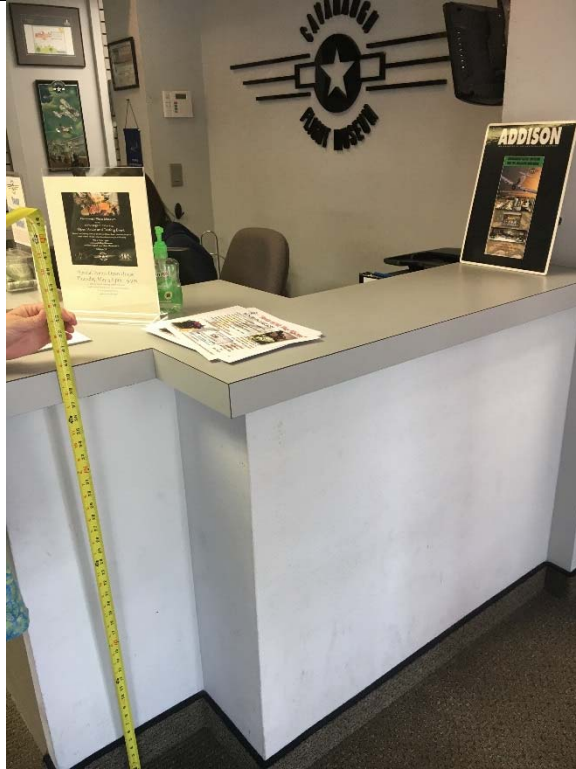
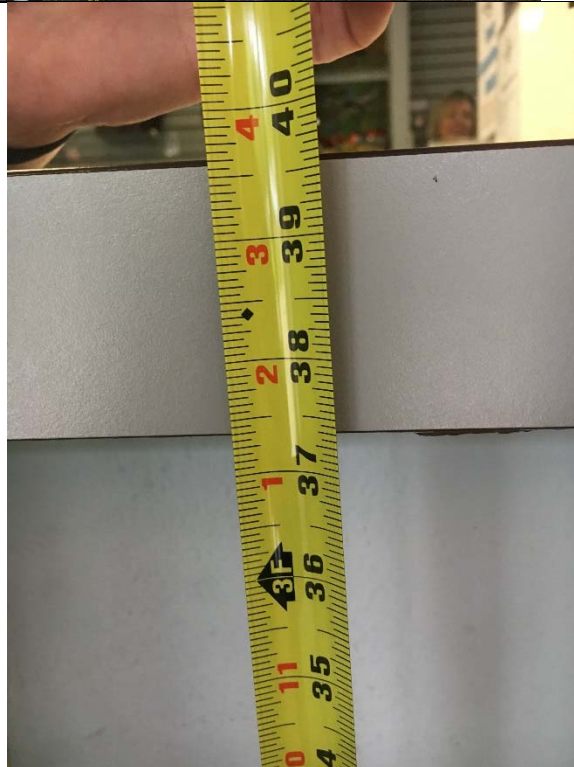
The front desk is 39-9/16" to the top of the counter.

**2010 ADAAG 904.4.1 Parallel Approach.**

**Violation 9** - The front desk is 39-9/16" to the top of the counter.

Replace desk or lower a portion of the desk to 36" above finished floor.

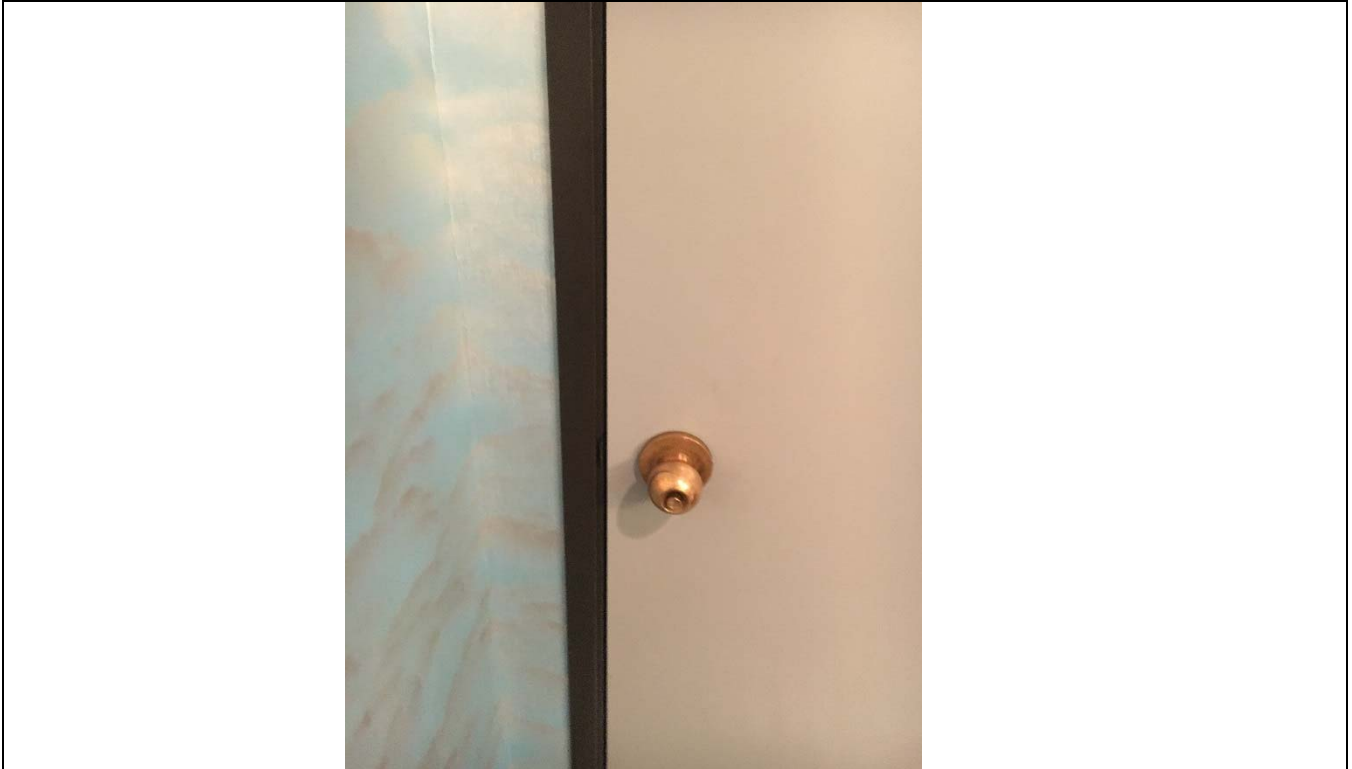
**Violation #10:** There are four (4) doors in the facility that have knob door hardware.

**Standard:** 2010 ADAAG 404.2.7 Door and Gate Hardware.

**Violation 10** - There are four (4) doors in the facility that have knob door hardware.

**Possible Solutions:** Replace hardware with lever hardware.

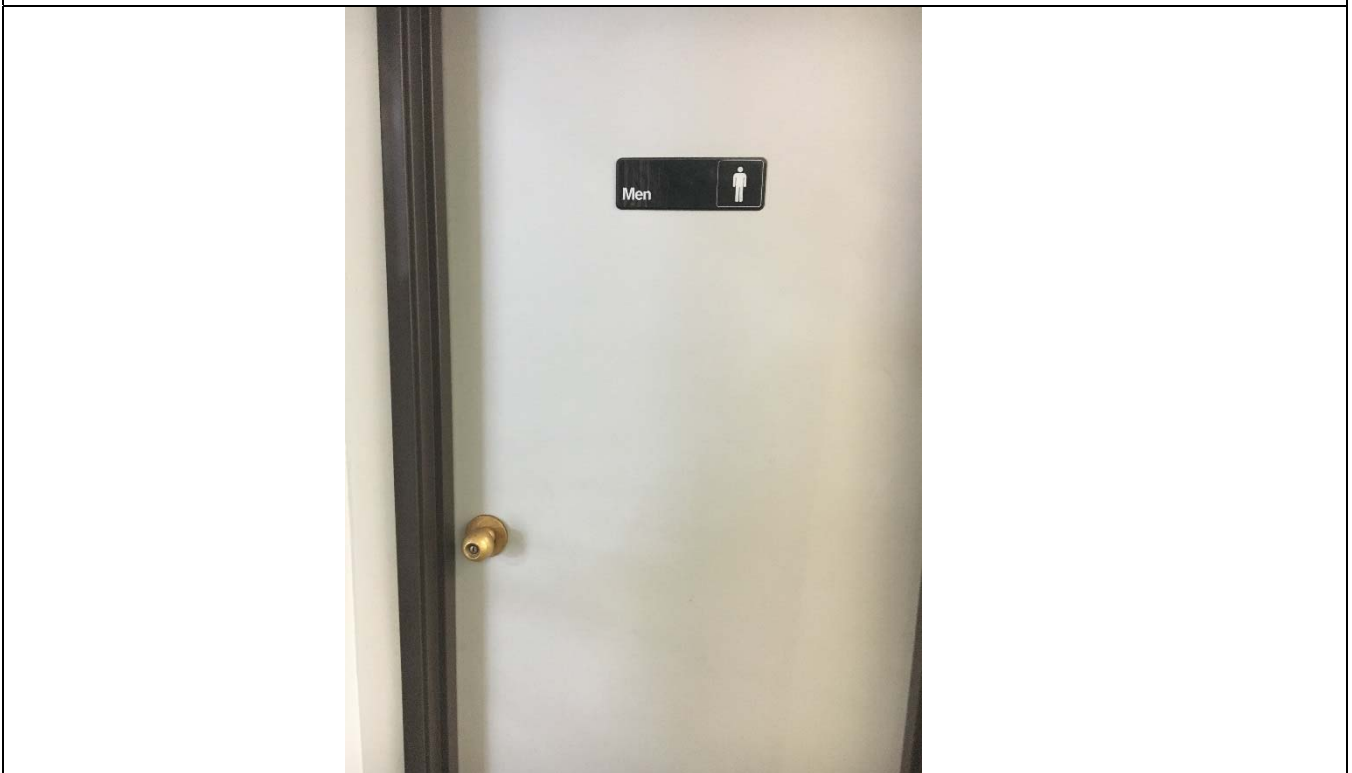
Men's Room: Signage is mounted on the door and does not have Braille or tactile characters.

2010 ADAAG 216.2 Designations.

**Violation 11** - Men's Room: Signage is mounted on the door and does not have Braille or tactile characters.

Install compliant signage on the wall on the latch side of the door.

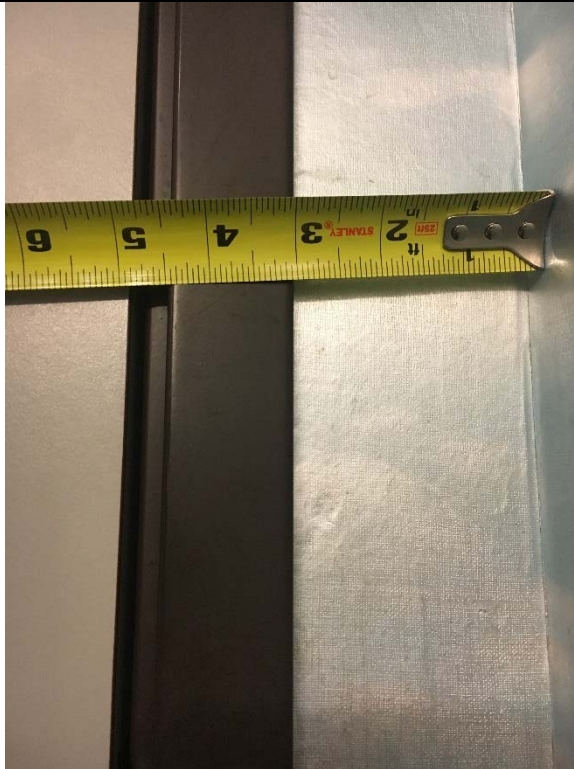
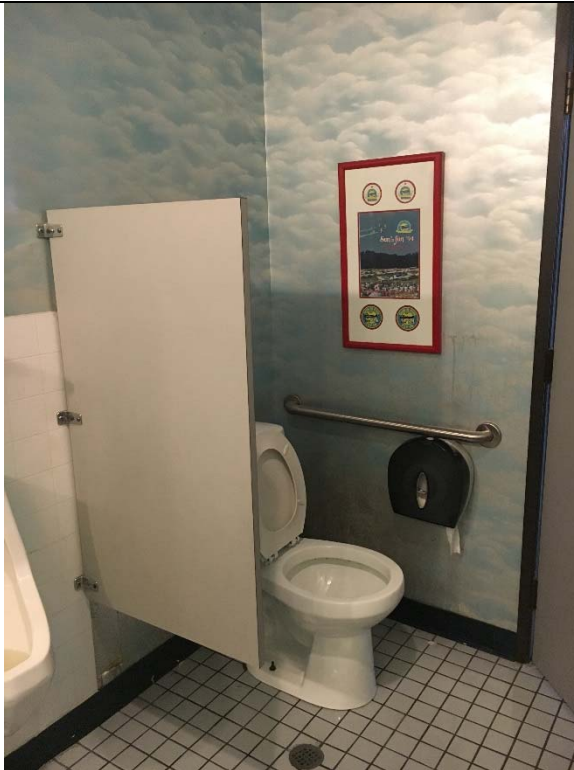
Men's Room: There is only a 4-1/2" maneuvering clearance on the pull side of the door where a minimum of 18" is required.

**2010 ADAAG 404.2.4.1 Swinging Doors and Gates.**

**Violation 12 - Men's Room:** There is only a 4-1/2" maneuvering clearance on the pull side of the door where a minimum of 18" is required.

Reverse the swing of the door.

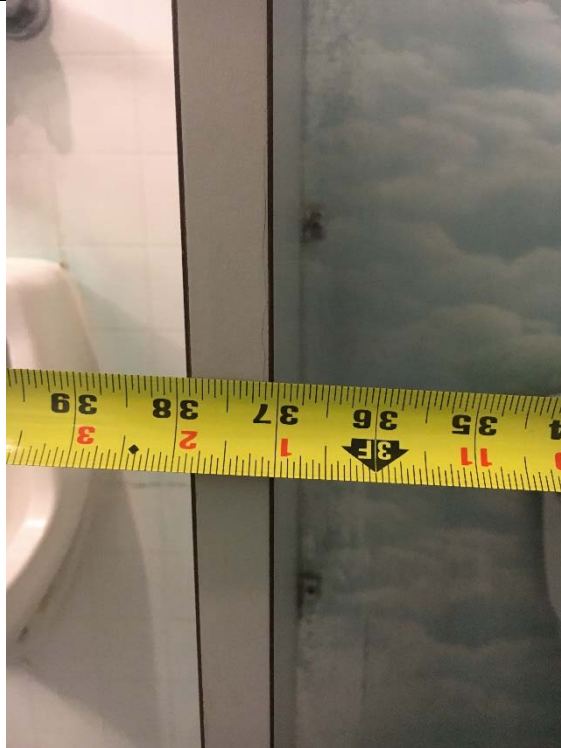
Men's Room: Water closet's required clear floor width is blocked by the urinal screen and the urinal.

**2010 ADAAG 604.3.1 Size.**

**Violation 13** - Men's Room: Water closet's required clear floor width is blocked by the urinal screen and the urinal.

Remove urinal and urinal screen to provide required clearances.

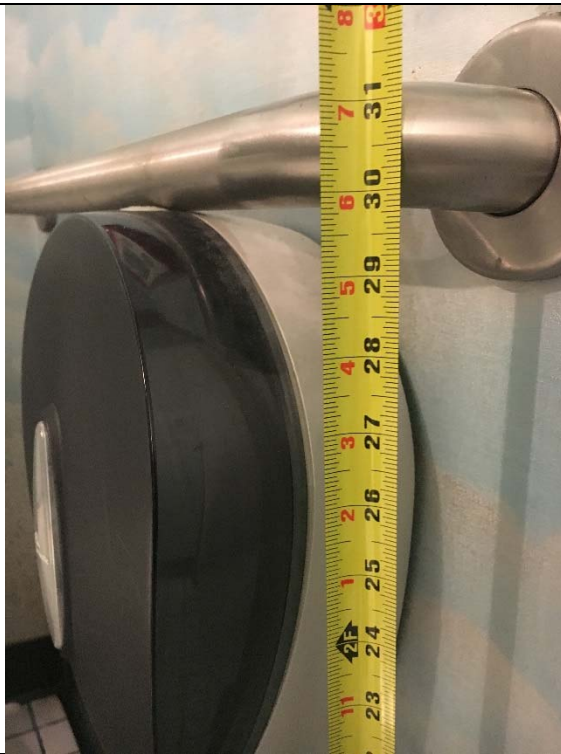
Men's Room: Only a side grab bar is provided where both side and rear grab bars are required to be provided.

**2010 ADAAG 604.5 Grab Bars.**

**Violation 14** - Men's Room: Only a side grab bar is provided where both side and rear grab bars are required to be provided.

Install compliant grab bars at rear and side of water closet.

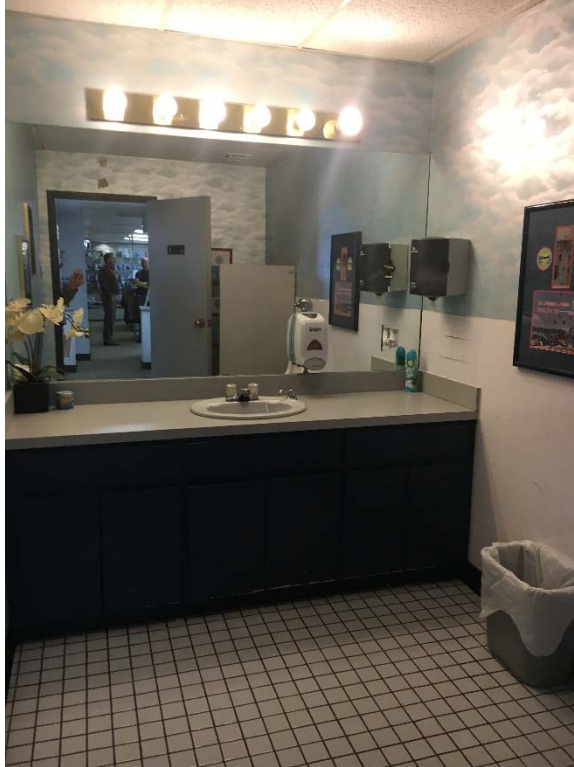
Men's Room: The lavatory does not have the required knee clearance provided.

**2010 ADAAG 606.2 Clear Floor Space.**

**Violation 15 - Men's Room:** The lavatory does not have the required knee clearance provided.

Modify or replace lavatory.

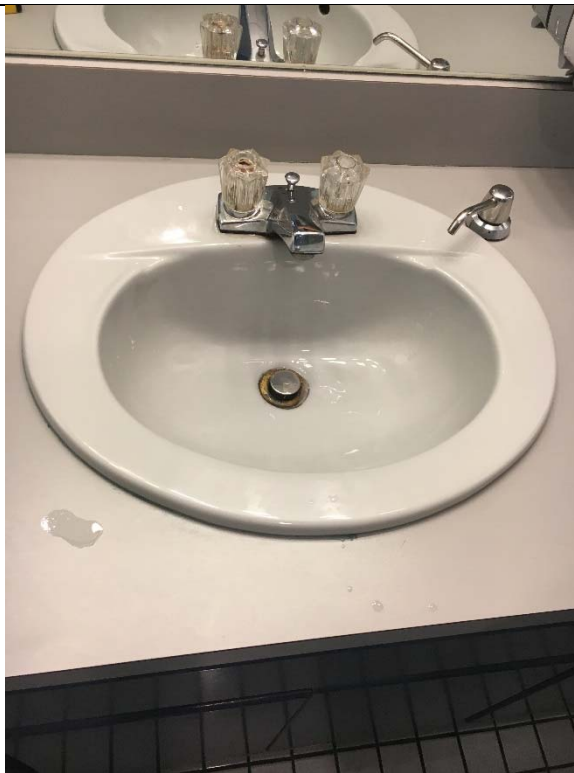
Men's Room: The lavatory faucets controls require grasping and twisting to operate.

**2010 ADAAG 606.4 Faucets.**

**Violation 16 - Men's Room:** The lavatory faucets controls require grasping and twisting to operate.

Replace with lever style hardware.

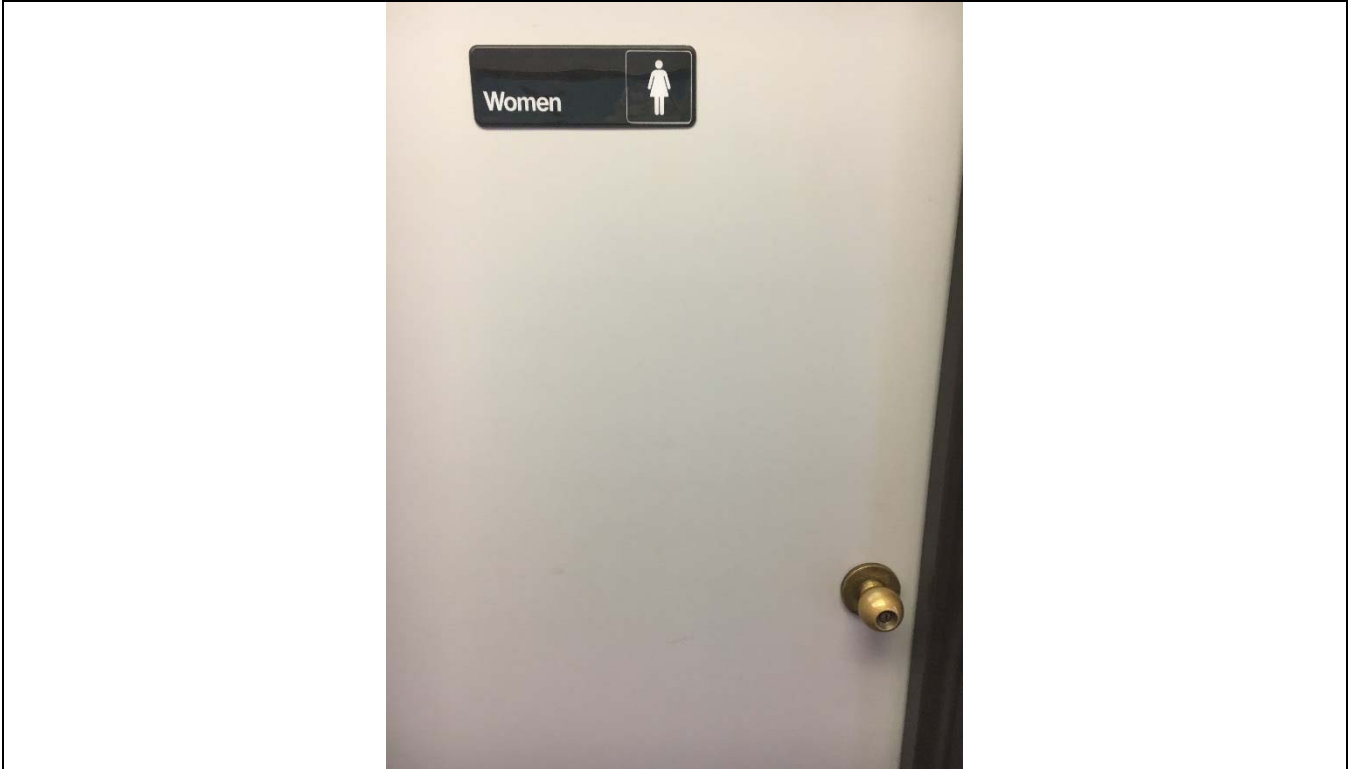
Women's Room: Signage is mounted on the door.

**2010 ADAAG 216.2 Designations.**

**Violation 17** - Women's Room: Signage is mounted on the door.

Install compliant signage on the wall on the latch side of the door.

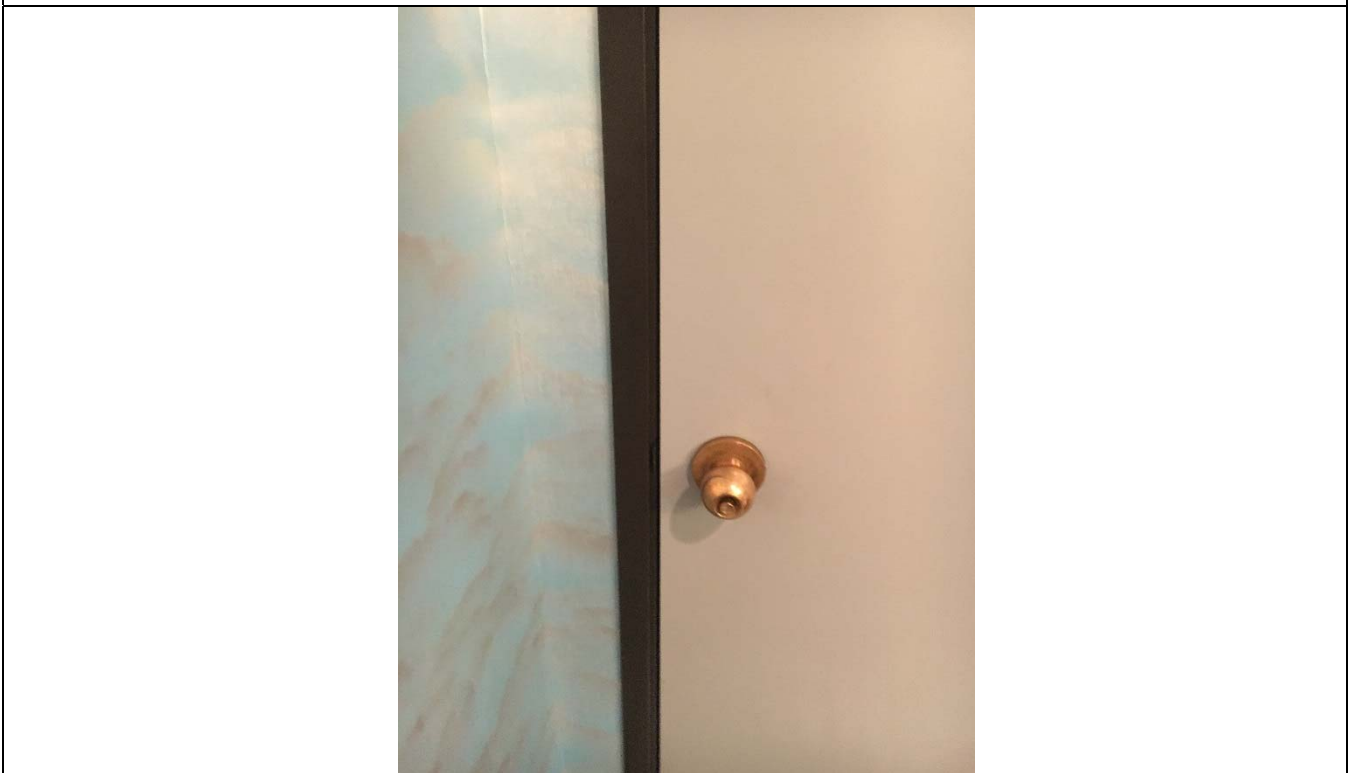
Women's Room: There is not a minimum of 18" provided on the pull side of the door.

**2010 ADAAG 404.2.4.1 Swinging Doors and Gates.**

**Violation 18** - Women's Room: There is not a minimum of 18" provided on the pull side of the door.

Reverse the swing of the door.

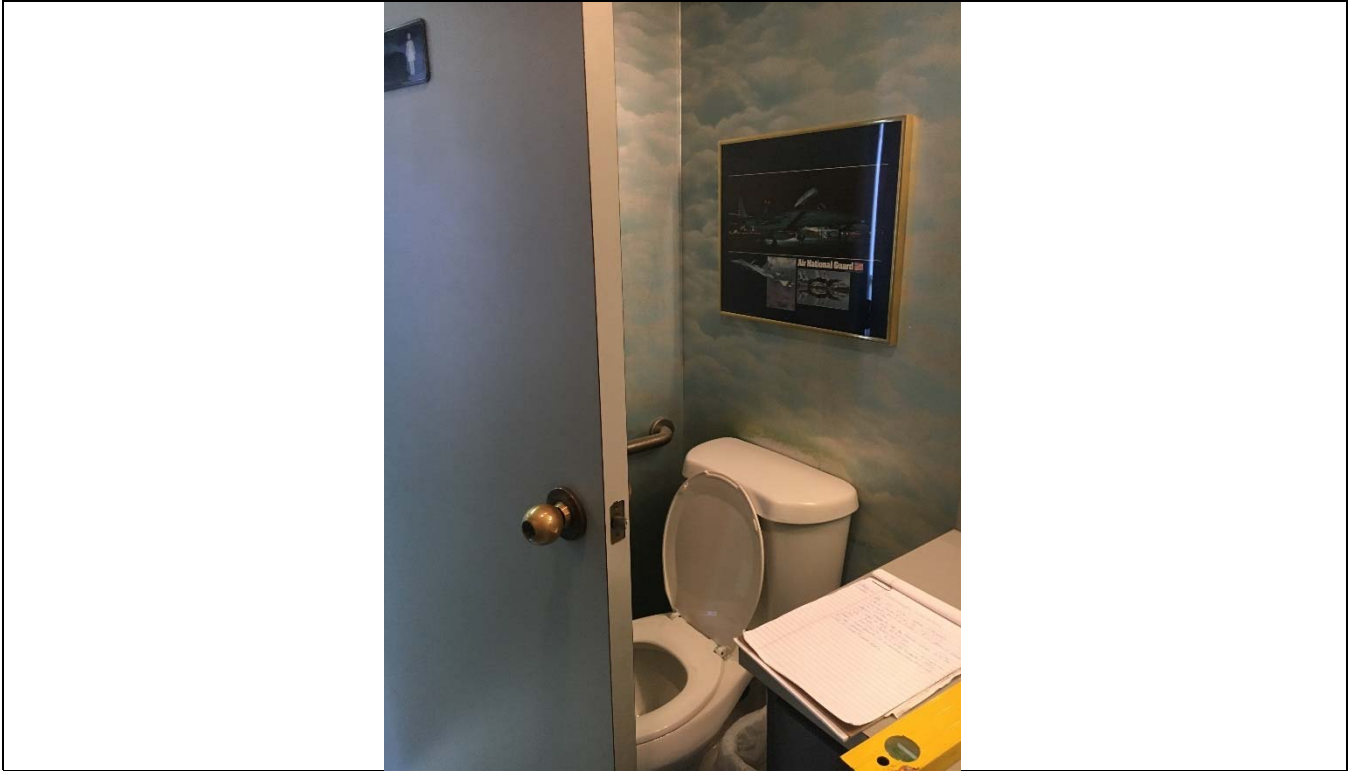
Women's Room: The lavatory encroaches on the required clear floor space width for the water closet.

**2010 ADAAG 604.3.1 Size.**

**Violation 19** - Women's Room: The lavatory encroaches on the required clear floor space width for the water closet.

Reconfigure room to provide the required clear floor space for the water closet.

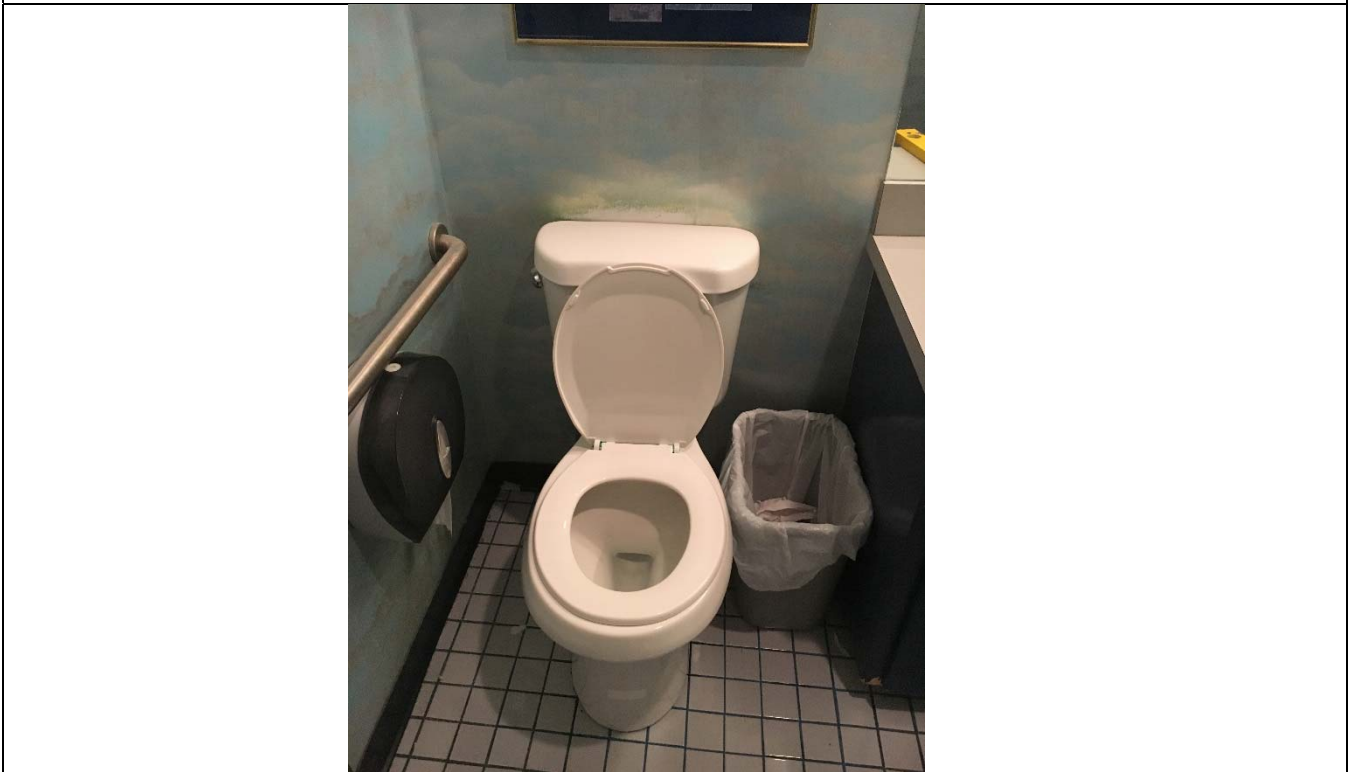
Women's Room: Flush control is on the closed side of the water closet.

**2010 ADAAG 604.9.5 Flush Controls**

**Violation 20** - Women's Room: Flush control is on the closed side of the water closet.

Replace flush valve to the open side.

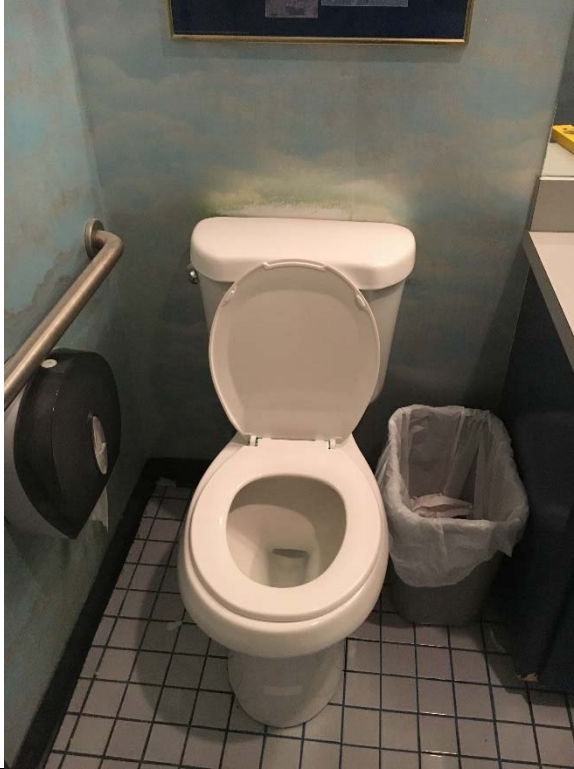
Women's Room: Only a side grab bar is provided where both side and rear grab bars are required to be provided.

**2010 ADAAG 604.5 Grab Bars.**

**Violation 21 - Women's Room:** Only a side grab bar is provided where both side and rear grab bars are required to be provided.

Install compliant grab bars at rear and side of water closet.

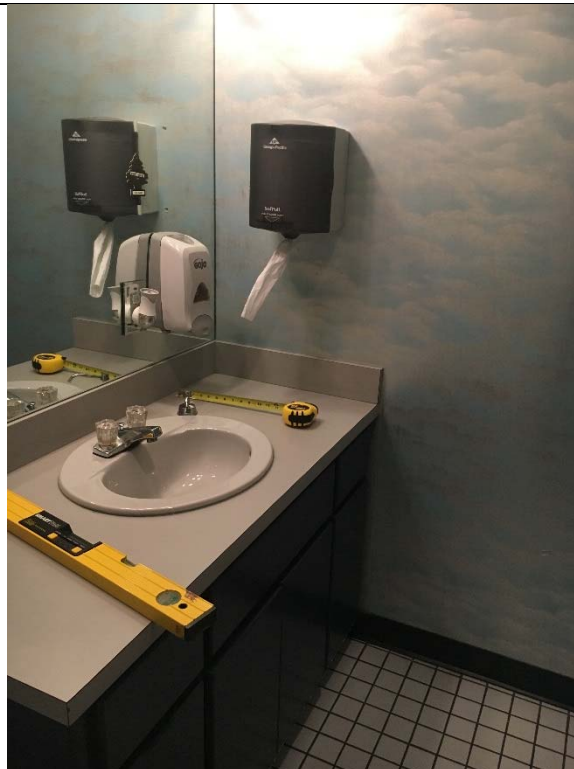
Women's Room: The lavatory does not have the required knee clearance provided.

**2010 ADAAG 606.2 Clear Floor Space.**

**Violation 22 - Women's Room:** The lavatory does not have the required knee clearance provided.

Modify or replace lavatory.

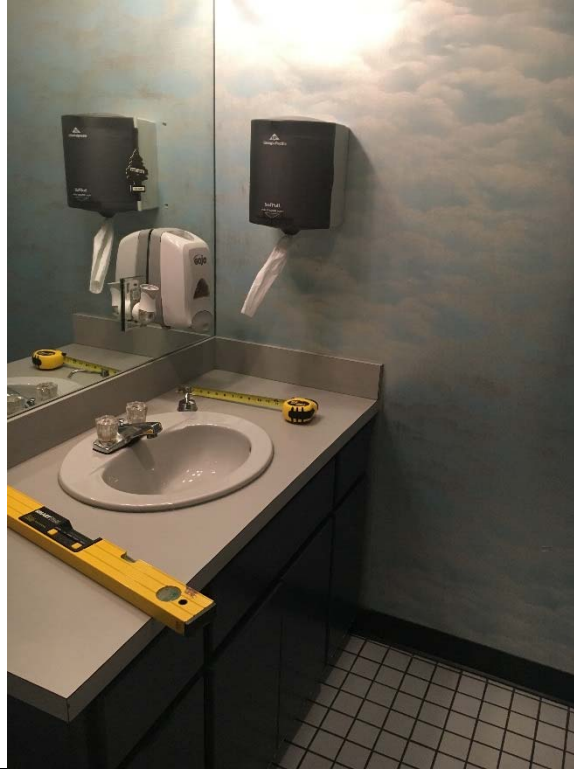
Women's Room: The faucet controls require grasping and twisting to operate.

**2010 ADAAG 606.4 Faucets.**

**Violation 23 - Women's Room:** The faucet controls require grasping and twisting to operate.

Replace faucet with lever style hardware.

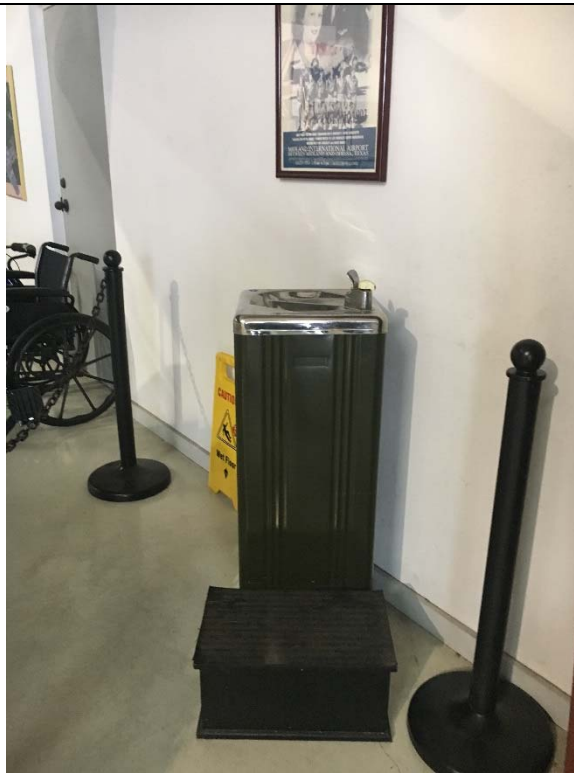
There is only one drinking fountain provided in the hangar area and it is not compliant.

2010 ADAAG 211.2 Minimum Number.

**Violation 24 -** There is only one drinking fountain provided in the hangar area and it is not compliant.

Remove or install a Hi/Low fountain.
