**ADDISON AIRPORT  
BUILDING REPORT**

**Facility Information:** **Facility Name:** Cavanaugh Flight Museum - Main Building  
**Facility Contact:** Lisa Pyles **Contact Phone:** 972-450-2878

**Accessology Inspector Information:**  
**Inspector:** Karen Jackson **Date:** April 17, 2017  
**Email:** Kjackson@accessology.com

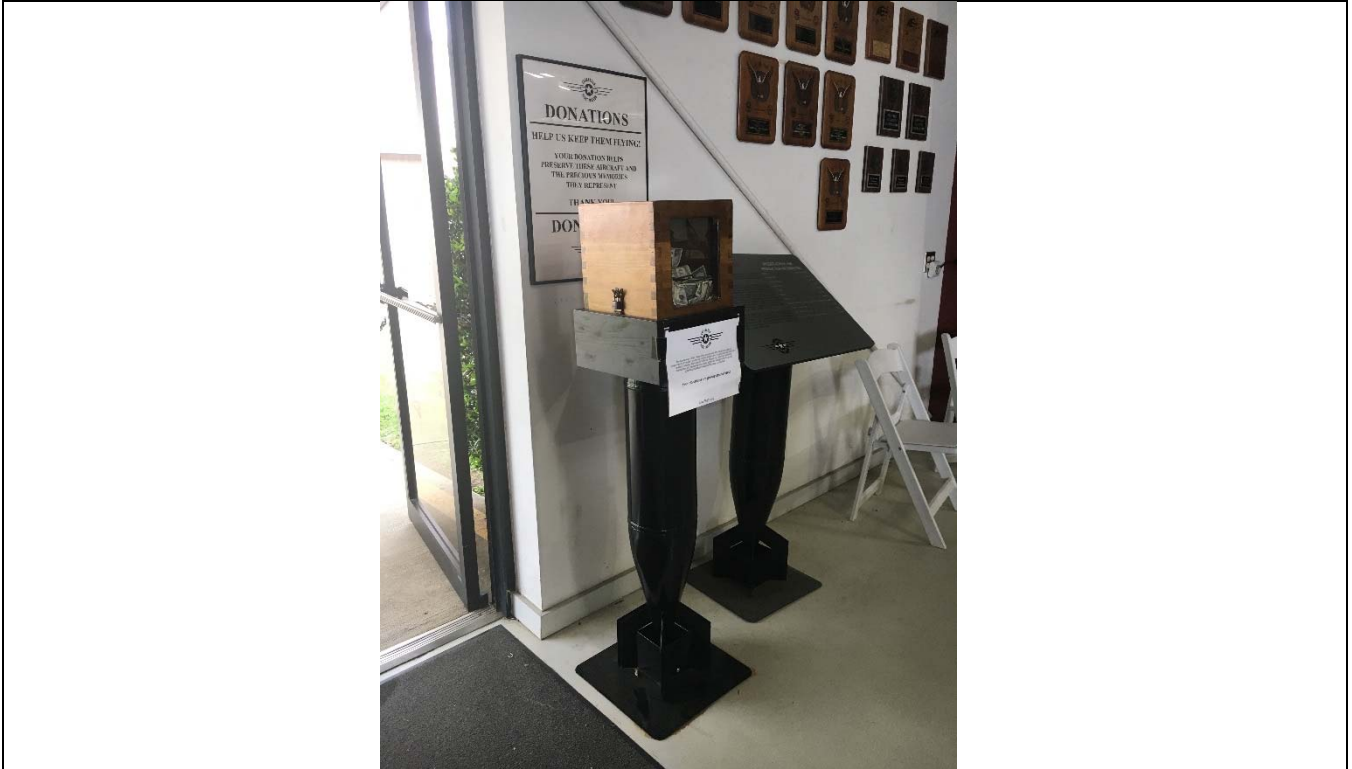
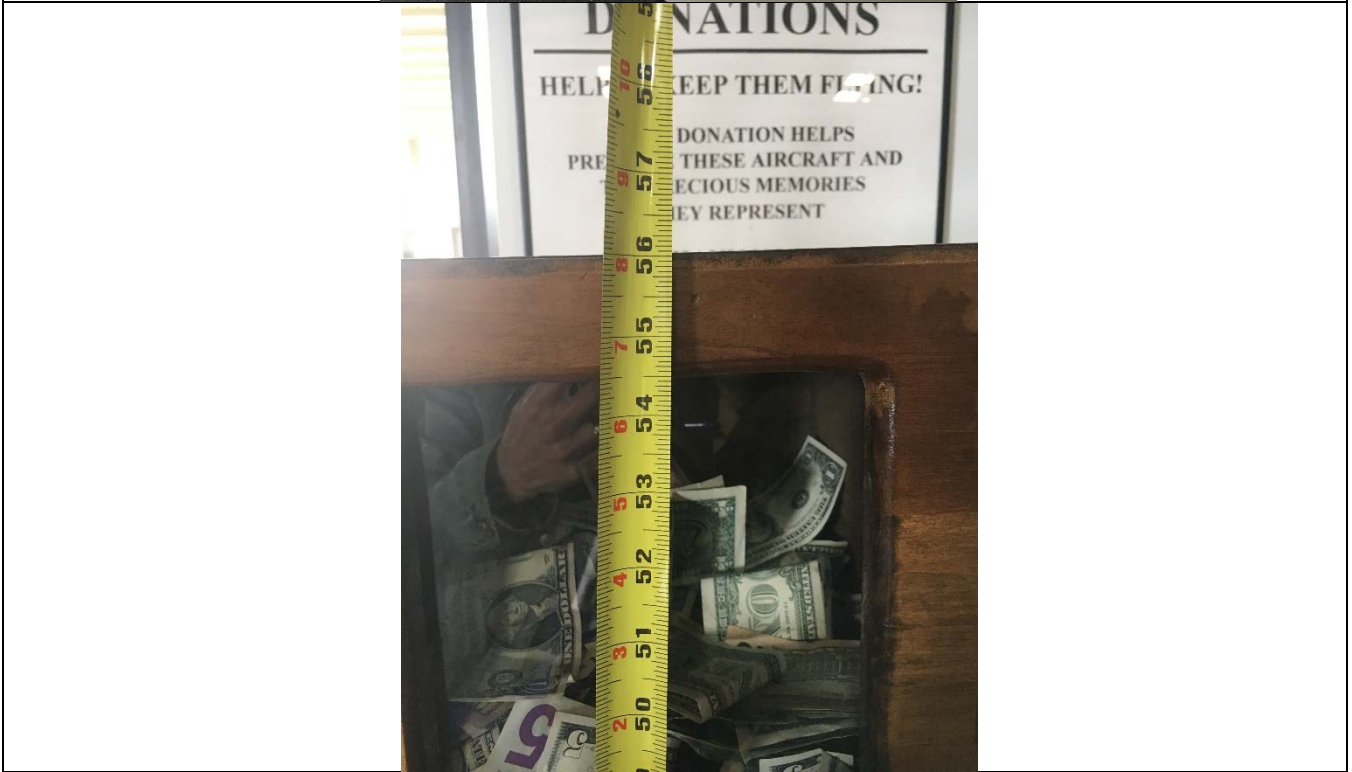
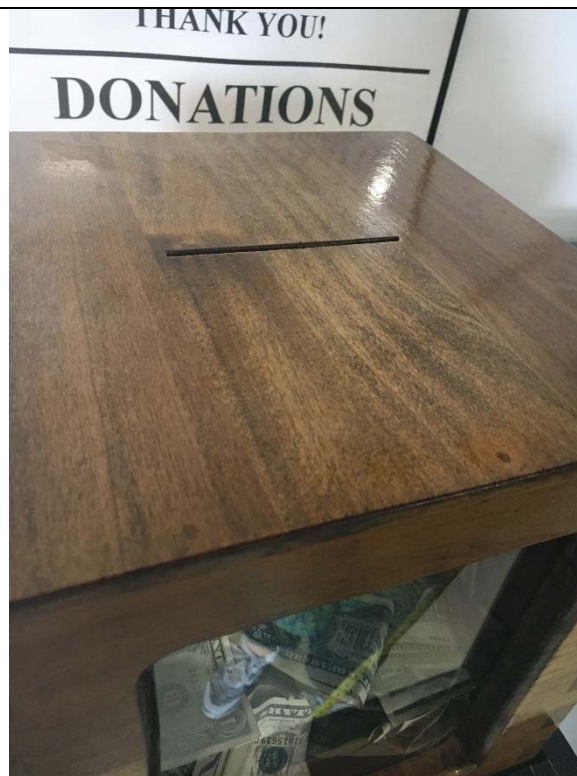
The top of the donation box is at 56" above finished floor.

2010 ADAAG 308.2.2 Obstructed High Reach.

**Violation 25** - The top of the donation box is at 56" above finished floor.

Lower the donation box so that it is no higher than 48" to the opening.

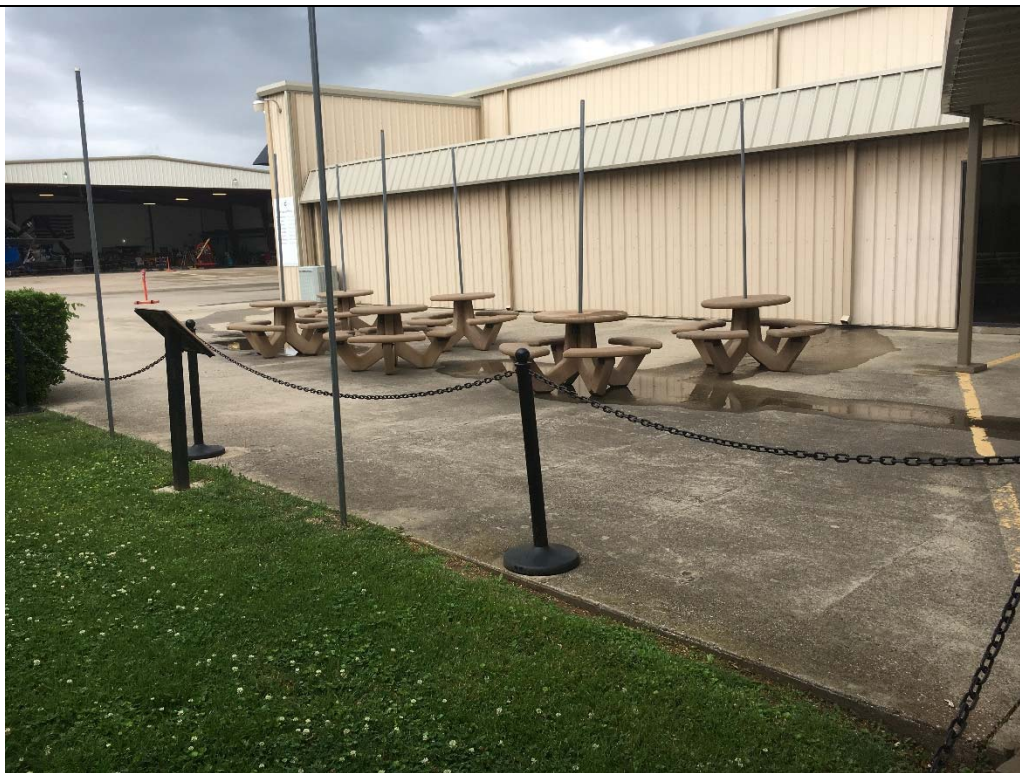
There are no accessible picnic tables provided.

**2010 ADAAG 902.2 Clear Floor or Ground Space.**

**Violation 26** - There are no accessible picnic tables provided.

Provide an accessible picnic table.
