**ADDISON AIRPORT
BUILDING REPORT**

Facility Information: **Facility Name:** Pilot Lounge North
Facility Contact: Lisa Pyles **Contact Phone:** 972-450-2878

Accessology Inspector Information:
Inspector: Karen Jackson **Date:** April 17, 2017
Email: Kjackson@accessology.com

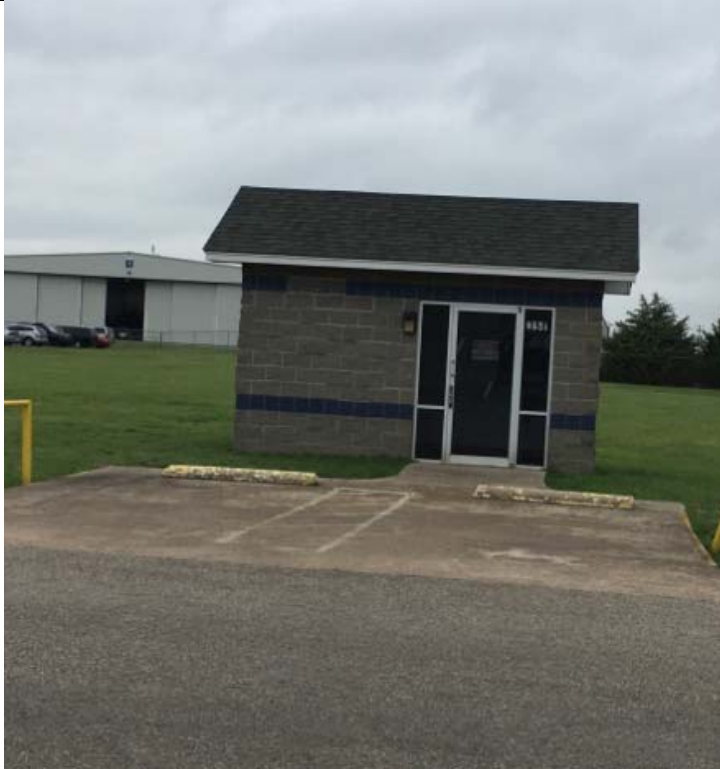
Violation #1: The accessible parking space is only 106" wide with an access aisle that is only 48" wide.

Standard: 2010 ADAAG 502.2 Vehicle Spaces.

Violation 1 - The accessible parking space is only 106" wide with an access aisle that is only 48" wide.

Restripe parking to provide a van accessible space that is 96" wide with an access aisle that is 96" wide.

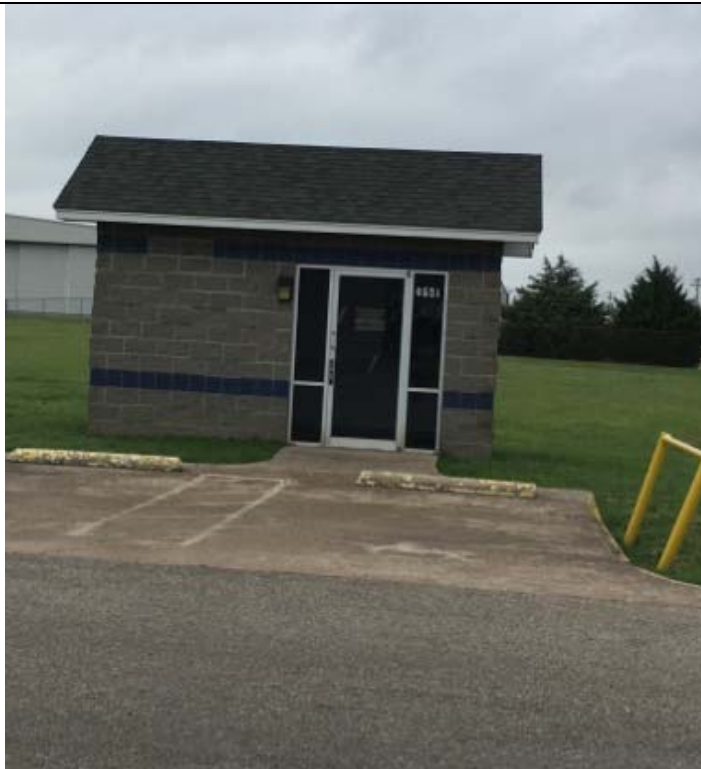
There is no parking signage provided.

2010 ADAAG 502.6 Parking Spaces Identification.

Violation 2 - There is no parking signage provided.

Provide "van accessible" parking sign at 60" minimum high to the bottom of the sign.

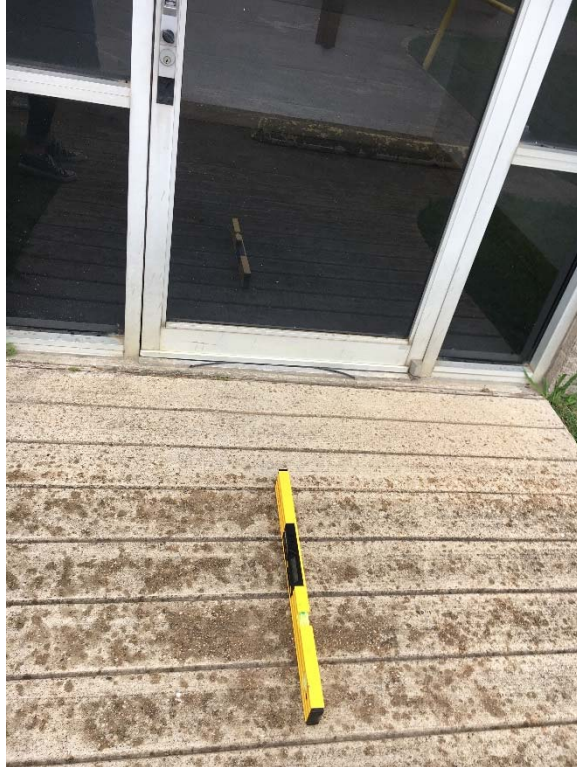
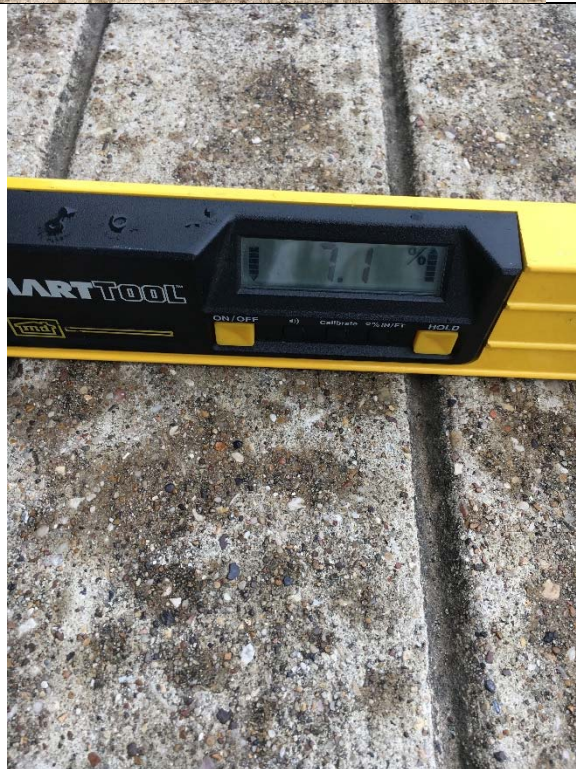
Violation #3: The landing at the entrance has a 7.1% running slope.

Standard: 2010 ADAAG 404.2.4.4 Floor or Ground Surface.

Violation 3 - The landing at the entrance has a 7.1% running slope.

Possible Solutions: Remove and replace landing to achieve slopes no greater than 1:48 in all directions.

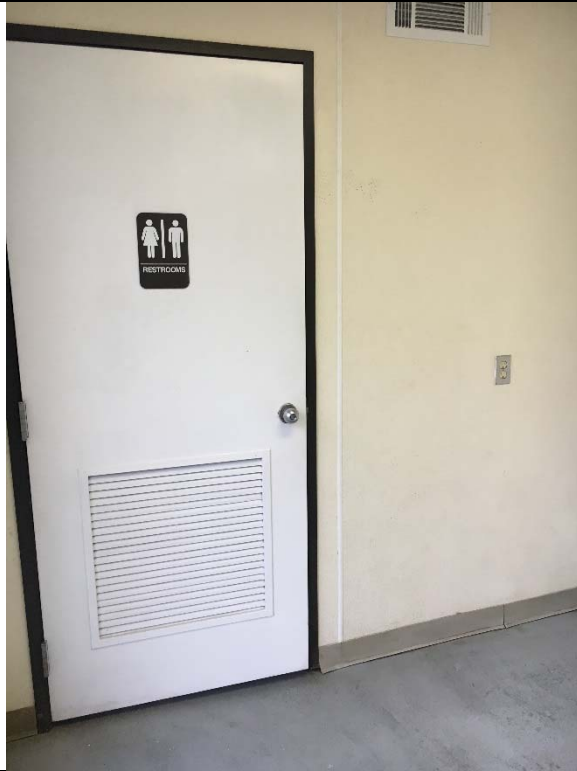
Restroom door hardware requires grasping and twisting of the wrist to operate.

2010 ADAAG 404.2.7 Door and Gate Hardware.

Violation 4 - Restroom door hardware requires grasping and twisting of the wrist to operate.

Replace hardware with lever style door hardware.

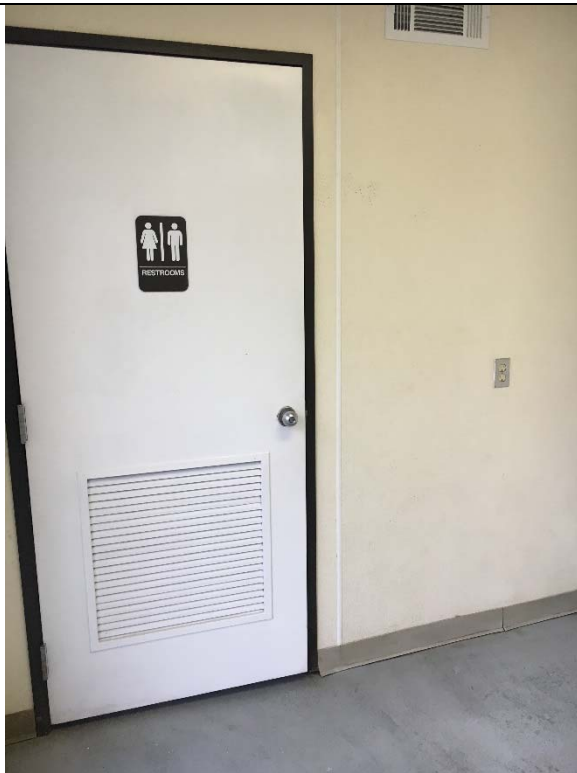
Restroom signage is mounted on the door.

Standard: 2010 ADAAG 703.4.2 Location.

Violation 5 - Restroom signage is mounted on the door.

Possible Solutions: Relocate signage to the latch side of the door.

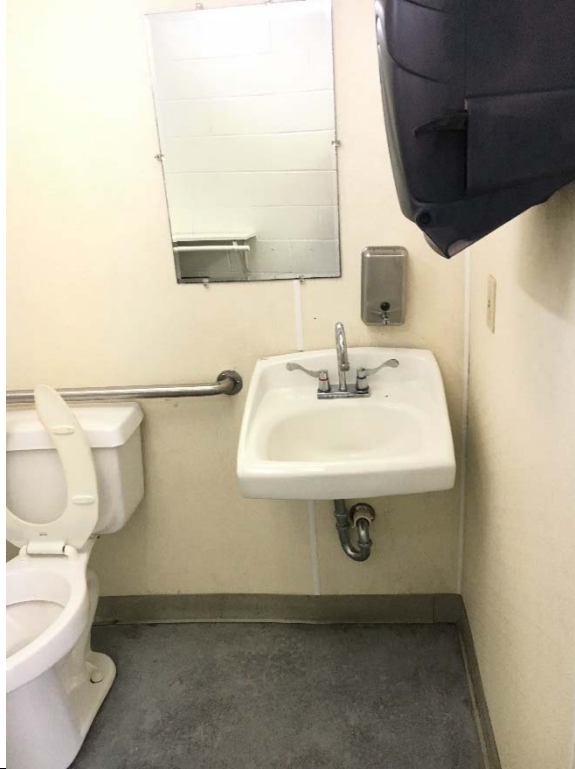
Violation #6: The lavatory encroaches on the required clear floor space for the water closet.

Standard: 2010 ADAAG 604.3.1 Size.

Violation 6 - The lavatory encroaches on the required clear floor space for the water closet.

Possible Solutions: Modify restroom to provide the required clear floor space for each element.

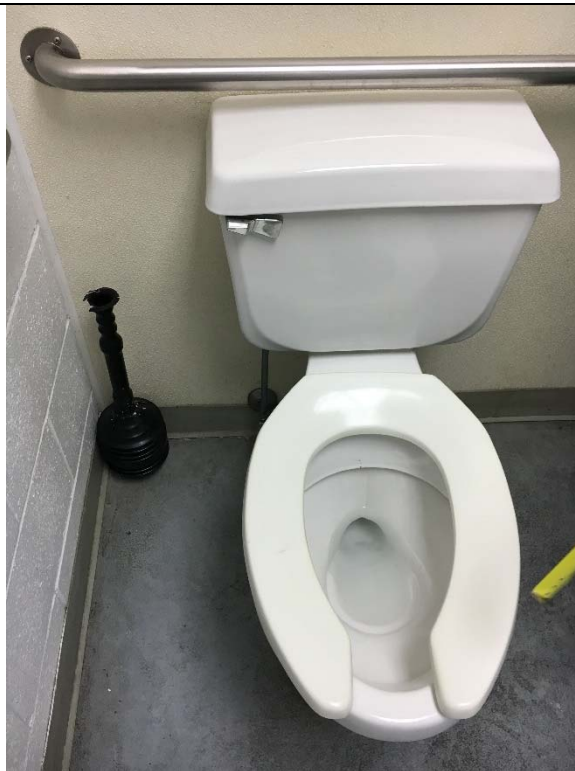
Violation #7: The flush control is mounted on the closed side.

Standard: 2010 ADAAG 604.6 Flush Controls.

Violation 7 - The flush control is mounted on the closed side.

Possible Solutions: Replace flush valve to the approach side.

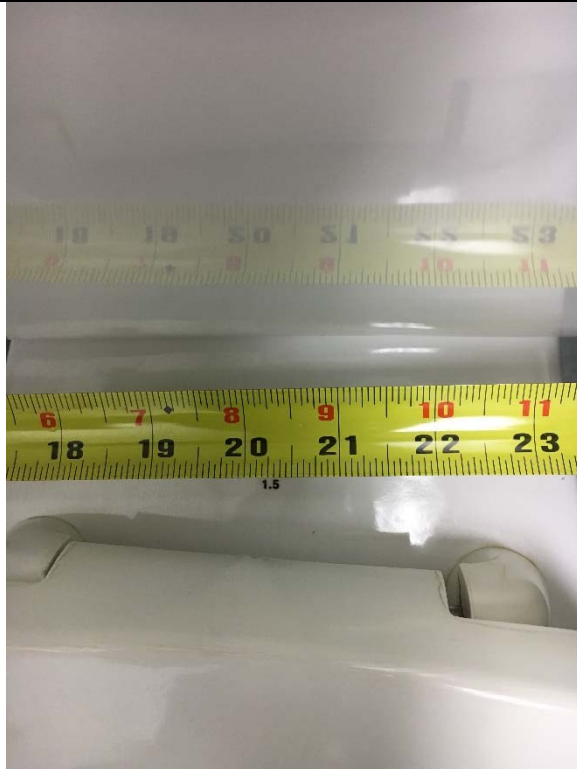
The centerline of the water closet is at 21-1/2".

2010 ADAAG 604.2 Location.

Violation 8 - The centerline of the water closet is at 21-1/2".

Re-mount water closet so the centerline is between 16"-18".

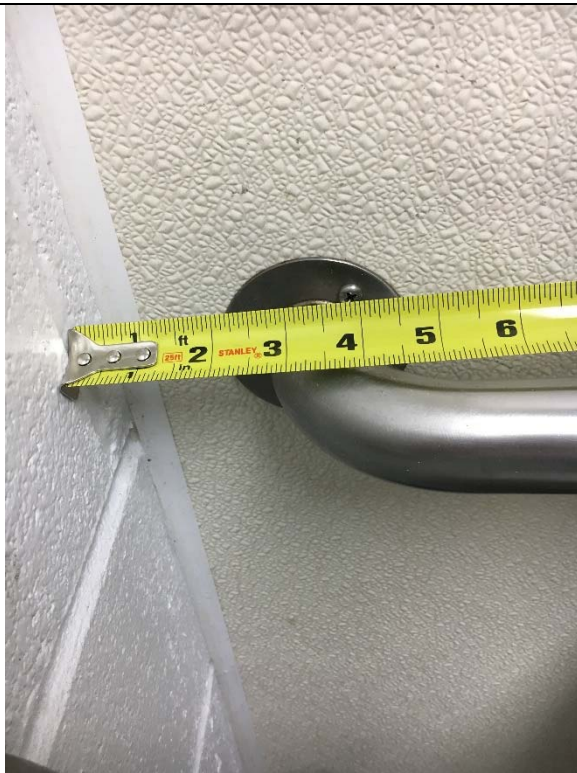
The rear grab bar is not mounted in the proper location.

2010 ADAAG 604.5.2 Rear Wall.

Violation 9 - The rear grab bar is not mounted in the proper location.

Relocate grab bar.

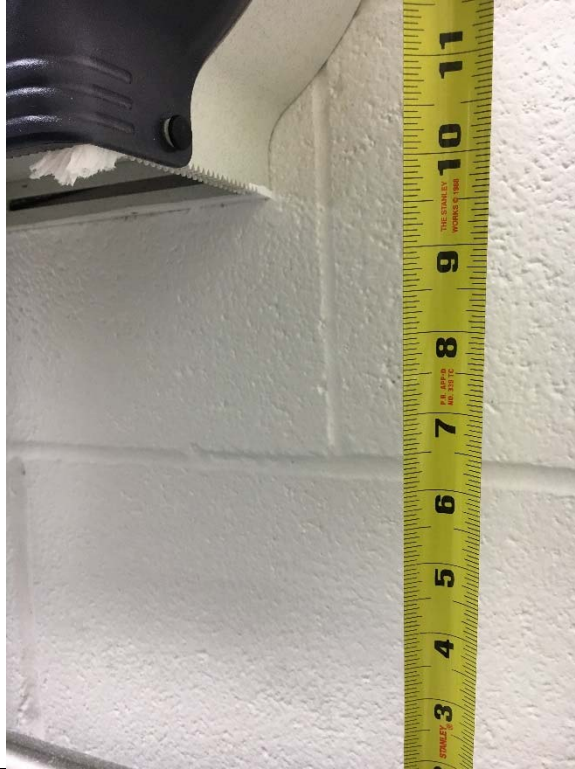
The toilet paper dispenser is mounted 9-1/2" above the grab bar where a minimum of 12" is required.

2010 ADAAG 609.3 Spacing.

Violation 10 - The toilet paper dispenser is mounted 9-1/2" above the grab bar where a minimum of 12" is required.

Remount toilet paper dispenser either 12" minimum above the grab bar or 1-1/2" minimum below the grab bar.

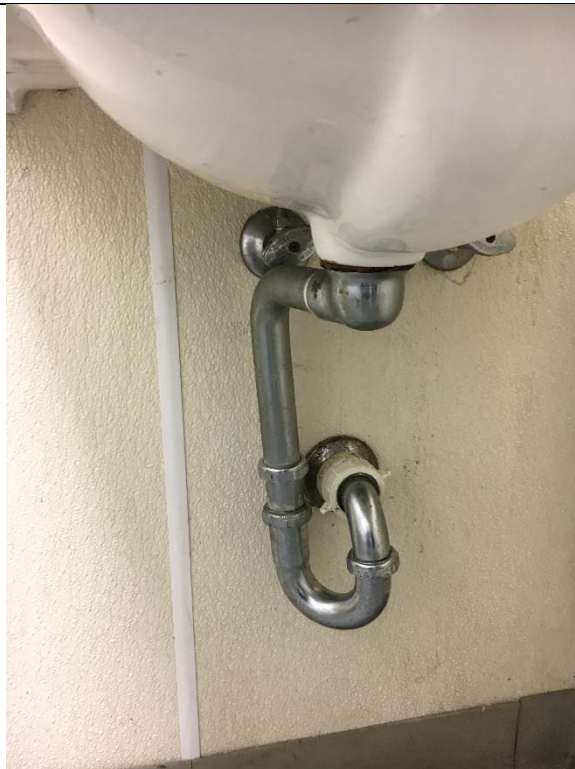
The lavatory pipes are not protected from contact.

2010 ADAAG 606.5 Exposed Pipes and Surfaces.

Violation 11 - The lavatory pipes are not protected from contact.

Provide protection at the exposed drains and water lines under the lavatories.

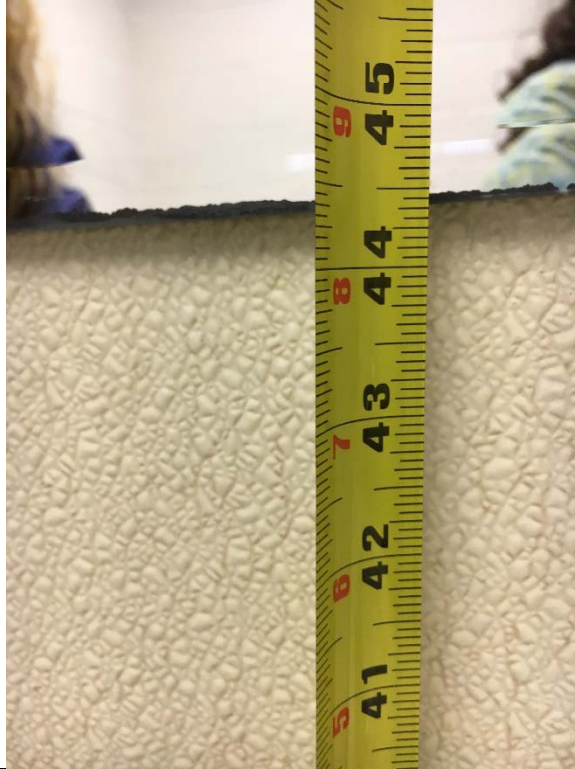
The mirror is mounted with the bottom of the reflective surface at 44-1/2" above finished floor.

2010 ADAAG 603.3 Mirrors.

Violation 12 - The mirror is mounted with the bottom of the reflective surface at 44-1/2" above finished floor.

Lower mirror so the bottom reflective surface is no higher than 40" above finished floor.
