**ADDION AIRPORT
BUILDING REPORT**

Facility Information: **Facility Name:** Pilot Lounge West

Inspector: Karen Jackson **Date:** April 17, 2017

Address: 4550 Richard Byrd **City:** Addison **County:** Dallas

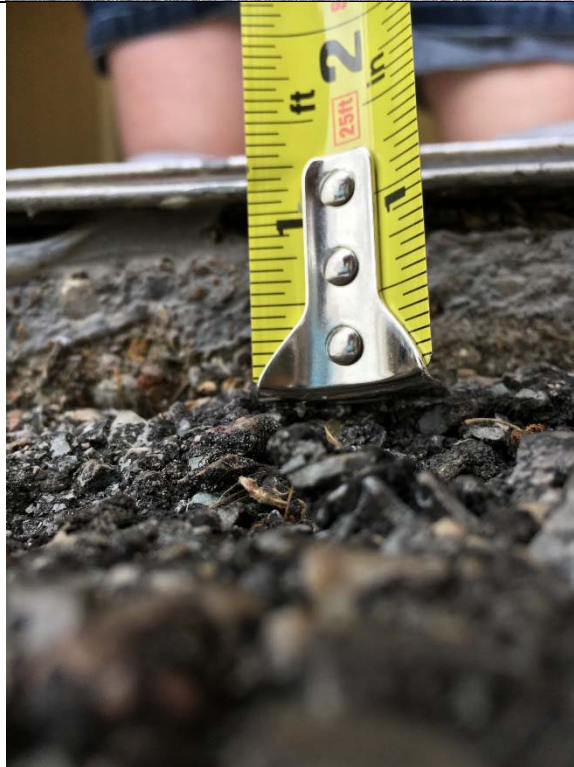
Violation #1: There is a 1-1/4" threshold at the entrance door.

Standard: 2010 ADAAG 404.2.5 Thresholds.

Text: Thresholds, if provided at doorways, shall be 1/2 inch high maximum. Raised thresholds and changes in level at doorways shall comply with 302 and 303.

Violation 1 - There is a 1-1/4" threshold at the entrance door.

Possible Solutions: Modify threshold.

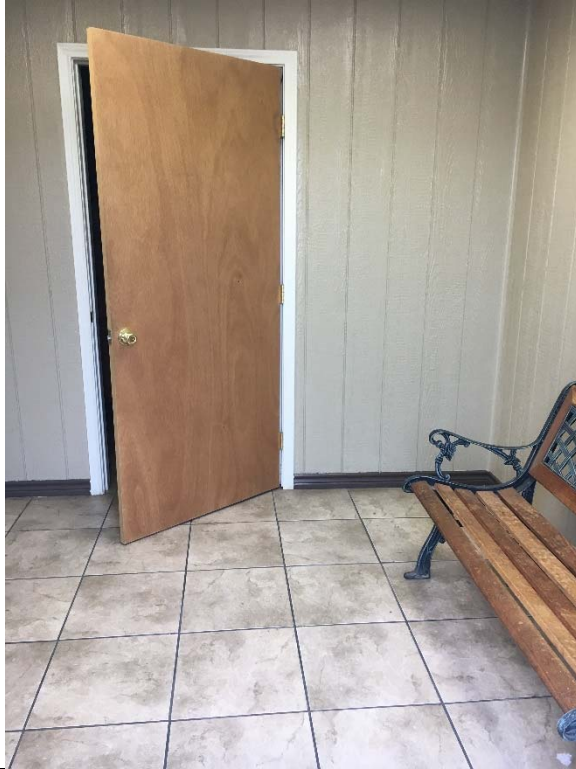
The restroom door has door hardware that requires grasping and twisting to operate.

2010 ADAAG 404.2.7 Door and Gate Hardware.

Handles, pulls, latches, locks, and other operable parts on doors and gates shall comply with 309.4.

Violation 2 - The restroom door has door hardware that requires grasping and twisting to operate.

Replace hardware with lever type hardware.

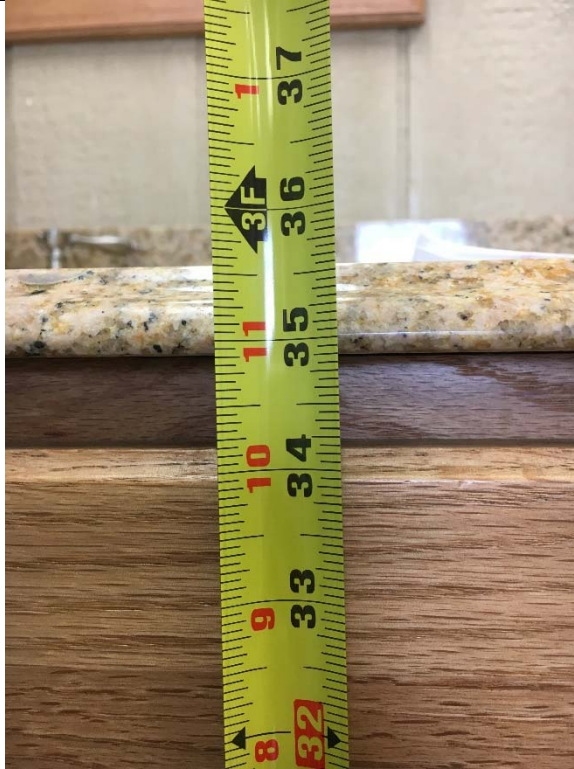
The lavatory is mounted at 35-1/2" to the counter and toe and knee clearance is not provided.

2010 ADAAG 606.3 Height.
2010 ADAAG 606.2 Clear Floor Space.

2010 ADAAG 606.3 Height. Lavatories shall be installed with the front of the higher of the rim or counter surface 34" max. above the finish floor.
2010 ADAAG 606.2 Clear Floor Space. A clear floor space complying with 305, positioned for a forward approach, and knee and toe clearance complying with 306 shall be provided.

Violation 3 - The lavatory is mounted at 35-1/2" to the counter and toe and knee clearance is not provided.

Replace lavatory with a compliant lavatory.

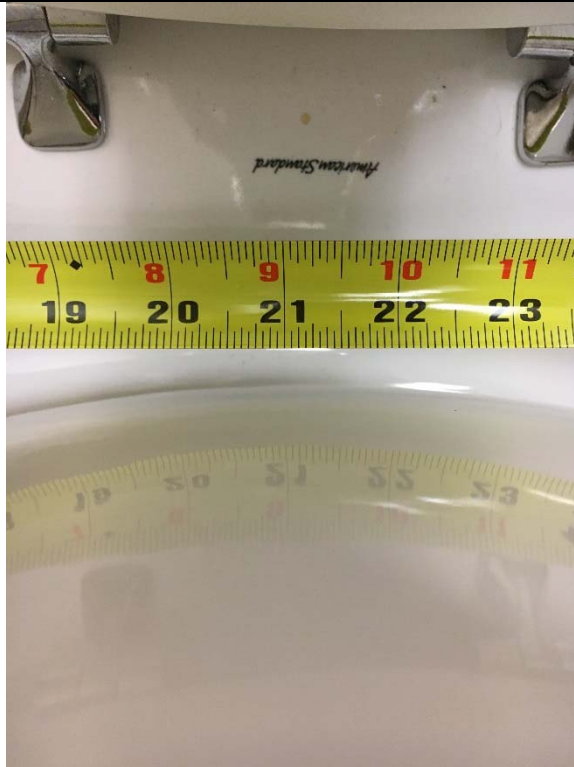
The water closet is mounted at 21-1/4" from the sidewall to the centerline.

2010 ADAAG 604.2 Location.

The water closet shall be positioned with a wall or partition to the rear and to one side. The centerline of the water closet shall be 16 inches minimum to 18 inches maximum from the side wall or partition.

Violation 4 - The water closet is mounted at 21-1/4" from the sidewall to the centerline.

Relocate water closet.

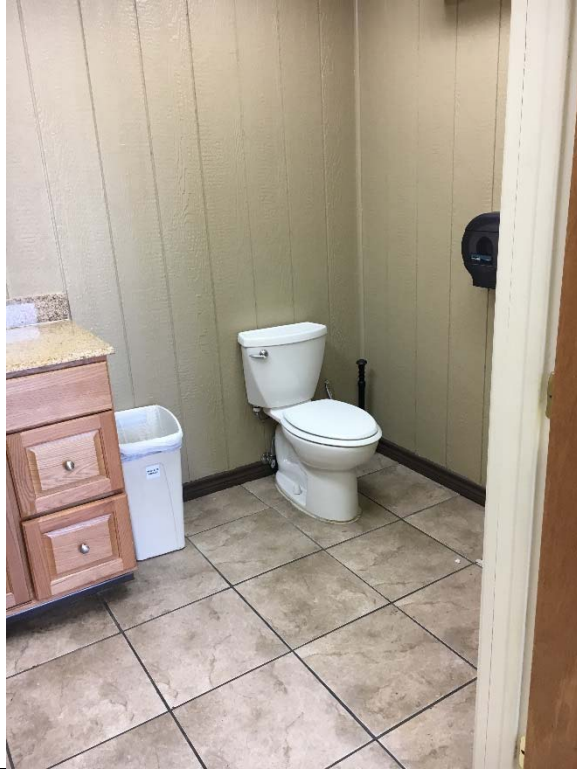
There are no grab bars provided.

2010 ADAAG 604.5 Grab Bars.

Grab bars for water closets shall comply with 609. Grab bars shall be provided on the side wall closest to the water closet and on the rear wall.

Violation 5 – There are no grab bars provided.

Install compliant grab bars.

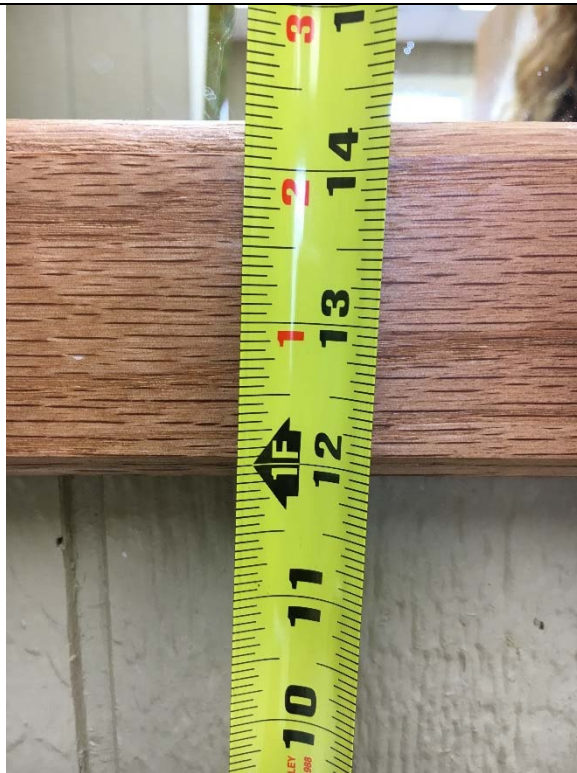
The mirror is mounted at 49" to the bottom of the reflective surface.

2010 ADAAG 603.3 Mirrors.

Mirrors located above lavatories or countertops shall be installed with the bottom edge of the reflecting surface 40" maximum above the finish floor or ground

Violation 6 - The mirror is mounted at 49" to the bottom of the reflective surface.

Lower mirror.

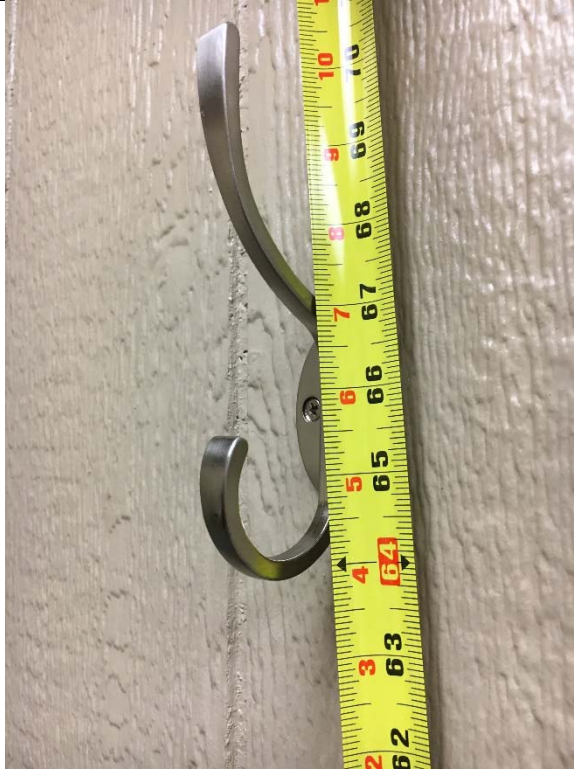
The coat hook is mounted too high at 67" above finished floor to the highest part where reach range no higher than 48" is required.

603.4 Coat Hooks and Shelves.

Coat hooks shall be located within one of the reach ranges specified in 308.

Violation 7 - The coat hook is mounted too high at 67" above finished floor to the highest part where reach range no higher than 48" is required.

Lower coat hook.
