**ADDISON AIRPORT
BUILDING REPORT**

Facility Information: **Facility Name:** Terminal Building
Facility Contact: Lisa Pyles **Contact Phone:** 972-450-2878

Accessology Inspector Information:
Inspector: Karen Jackson **Date:** April 17, 2017
Email: Kjackson@accessology.com

Latitude: 32.967685 **Longitude:** -96.830112
Address: 16051 Addison Road **City:** Addison **County:** Dallas

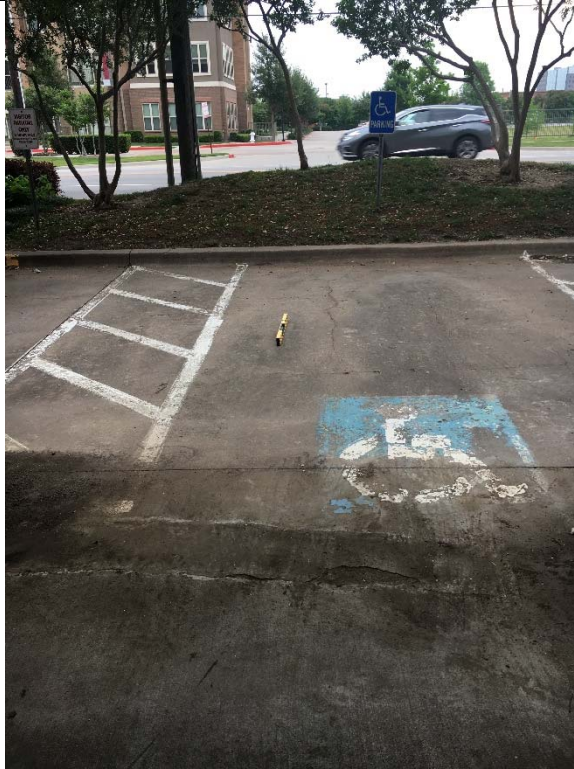
Violation #1: The accessible parking space on the left facing the street has a running slope of 3.1%.

Violation 1 - The accessible parking space on the left facing the street has a running slope of 3.1%.

Regrade the accessible parking space to achieve a 1:48 (2.08%) maximum slope in all directions and ensure one of the accessible parking spaces is a

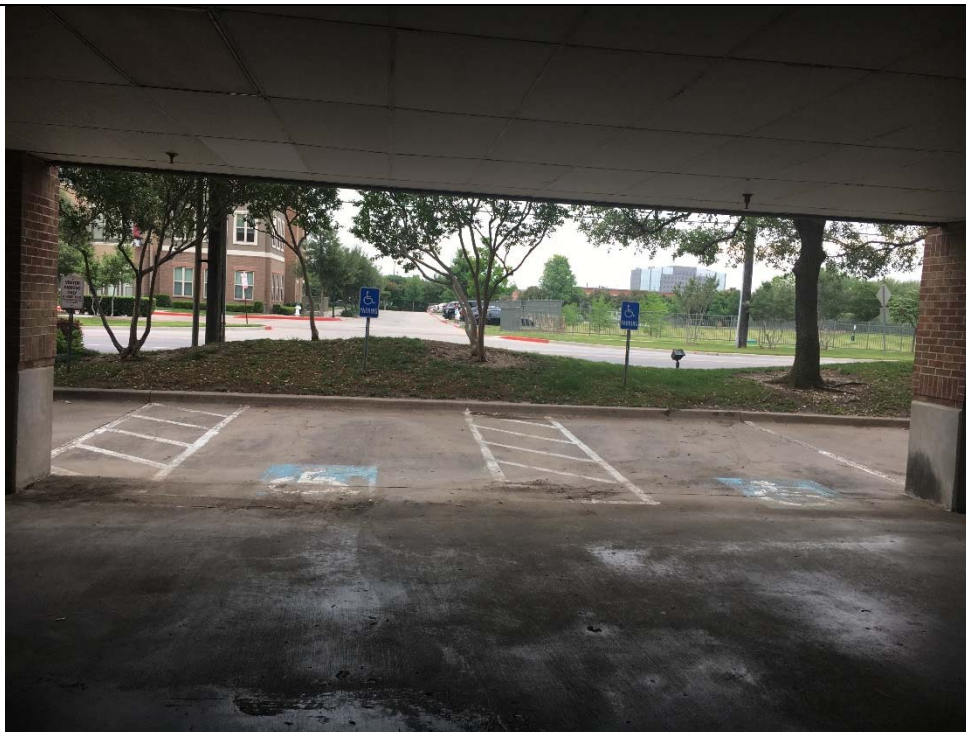
The both access aisles facing the street are only 47" wide where a minimum 60" wide access aisle is required. Neither accessible parking space is wide enough to accommodate a van accessible space.

Violation 2 - The both access aisles facing the street are only 47" wide where a minimum 60" wide access aisle is required. Neither accessible parking space is wide enough to accommodate a van accessible space.

Restripe to allow for 60" minimum wide access aisles and one accessible parking space to be 132" wide van accessible parking space.

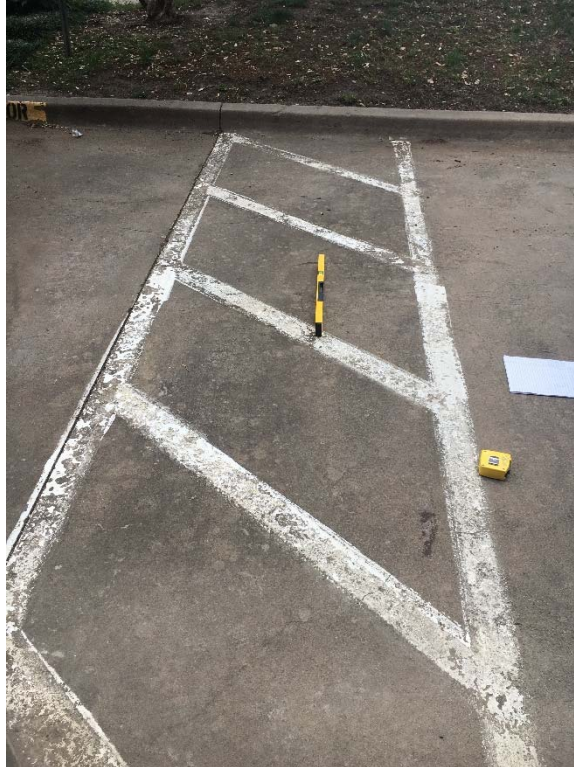
The left access aisle facing the street has a running slope of 2.3%.

Violation 3 - The left access aisle facing the street has a running slope of 2.3%.

Regrade the access aisle to achieve a 1:48 (2%) maximum slope in all directions.

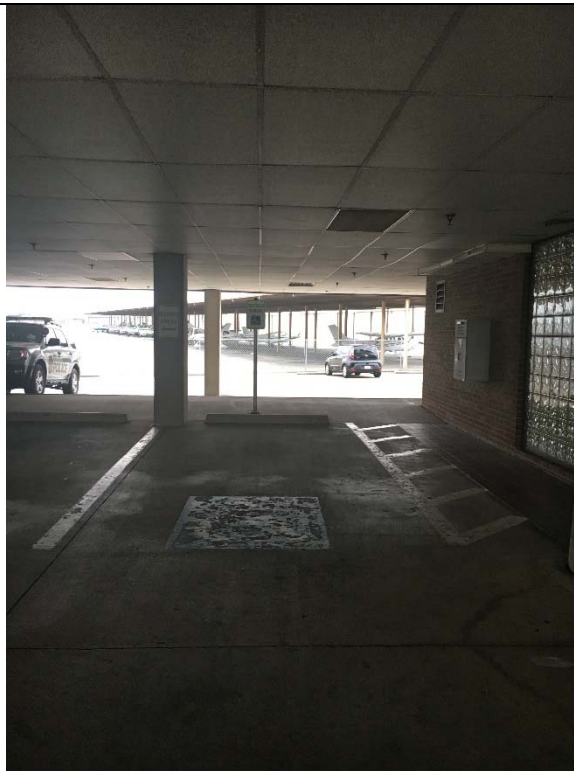
The accessible parking space provided in the covered parking area has a running slope of 3.1% and a cross slope of 2.3%.

Violation 4 - The accessible parking space provided in the covered parking area has a running slope of 3.1% and a cross slope of 2.3%.

Regrade the access aisle to achieve a 1:48 (2%) maximum slope in all directions and ensure the accessible space is a minimum of 132" wide to serve as a van accessible space.

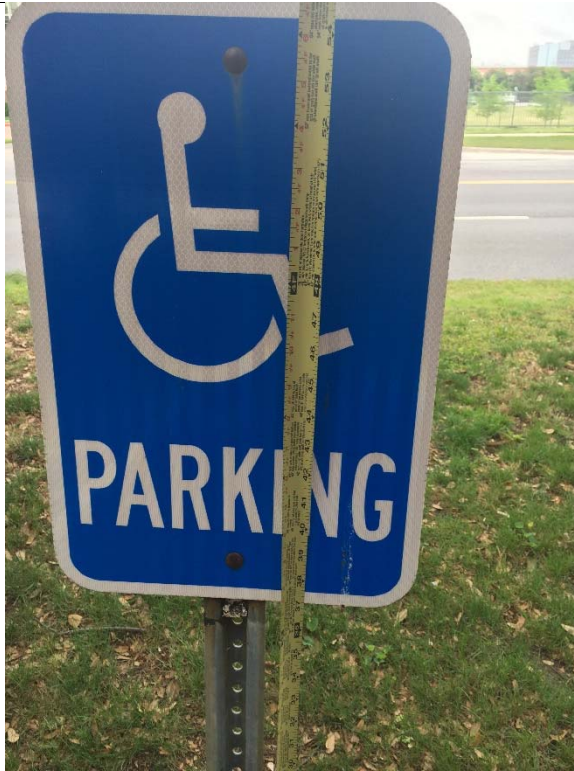
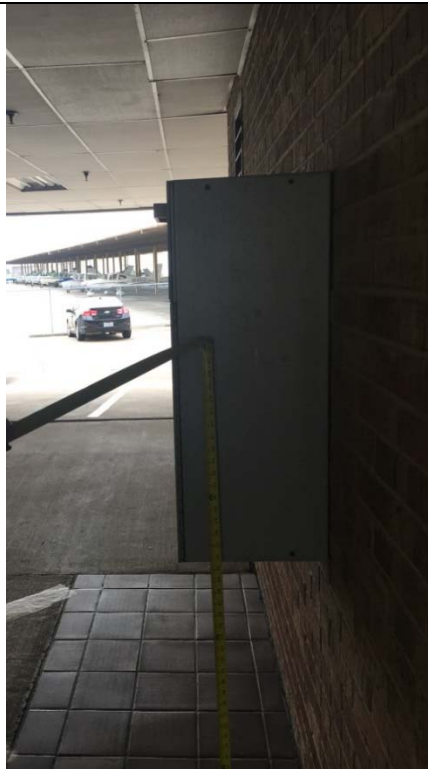
All accessible parking signs are mounted too low and none of the spaces are marked for "Van Accessible".

Violation 5 - All accessible parking signs are mounted too low and none of the spaces are marked for "Van Accessible".

Raise all signage and add van accessible signage to the covered parking as well as one of the uncovered parking spaces.

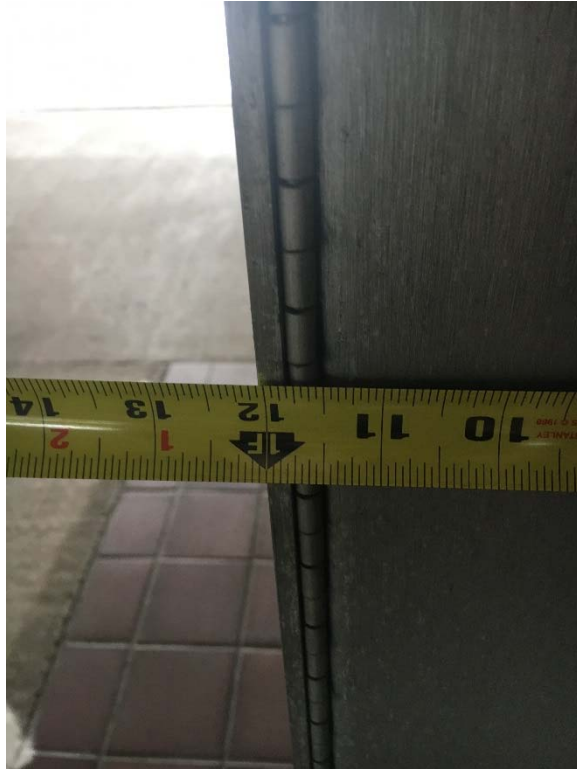
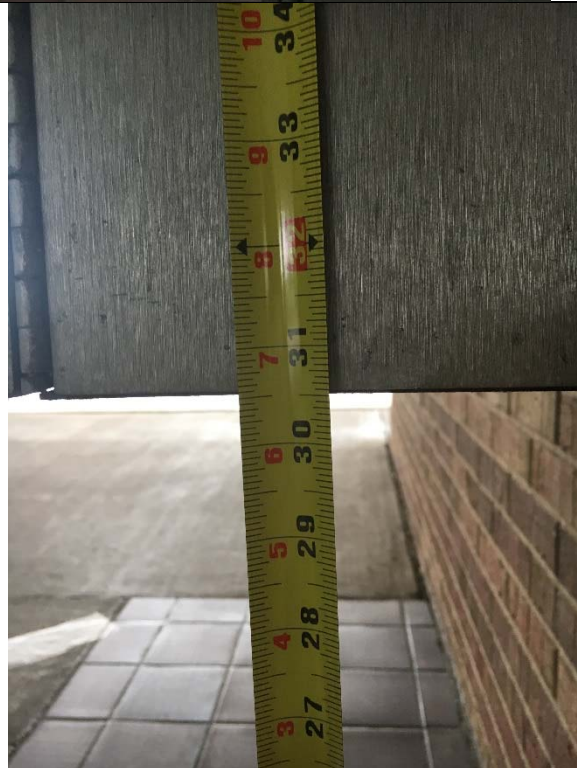
The access aisle serving the covered accessible parking space is partially brick and goes all the way up to the building where a mailbox is mounted on the building and protrudes into the access aisle 12" at 30-1/2" above finished floor.

Violation 6 – The access aisle serving the covered accessible parking space is partially brick and goes all the way up to the building where a mailbox is mounted on the building and protrudes into the access aisle 12" at 30-1/2" above finished floor.

Relocate mailbox out of the path of circulation path.

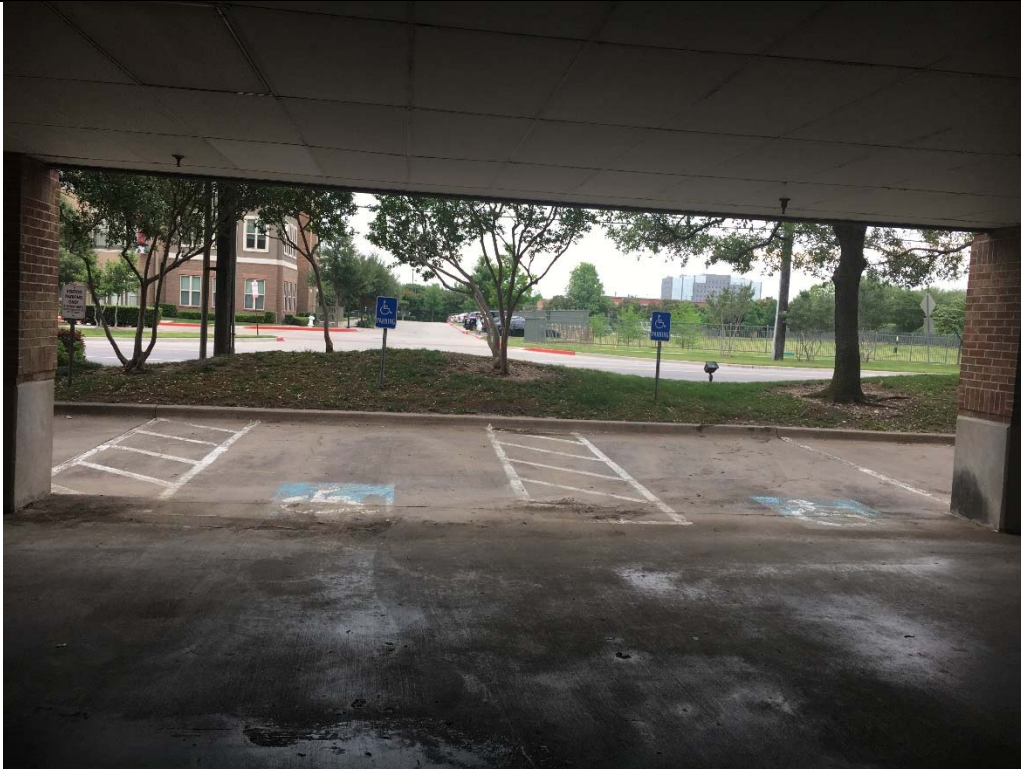
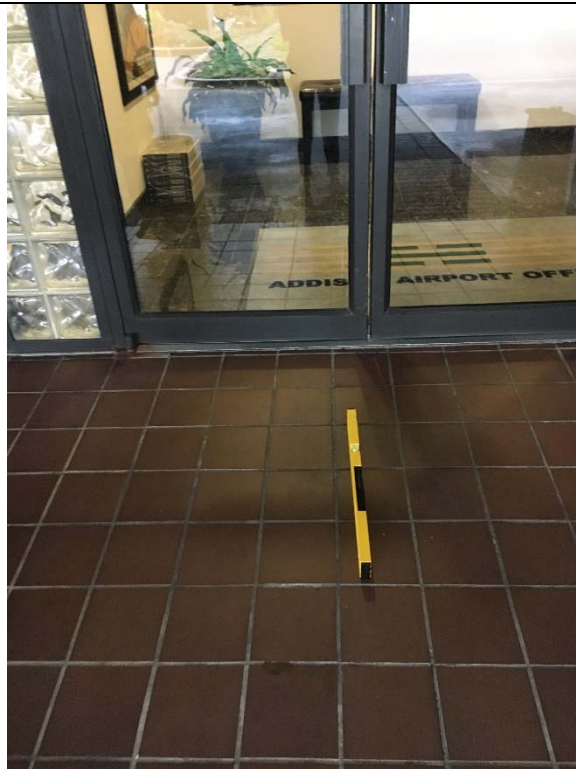
There are only 3 accessible parking spaces provided, where 5 are required with one being van accessible.

Violation 7 - There are only 3 accessible parking spaces provided, where 5 are required with one being van accessible.

Add two accessible parking spaces (one that is van accessible) with access aisles serving them with compliant signage.

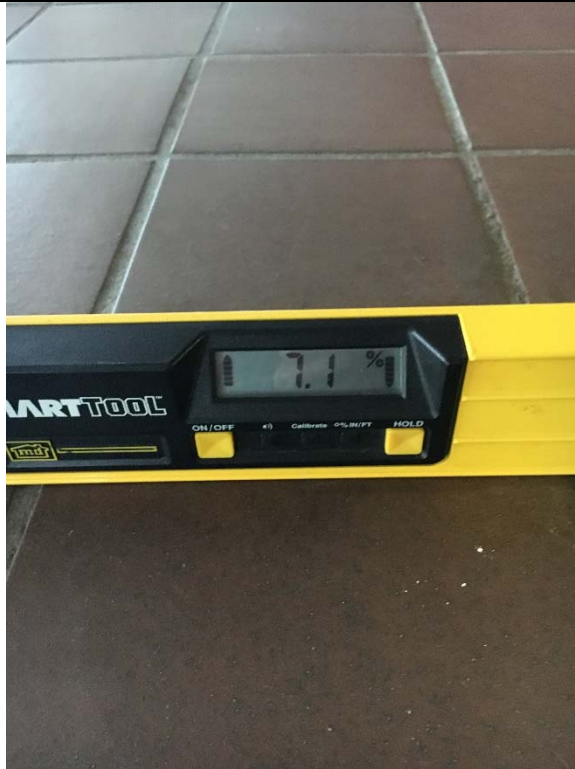
The landing at the main entrance to the building has a running slope of 7.1%.

Violation 8 - The landing at the main entrance to the building has a running slope of 7.1%.

Remove and regrade the area in front of the door to achieve a smooth and level landing.

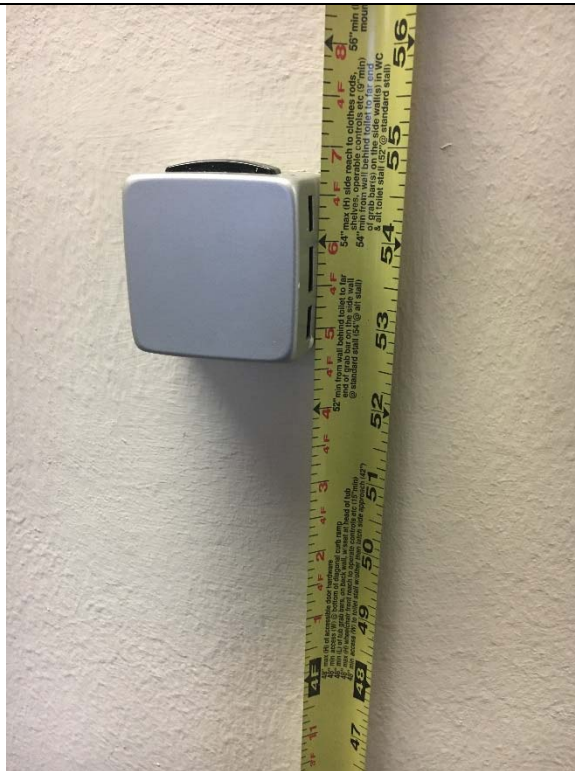
The thermostat control in the hallway is mounted with the highest operable part at 54-5/8" above finished floor where 48" high maximum is required.

Violation 9 - The thermostat control in the hallway is mounted with the highest operable part at 54-5/8" above finished floor where 48" high maximum is required.

Lower thermostat so the highest operable part is at 48".

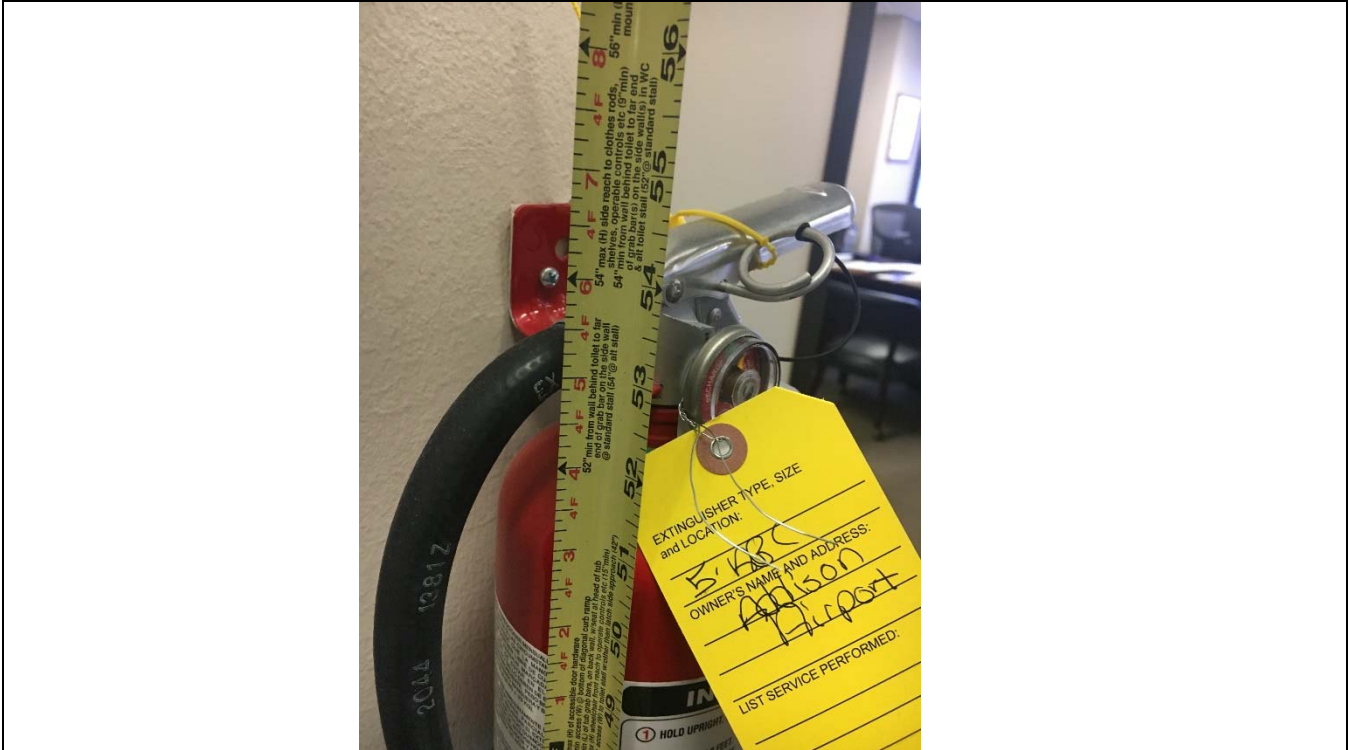
The fire extinguisher provided in the hallway is mounted with the highest operable part at 54" above finished floor where 48" high maximum is allowed.

Violation 10 - The fire extinguisher provided in the hallway is mounted with the highest operable part at 54" above finished floor where 48" high maximum is allowed.

Lower the fire extinguisher so the highest operable part is at 48".

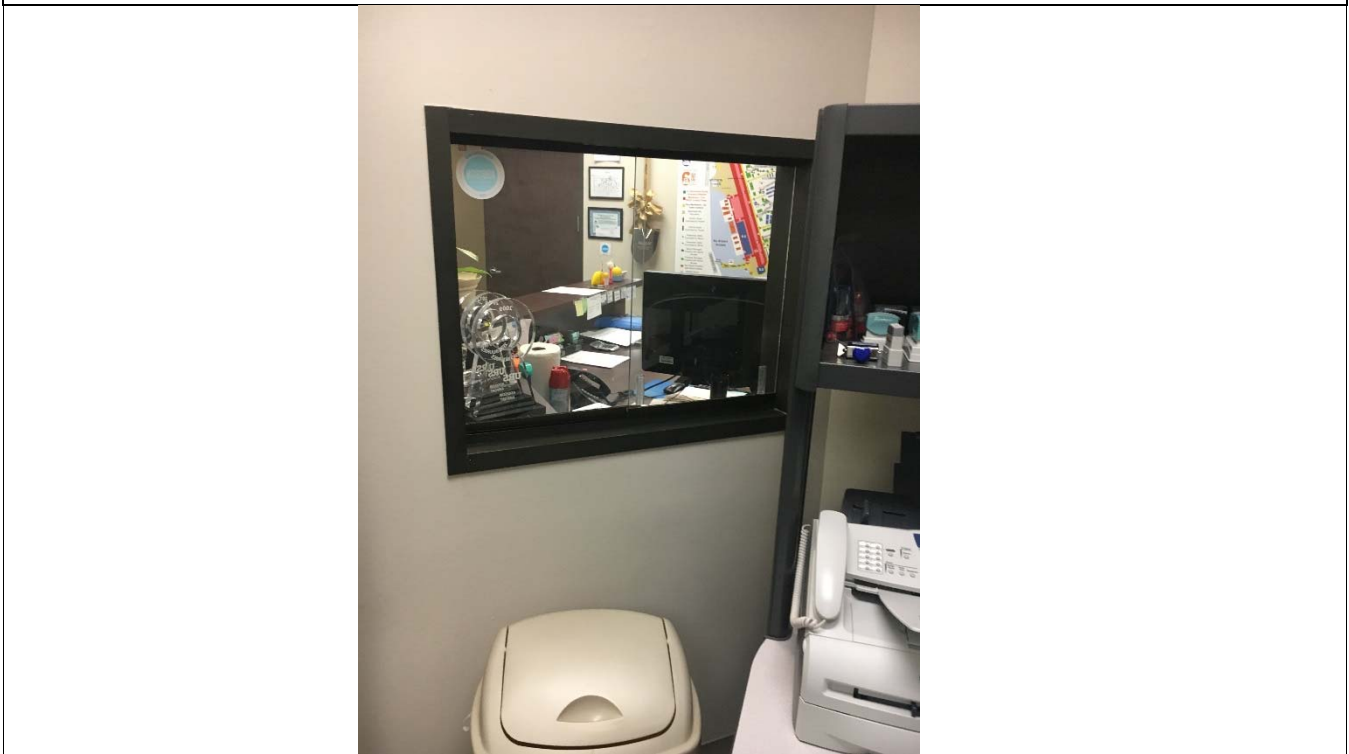
The transaction window provided behind reception is mounted at 40" above finished floor.

Violation 11 - The transaction window provided behind reception is mounted at 40" above finished floor.

Lower counter so it is no higher than 36" above finished floor.

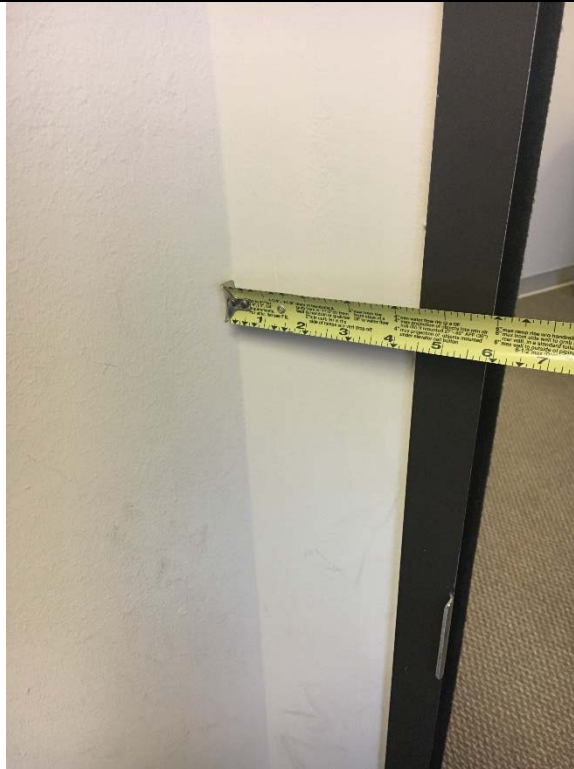
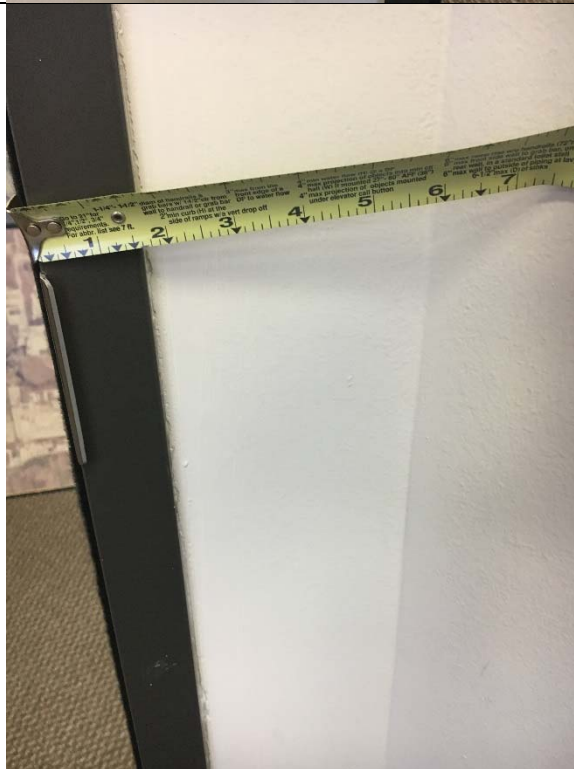
Two of the offices do not have a minimum of 18" maneuvering clearance on the pull side.

Violation 12 - Two of the offices do not have a minimum of 18" maneuvering clearance on the pull side.

Modify doors to provide an 18" minimum maneuvering clearance.

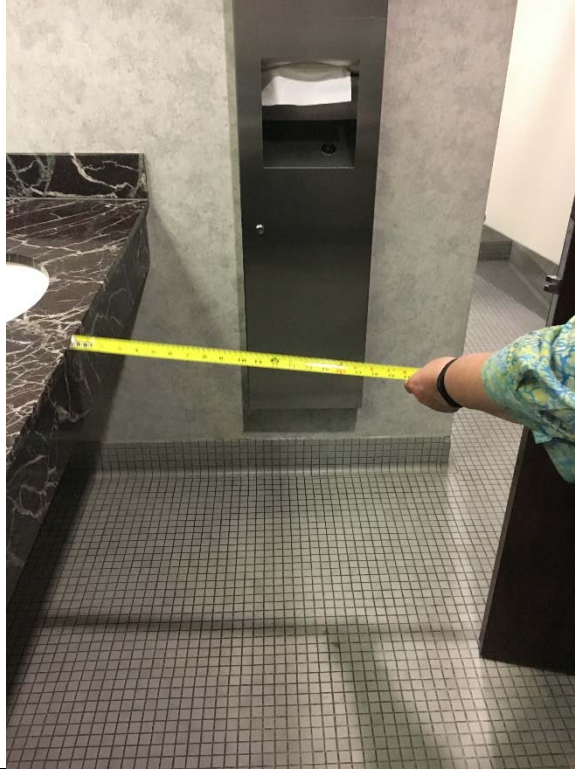
Women's Restroom - The distance between the door and the lavatory is only 29".
A minimum of 48" maneuvering clearance is required.

Violation 13 – Women's Restroom - The distance between the door and the lavatory is only 29". A minimum of 48" maneuvering clearance is required.

Reverse the swing of the door.

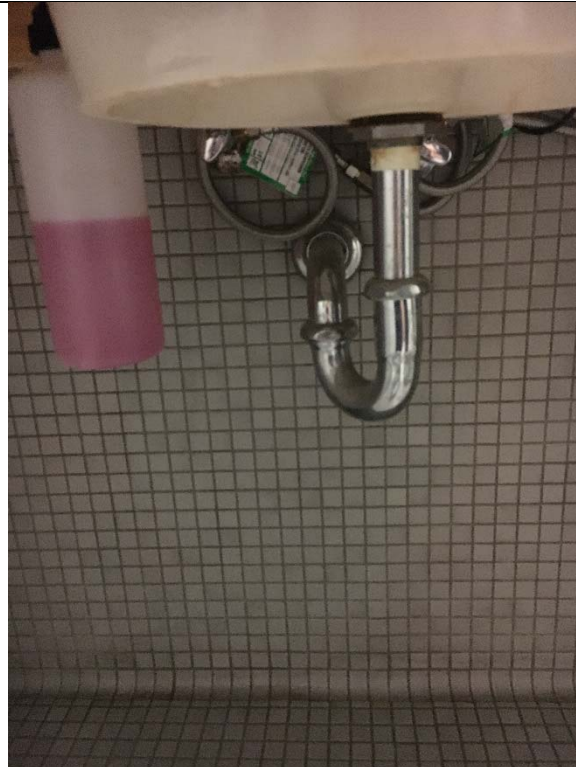
Women's Restroom - Pipes under the lavatory are not wrapped.

Violation 14 - Women's Restroom - Pipes under the lavatory are not wrapped.

Provide protection at the exposed drains and water lines under the lavatories.

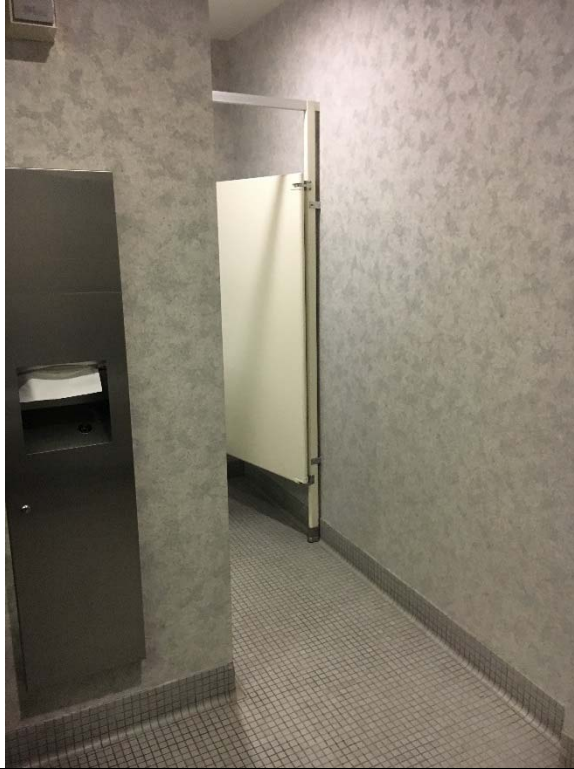
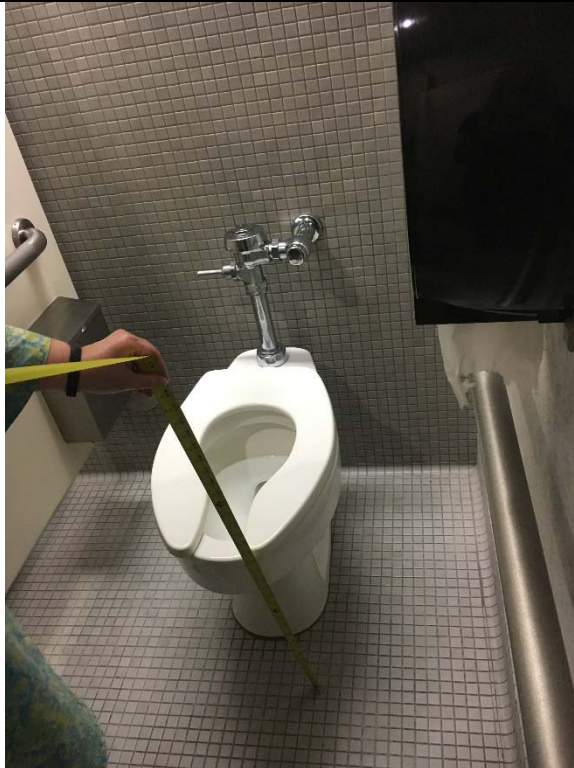
Women's Restroom - No accessible stall is provided; only an ambulatory stall is provided.

Violation 15 - Women's Restroom - No accessible stall is provided; only an ambulatory stall is provided.

Modify partitions to provide a wheelchair accessible compartment. Clearance around a water closet shall be 60" minimum measured perpendicular from the side wall and 56" minimum measured perpendicular from the rear wall.

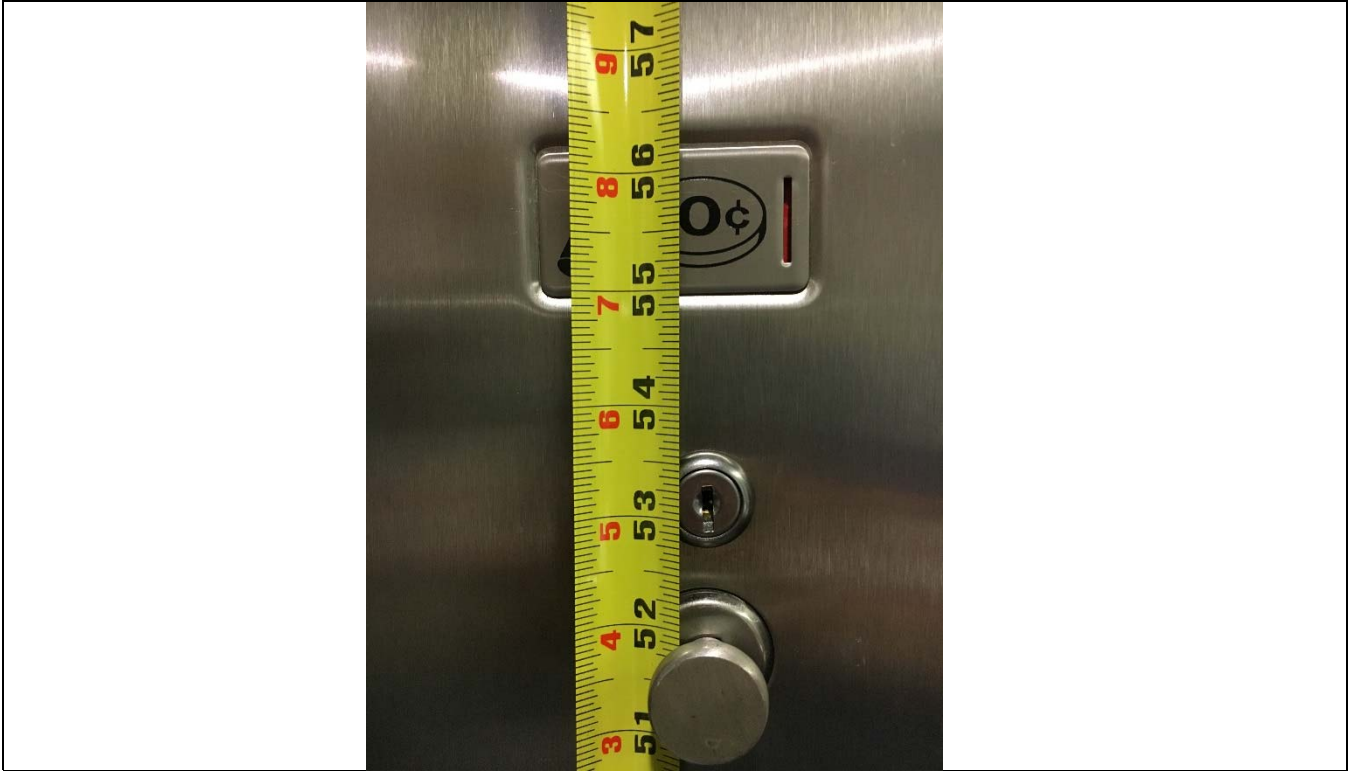
Women's Restroom - The feminine product dispenser is mounted with the highest operable part at 55-1/2" above finished floor and requires grasping to operate.

Violation 16 - Women's Restroom - The feminine product dispenser is mounted with the highest operable part at 55-1/2" above finished floor and requires grasping to operate.

Remove dispenser or replace with a compliant dispenser mounted with highest operable part at 48".

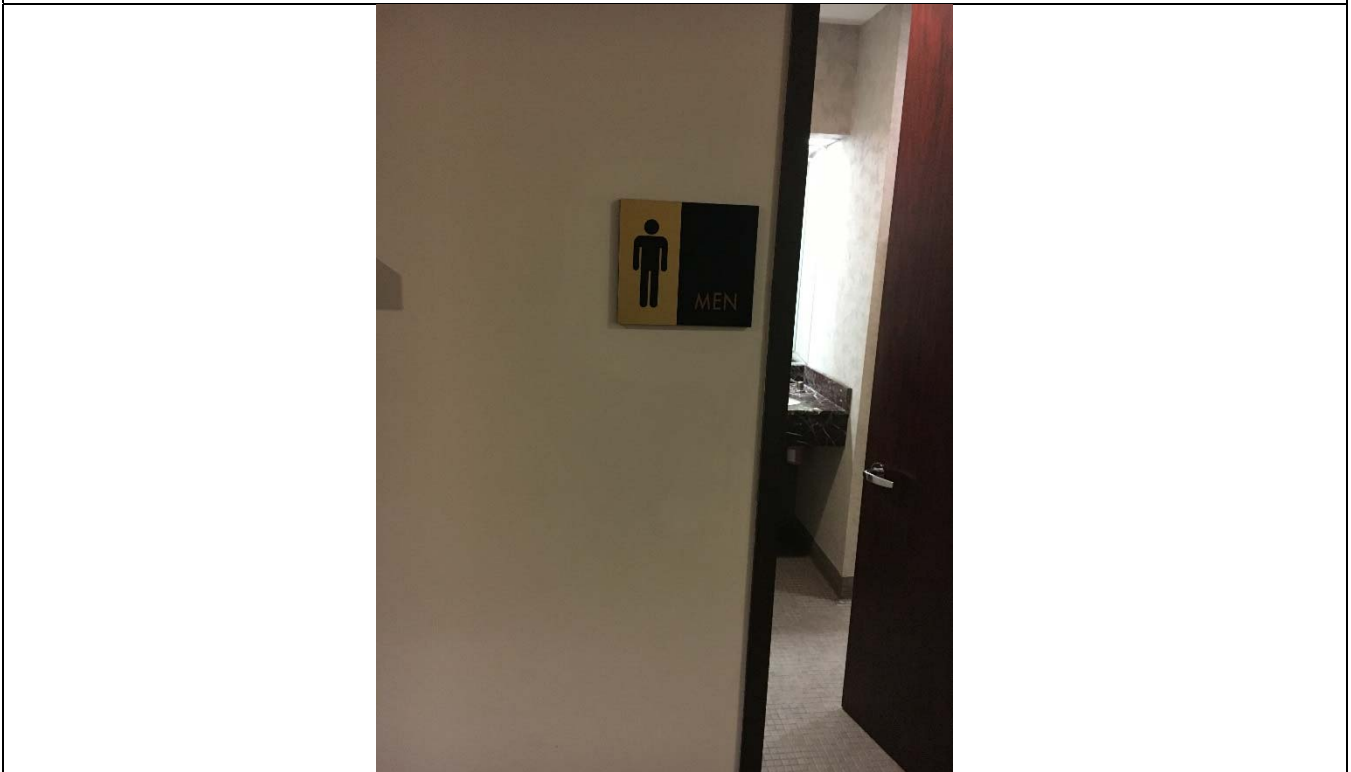
Men's Restroom - Entry door requires more than 5lbs to open.

Violation 17 - Men's Restroom - Entry door requires more than 5lbs to open.

Adjust closer.

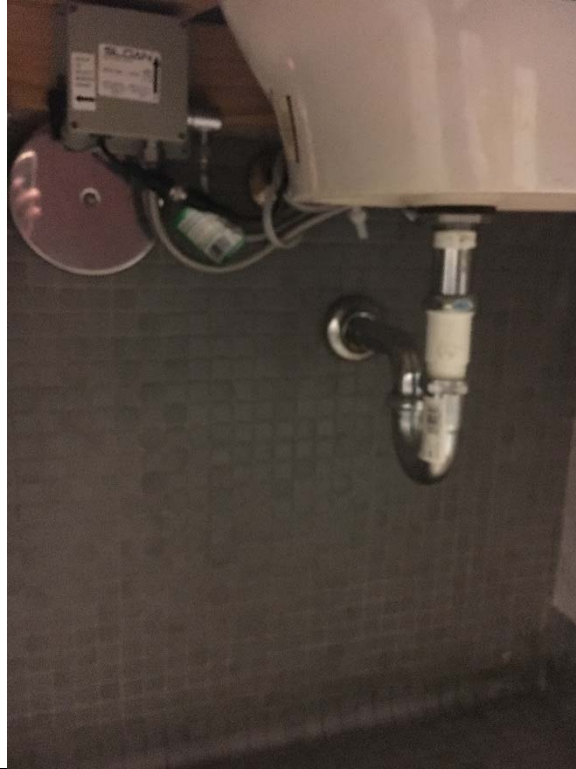
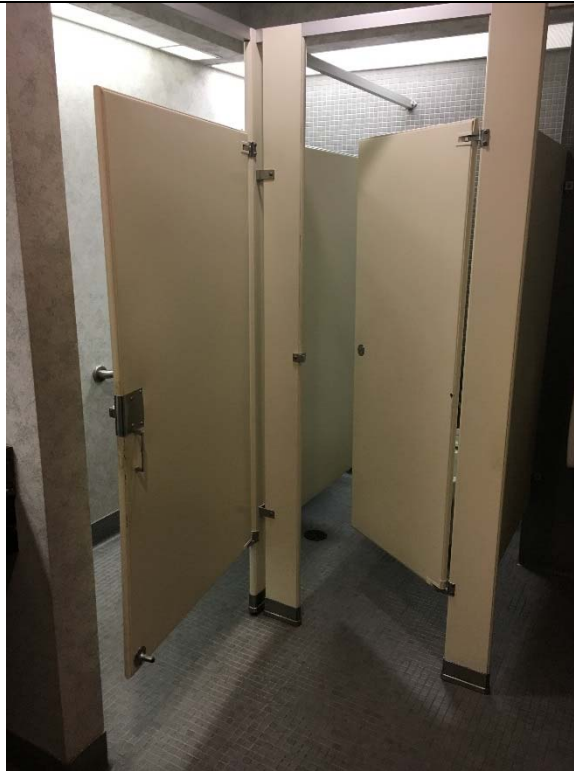
Men's Restroom - Pipes under the lavatory are not wrapped.

Violation 18 - Men's Restroom - Pipes under the lavatory are not wrapped.

Provide protection at the exposed drains and water lines under the lavatories.

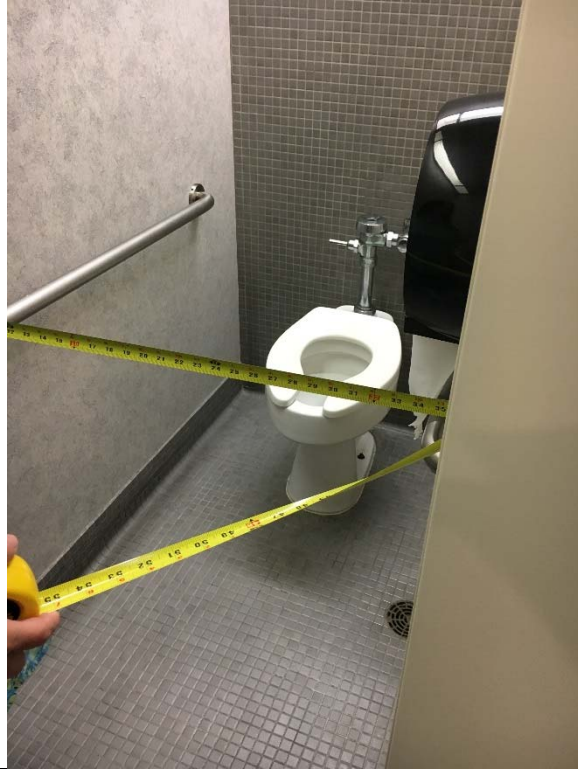
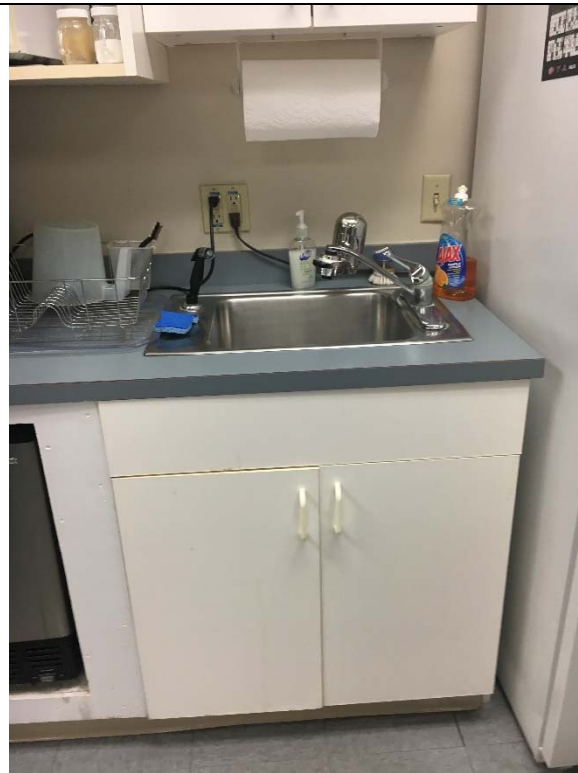
Men's Restroom - No accessible stall provided; only an ambulatory stall is provided.

Violation 19 - Men's Restroom - No accessible stall provided; only an ambulatory stall is provided.

Modify partitions to provide a wheelchair accessible compartment. Clearance around a water closet shall be 60" minimum measured perpendicular from the side wall and 56" minimum measured perpendicular from the rear wall.

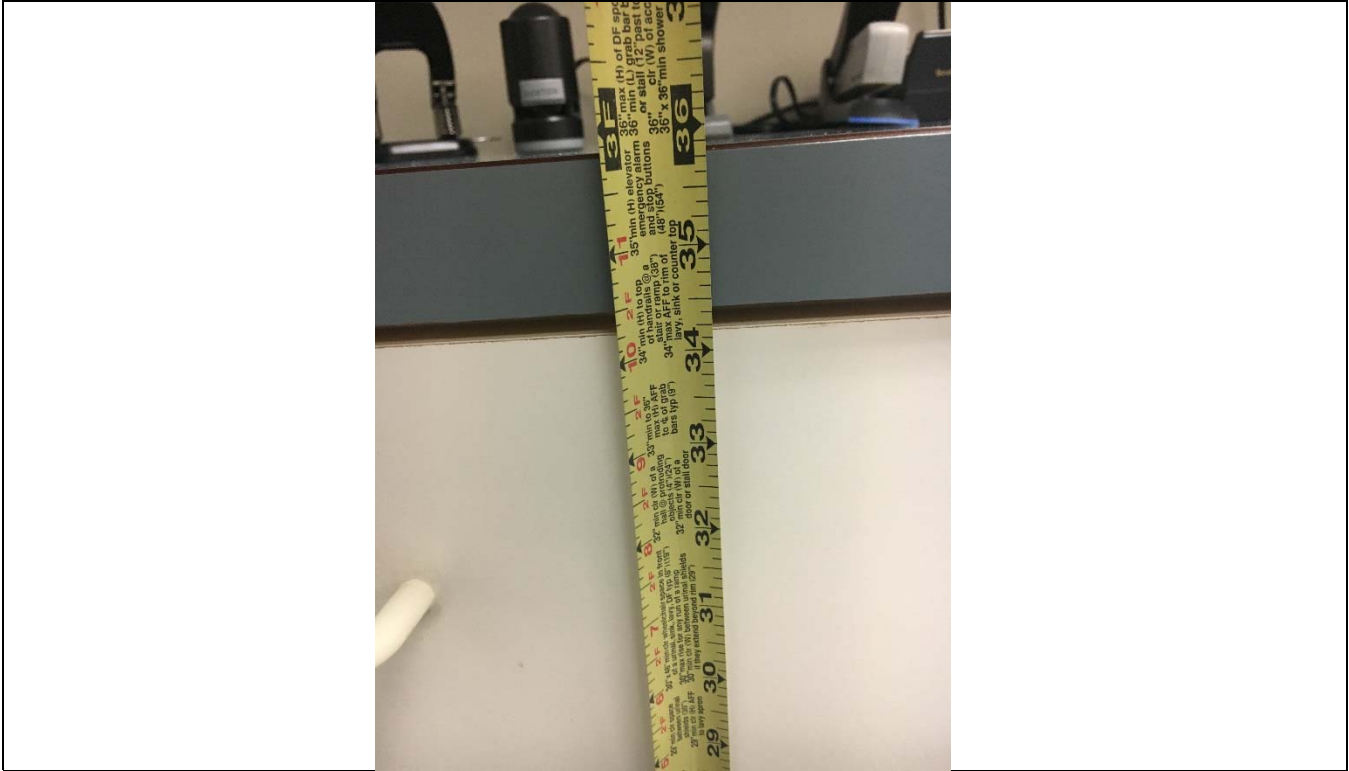
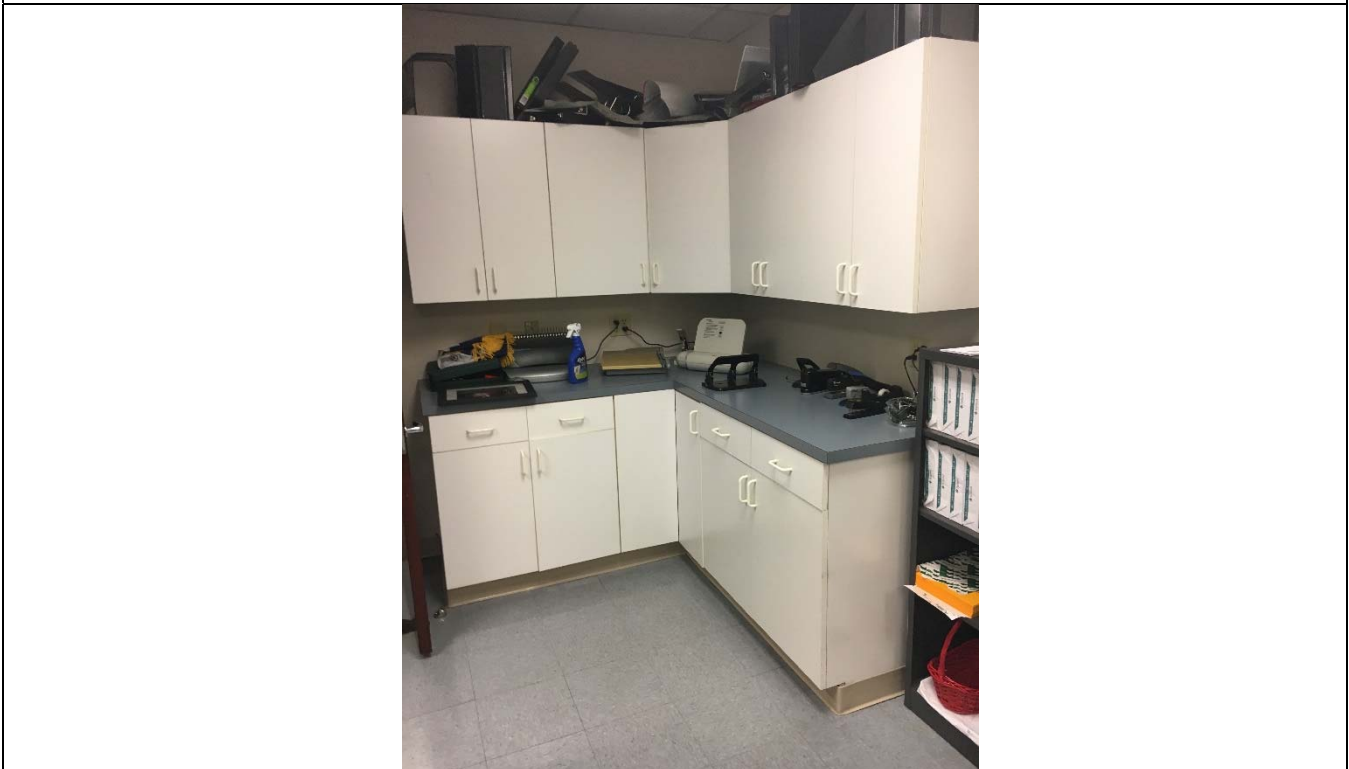
Violation #20: The counter in the break room is 35-3/4" above finished floor to the top of the counter at the sink where a maximum of 34" is required.

Violation 20 - The counter in the break room is 35-3/4" above finished floor to the top of the counter at the sink where a maximum of 34" is required.

Possible Solutions: Modify sink to provide 34" maximum height.

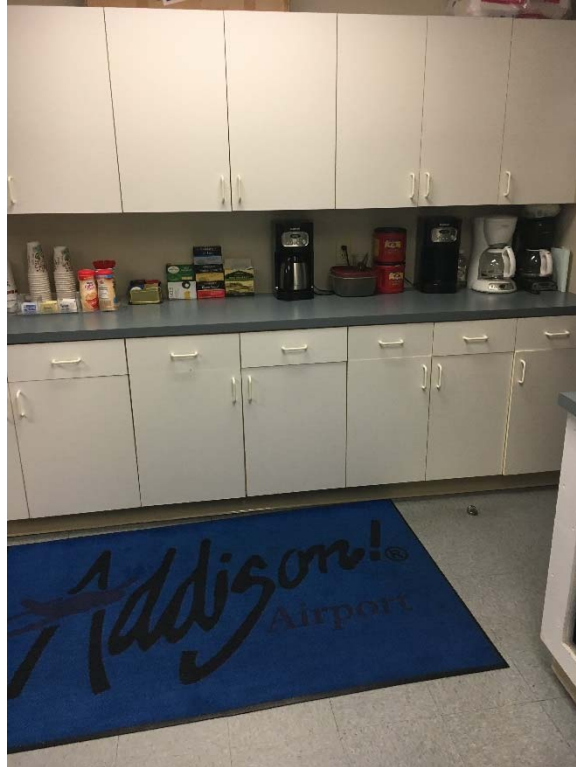
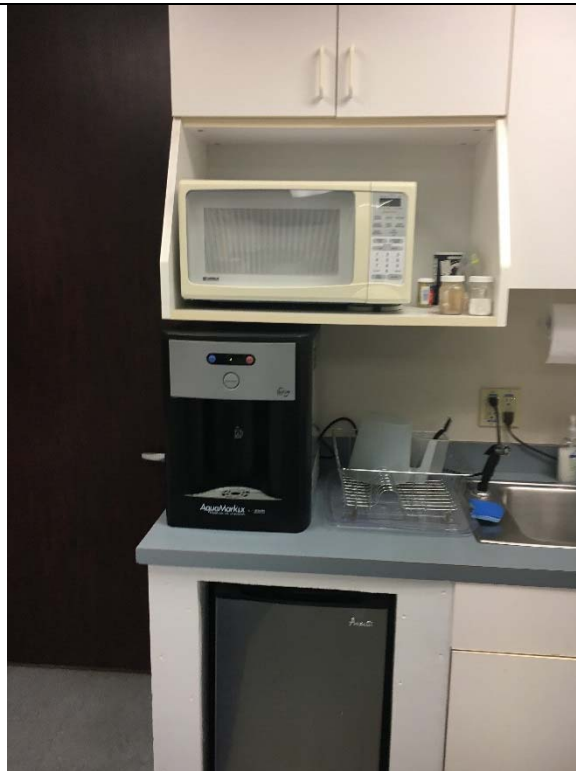
Violation #21: The counters in the break room are from 35" to 36" above finished floor.

Violation 21 - The counters in the break room are from 35" to 36" above finished floor.

Possible Solutions: Lower a portion of the counter to 34" above finished floor.

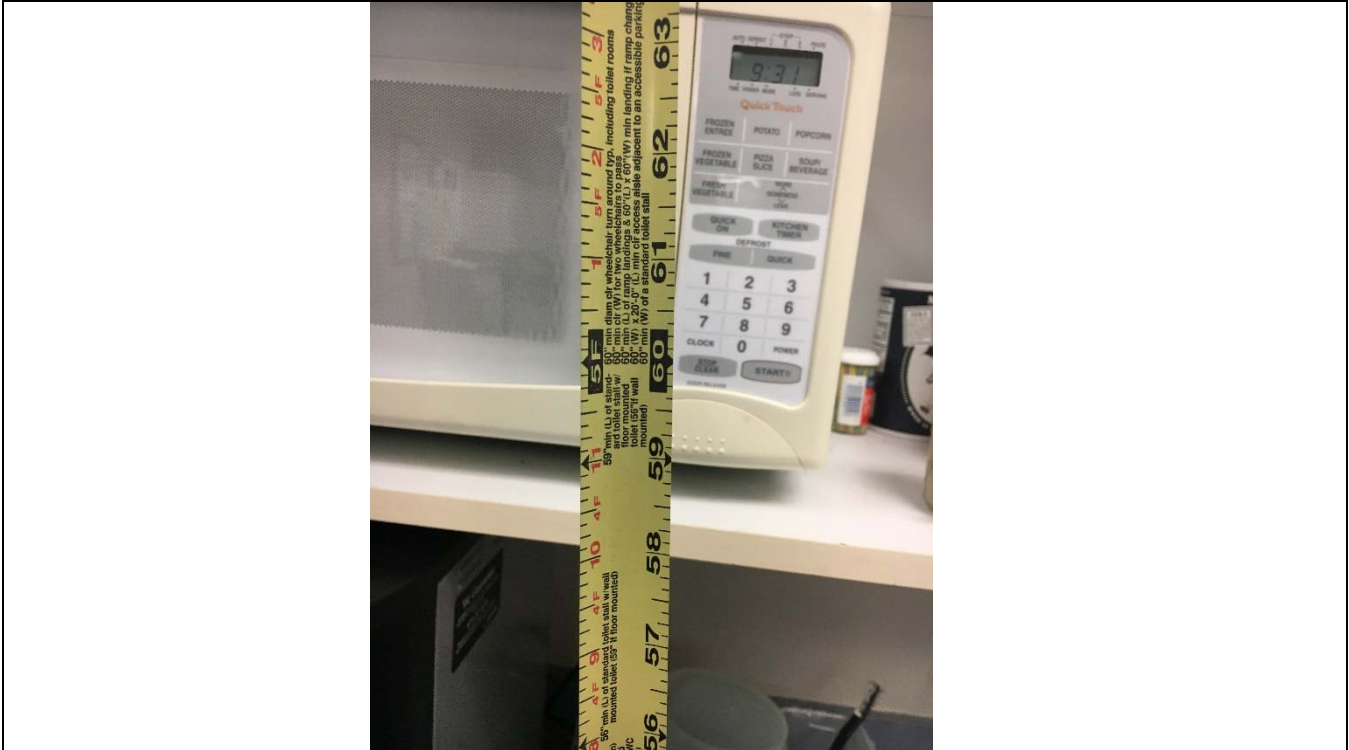
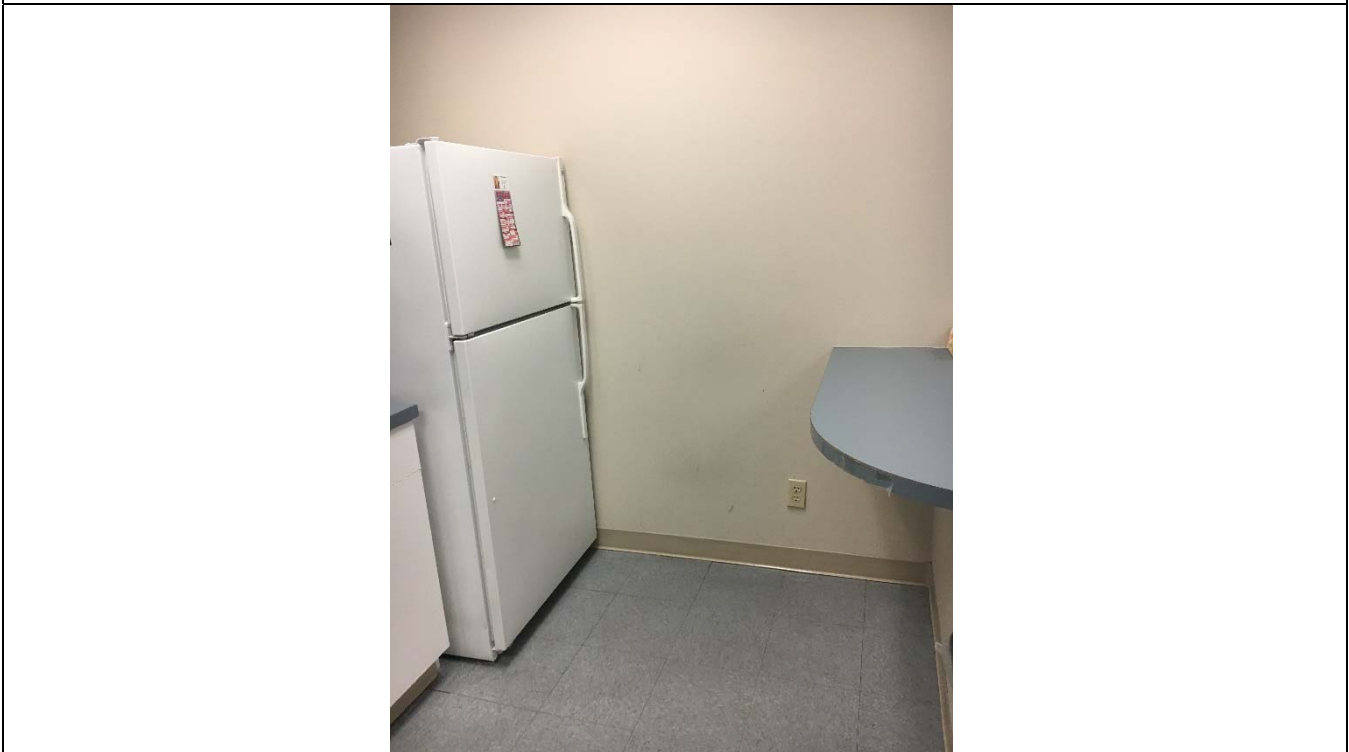
Violation #22: The microwave is mounted with the highest operable part at 62-1/2" above finished floor.

Violation 22 - The microwave is mounted with the highest operable part at 62-1/2" above finished floor.

Possible Solutions: Relocate microwave or add another one where it is within reach range.
