**TOWN OF ADDISON
BUILDING REPORT**

Facility Name: Wiley Post Office Building

Date: April 10, 2017

Address: 4308 & 4310 Wiley Post Road

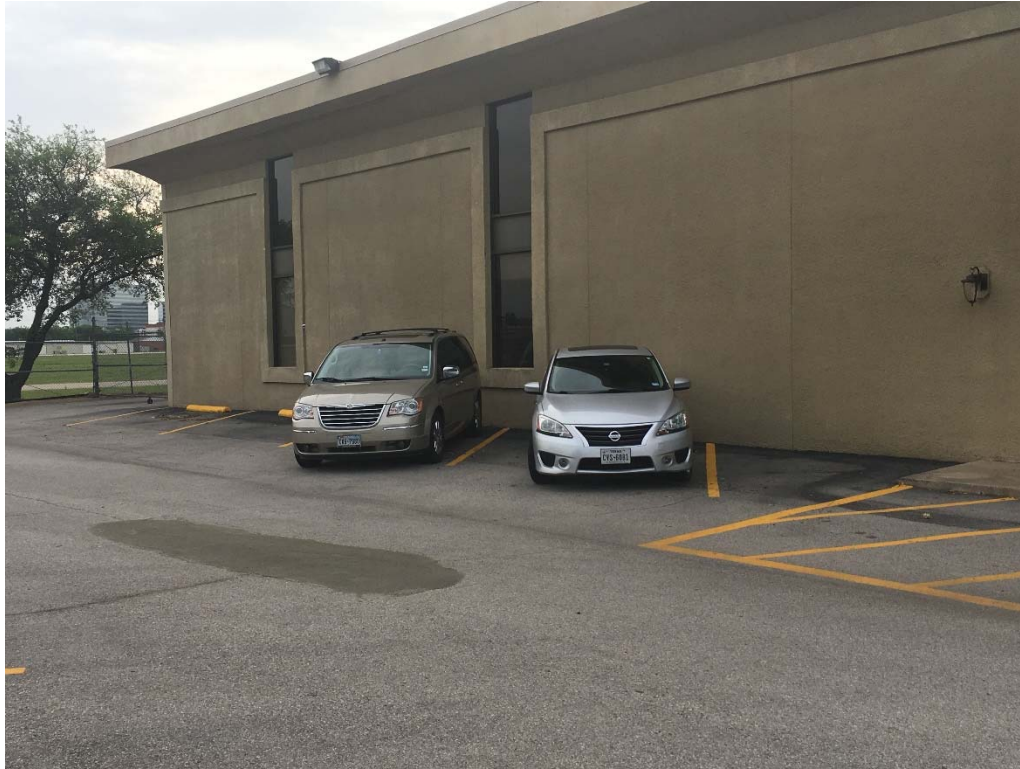
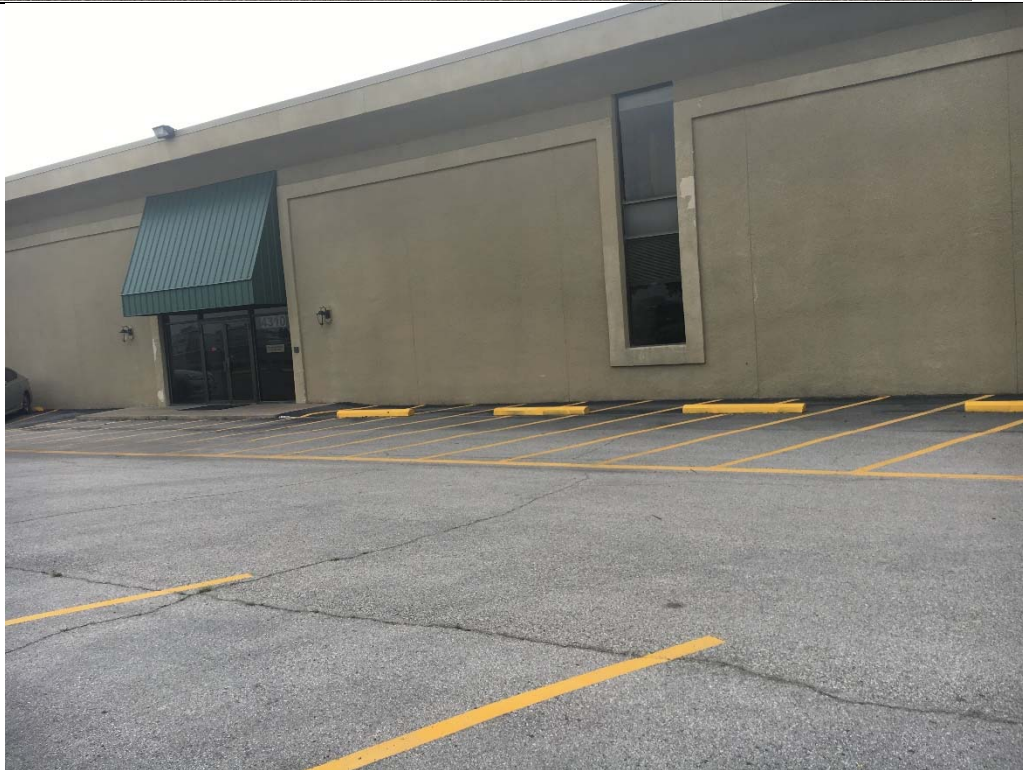
There are 38 uncovered parking spaces with no accessible parking spaces provided.

Violation 1 - There are no accessible parking spaces serving the building.

Provide two accessible parking spaces, one being van accessible parking space, an access aisle and compliant signage. See general Note

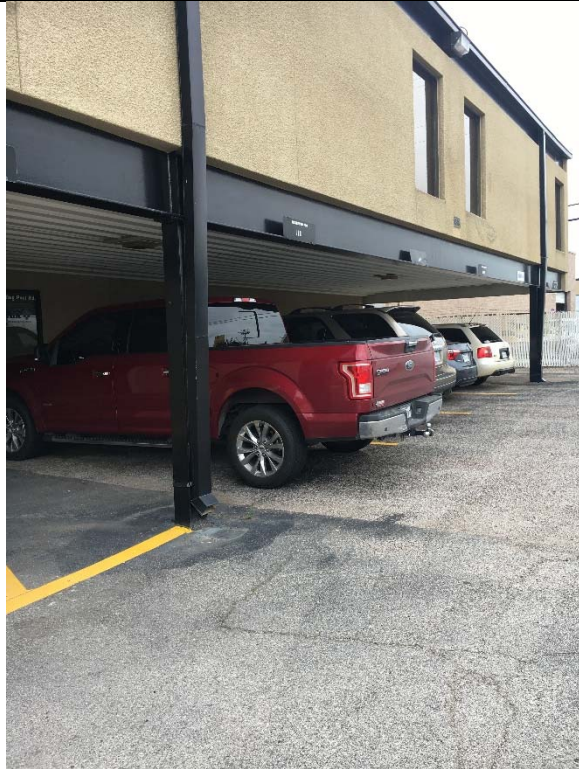
There are 5 covered parking spaces at the west portion of the building (4308) with no accessible parking spaces provided.

Violation 2 -There are 5 covered parking spaces at the west portion of the building (4308) with no accessible parking spaces provided.

Provide one van accessible parking space, access aisle and compliant signage. See general Note

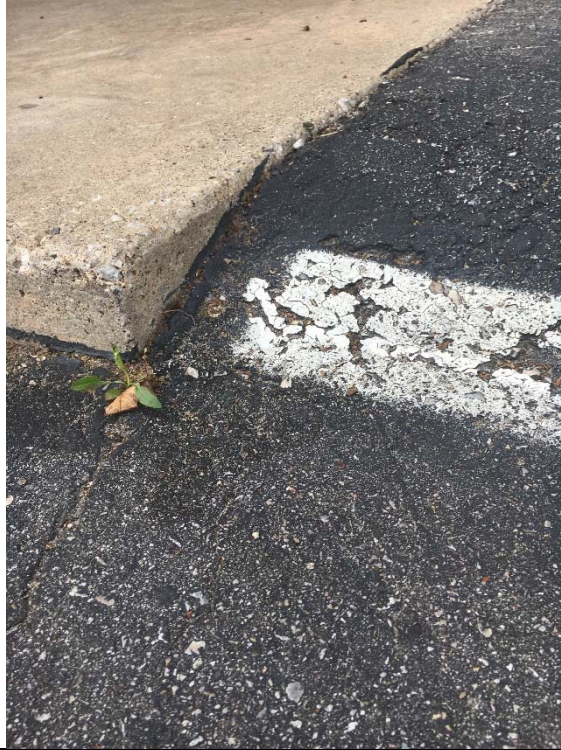
Violation #3: The ramp provided leading to the main entrance of the building (4310) has a drop off at the corner.

Violation 3 - The ramp provided leading to the main entrance of the building (4310) has a drop off at the corner.

Possible Solutions: Add edge protection.

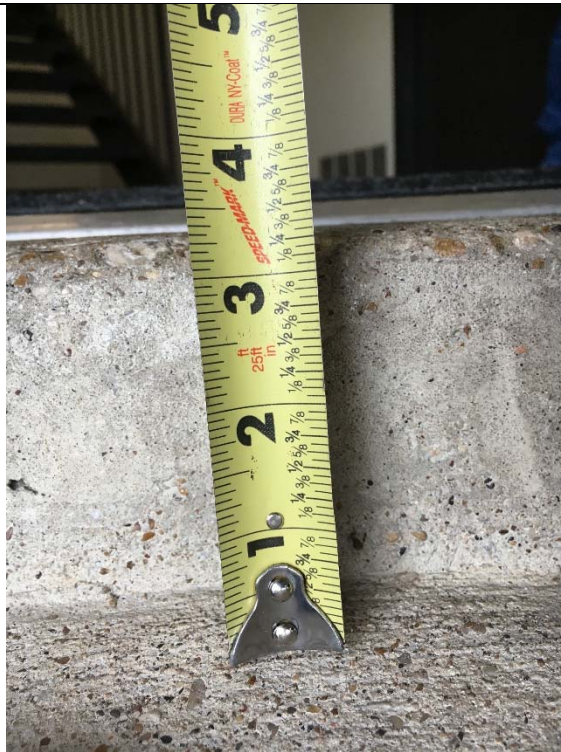
Violation #4: A step up of 3-1/4" is required for access to the porch at the entrance to the 4308 portion of the building.

Violation 4 - A step up of 3-1/4" is required for access to the porch at the entrance to the 4308 portion of the building.

Provide an accessible route to the building entrance.

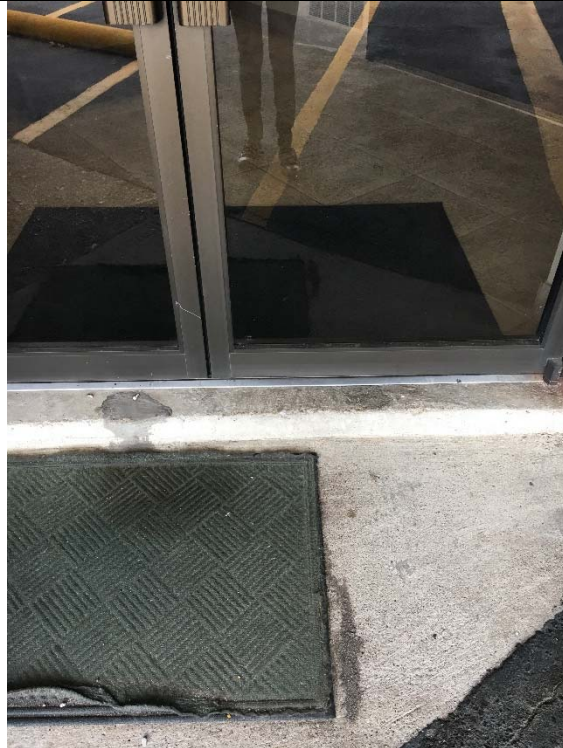
Violation #5: There is a level change as well as an unsecured mat at the entrance to 4308.

Violation 5 - There is a level change as well as an unsecured mat at the entrance to 4308.

Possible Solutions: Modify threshold so it is no greater than 1/2".

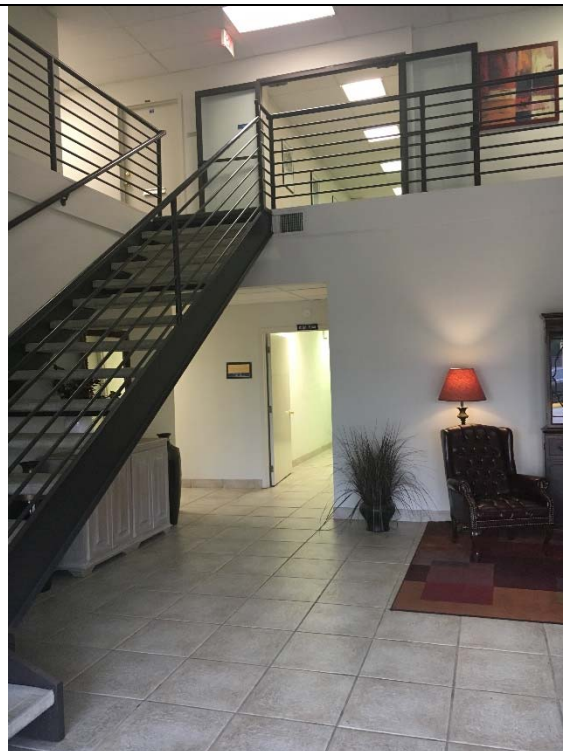
There is no accessible route to the 2nd floor, no elevator is provided in building in common area.

Violation 6 – There is no accessible route to the 2nd floor, no elevator is provided in building.

Add a fully compliant elevator when needed to accommodate an employee if an accommodation can not be made in a more accessible location. Until the elevator is needed, it's a low priority.

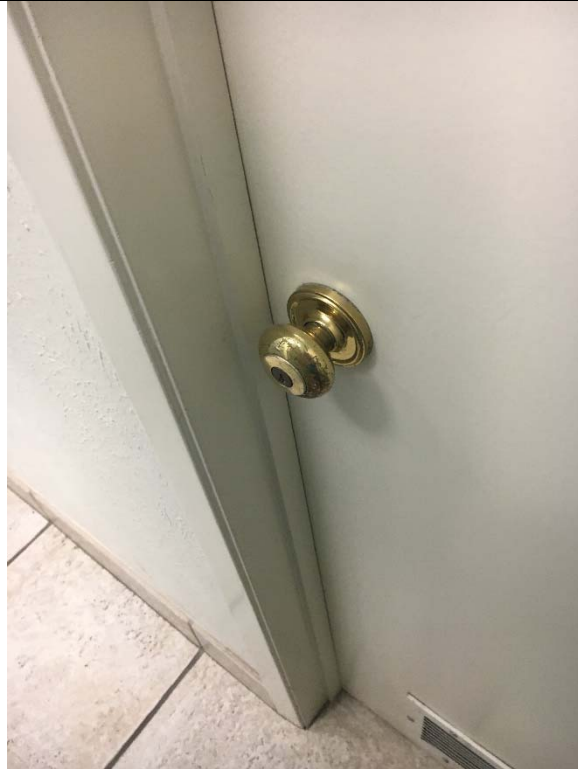
There are approximately 100 doors with knob hardware throughout the facility.

Violation 7 - There are approximately 100 doors with knob hardware throughout the facility.

Replace all knob hardware with lever hardware that doesn't require tight grasping or twisting to operate.

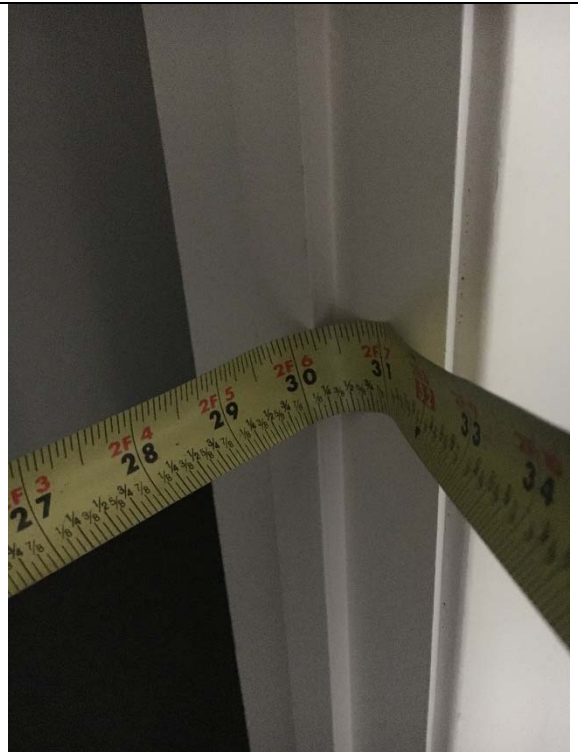
There is one office door on the first floor that has an opening that is less than the required 32" minimum wide.

Violation 8 - There is one office door on the first floor that has an opening that is less than the required 32" minimum wide.

Modify door to provide minimum 32" clear opening.

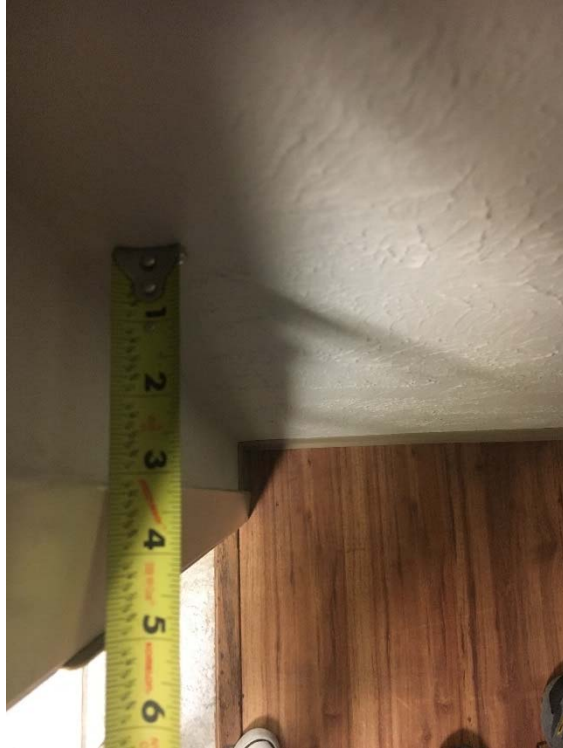
There are 5 office doors on the first floor that does not have the minimum 18" maneuvering clearance on the pull side.

Violation 9 - There are 5 office doors on the first floor that does not have the minimum 18" maneuvering clearance on the pull side.

Modify doo to provide 18" clearance.

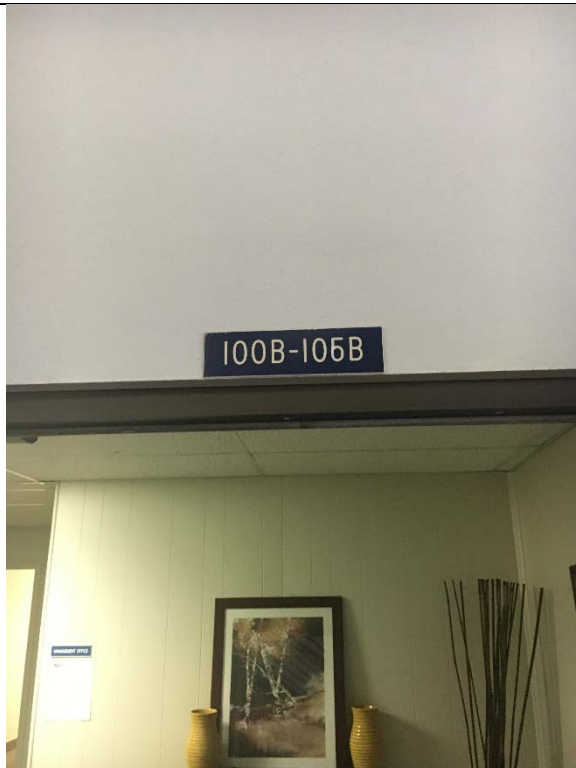
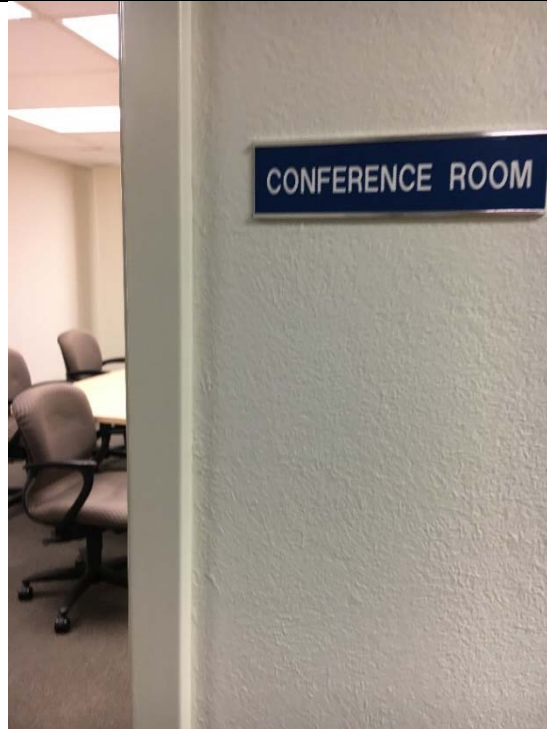
Signage throughout the building which designate permanent spaces is mounted above the door, or in the wrong location and does not have Braille or tactile characters. (approximately 75 signs) to include directional, room identification, restroom signage and tenant signage,

Violation 10 - Signage throughout the building (approximately 75 signs) to include directional, room identification, restroom signage and tenant signage, is mounted above the door, or in the wrong location and does not have Braille or tactile characters.

Install compliant signage on the wall next to the latch side of the door. It shall be no more than 8" from the door frame, and between 48" and 60" high. Ensure signage has both raised texture and Braille.

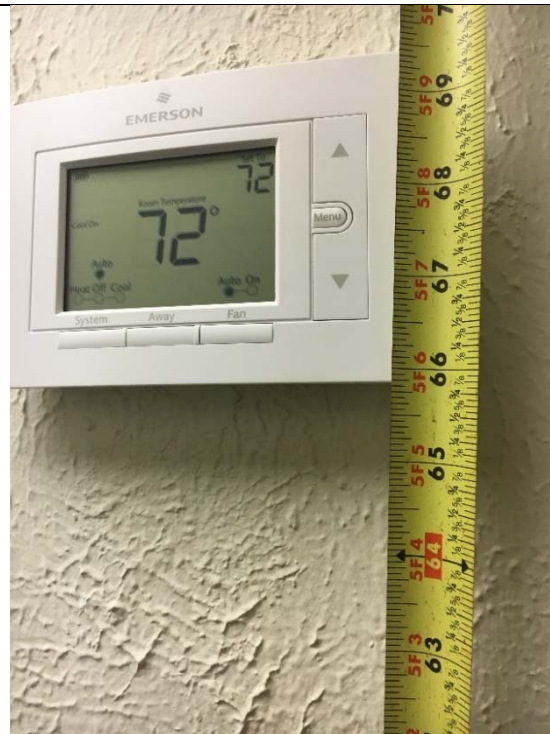
Thermostats throughout the facility are mounted with the highest operable parts between 60"- 68" above finished floor.

Violation 11 - Thermostats throughout the facility are mounted with the highest operable parts between 60" - 68" above finished floor.

Lower thermostats so the highest operable part is at 48" high maximum or lock them from public access.

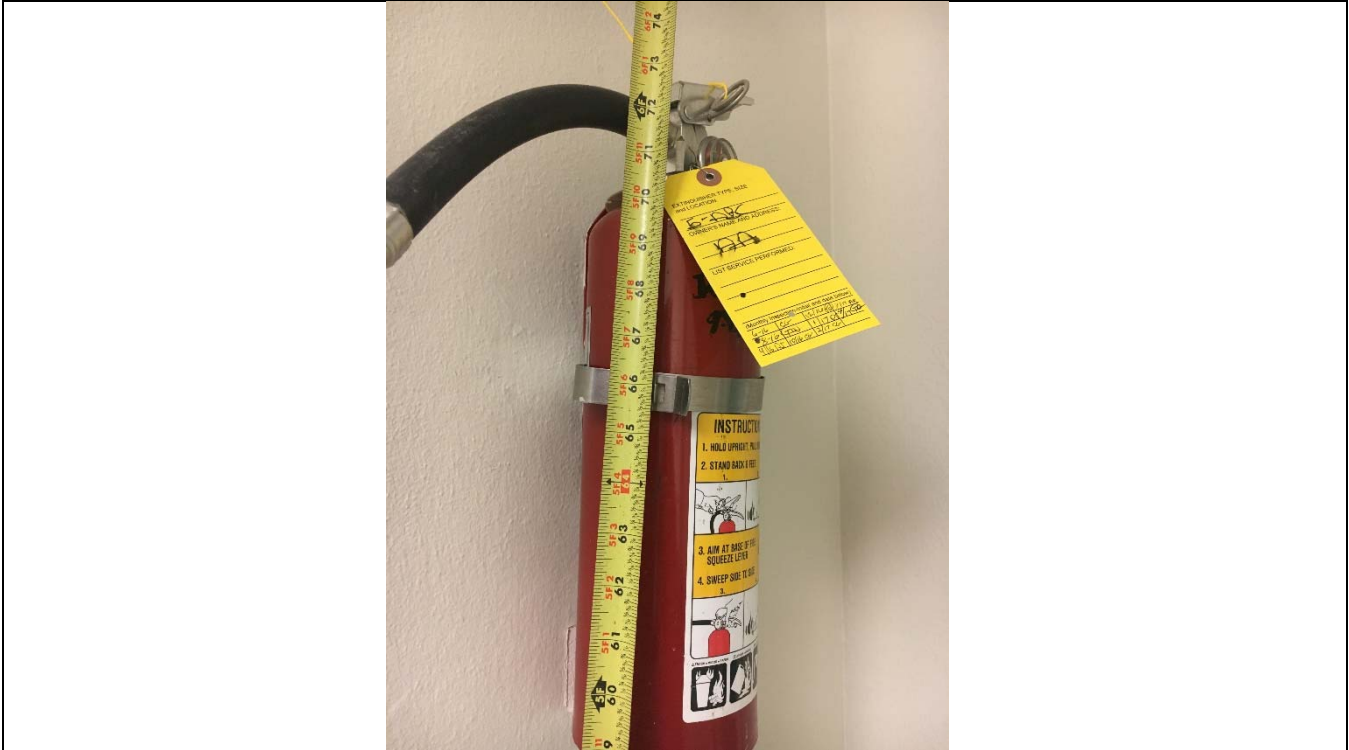
The Fire extinguishers throughout the facility are mounted where the highest operable part is between 63-1/2" to 72" above finished floor.

Violation 12 - The Fire extinguishers throughout the facility are mounted where the highest operable part is between 63-1/2"-72" above finished floor.

Lower fire extinguishers so the highest operable part is at 48" above finished floor.

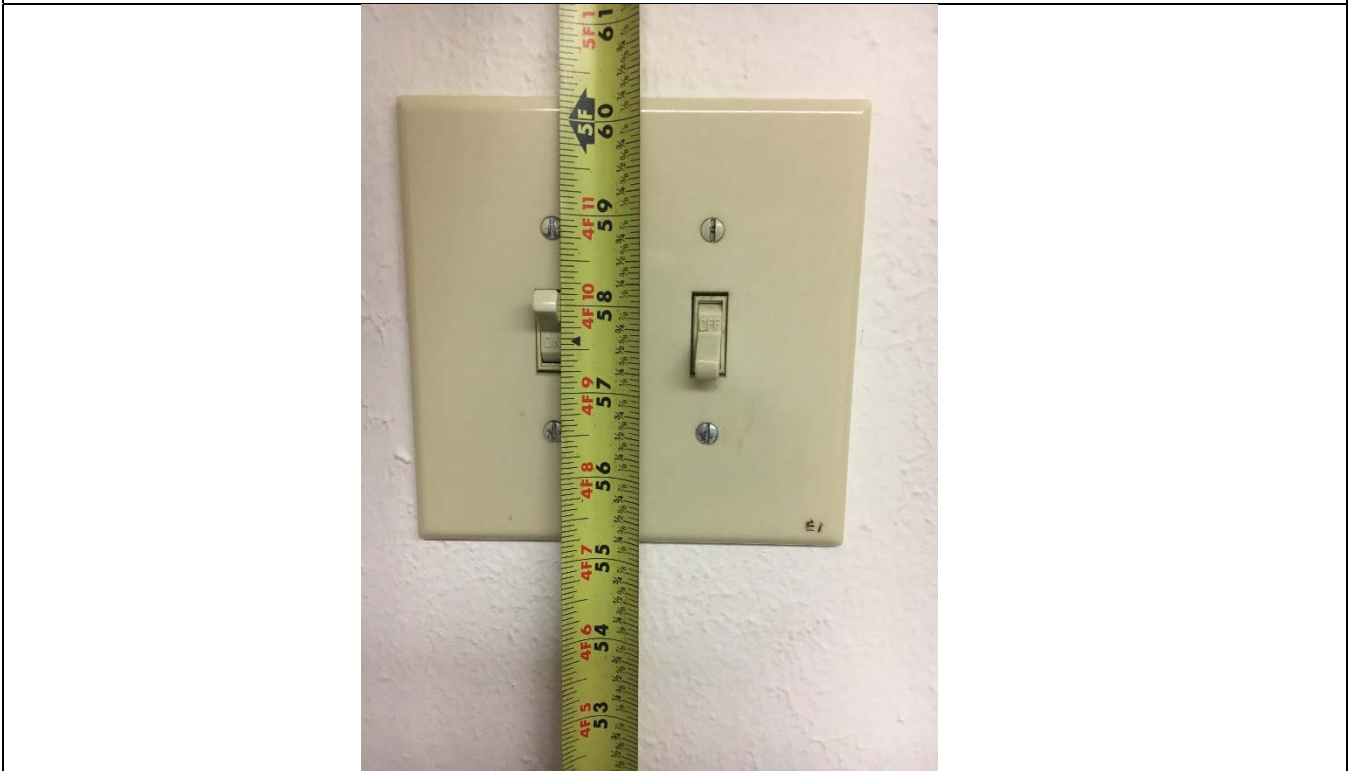
Light switches from 49"-58" above finished floor to the highest operable part.

Violation 13 - Light switches from 49"-58"aff to the highest operable part.

Lower light switches so the highest operable part is at 48" above finished floor.

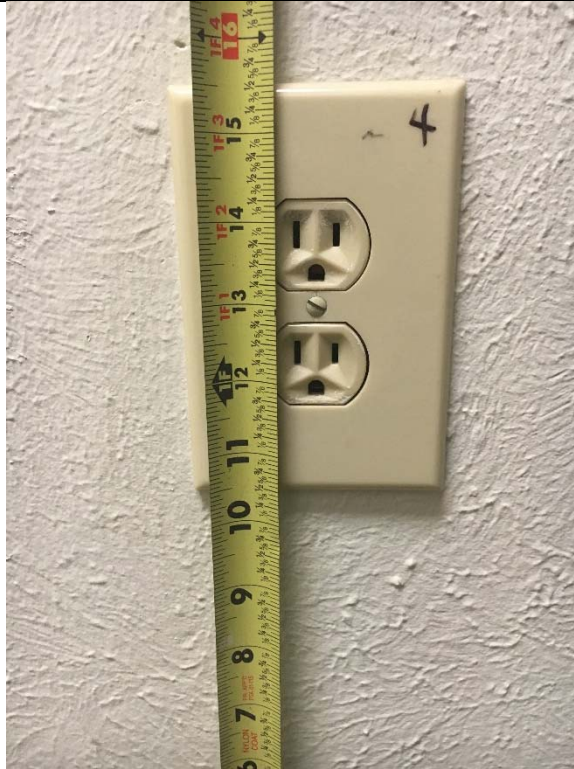
Some outlets in the facility are mounted with the highest operable parts below the minimum requirement of 15" above finished floor.

Violation 14 - Some outlets in the facility are mounted with the highest operable parts below the minimum requirement of 15" above finished floor.

Remount outlets so they are a minimum of 15" above finished floor to the lowest operable part.

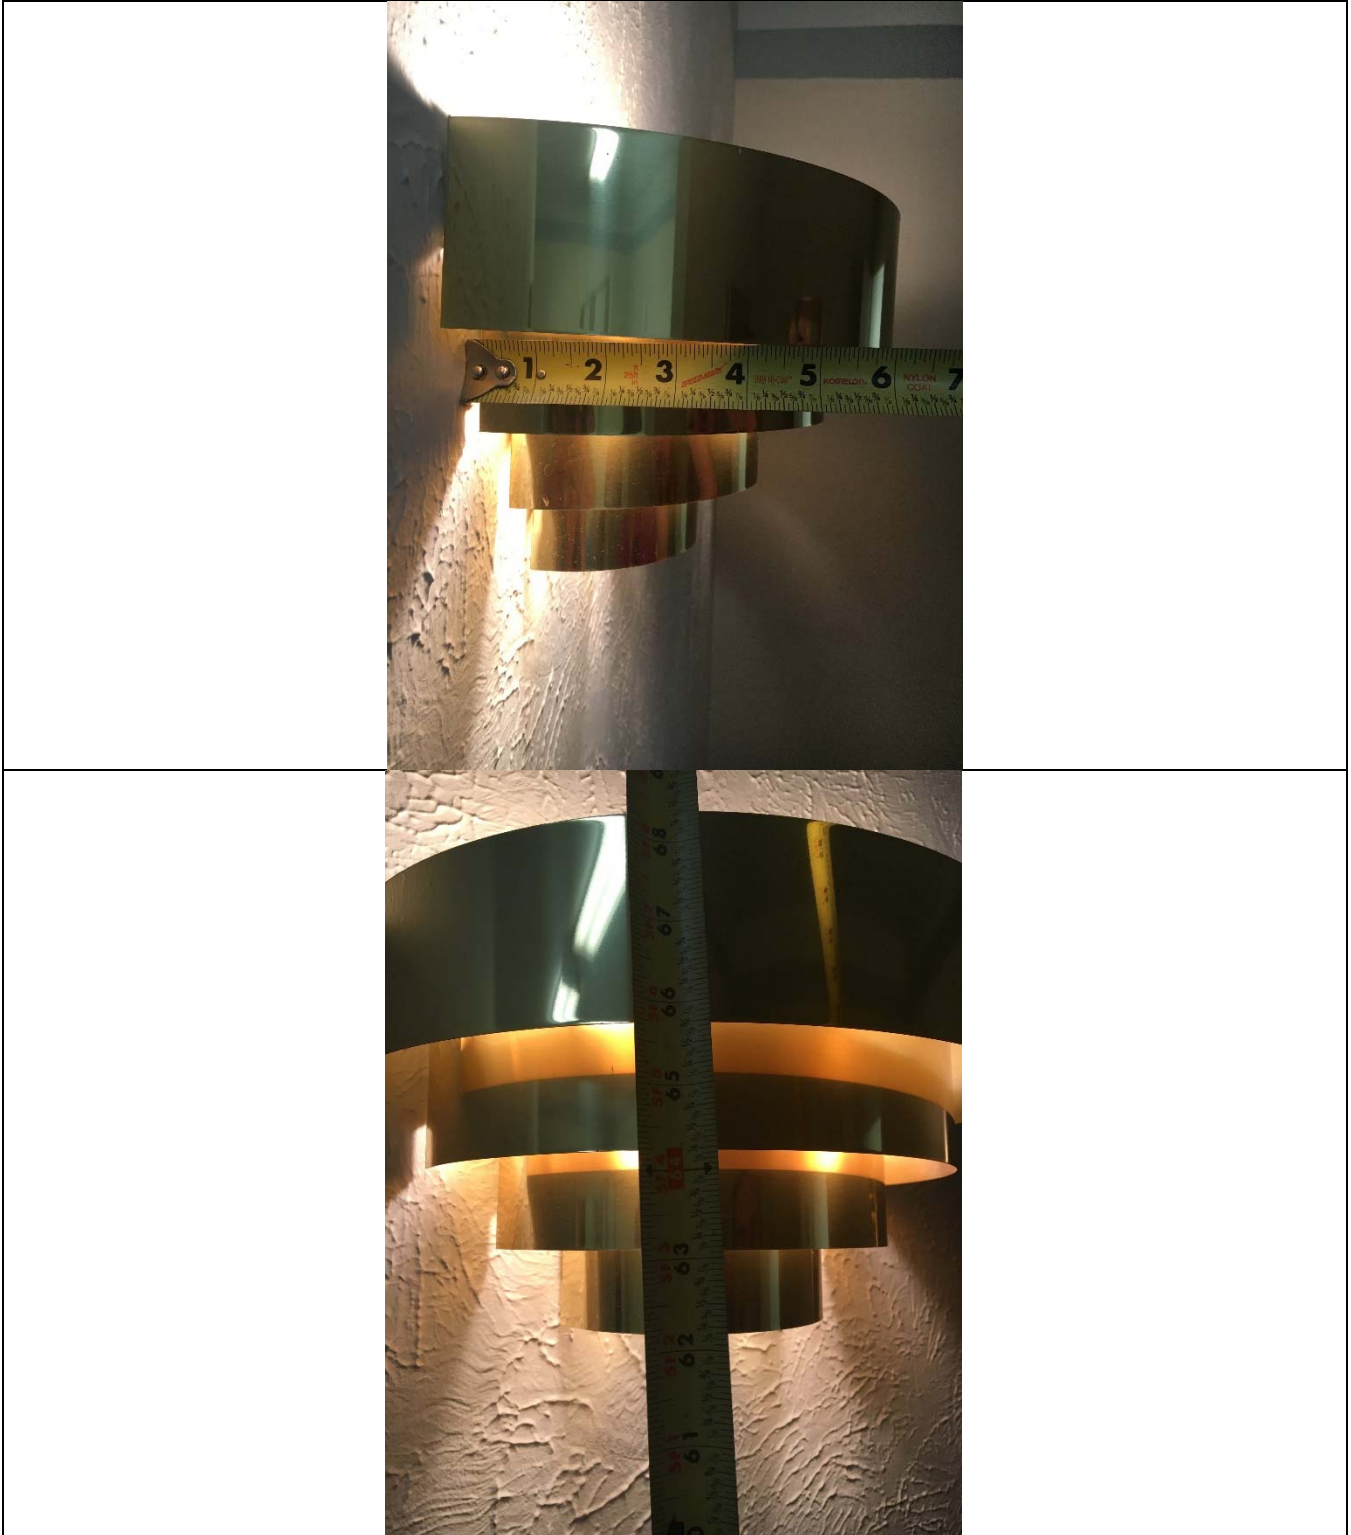
Violation 15 - There is a light fixture in the hallway that protrudes 6" into the path of travel at 62-3/16" above finished floor.

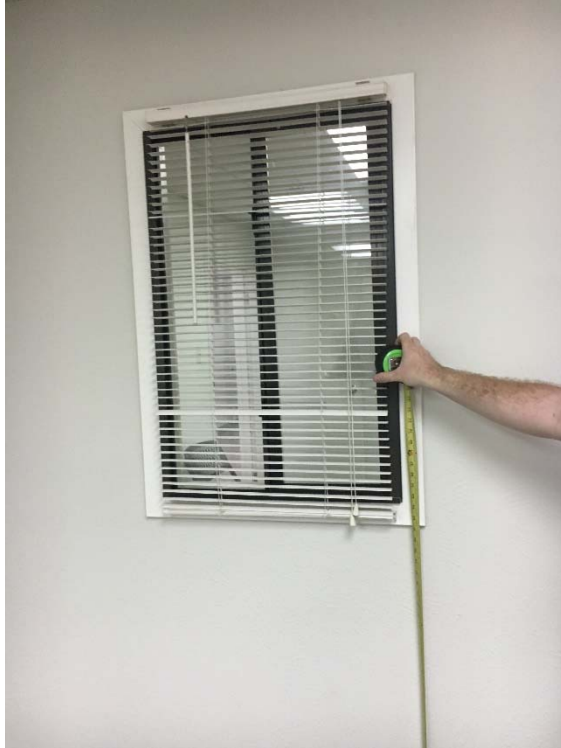
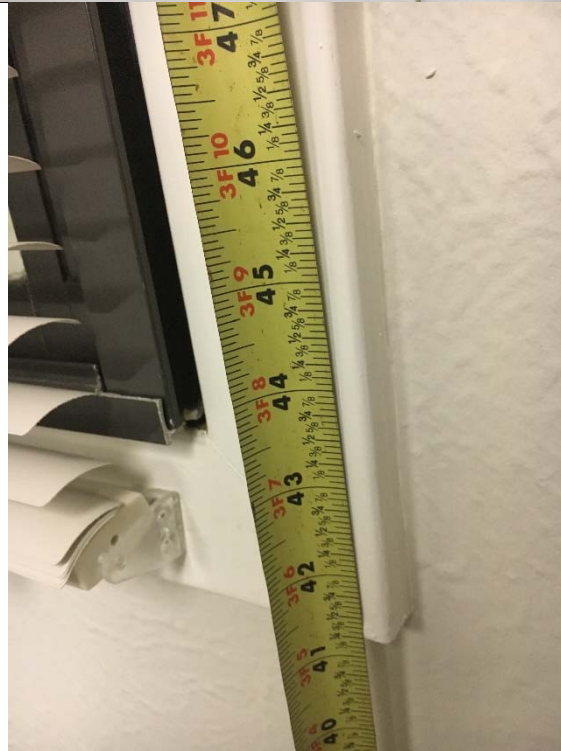
Violation 16 - There is a transaction window in Room 203 that measures 43-3/4" above finished floor.

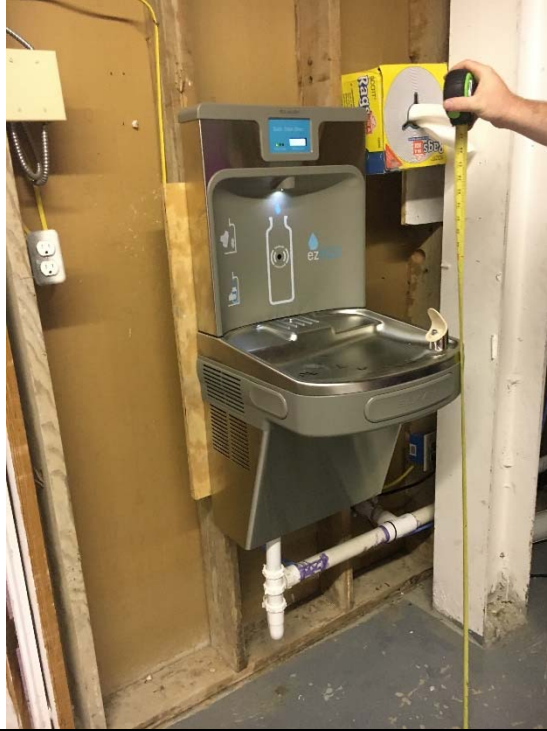
Violation 17 - The drinking fountain provided in the maintenance area has a spout at 42" above finished floor with no accessible fountain. Additionally, the operable portion of the bottle fill portion of the drinking fountain is mounted at 53-1/3" above finished floor.

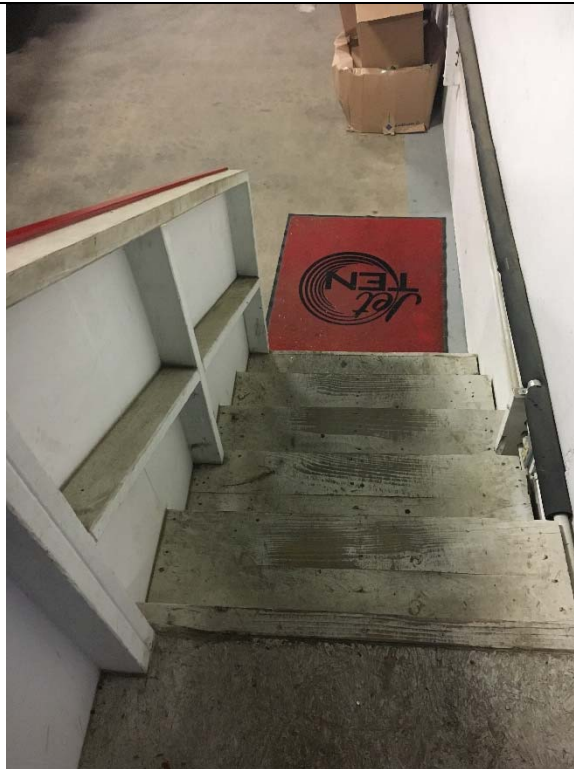
Violation 18 - There is no access to the warehouse, stairs only are provided.

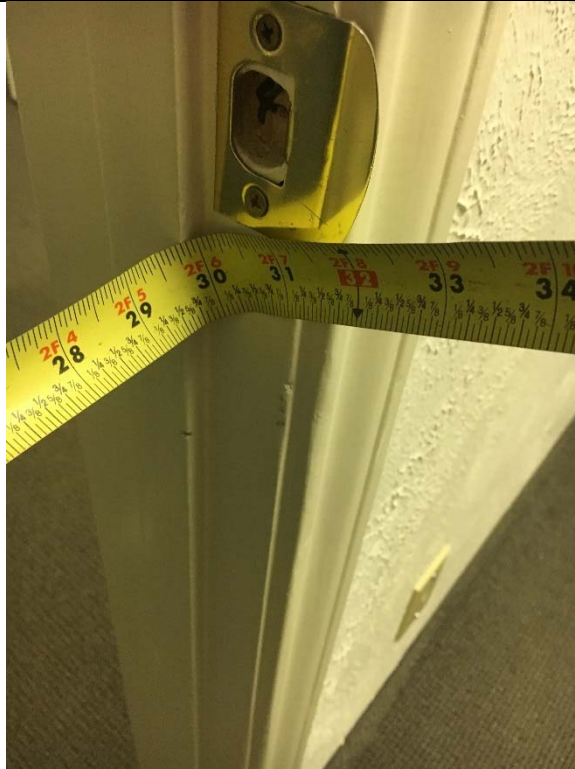
Violation 19 - There are 2 office doors on the 2nd floor that have openings that are less than the required 32" minimum wide.

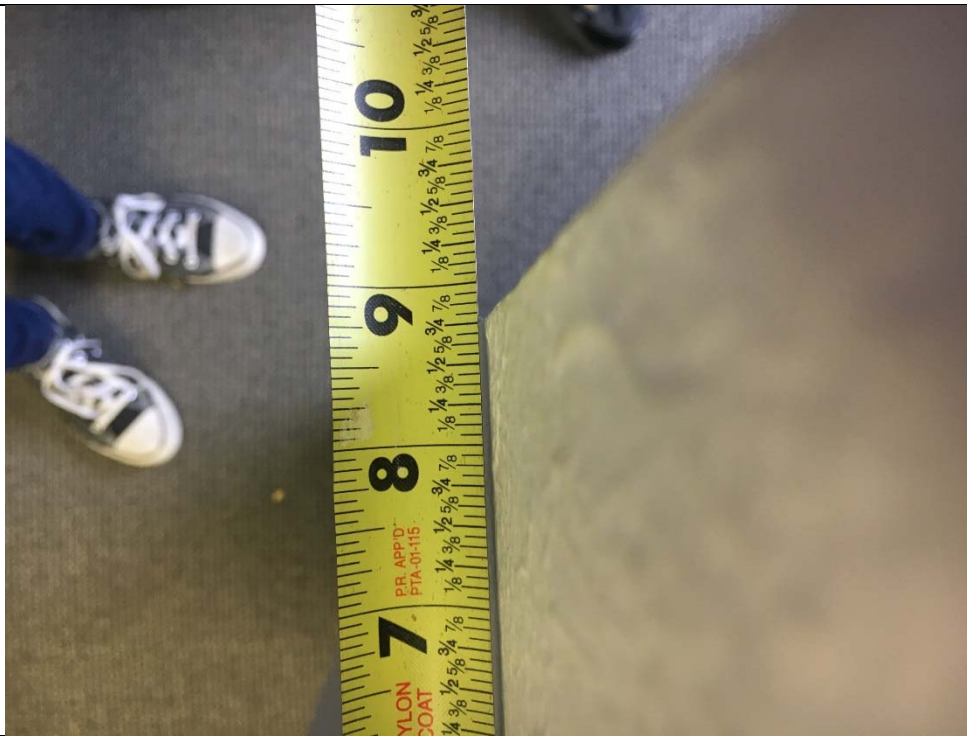
Violation 20 - There is one office door on the 2nd floor that does not have the minimum 18" maneuvering clearance on the pull side.

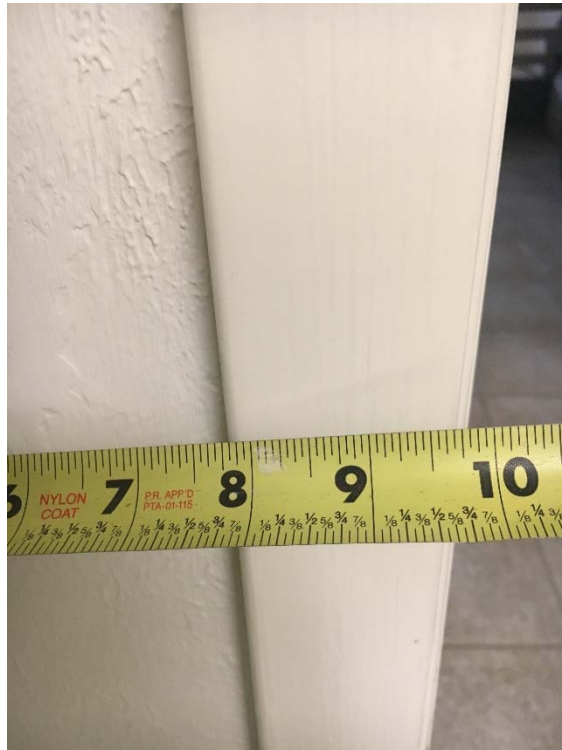
Violation #21: The door leading from the main hallway into the lobby on the first floor does not have the minimum 18" maneuvering clearance on the pull side of the door.

Violation 21 - The door leading from the main hallway into the lobby on the first floor does not have the minimum 18" maneuvering clearance on the pull side of the door.

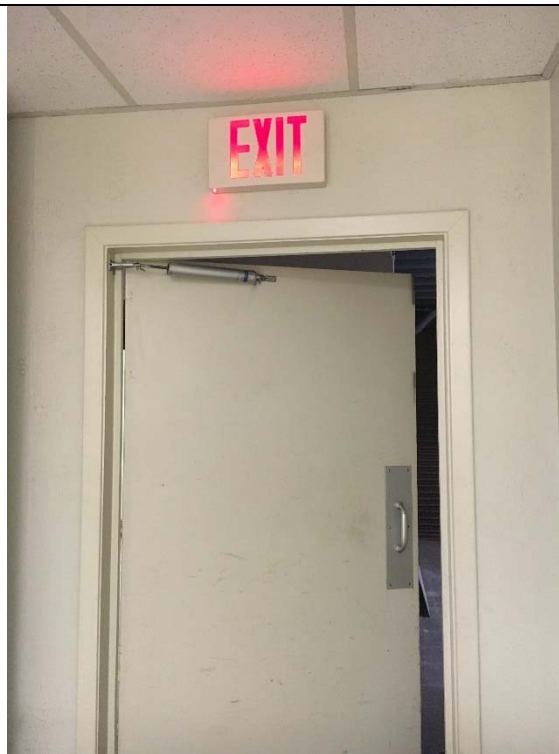
Violation #22: The exit door leading into the maintenance area does not have a minimum 18" maneuvering clearance on the pull side.

Violation 22 - The exit door leading into the maintenance area does not have a minimum 18" maneuvering clearance on the pull side.

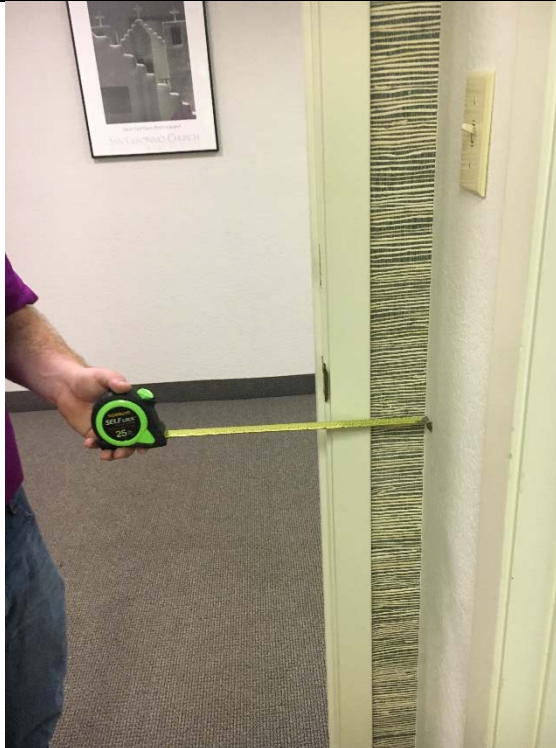
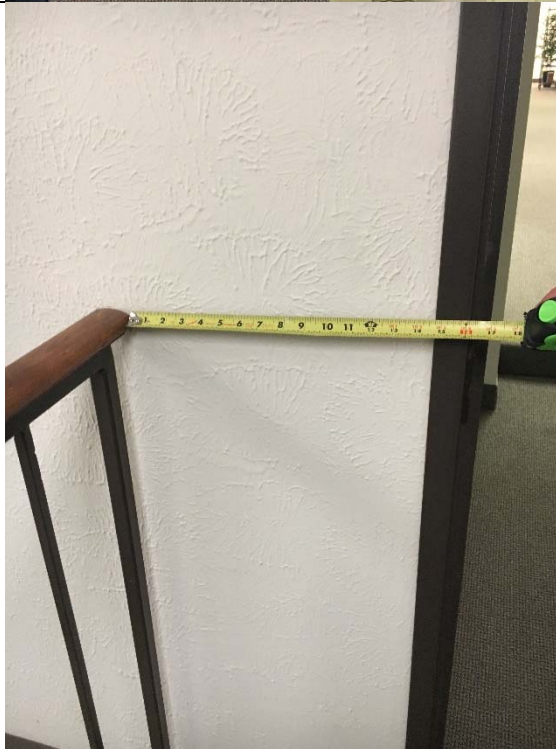
Violation 23 - The door leading from the main hallway into the lobby on the 2nd floor as well as the door on the 2nd floor that connects 4308 with 4310 do not have the minimum 18" maneuvering clearance on the pull side of the door.

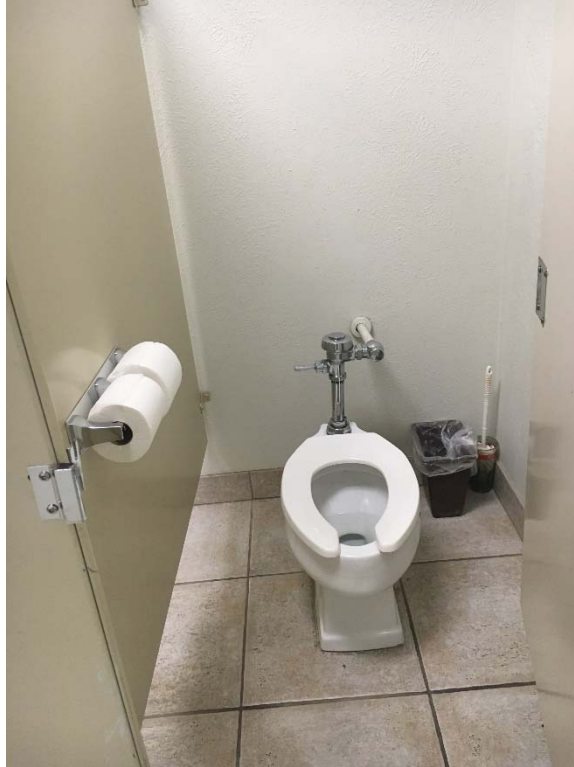
Violation 24 - Women's Restroom first floor of 4310 - Does not have an accessible stall provided.

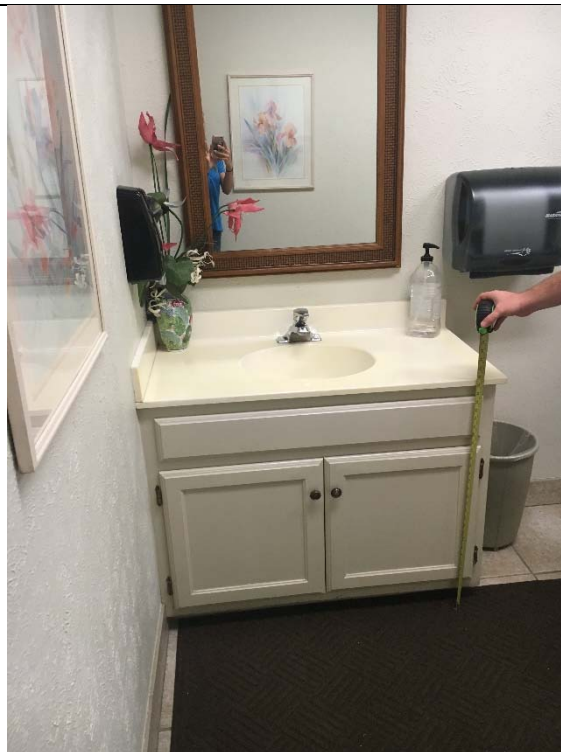
Violation 25 - Women's Restroom first floor of 4310 - There is a cabinet beneath the lavatory blocking the required knee clearance.

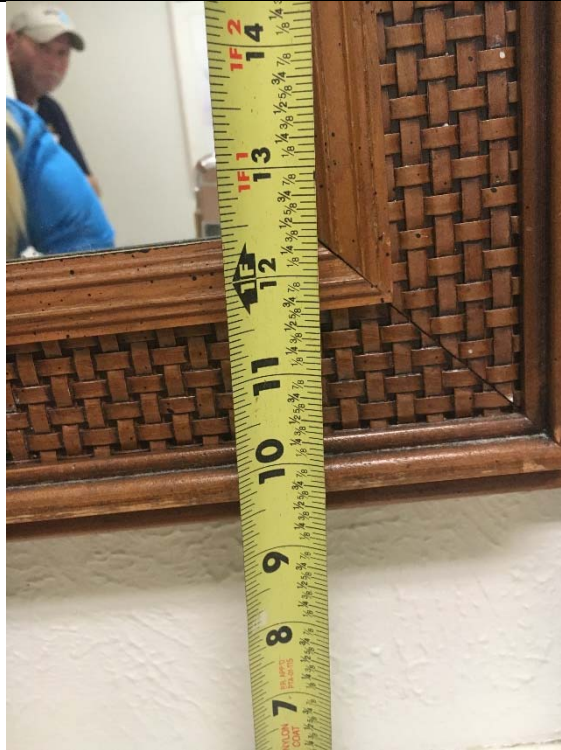
Violation 26 - Women's Restroom first floor of 4310 - The mirror is mounted at 43" above finished floor.

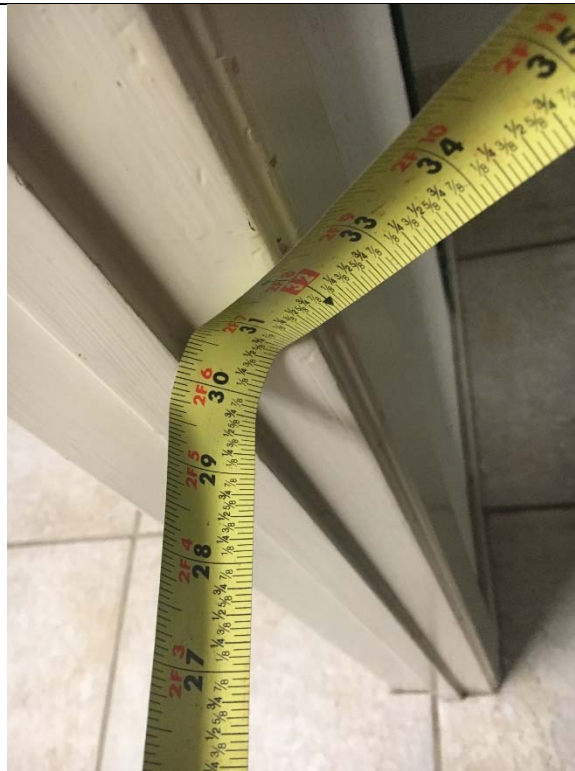
Violation 27 - Men's Restroom first floor of 4310 - Entrance door is only 31" wide.

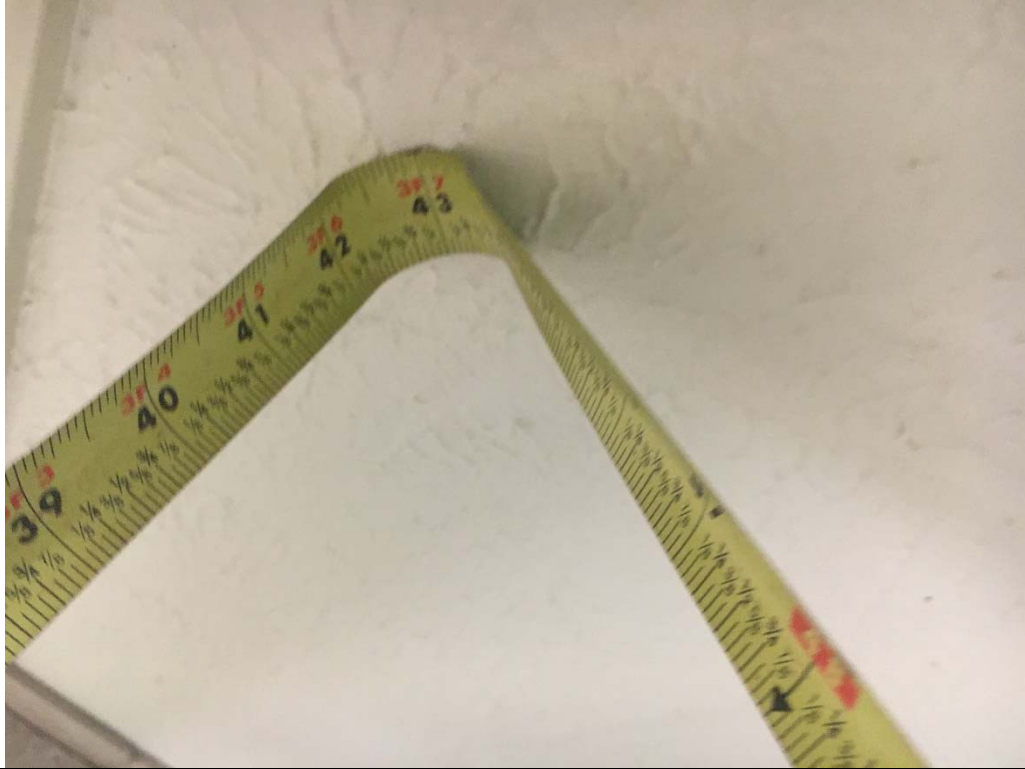
Violation 28 - Men's Restroom first floor of 4310 - Entrance door maneuvering clearance is only 43" deep on the pull side where a 48" deep maneuvering clearance is required.

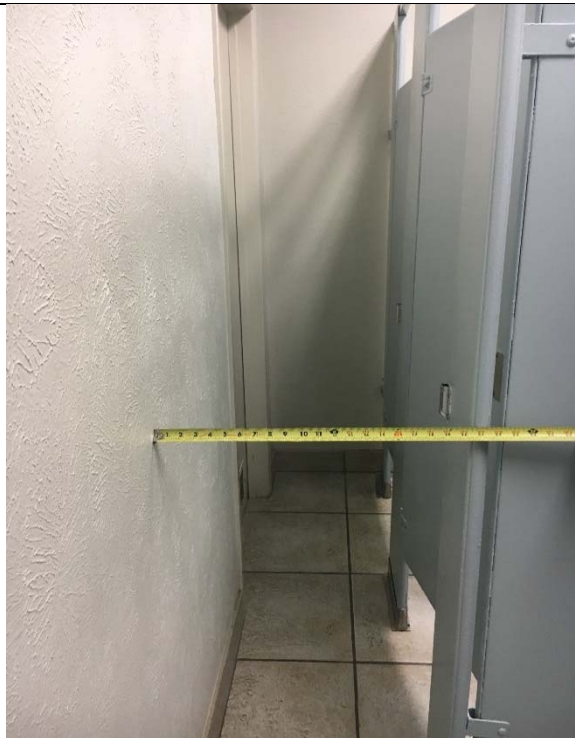
Violation 29 - Men's Restroom first floor on 4310 - The path leading to the stalls is only 20-1/2" wide.

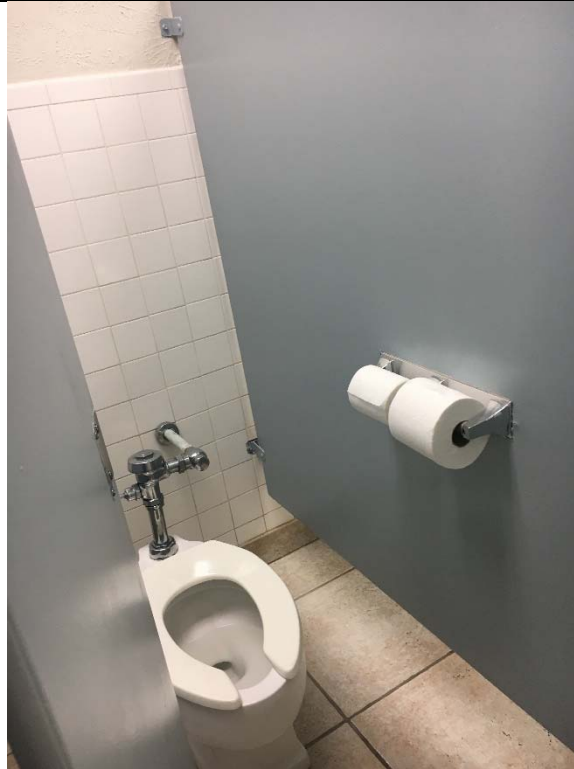
Violation 30 - Men's Restroom first floor of 4310 - Does not have an accessible stall provided.

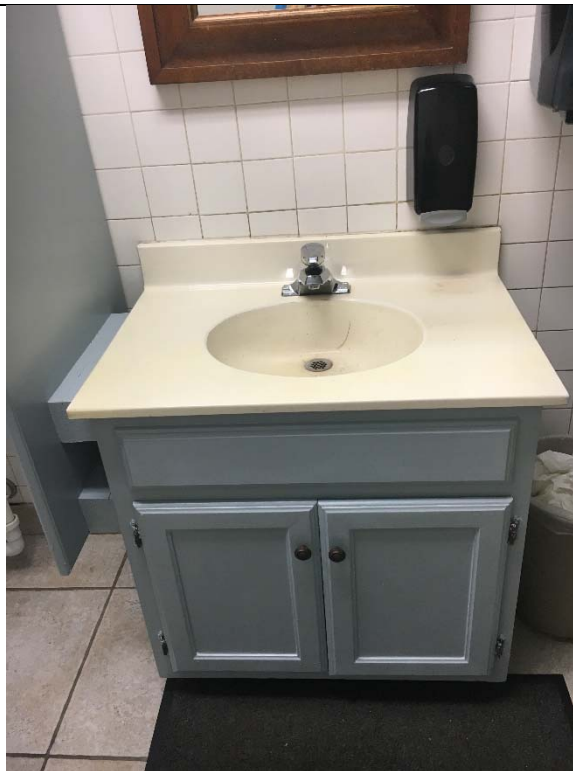
Violation 31 - Men's Restroom first floor of 4310 - There is a cabinet beneath the lavatory blocking the required knee clearance.

Replace the lavatory with one that provides the required knee and toe clearance for a forward approach.

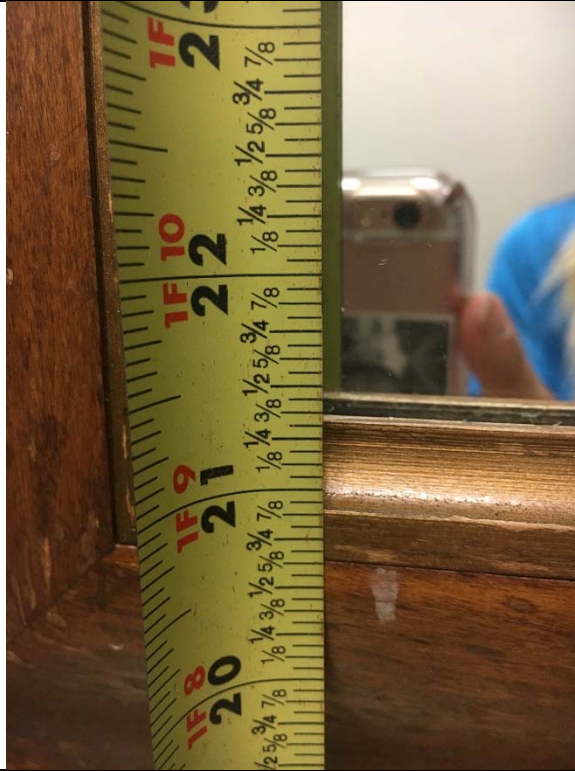
Violation #32: Men's Restroom first floor of 4310 - The mirror is mounted at 53" above finished floor.

Violation 32 - Men's Restroom first floor of 4310 - The mirror is mounted at 53" above finished floor.

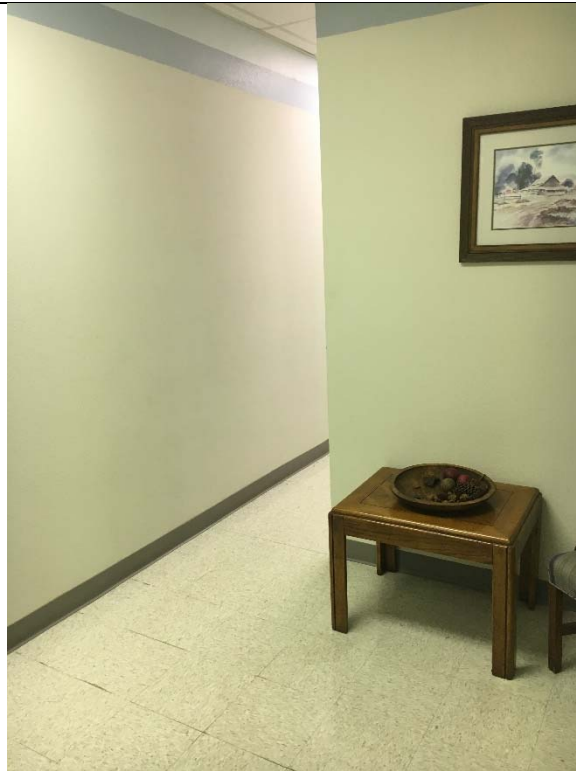
Violation #33: Women's Restroom second floor of 4310 - The opening leading into the restroom is only 30" wide.

Violation 33 - Women's Restroom second floor of 4310 - The opening leading into the restroom is only 30" wide.

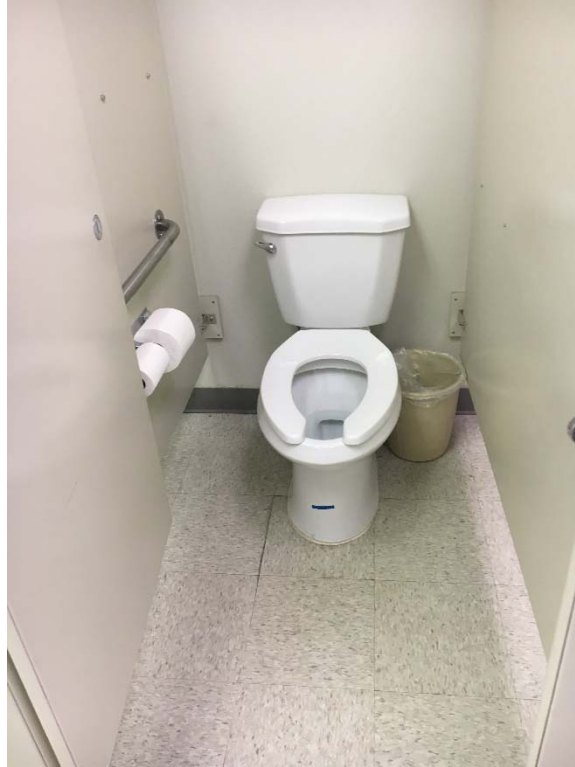
Violation #34: Women's Restroom second floor of 4310 - Does not have an accessible toilet compartment provided.

Violation 34 - Women's Restroom second floor of 4310 - Does not have an accessible stall provided.
