**TOWN OF ADDISON
BUILDING REPORT**

Facility Name: Wiley Post Office Building

Date: April 10, 2017

Address: 4308 & 4310 Wiley Post Road

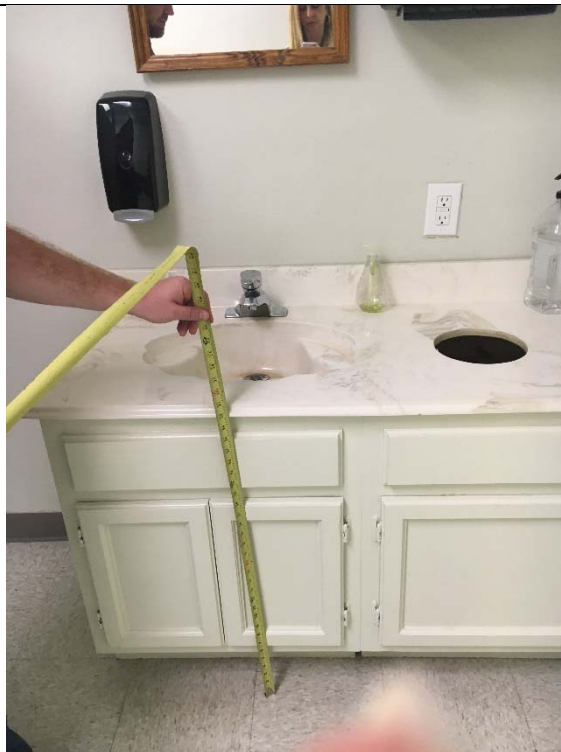
Violation 35 - Women's Restroom second floor 4310 - There is a cabinet beneath the lavatory blocking the required knee clearance.

Replace the lavatory with one that provides the required knee and toe clearance for a forward approach.

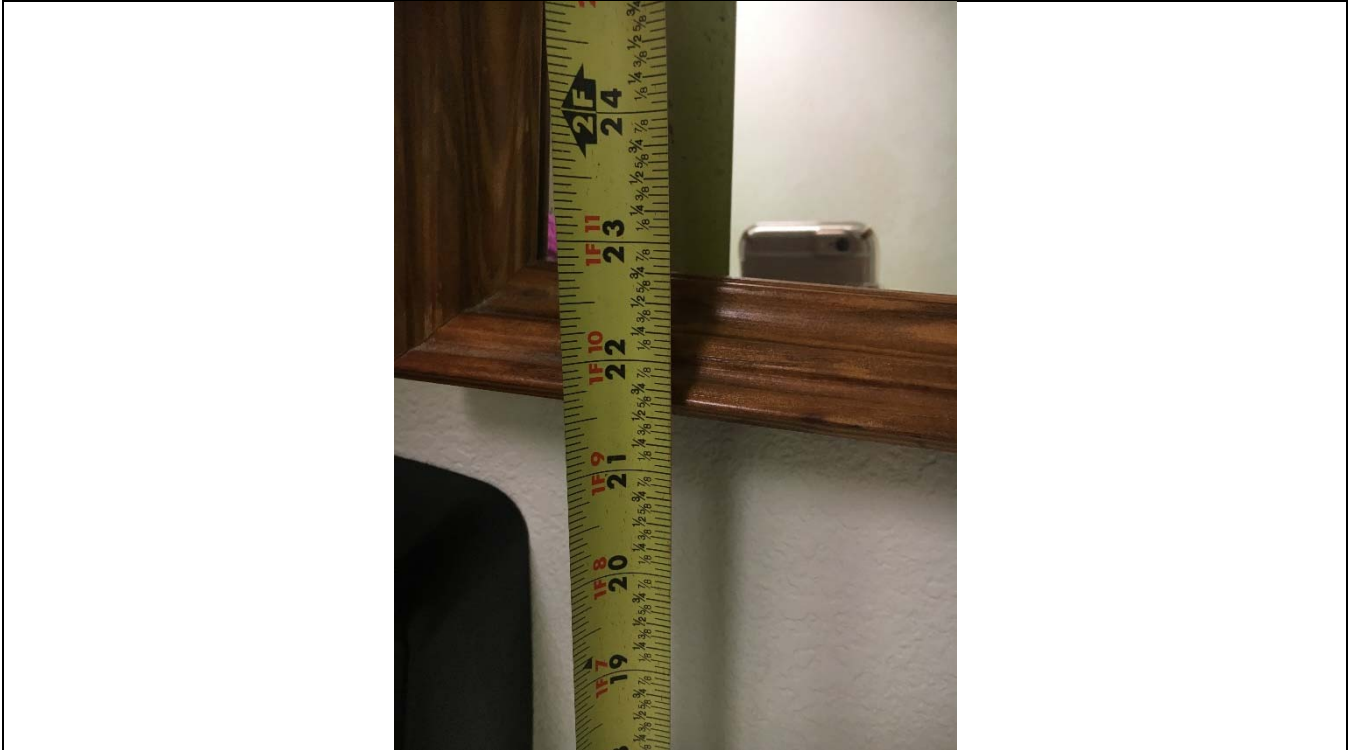
Violation 36 - Women's Restroom second floor of 4310 - The mirror is mounted at 52" above finished floor.

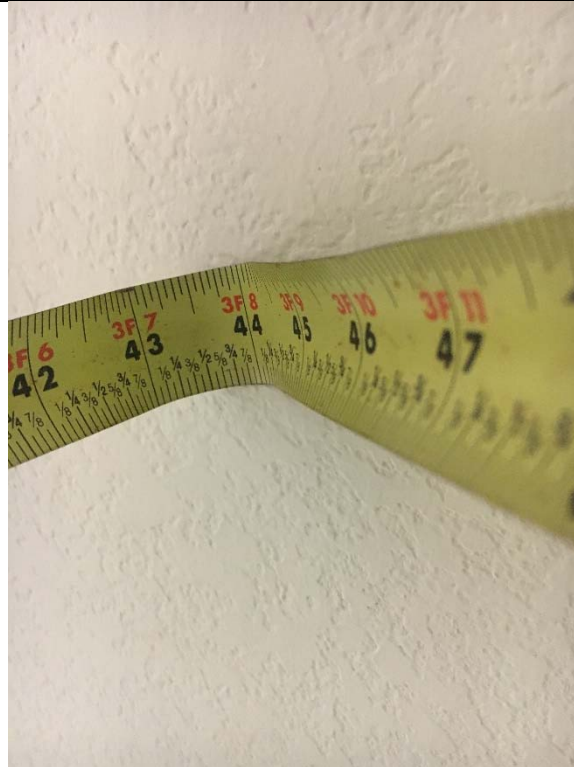
Violation 37 - Men's Restroom second floor of 4310 - The maneuvering clearance on pull side of the door is only 44" deep.

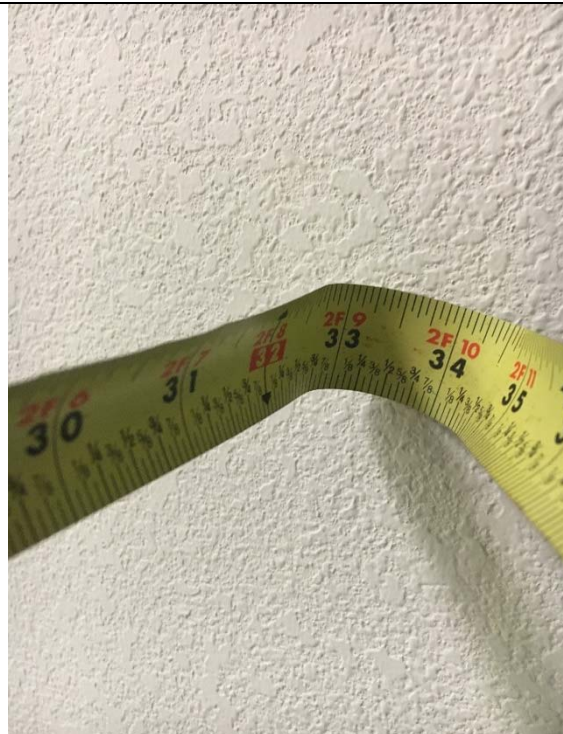
Violation 38 - Men's Restroom second floor of 4310 - The opening leading into the restroom is only 33-1/2" wide.

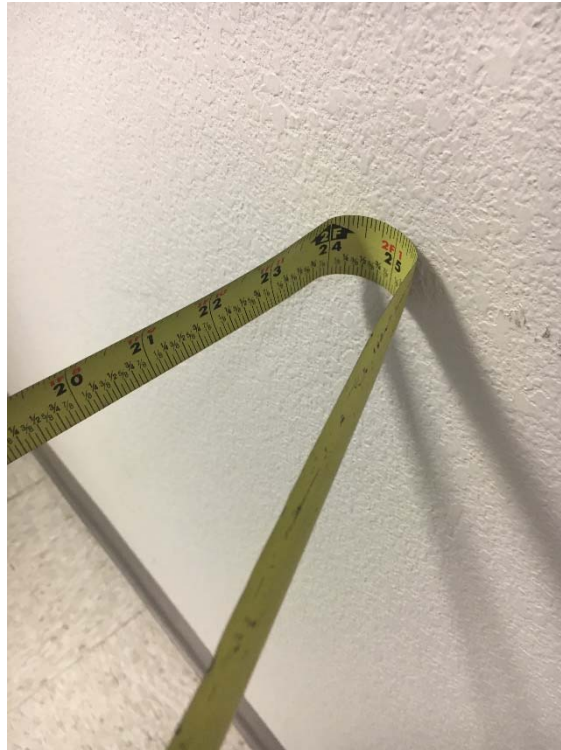
Violation 39 - Men's Restroom second floor of 4310 - The path leading to the stalls is only 25" wide between the stalls and the wall.

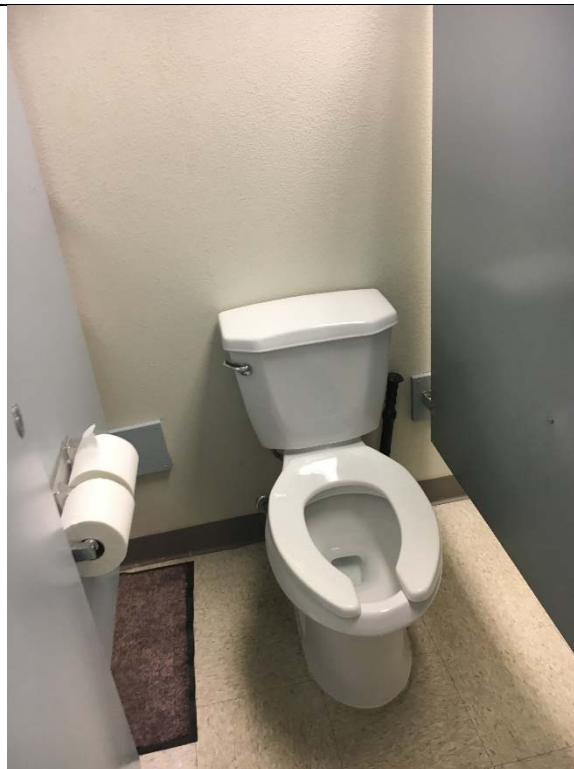
Violation 40 - Men's Restroom second floor of 4310 - Does not have an accessible stall provided.

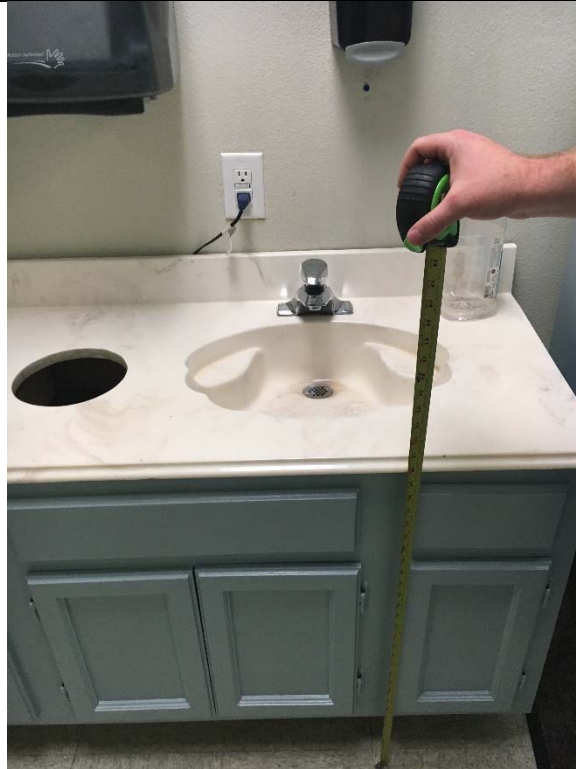
Violation 41 - Men's Restroom second floor of 4310 - There is a cabinet beneath the lavatory blocking the required knee clearance.

Replace the lavatory with one that provides the required knee and toe clearance for a forward approach.

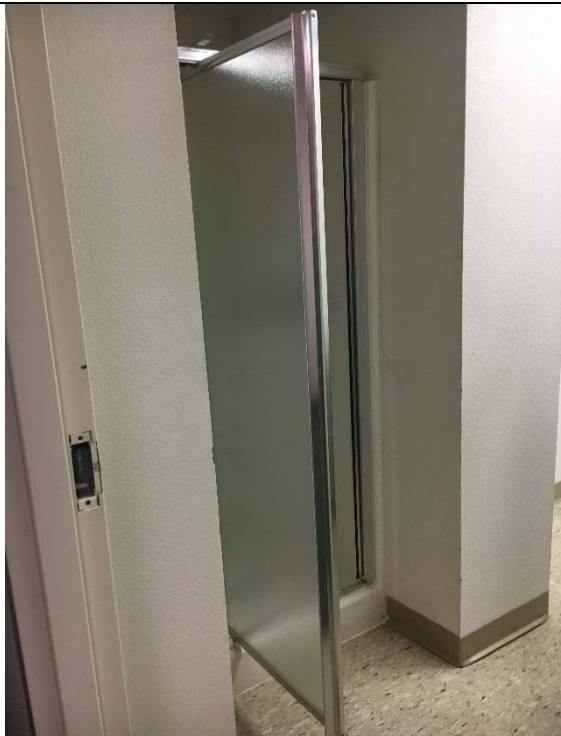
Violation 42 - There is a shower provided in the shower room on the 4310 side on the 2nd floor that has no compliant features.

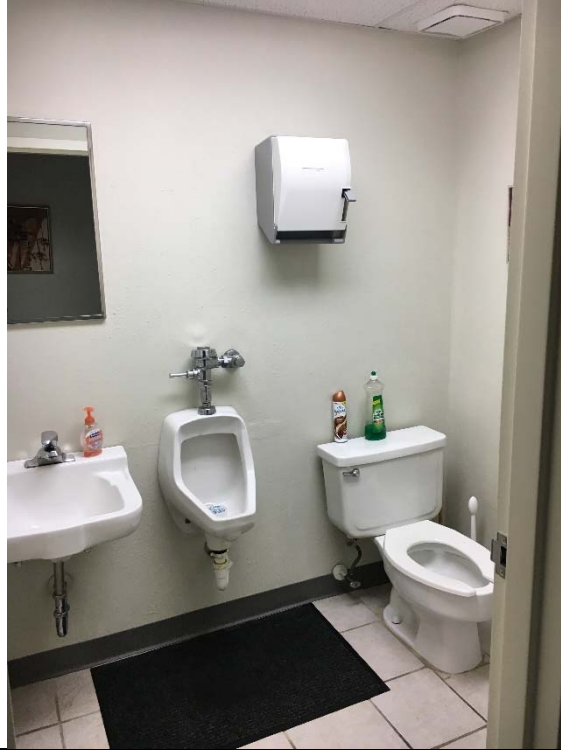
Violation 43 - Men's Restroom first floor of 4308 - Toilet room is not large enough to accommodate a wheelchair turning space.

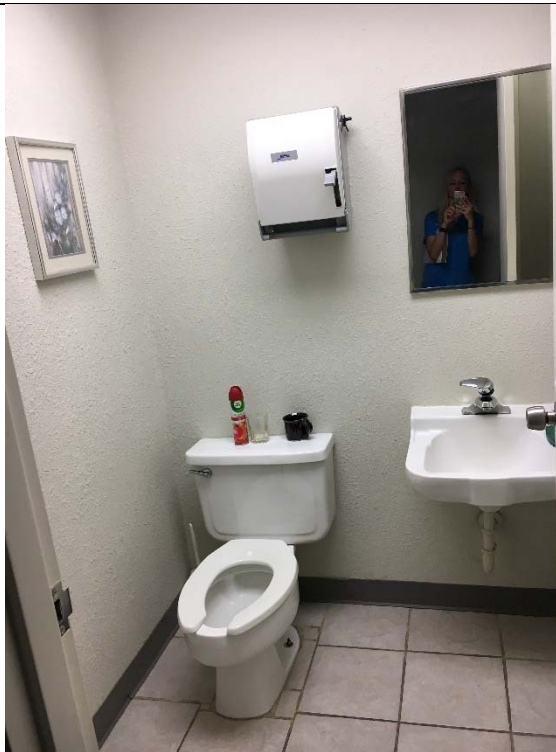
Violation 44 - Women's Restroom first floor of 4308 - Toilet room is not large enough to accommodate a wheelchair turning space.

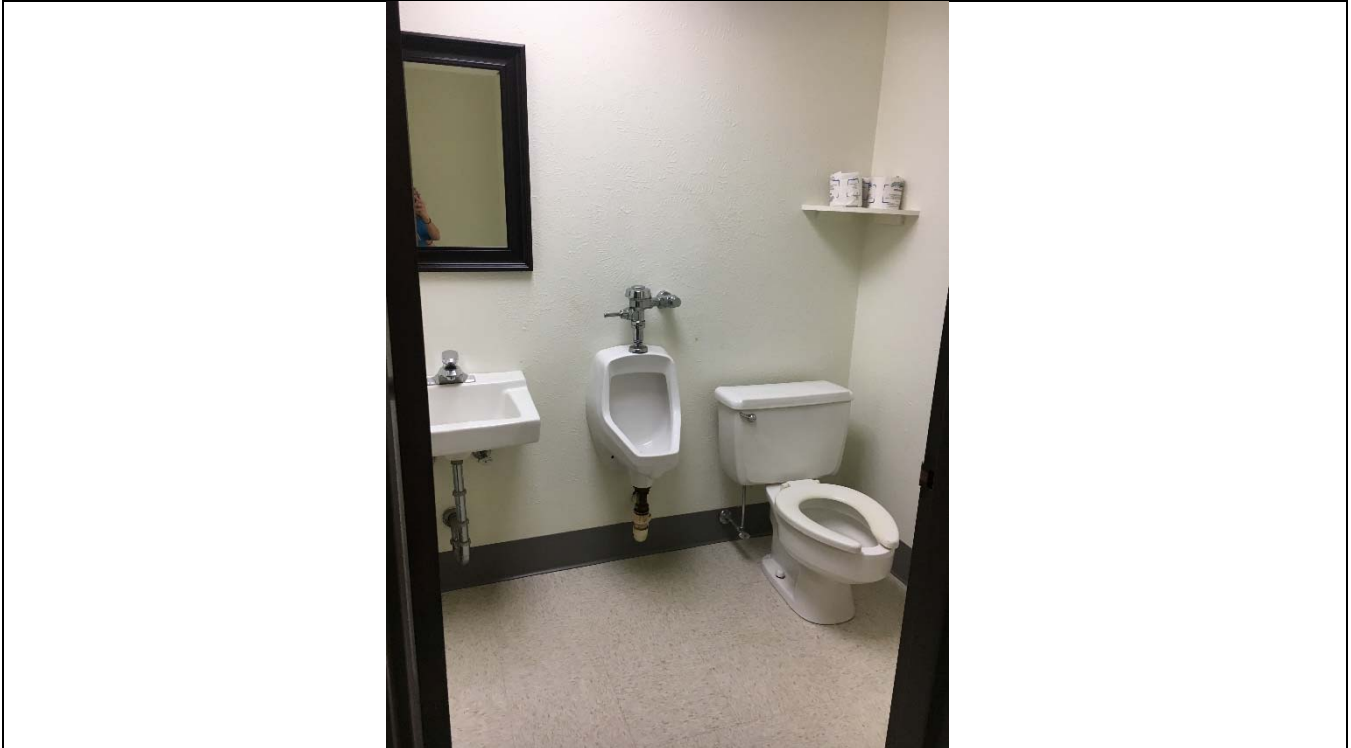
Violation 45 - Men's Restroom second floor of 4308 - Toilet room is not large enough to accommodate a wheelchair turning space.

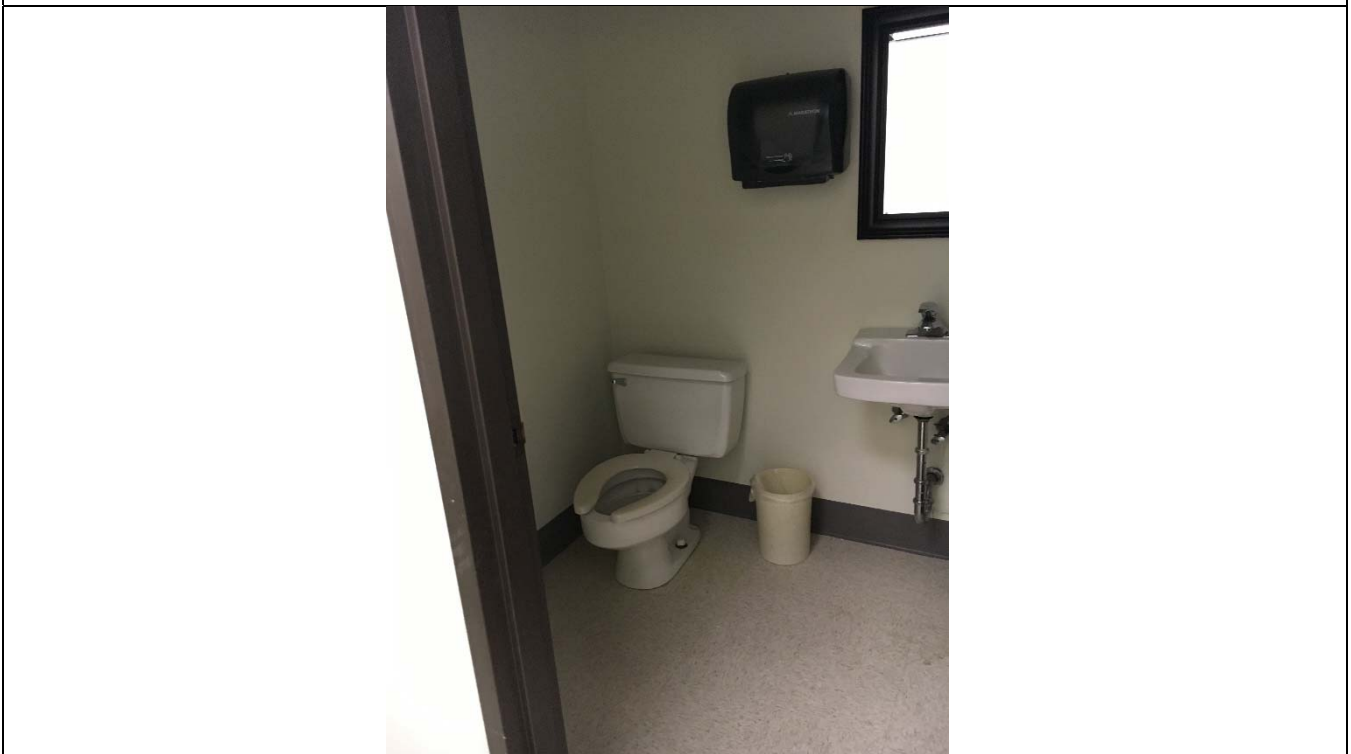
Violation 46 - Women's Restroom second floor of 4308 - Toilet room is not large enough to accommodate a wheelchair turning space.

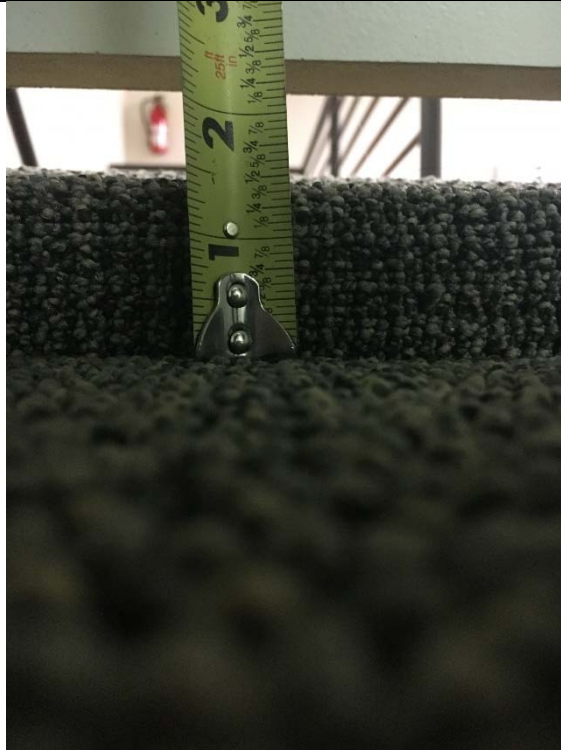
Violation #47: There is a change in level greater than 1/2" leading to the break room from the office and from the hallway.

Violation 47 - There is a change in level greater than 1/2" leading to the break room from the office and from the hallway.

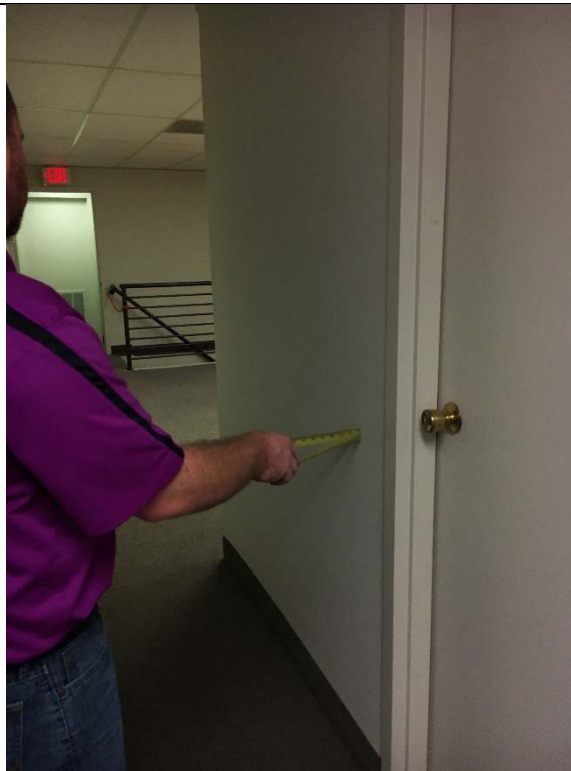
Violation #48: The hallway leading into the breakroom is only 33" wide.

Violation 48 - The hallway leading into the breakroom is only 33" wide.

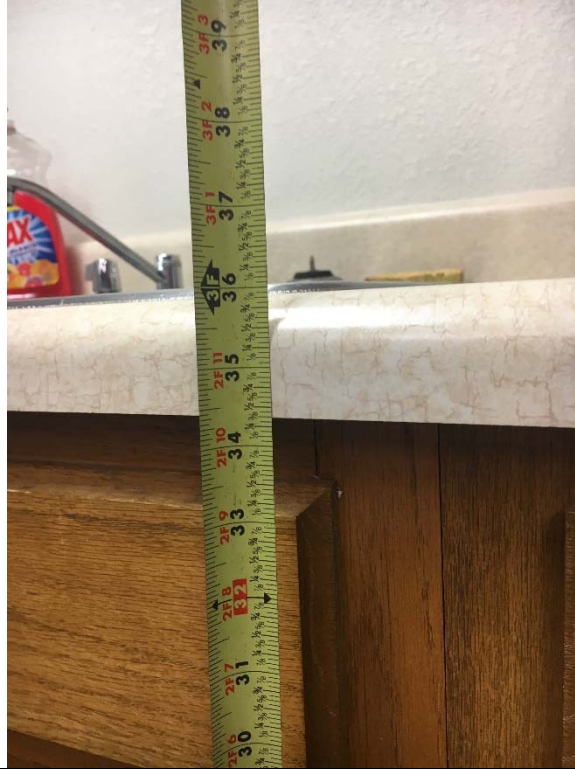
Violation #49: The counter in the break room is 36" above finished floor to the top of the counter at the sink where a maximum of 34" is required.

Violation 49 - The counter in the break room is 36" above finished floor to the top of the counter at the sink where a maximum of 34" is required.
