**TOWN OF ADDISON  
BUILDING REPORT**

**Facility Information:** **Facility Name:** Athletic Club  
**Facility Contact:** Lisa Pyles **Contact Phone:** 972-450-2878

**Accessology Inspector Information:**  
**Inspector:** Karen Jackson **Date:** April 25, 2017  
**Email:** Kjackson@accessology.com

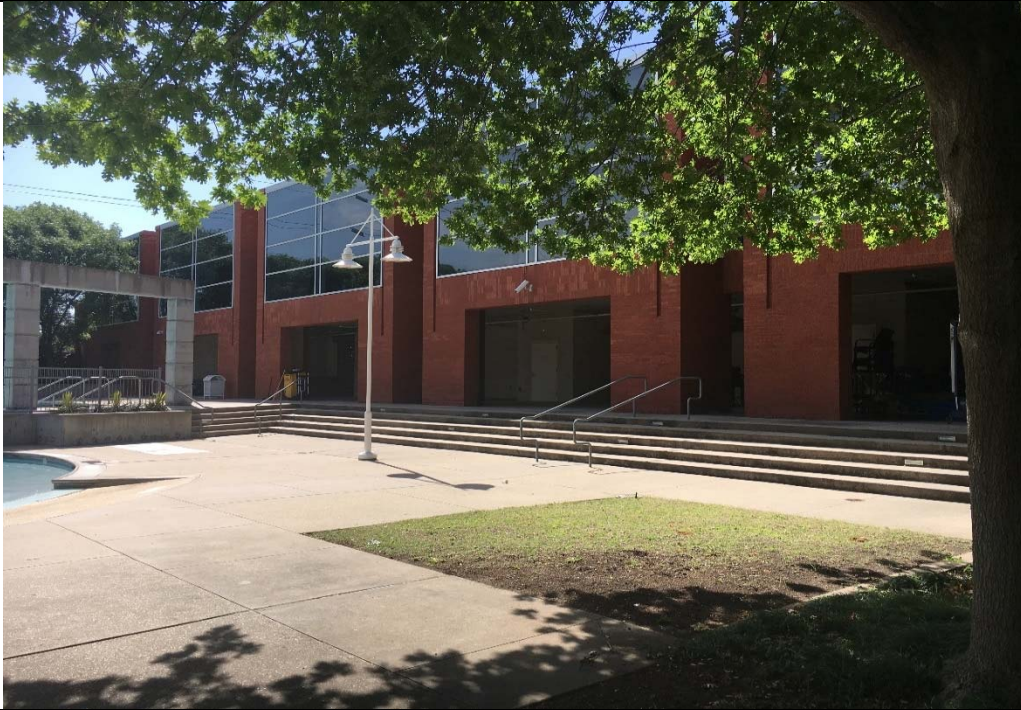
**Violation 2** - The ramp leading to the exterior upper pool area and the exterior restrooms has a 5.4% running slope with no handrails.

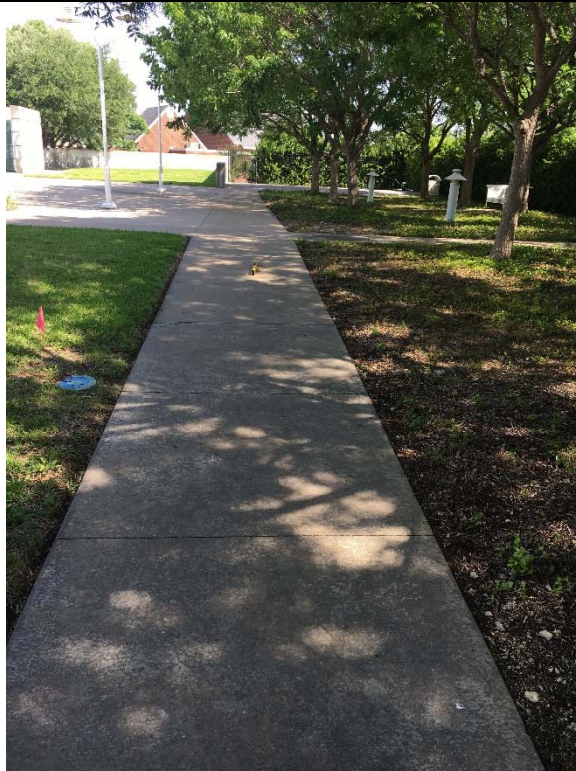
**Violation 3** - There is no signage provided at the outside pool area to direct people to the accessible route to the upper pool area.

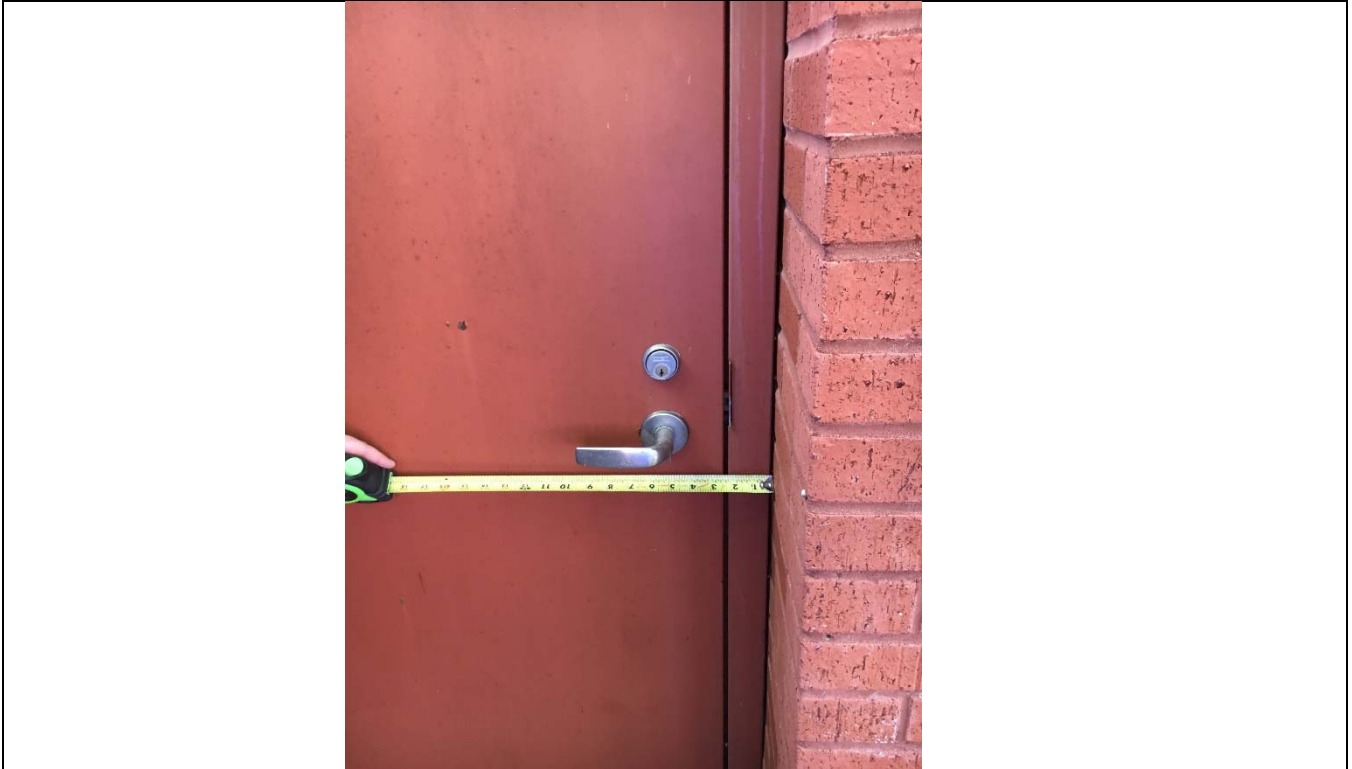
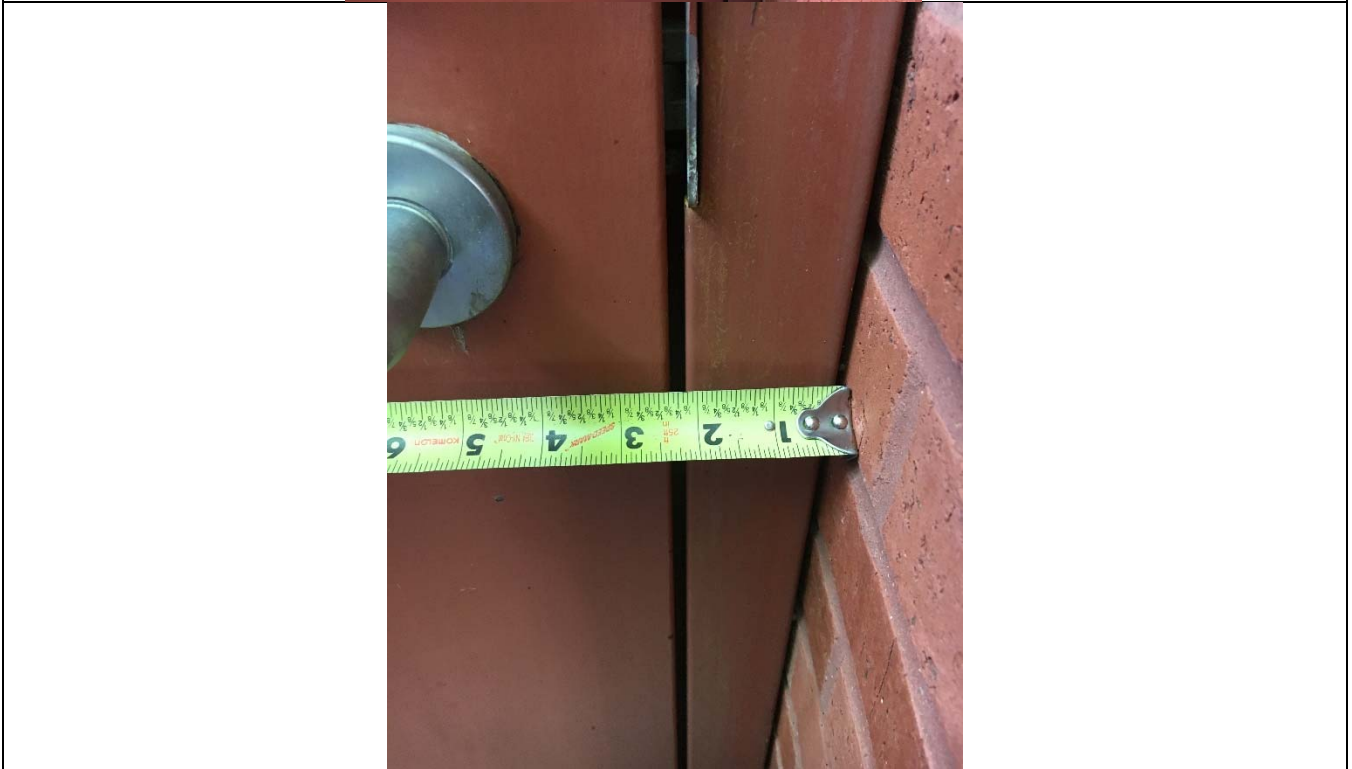
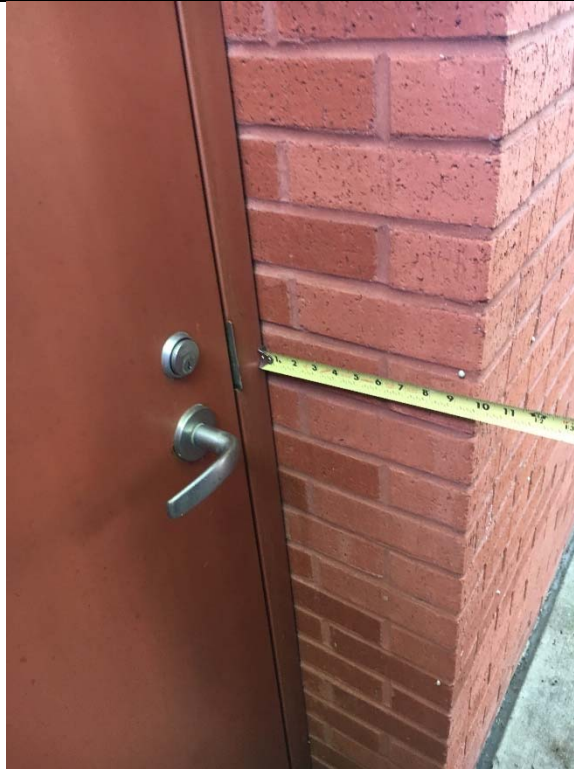
**Violation 5** - The door at the employee entrance from the outside pool area does not have an 18" maneuvering clearance on the pull side.

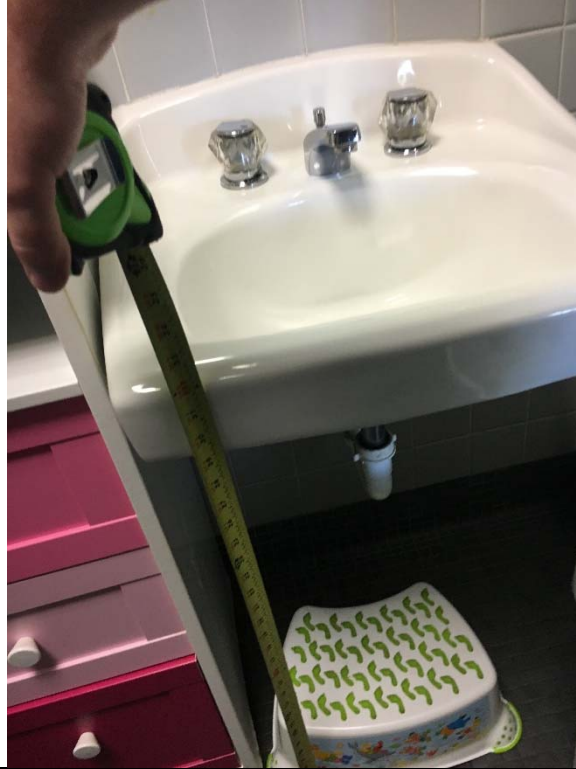
**Violation 16** - The water closet in the child care restroom does not have the required clear floor space provided. Additionally, the flush control is on the closed side.

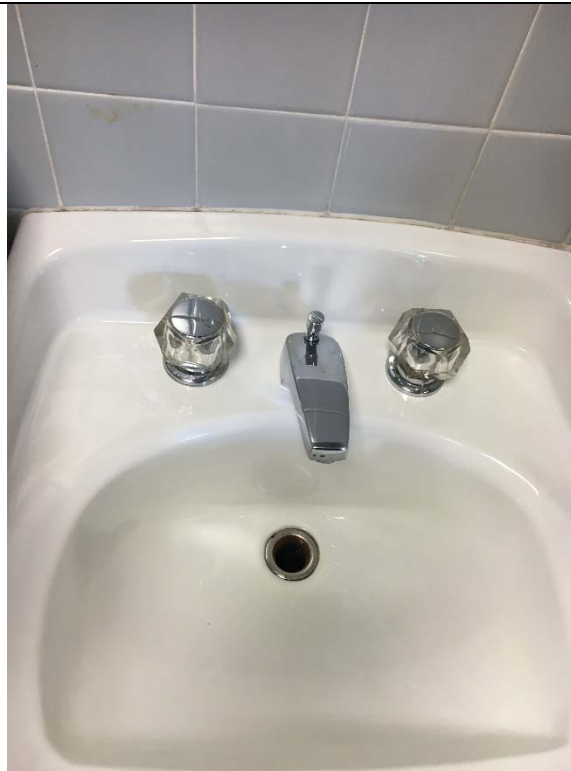
**Violation 17** - The lavatory in the child care restroom lavatory pipes are not protected.

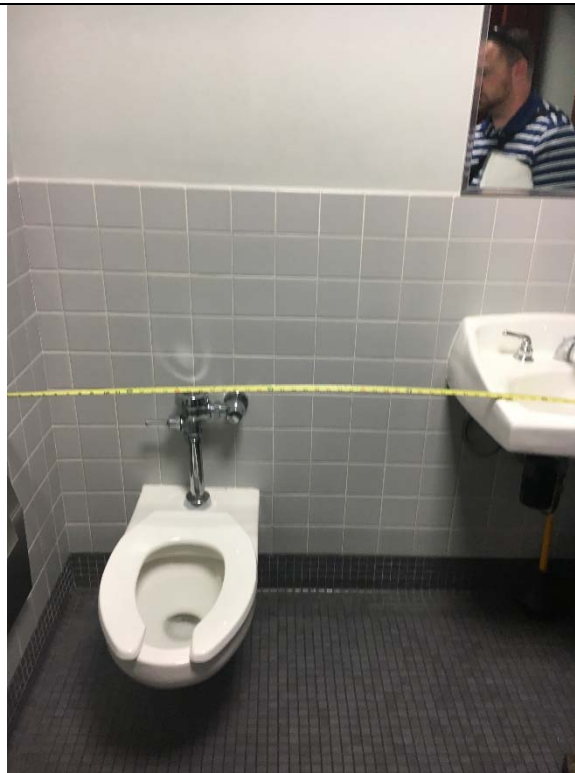
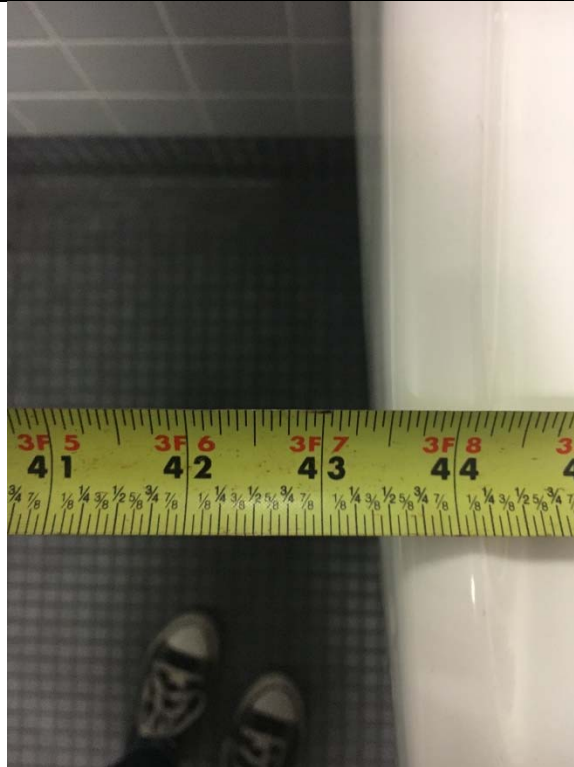
**Violation 21** - Single user restroom on 2nd floor - The flush control on the water closet is located on the wrong side of the toilet tank. Flush controls must be installed on the open side of the water closet.

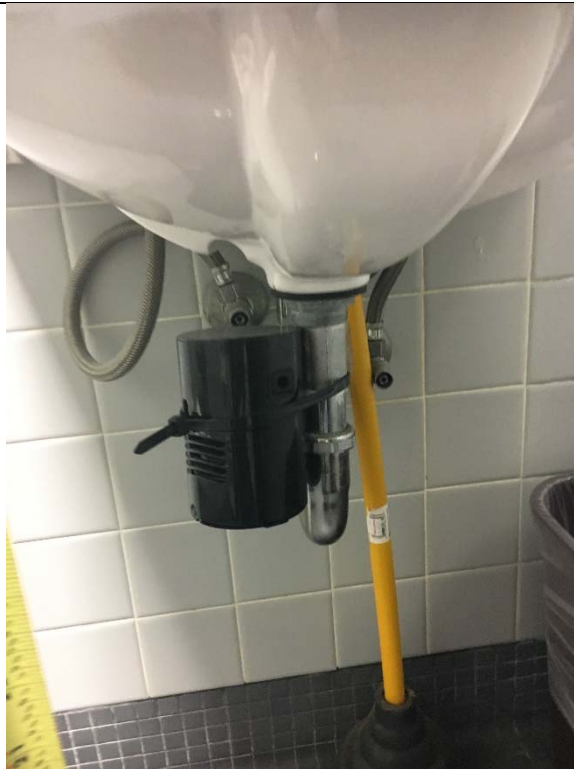
**Violation 22** - Single user restroom on 2nd floor - The lavatory encroaches into the required clear floor width of the water closet.

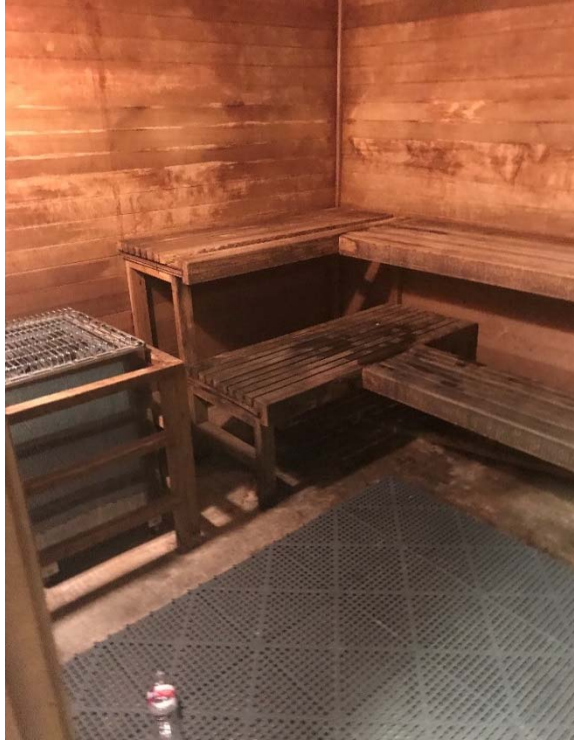
**Violation 37 - Men's Locker Room - There is a 5.7% slope leading into the sauna, there is no level landing provided.**

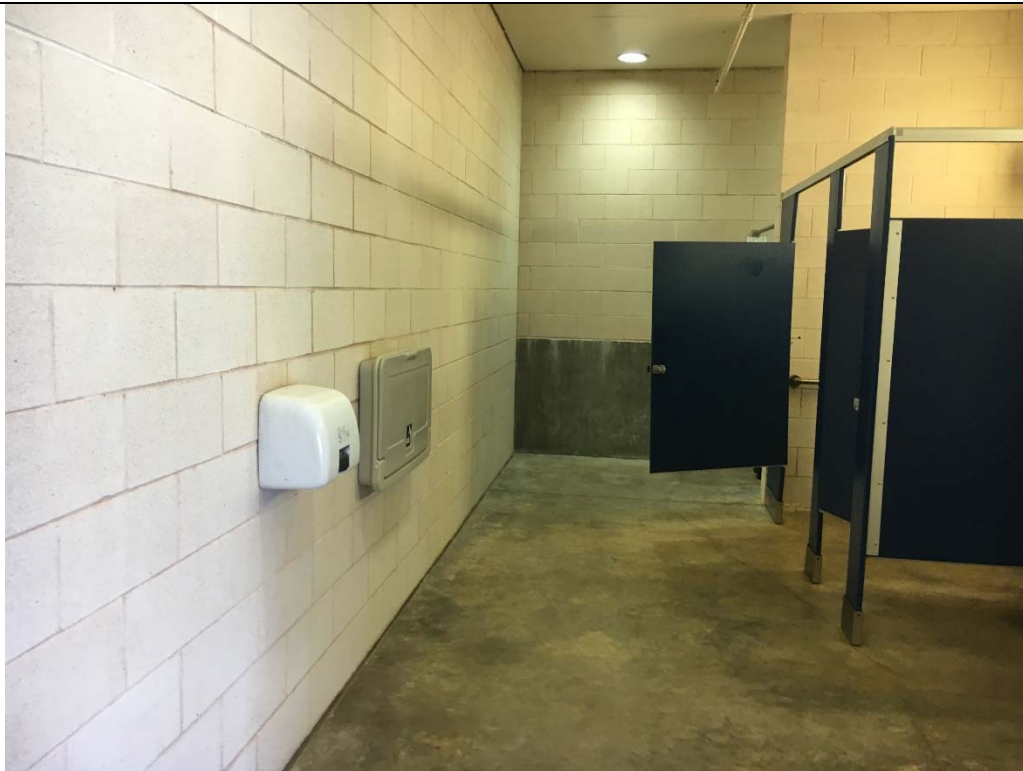
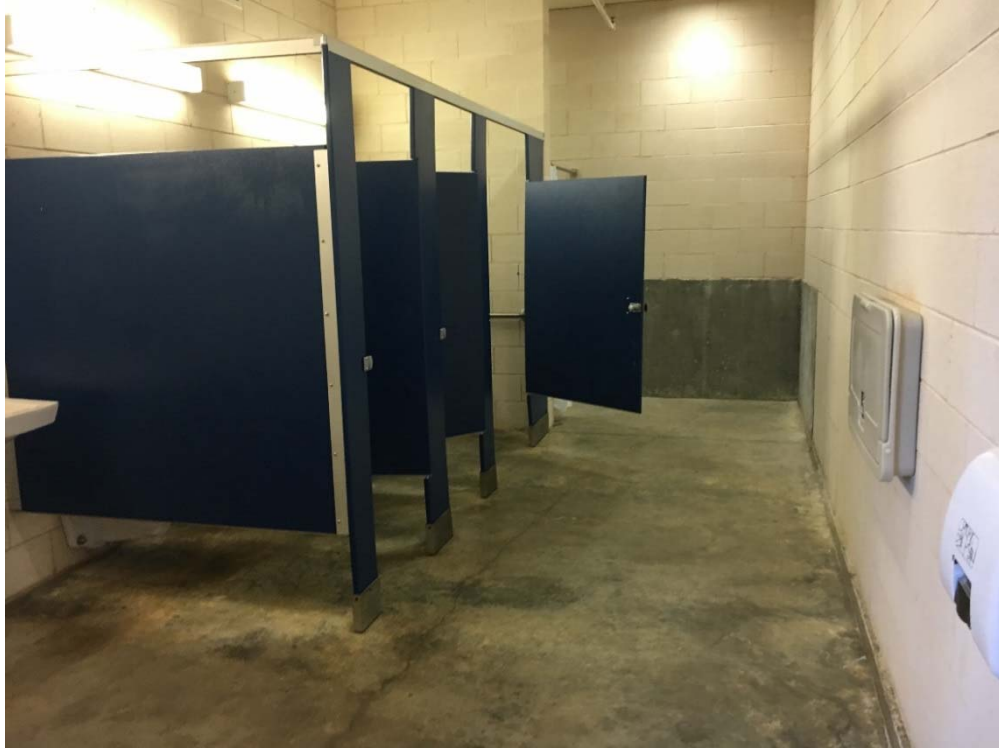
**Violation 42 - Men's Locker Room - No accessible bench is provided.**

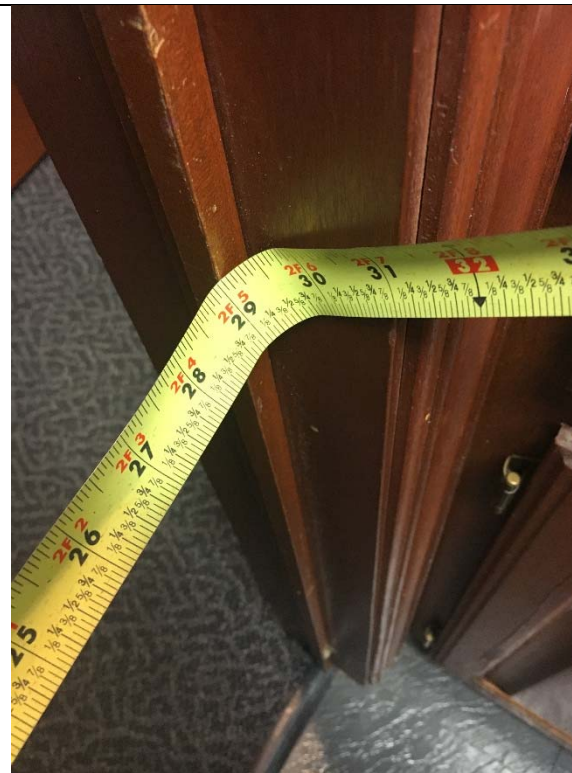
**Violation 45** - There is only a 2" maneuvering clearance on the pull side of the door leading into the breakroom on the 2nd floor, a minimum of 18" is required.

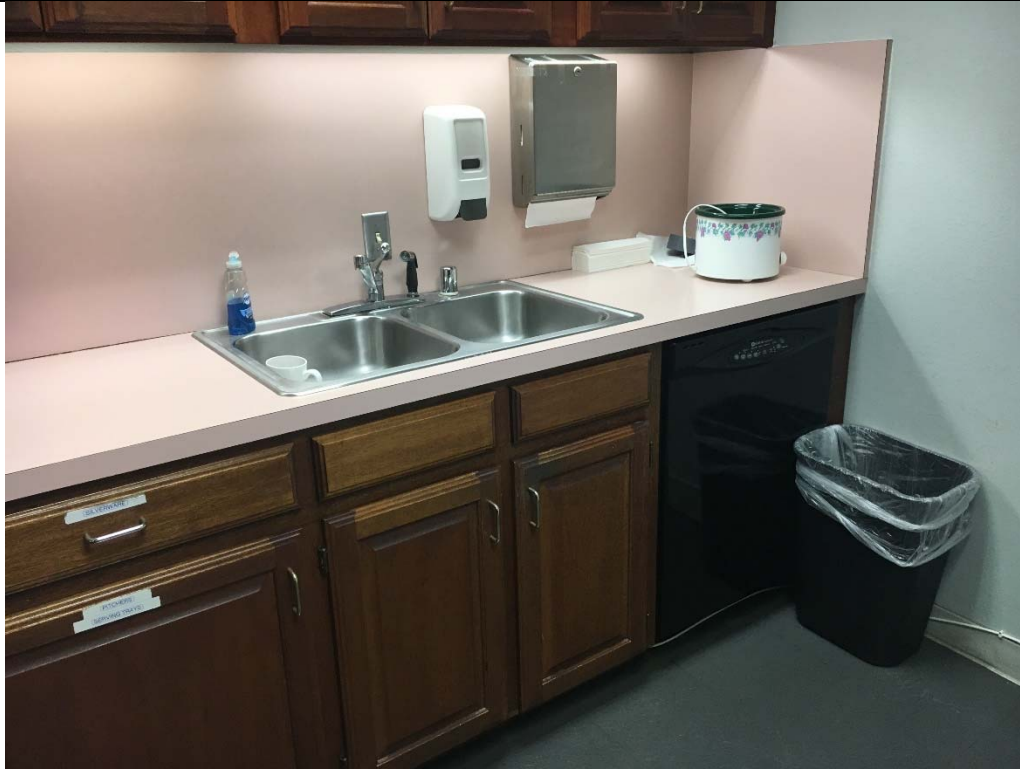
**Violation 46** - The 2nd floor breakroom door only has a 29" opening where a minimum of 32" is required.
