**TOWN OF ADDISON
BUILDING REPORT**

Facility Information: **Facility Name:** Conference Centre
Facility Contact: Lisa Pyles **Contact Phone:** 972-450-2878

Accessology Inspector Information:
Inspector: Karen Jackson **Date:** April 19, 2017
Email: Kjackson@accessology.com

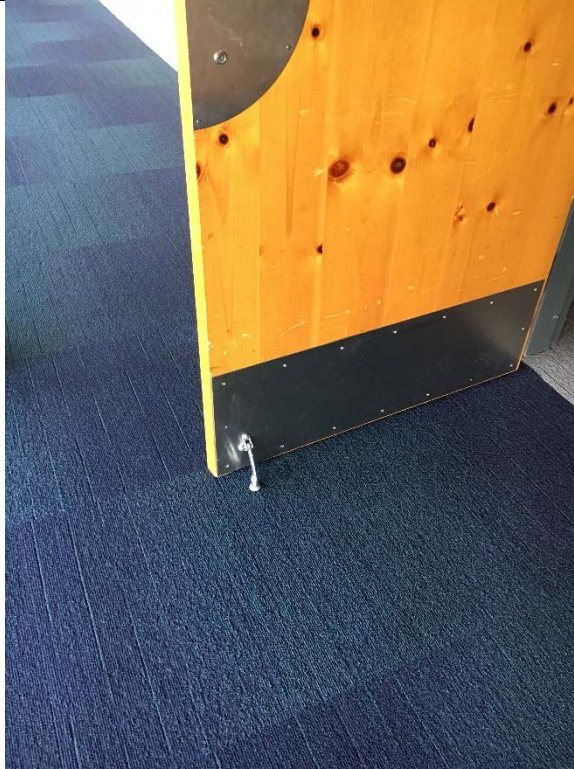
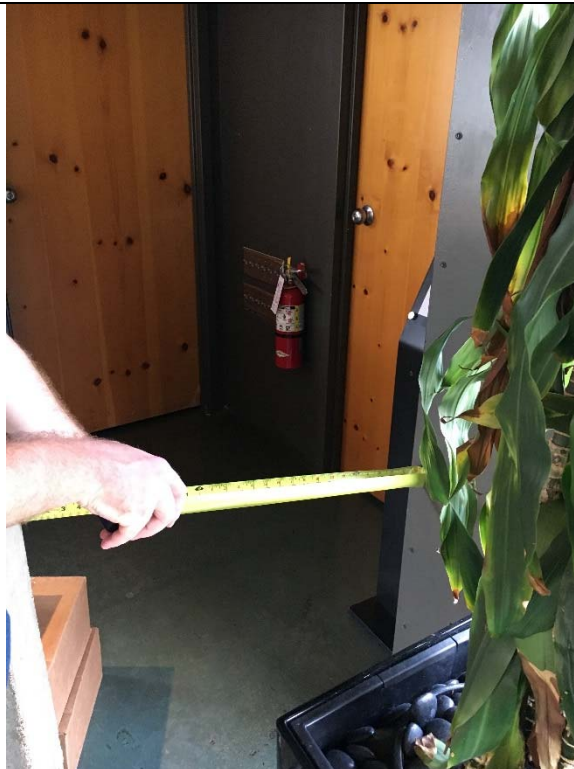
The double doors leading into the conference rooms (4 sets) have door stops at the bottoms of each door.

2010 ADAAG 404.2.10 Door and Gate Surfaces.

Swinging door surfaces within 10 inches of the finish floor measured vertically shall have a smooth surface on the push side extending the full width of the door or gate.

Violation 1 – The double doors leading into the conference rooms (4 sets) have door stops at the bottom of each door.

Remove door stops.

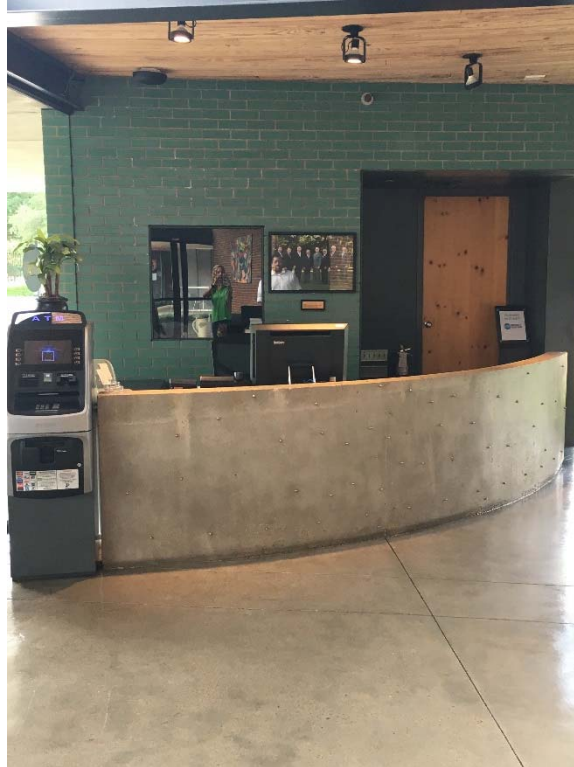
The route leading behind the reception desk is only 29" wide.

Standard: 2010 ADAAG 403.5.1 Clear Width.

Text: Except as provided in 403.5.2 and 403.5.3, the clear width of walking surfaces shall be 36 inches minimum.

Violation 2 – The route leading behind the reception desk is only 29” wide.

Possible Solutions: Widen route leading behind the reception desk to provide 32" minimum clear width.

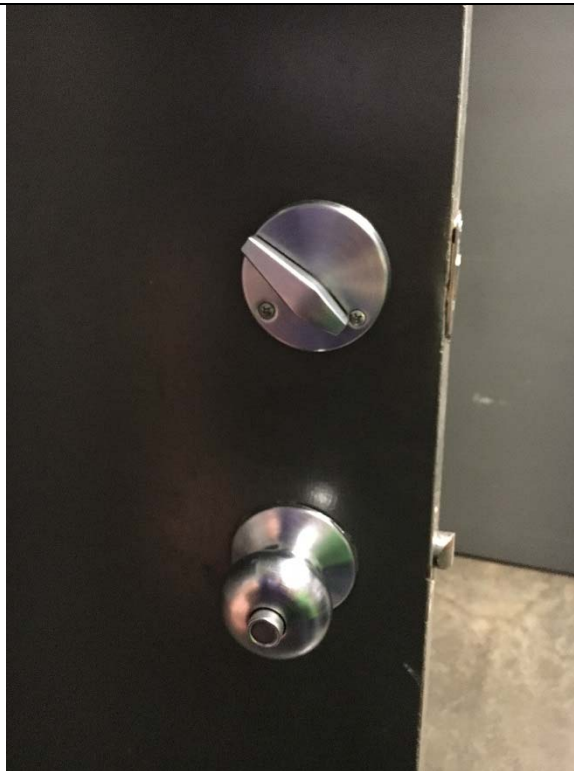
Violation #3: There are 8 doors in this facility that have knob type door hardware that requires grasping and twisting to operate.

Standard: 2010 ADAAG 404.2.7 Door and Gate Hardware.

Text: Handles, pulls, latches, locks, and other operable parts on doors and gates shall comply with 309.4.

Violation 3 – There are 8 doors in this facility that have knob type door hardware that requires grasping and twisting to operate.

Possible Solutions: Replace with lever type door hardware.

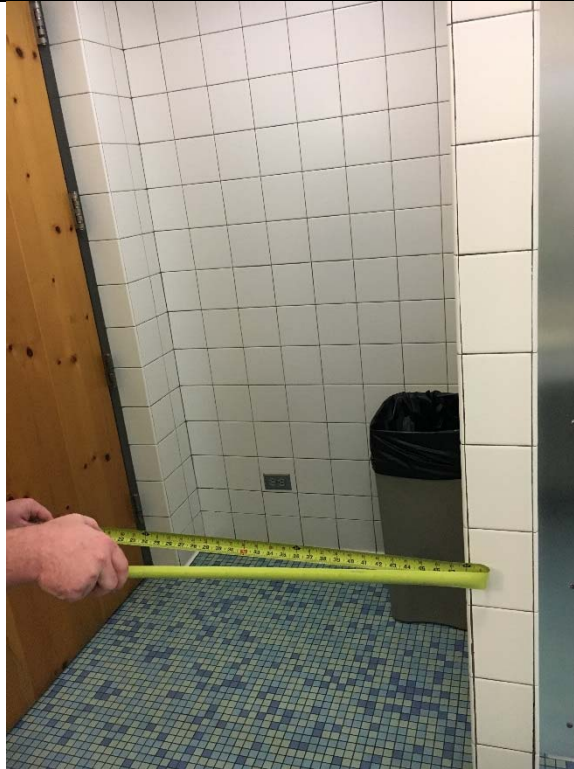
The Men's restroom does not have a minimum of 54" deep maneuvering clearance provided on the pull side of the door.

404.2.4.1 Swinging Doors and Gates.

Swinging doors and gates shall have maneuvering clearances complying with Table 404.2.4.1.

Violation 4 – The Men’s restroom does not have a minimum of 54” deep maneuvering clearance provided on the pull side of the door.

Reverse the swing of the door.

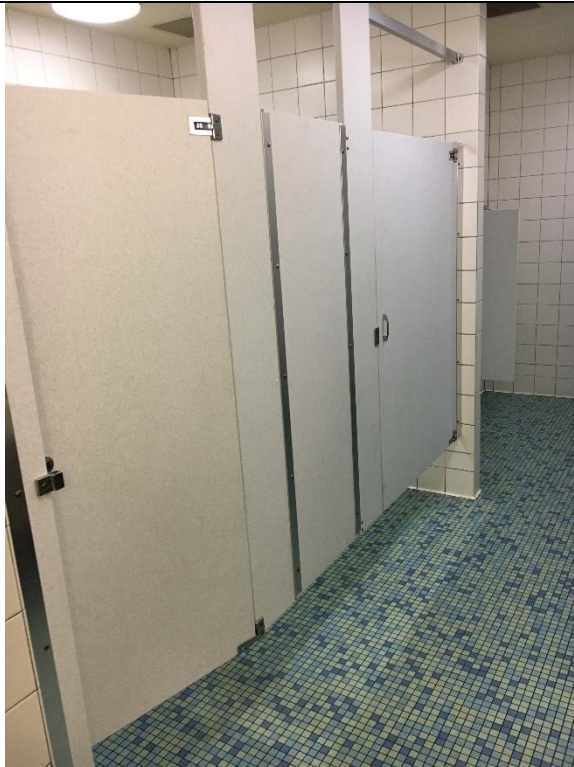
The Men's restroom has eight (8) fixtures and no ambulatory toilet compartment.

2010 ADAAG 213.3.1 Toilet Compartments.

In addition to the compartment required to comply with 604.8.1, at least one compartment shall comply with 604.8.2 where six or more toilet compartments are provided, or where the combination of urinals and water closets totals six or more fixtures.

Violation 5 – The Men’s restroom has eight (8) fixtures and no ambulatory toilet compartment.

Add/convert existing non-accessible stall into an ambulatory stall.

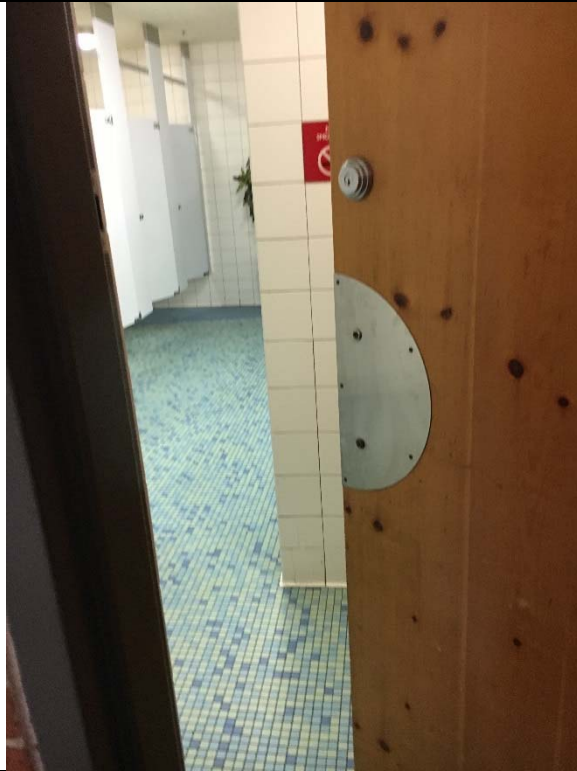
The Women's restroom does not have a minimum of 54" deep maneuvering clearance provided on the pull side of the door.

404.2.4.1 Swinging Doors and Gates.

Swinging doors and gates shall have maneuvering clearances complying with Table 404.2.4.1.

Violation 6 - The Women's restroom does not have a minimum of 54" deep maneuvering clearance provided on the pull side of the door.

Reverse the swing of the door.

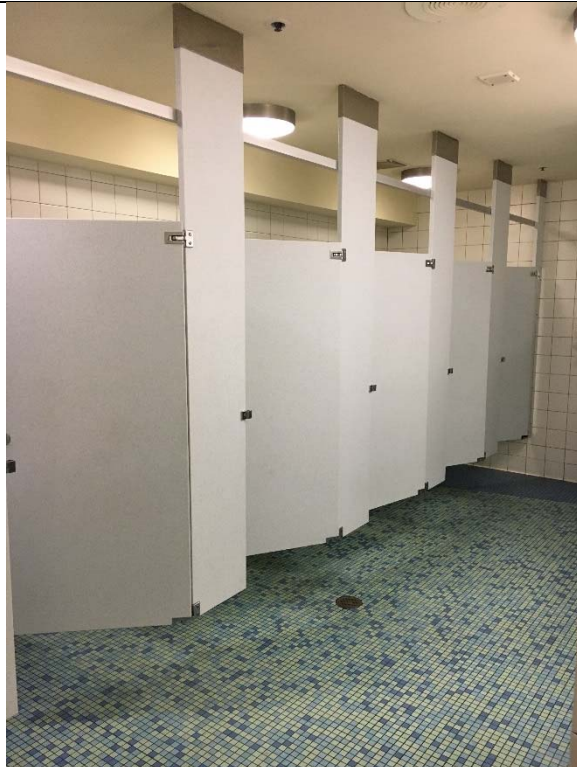
The Women's restroom has seven (7) toilet compartments and no ambulatory stall.

2010 ADAAG 213.3.1 Toilet Compartments.

In addition to the compartment required to comply with 604.8.1, at least one compartment shall comply with 604.8.2 where six or more toilet compartments are provided, or where the combination of urinals and water closets totals six or more fixtures.

Violation 7 - The Women's restroom has seven (7) toilet compartments and no ambulatory stall.

Add/convert existing non-accessible stall into an ambulatory stall in compliance with section 604.8.2.

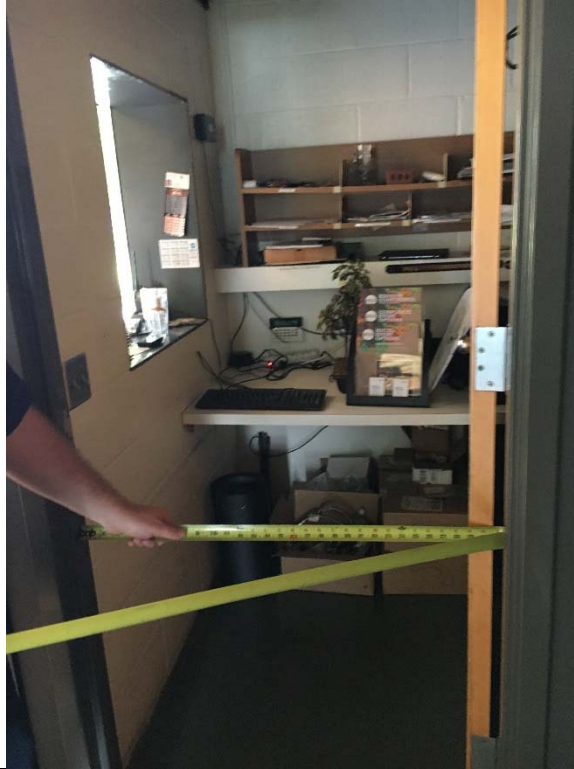
The work room behind the reception area only has a 28.5" door opening with a 5.5" maneuvering clearance provided on the pull side of the door.

2010 ADAAG 404.2.3 Clear Width. & 404.2.4.1 Swinging Doors and Gates

Door openings shall provide a clear width of 32" min. Clear openings of doorways shall be measured between the face of the door and the stop, with the door open 90 degrees. Swinging doors shall have maneuvering clearances complying with Table 404.2.4.1.

Violation 8 - The work room behind the reception area only has a 28.5" door opening with a 5.5" maneuvering clearance provided on the pull side of the door.

Reverse the swing of the door.

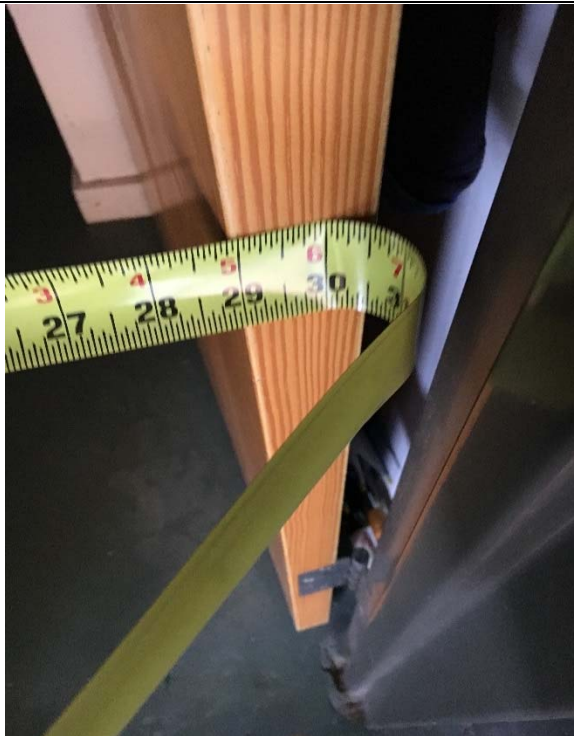
The storage room behind the reception area only has a 29" door opening with a 10 1/4" maneuvering clearance on the pull side.

2010 ADAAG 404.2.3 Clear Width. & 404.2.4.1 Swinging Doors and Gates

Door openings shall provide a clear width of 32" min. Clear openings of doorways shall be measured between the face of the door and the stop, with the door open 90 degrees. Swinging doors shall have maneuvering clearances complying with Table 404.2.4.1.

Violation 9 - The storage room behind the reception area only has a 29" door opening with a 10 1/4" maneuvering clearance on the pull side.

Modify door to provide 32" minimum clear width.

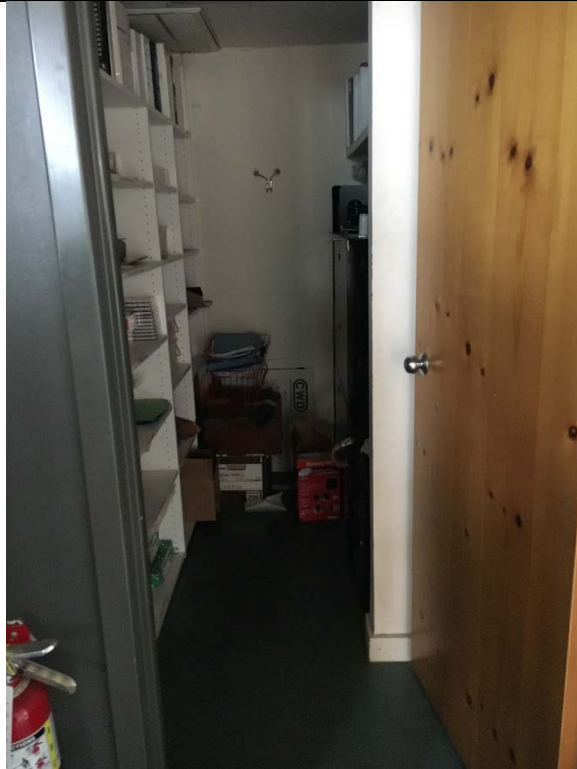
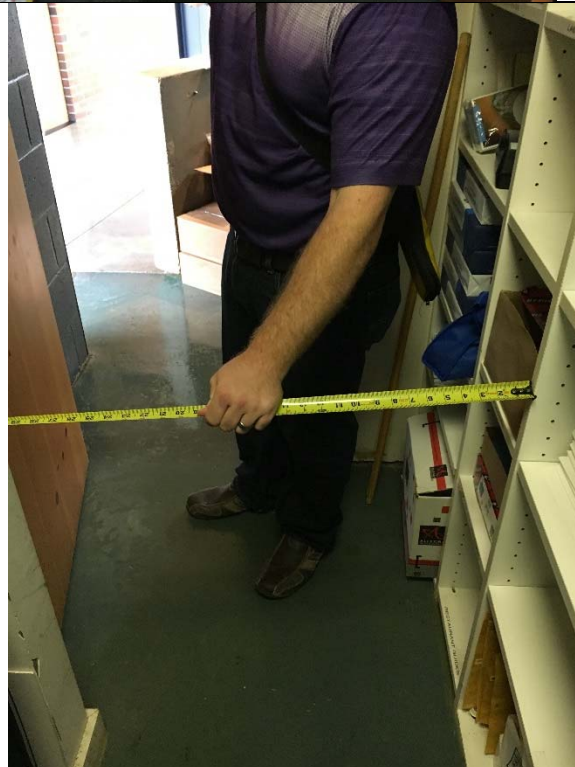
Violation 10 - There is a wing wall in the storage room behind the reception desk that reduces the room size to 29.5" wide obstructing full access into the room.
