**TOWN OF ADDISON  
BUILDING REPORT**

**Facility Information:** **Facility Name:** Finance Building  
**Facility Contact:** Lisa Pyles **Contact Phone:** 972-450-2878

**Accessology Inspector Information:**  
**Inspector:** Karen Jackson **Date:** April 21, 2017  
**Email:** Kjackson@accessology.com

**Latitude:** 32.953362 **Longitude:** -96.813731  
**Address:** 5350 Beltline Road **City:** Addison **County:** Dallas

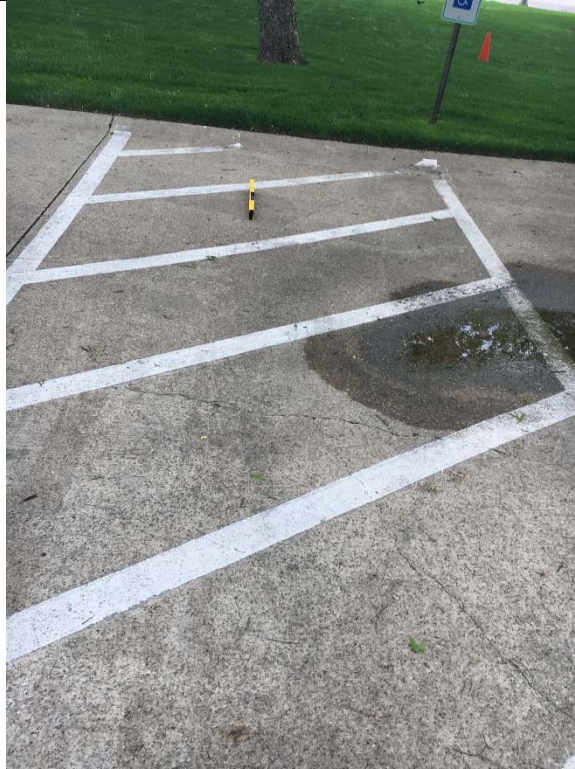
**Violation #1:** The access aisle has slopes ranging from 2.4% to 4.4%.

**Standard:** 2010 ADAAG 502.4 Floor or Ground Surfaces.

**Text:** Parking spaces and access aisles serving them shall comply with 302. Access aisles shall be at the same level as the parking spaces they serve. Changes in level are not permitted. EXCEPTION: Slopes not steeper than 1:48 shall be permitted.

**Violation 1** - The access aisle has slopes ranging from 2.4% to 4.4%.

**Possible Solutions:** Repave access aisle to achieve slopes in all directions no greater than 1:48. Cost for corrections is included under Violation #2.

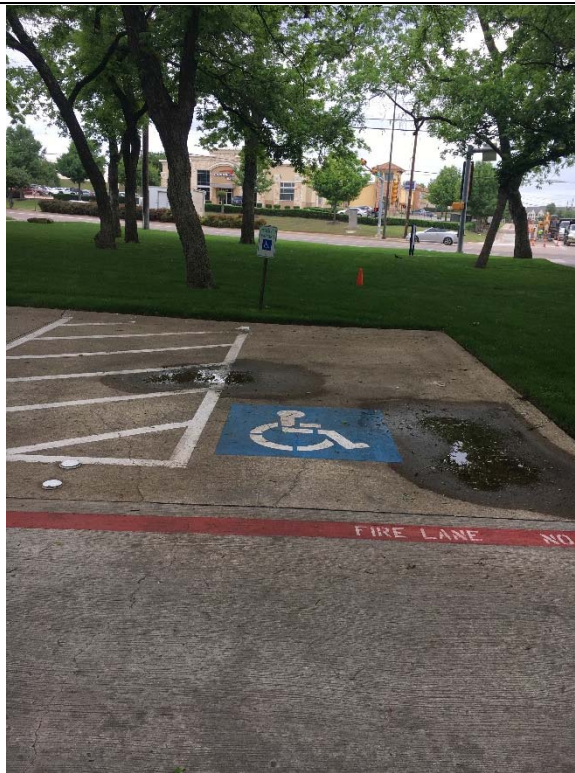
**Violation #2:** There is evidence of ponding in the accessible parking space.

**Standard:** 2010 ADAAG 302.1 General.

**Text:** Floor and ground surfaces shall be stable, firm, and slip resistant and shall comply with 302.

**Violation 2** - There is evidence of ponding in the accessible parking space.

**Possible Solutions:** Repave area to achieve a smooth surface.

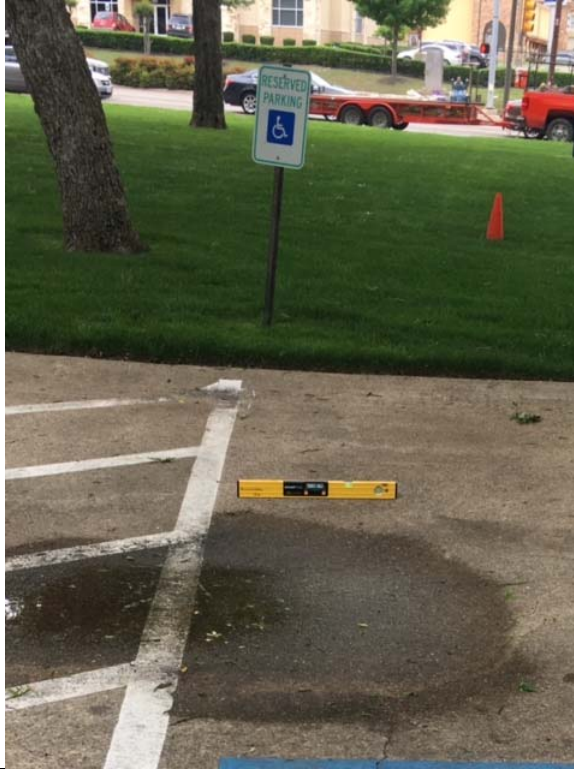
**Violation #3:** The accessible signage is mounted too low.

**Standard:** 2010 ADAAG 502.6 Identification.

**Text:** Signs identifying van parking spaces shall contain the designation “van accessible.” Signs shall be 60" min. above the ground surface measured to the bottom of the sign.

**Violation 3** - The accessible signage is mounted too low.

**Possible Solutions:** Raise signage.

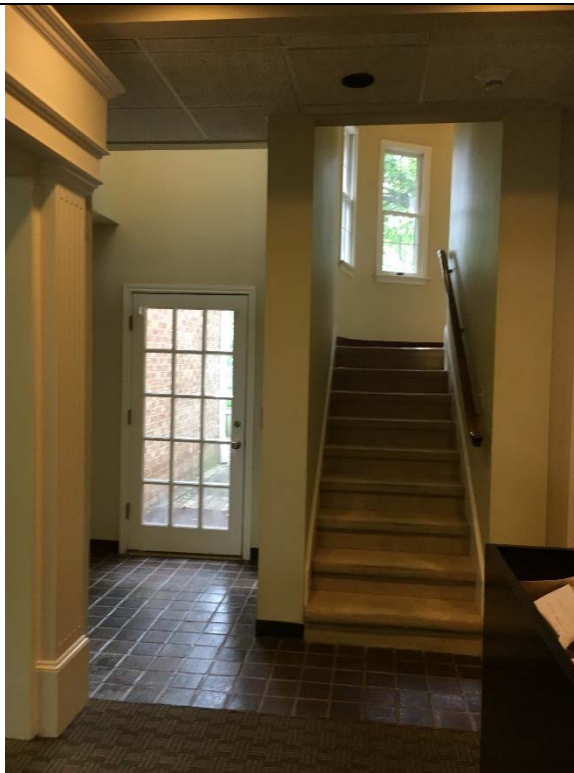
**Violation #4:** There is no elevator serving this building, therefore there is no access to the 2nd floor.

**Standard:** 2010 ADAAG 206.2.3 Multi-Story Buildings and Facilities.

**Text:** At least one accessible route shall connect each story and mezzanine in multi-story buildings and facilities.

**Violation 4** - There is no elevator serving this building, therefore there is no access to the 2nd floor.

**Possible Solutions:** Install a compliant elevator unless all programs can be moved to more accessible location.

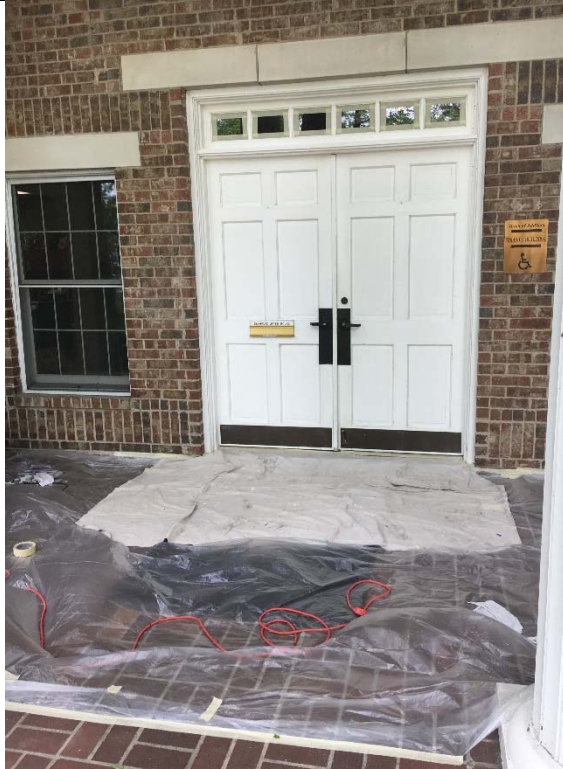
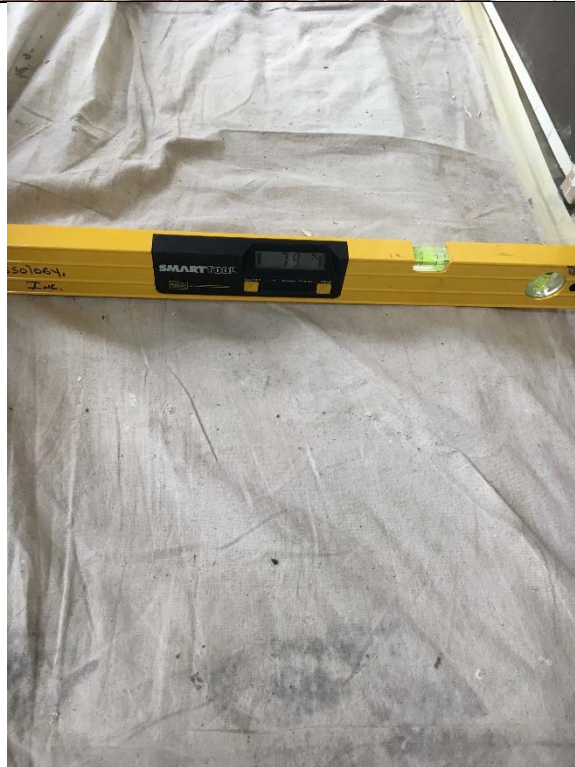
**Violation #5:** The building entrance has a 7.9% sloped area at the building entrance.

**Standard:** 2010 ADAAG 404.2.4.4 Floor or Ground Surface.

**Text:** Floor or ground surface within required maneuvering clearances shall comply with 302. Changes in level are not permitted. EXCEPTIONS: Slopes not steeper than 1:48 shall be permitted.

**Violation 5** - The building entrance has a 7.9% sloped area at the building entrance.

**Possible Solutions:** Modify building entrance to be served by a level maneuvering clearance.

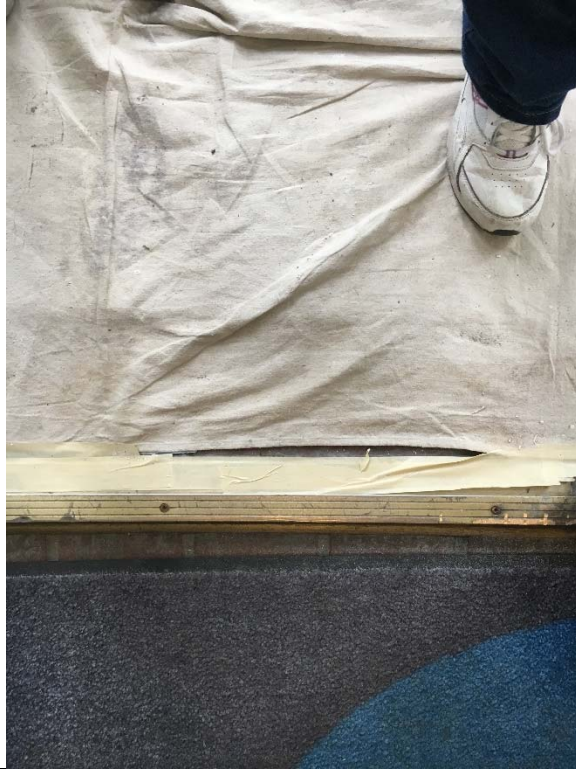
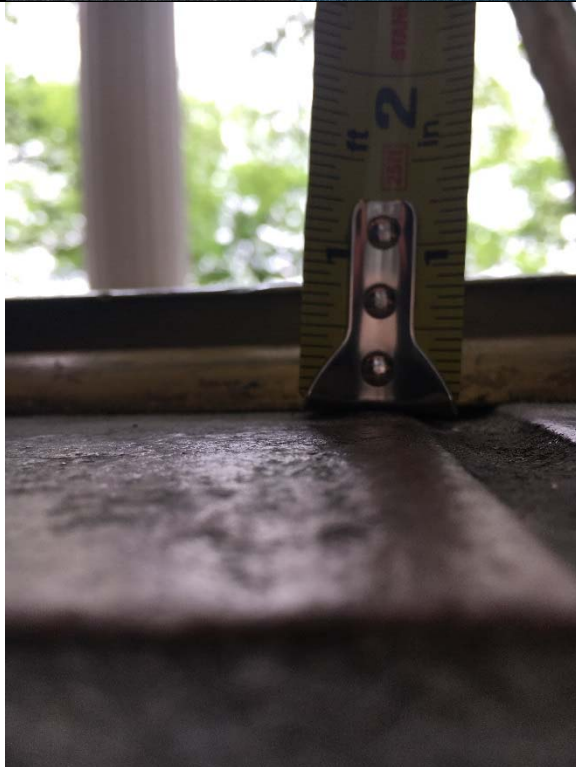
**Violation #6:** The threshold at the entrance door is greater than 1/2".

**Standard:** 2010 ADAAG 404.2.5 Thresholds

Thresholds, if provided at doorways, shall be 1/2" high max. Raised thresholds and changes in level at doorways shall comply with 302 and 303.

**Violation 6** - The threshold at the entrance door is greater than 1/2".

Modify threshold to achieve a change in level no greater than 1/2".

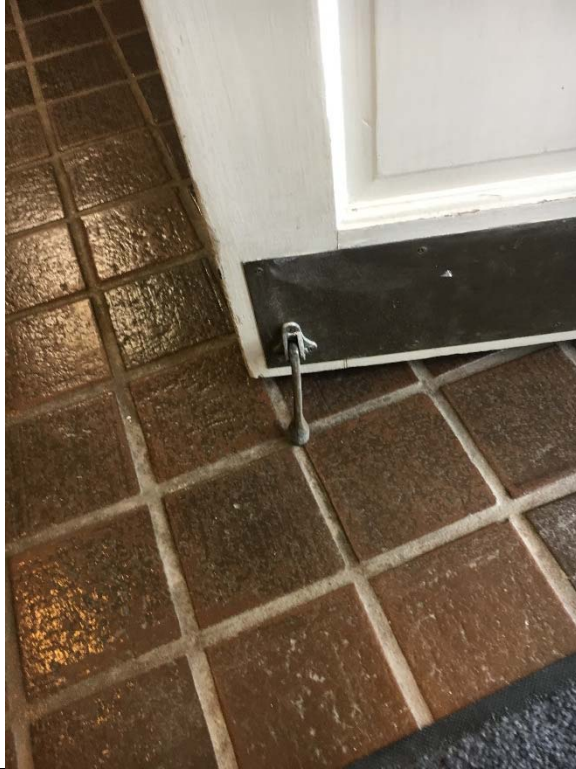
The entrance door has a door stop at the bottom, therefore, the bottom 10" of the door does not have a smooth surface.

**2010 ADAAG 404.2.10 Door and Gate Surfaces.**

Swinging door and gate surfaces within 10 inches of the finish floor or ground measured vertically shall have a smooth surface on the push side extending the full width of the door or gate.

**Violation 7** - The entrance door has a door stop at the bottom, therefore, the bottom 10" of the door does not have a smooth surface.

Remove door stop. This is a TDLR requirement not a Federal standard.

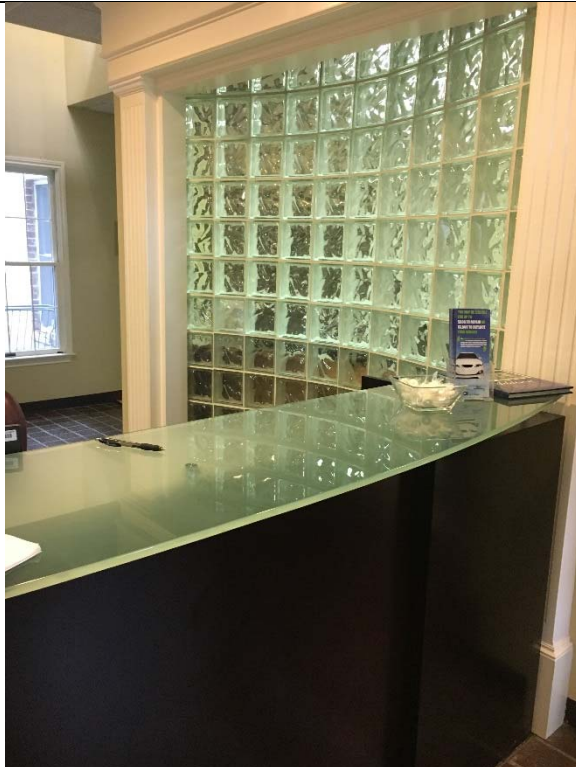
The reception desk is 44" above finished floor to the top of the counter.

**2010 ADAAG 904.4.1 Parallel Approach.**

A portion of the counter surface that is 36" long min. 36" high max. above the finish floor shall be provided. A clear floor or ground space complying with 305 shall be positioned for a parallel approach adjacent to the 36" min. length of counter.

**Violation 8** - The reception desk is 44" above finished floor to the top of the counter.

Replace desk or provide a portion of the desk that is no higher than 36" above finished floor.

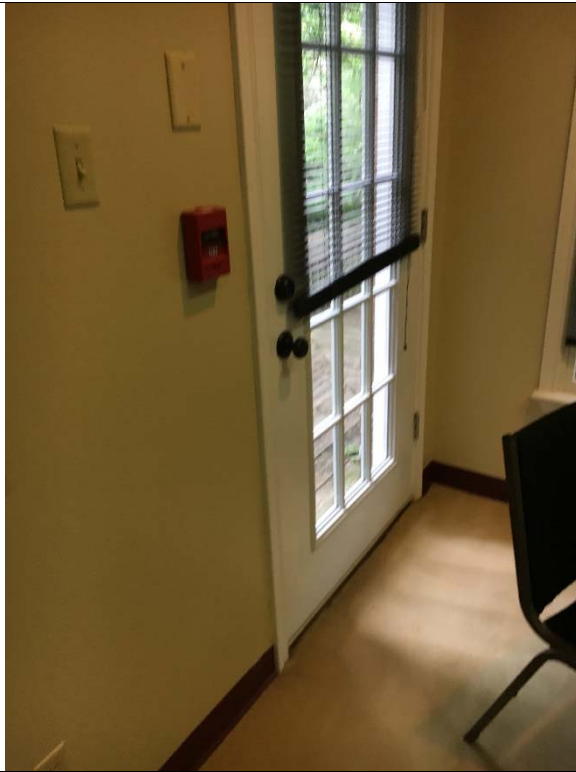
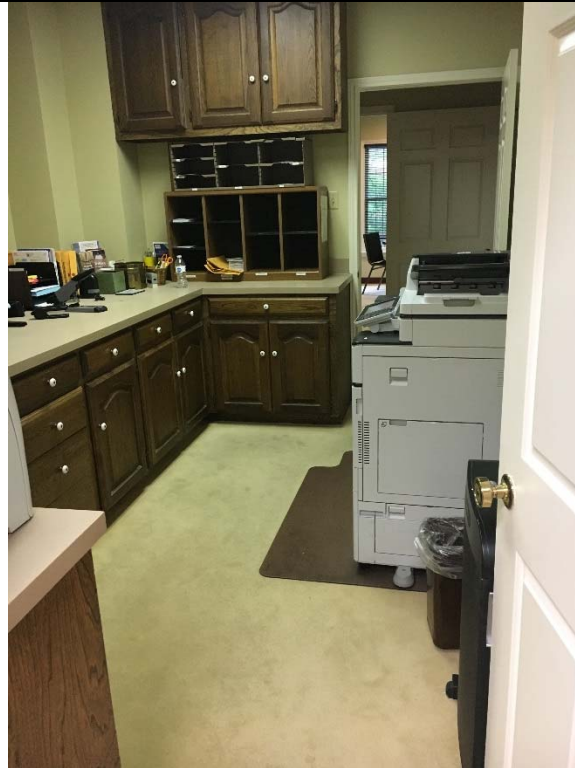
There are approximately 12 door knobs provided throughout the facility.

**2010 ADAAG 404.2.7 Door and Gate Hardware.**

Handles, pulls, latches, locks, and other operable parts on doors and gates shall comply with 309.4.

**Violation 9** - There are approximately 12 door knobs provided throughout the facility.

Replace with lever type handles.

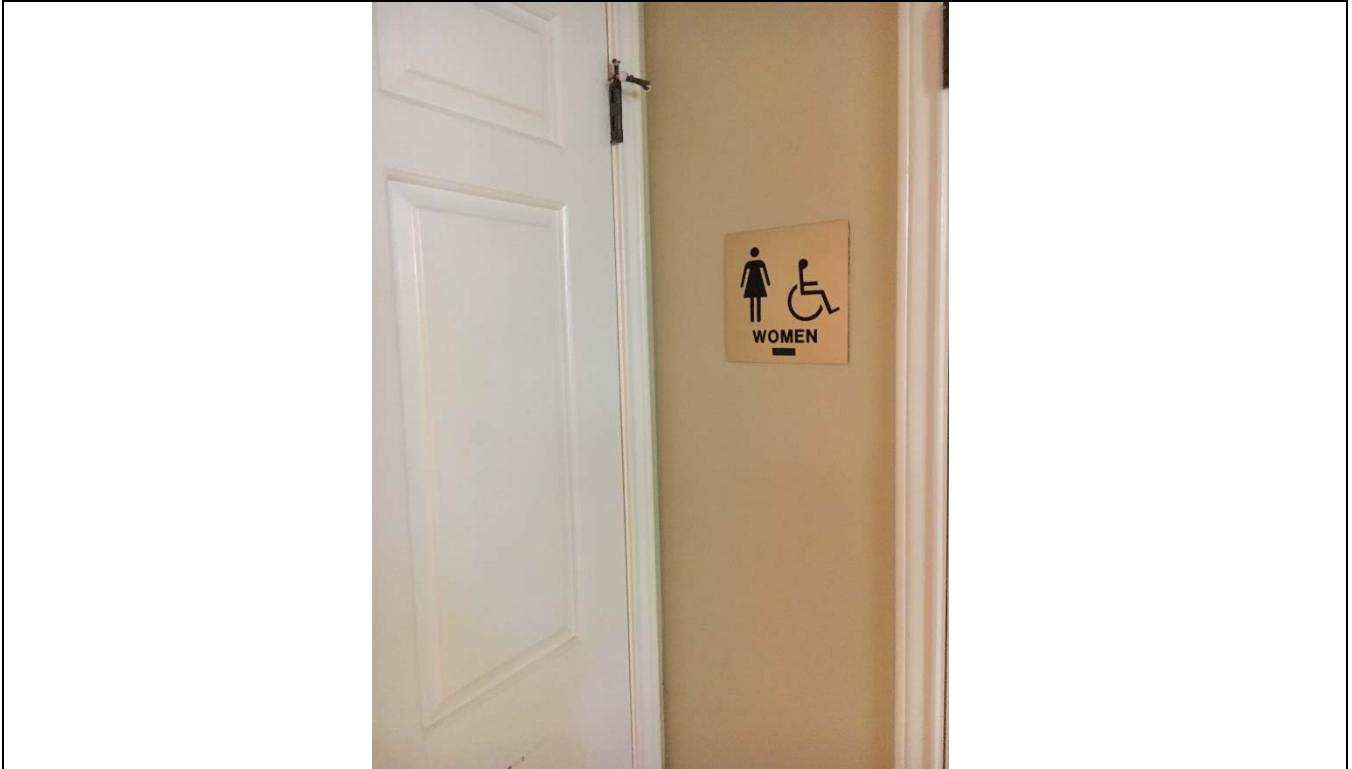
Women's Restroom: Signage is mounted on the wall next to the hinge side of the door.

2010 ADAAG 703.4.2 Location.

Where a tactile sign is provided at a door, the sign shall be located alongside the door at the latch side. Signs containing tactile characters shall be located so that a clear floor space of 18" x 18" min., centered on the tactile characters, is provided beyond the arc of any door swing between the closed position and 45 degree open position.

**Violation 10** - Women's Restroom: Signage is mounted on the wall next to the hinge side of the door.

Relocate signage to the latch side of the door.

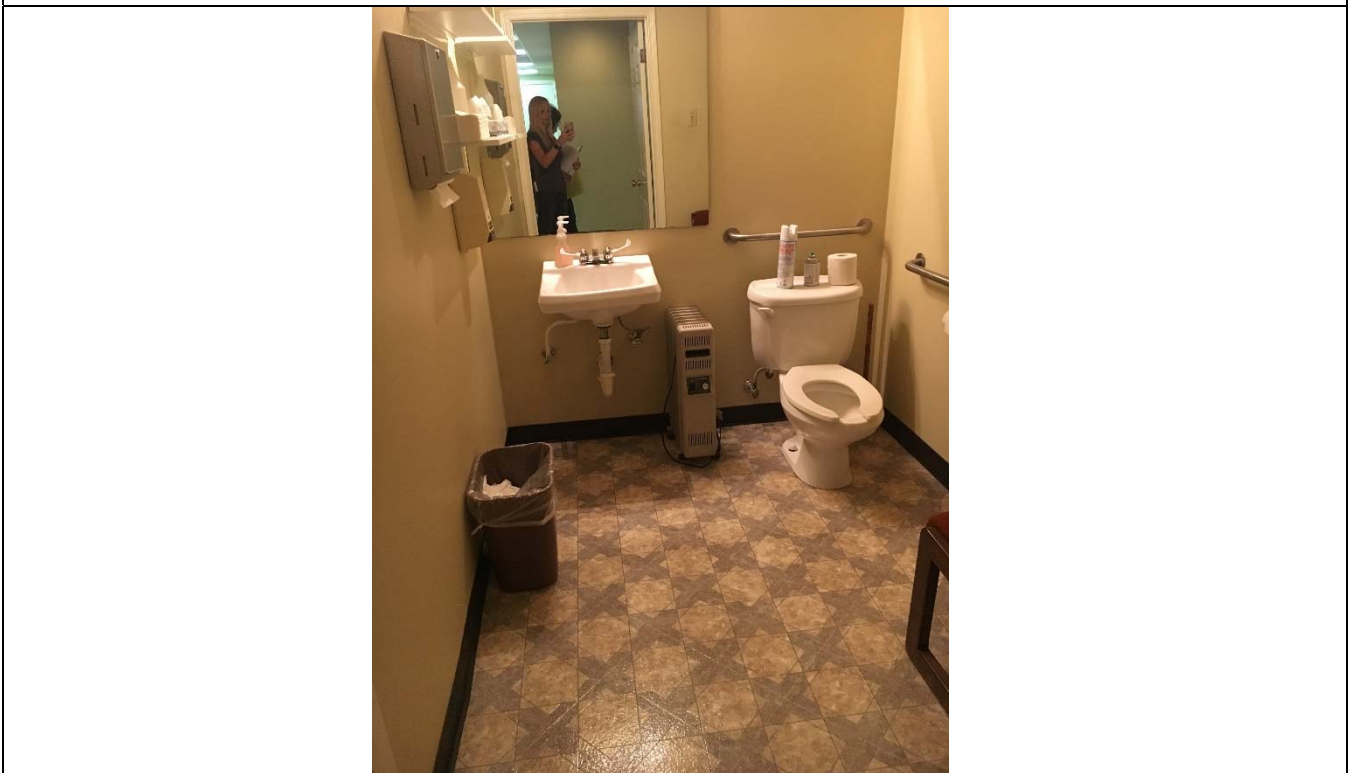
Women's Restroom: The required clear floor space around the water closet is not provided.

**2010 ADAAG 604.3.1 Size.**

Clearance around a water closet shall be 60 inches minimum measured perpendicular from the side wall and 56 inches minimum measured perpendicular from the rear wall.

**Violation 11** - Women's Restroom: The required clear floor space around the water closet is not provided.

Remove and relocated lavatory to achieve required clear floor space.

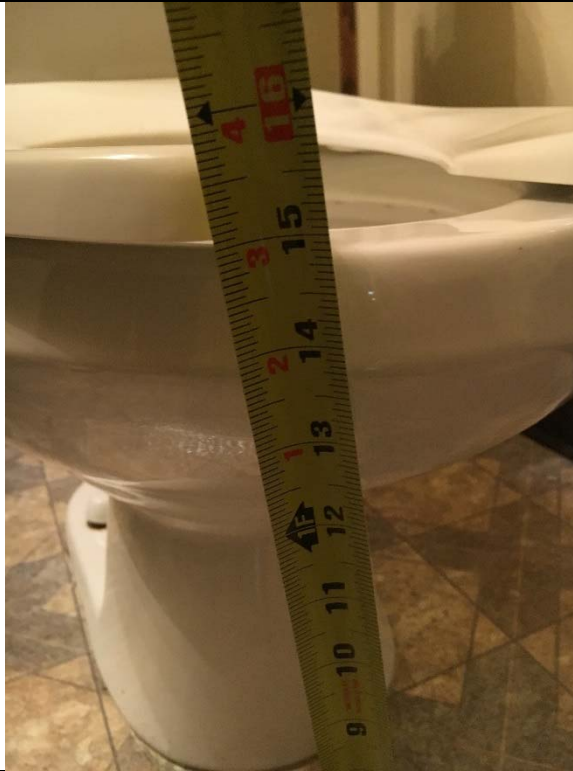
Women's & Men's Restrooms: Water closet seats are 15.5" above finished floor.

**2010 ADAAG 604.4 Seats.**

The seat height of a water closet above the finish floor shall be 17 inches minimum and 19 inches maximum measured to the top of the seat. Seats shall not be sprung to return to a lifted position.

**Violation 12** - Women's & Men's Restrooms: Water closet seats are 15.5" above finished floor.

Install a complaint water closet in each restroom.

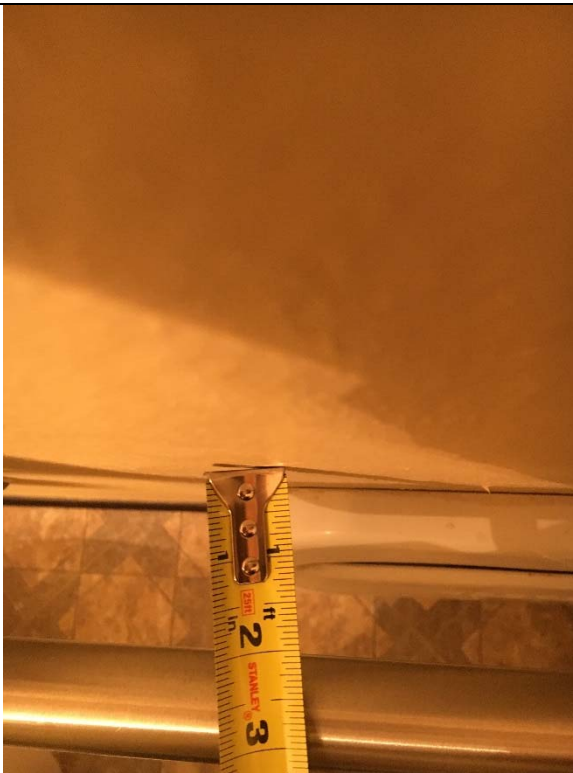
Women's & Men's Restrooms: The space between the grab bar and the wall is 2".

**2010 ADAAG 609.3 Spacing.**

The space between the wall and the grab bar shall be 1½".

**Violation 13** - Women's & Men's Restrooms: The space between the grab bar and the wall is 2".

Remove and remount grab bars so that 1-1/2" clearance is achieved.

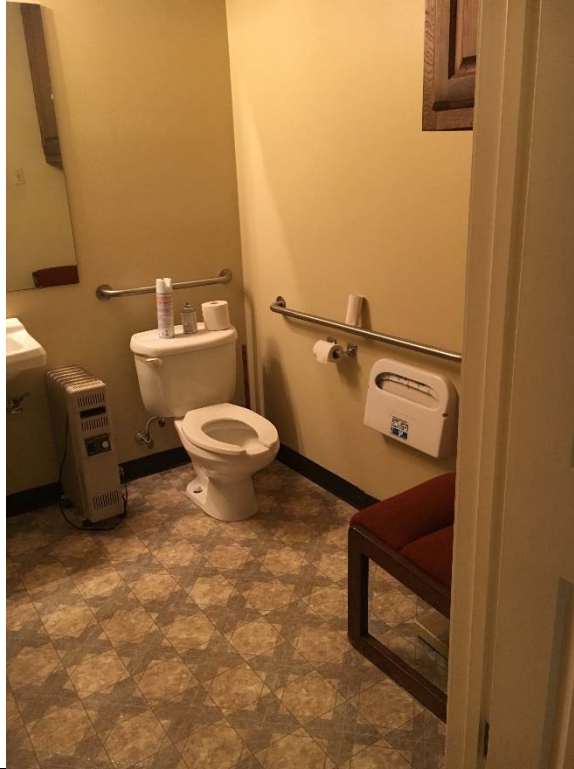
Women's Restroom: The rear grab bar is only 24" long.

**2010 ADAAG 604.5.2 Rear Wall.**

The rear wall grab bar shall be 36" long minimum and extend from the centerline of the water closet 12" minimum on one side and 24" minimum on the other side.

**Violation 14 - Women's Restroom:** The rear grab bar is only 24" long.

Install a compliant grab bar. The cost for compliance is included in Violation #13.

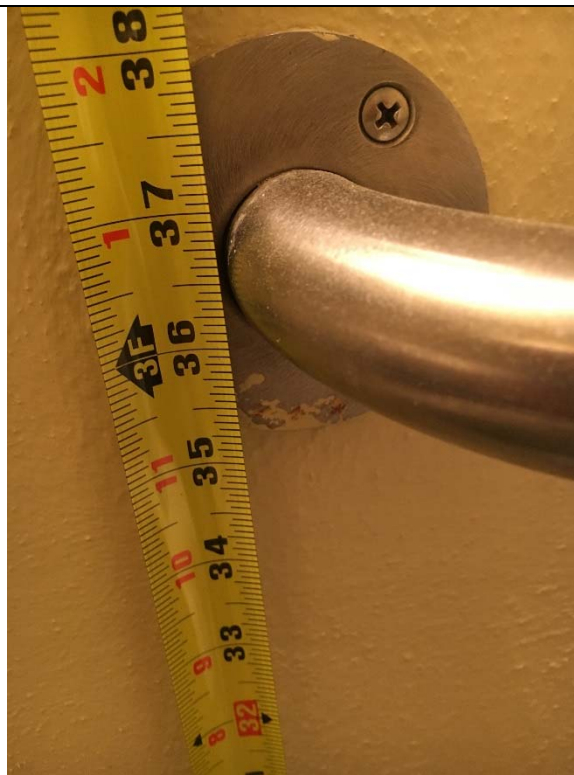
Women's Restroom: The rear grab bar is mounted too high at 37" above finished floor.

**2010 ADAAG 609.4 Position of Grab Bars.**

Grab bars shall be installed in a horizontal position, 33" - 36" maximum above the finish floor measured to the top of the gripping surface.

**Violation 15 - Women's Restroom:** The rear grab bar is mounted too high at 37" above finished floor.

Remount grab bar to compliant height. The cost for compliance is included in Violation #13.

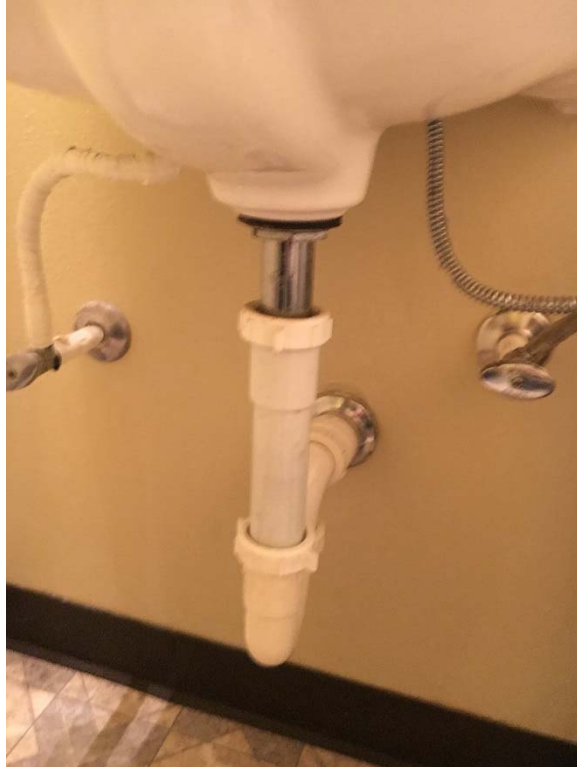
Women's Restroom: Lavatory pipes and valves are not wrapped to protect against contact.

**2010 ADAAG 606.5 Exposed Pipes and Surfaces.**

Water supply and drain pipes under lavatories and sinks shall be insulated or otherwise configured to protect against contact. There shall be no sharp or abrasive surfaces under lavatories and sinks.

**Violation 16 - Women's Restroom:** Lavatory pipes and valves are not wrapped to protect against contact.

Provide protection at the exposed drains and water lines under the lavatories.

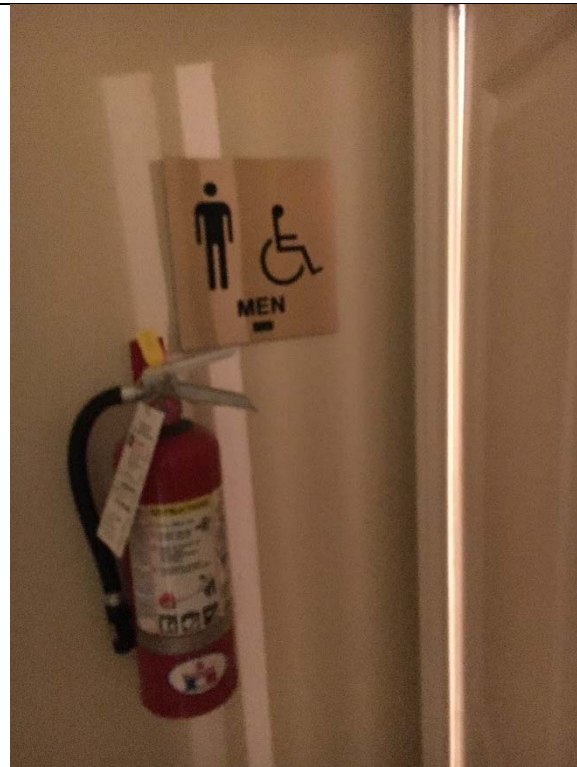
Men's Restroom: Signage is mounted on the wall next to the hinge side of the door.

**2010 ADAAG 703.4.2 Location.**

Where a tactile sign is provided at a door, the sign shall be located alongside the door at the latch side. Signs containing tactile characters shall be located so that a clear floor space of 18" x 18" min., centered on the tactile characters, is provided beyond the arc of any door swing between the closed position and 45 degree open position.

**Violation 17 - Men's Restroom:** Signage is mounted on the wall next to the hinge side of the door.

Relocate signage to the latch side of the door.

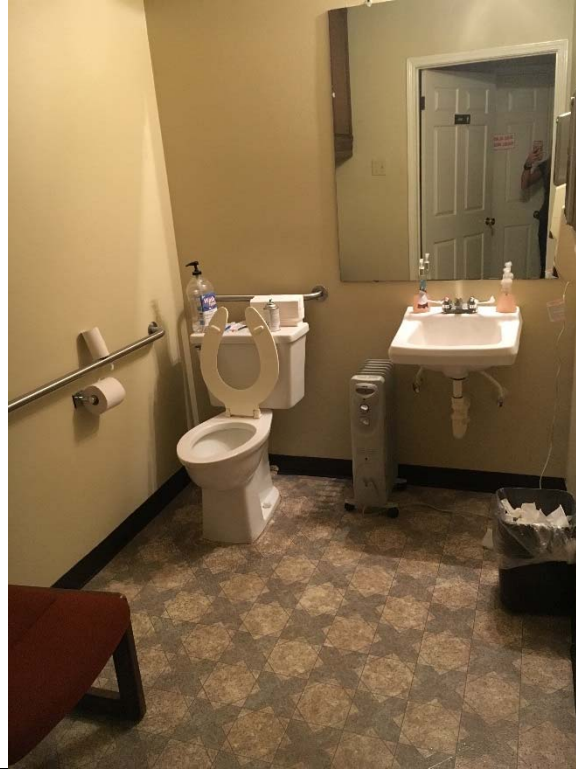
Men's Restroom: The required clear floor space around the water closet is not provided.

**2010 ADAAG 604.3.1 Size.**

Clearance around a water closet shall be 60 inches minimum measured perpendicular from the side wall and 56 inches minimum measured perpendicular from the rear wall.

**Violation 18 - Men's Restroom:** The required clear floor space around the water closet is not provided.

Remove and relocate lavatory to achieve required clear floor space.

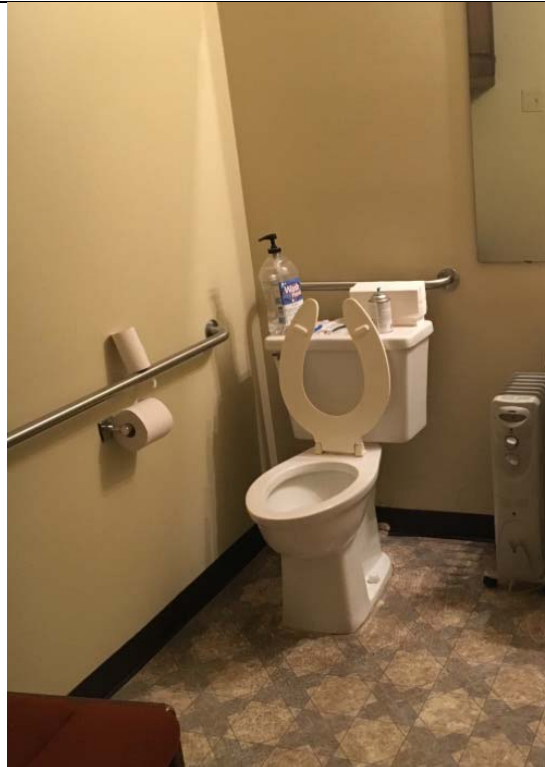
Men's Restroom: The rear grab bar is only 24" long.

**2010 ADAAG 604.5.2 Rear Wall.**

The rear wall grab bar shall be 36" long minimum and extend from the centerline of the water closet 12" minimum on one side and 24" minimum on the other side.

**Violation 19 - Men's Restroom:** The rear grab bar is only 24" long.

Install a compliant grab bar. The cost for compliance is included in Violation #18.

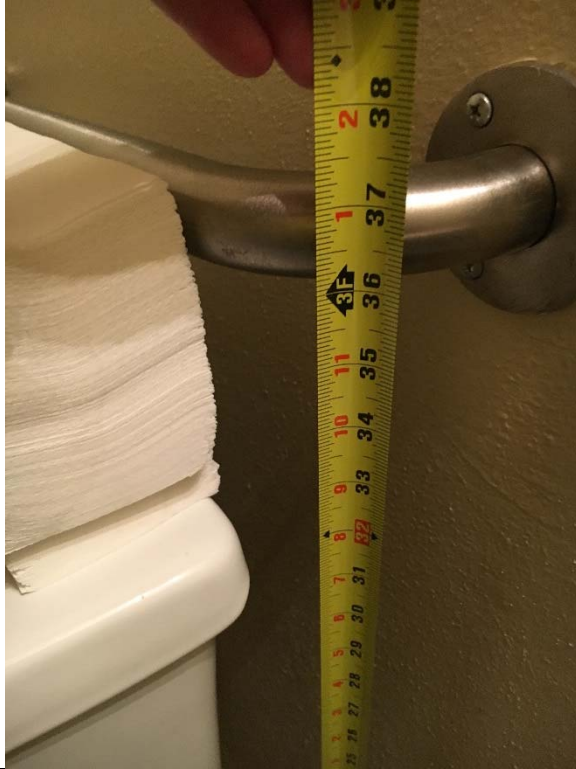
Men's Restroom: The rear grab bar is mounted too high at 37" above finished floor.

**2010 ADAAG 609.4 Position of Grab Bars.**

Grab bars shall be installed in a horizontal position, 33" - 36" maximum above the finish floor measured to the top of the gripping surface.

**Violation 20 - Men's Restroom:** The rear grab bar is mounted too high at 37" above finished floor.

Remount grab bar to compliant height. The cost for compliance is included in Violation #18.

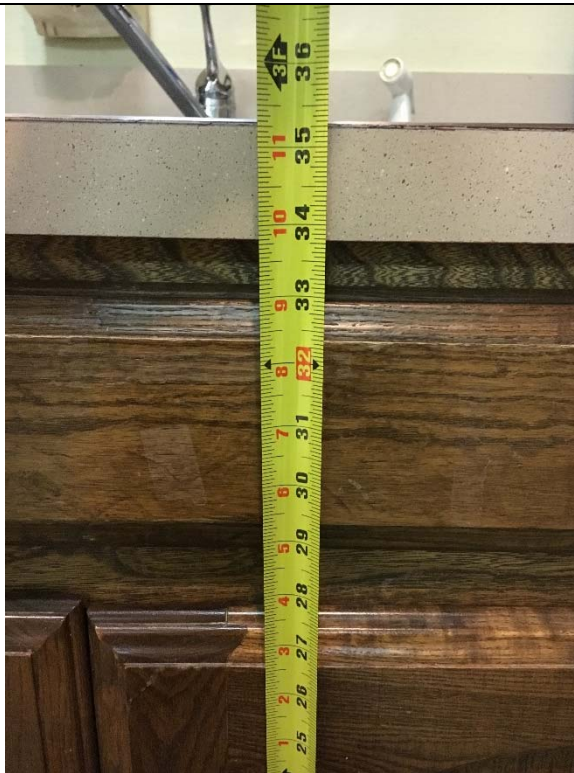
**Violation #21:** The sink is mounted higher than 34" above finished floor.

**Standard:** 2010 ADAAG 606.3 Height.

**Text:** Lavatories and sinks shall be installed with the front of the higher of the rim or counter surface 34 inches maximum above the finish floor or ground.

**Violation 21 -** The sink is mounted higher than 34" above finished floor.

**Possible Solutions:** Lower sink ensure front of the rim or counter surface is 34 inches maximum above the finish floor or ground.

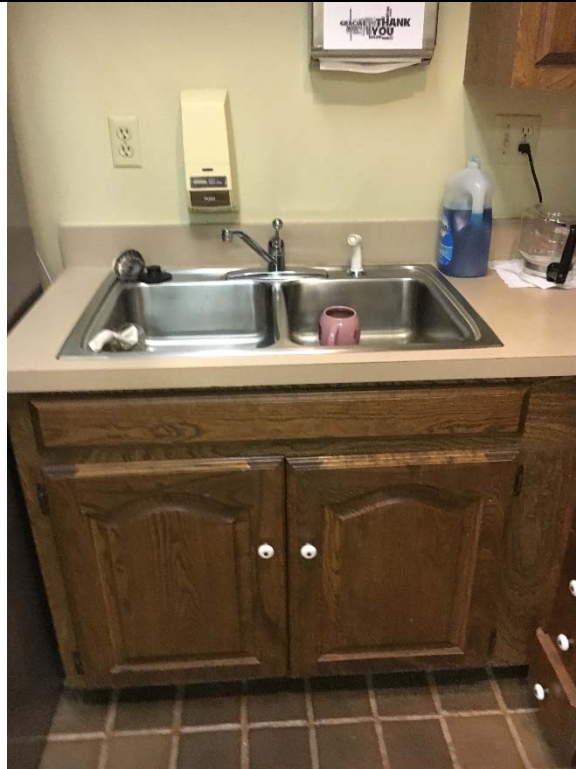
**Violation #22:** The sink does not have the required knee clearance provided.

**Standard:** 2010 ADAAG 606.2 Clear Floor Space.

A clear floor space complying with 305, positioned for a forward approach, and knee and toe clearance complying with 306 shall be provided.

**Violation 22** - The sink does not have the required knee clearance provided.

Modify cabinets to provide the required toe and knee clearance. The cost for compliance is included in Violation #21.

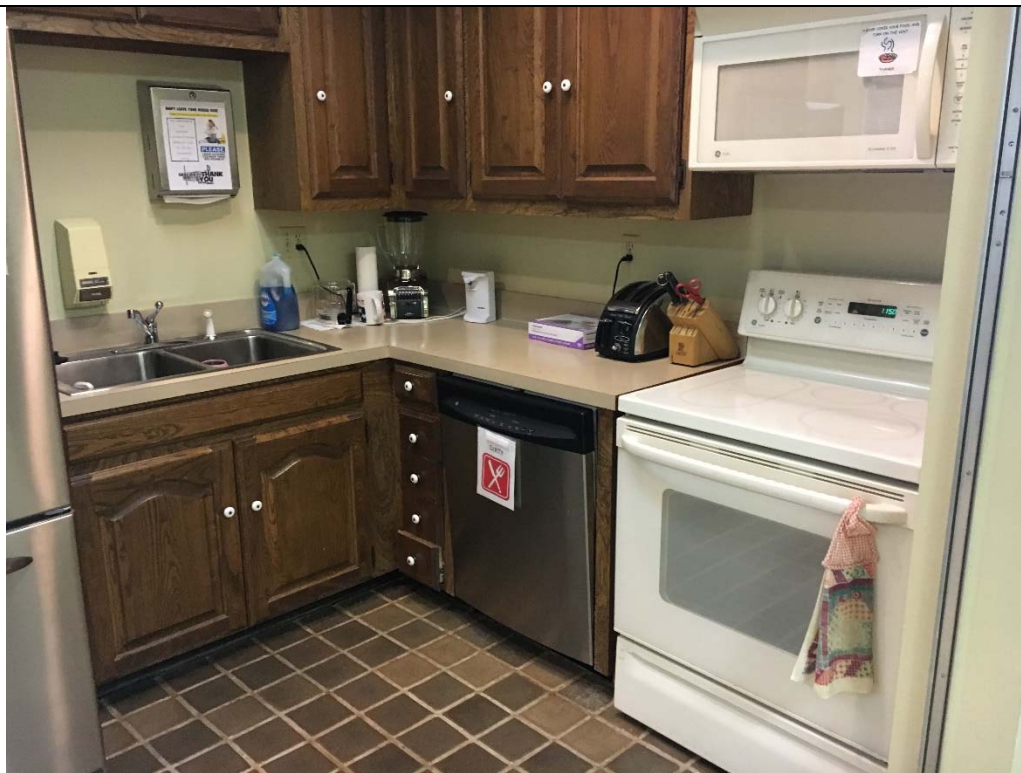
The microwave is mounted above 48" to the highest operable part.

**2010 ADAAG 308.3.2 Obstructed High Reach.**

Where a clear floor or ground space allows a parallel approach to an element and the high side reach is over an obstruction, the height of the obstruction shall be 34" max. and the depth of the obstruction shall be 24" max.

**Violation 23** - The microwave is mounted above 48" to the highest operable part.

Relocate microwave so that it is located within the required reach range.
