TOWN OF ADDISON BUILDING REPORT			
Facility Information:		Facility Name: Police Sul	ostation - Vitruvian
Facility Contact: Lisa	Pyles	Contact Phone: 972-450-2	2878
Accessology Inspector Infor	mation:		
<b>Inspector:</b> Kare <b>Email:</b> Kjacl	n Jackson kson@accessology.com		<b>Date:</b> April 19, 2017
Latitude: 32.93		<b>Longitude:</b> -96.84999	
Address: 4015	Vitruvian Way	City: Addison	County: Dallas
General Parking Notes:			
There build	_	g spaces provided in the parking	g lot adjacent to this
Total Parking Spaces:  Total Accessible Parking Spaces:  Number of van accessible spaces:  Is the accessible parking substantially compliant?  No			0
Violation #1:	e are no accessible parkin	ng spaces provided to serve this p	parking lot.
Standard:	2010 ADAAG 208.2 M	Ainimum Number.	
Text:		ring with 502 shall be provided i required by 208.2.1, 208.2.2, and	
Possible Solutions:  Create one accessible parking space and access an access aisle serving it with accessible signage.		ess aisle serving it

## **Summary Sheet for Police Substation - Vitruvian**

## **Police Substation - Vitruvian**

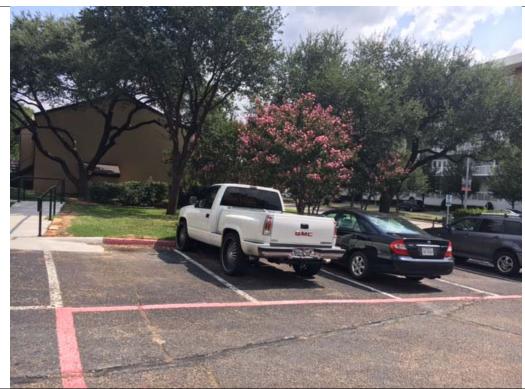
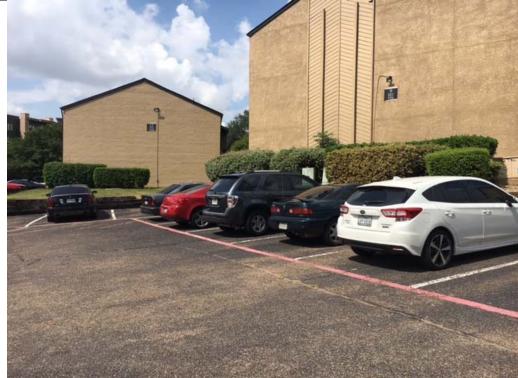
Violation 1 - There are no accessible parking spaces provided to serve this parking lot.

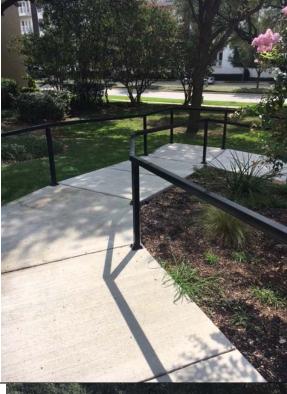
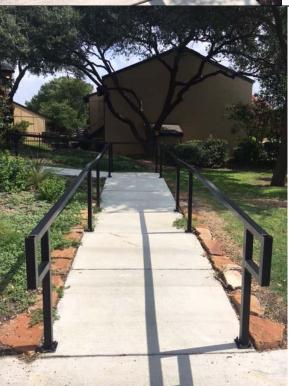
TOWN OF ADDISON BUILDING REPORT				
Facility Information:		Facility Name: Police Substation	on - Vitruvian	
Facility Contact: Lisa	a Pyles	<b>Contact Phone:</b> 972-450-2878		
Accessology Inspector Info	ormation:			
<b>Inspector:</b> Kar <b>Email:</b> Kja	en Jackson ckson@accessology.com		<b>te:</b> April 19, 2017	
Latitude: 32.9	937526	<b>Longitude:</b> -96.849994		
Address: 401	5 Vitruvian Way	City: Addison	County: Dallas	
		building entrance from the ramp is in sul	bstantial	
Is the path of travel from a Does the path of travel serv Is the path of travel from b entrance substantially com	ve all exterior amenition ouilding entrances to a		Yes N/A N/A	
Violation #2:	ramp leading to the bu	ilding entrance has no edge protection.		
Standard:	2010 ADAAG 405.	9 Edge Protection.		
Text:		inplying with 405.9.1 or 405.9.2 shall be ans and at each side of ramp landings.	provided on	
Possible Solutions:	Add edge protection	1.

Violation 2 - The ramp leading to the building entrance has no edge protection.

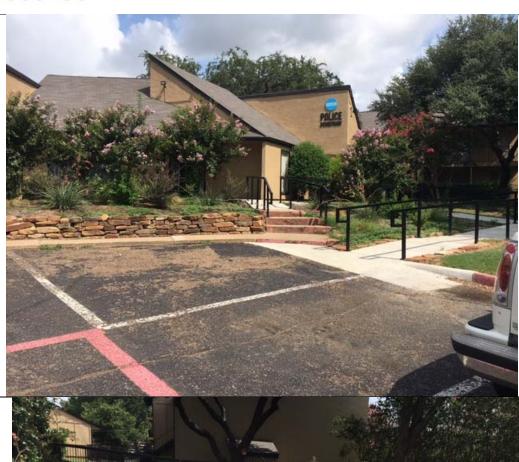
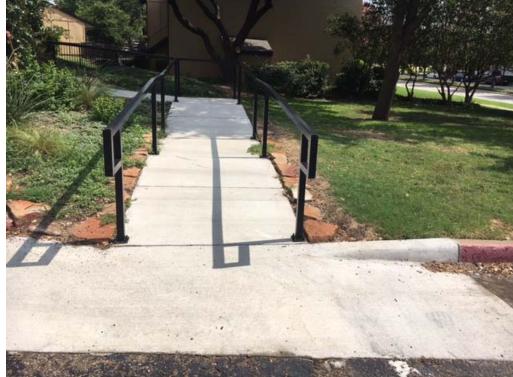
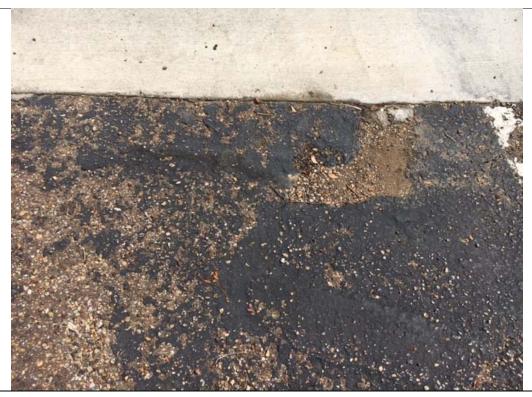
Violation #2 Cost:	\$5,250	Priority Level 4		
Violation #3•	bottom section of the r broken concrete.	ramp where it connects to the parking lot	has uneven	
Standard:	2010 ADAAG 405. ADAAG 302.1 Ger	<del>-</del>	2010

**Violation 3 -** The bottom section of the ramp where it connects to the parking lot has uneven and broken concrete.

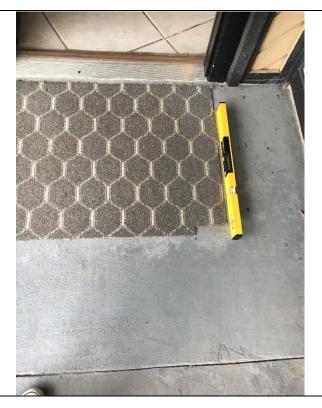
TOWN OF ADDISON BUILDING REPORT	
Facility Information:		Facility Name: Police Substation	on - Vitruvian
Facility Contact: Li	sa Pyles	<b>Contact Phone:</b> 972-450-2878	
Accessology Inspector Inf	formation:		
Inspector: Ka Email: Kj	aren Jackson jackson@accessology.c		<b>te:</b> April 19, 2017
Latitude: 32	2.937526	<b>Longitude:</b> -96.849994	
Address: 40	15 Vitruvian Way	City: Addison	County: Dallas
General Entrance Notes:			
Th	ne entrance into this fac	ility is not compliant.	
Is the main entry door ac Is there an alternate door If so, does the inaccessible of the nearest accessible of	that is accessible? e door have signage in	dicating the location	No No N/A
Violation #4:	nere is a 5.5% running s	slope up to the entrance door.	
Standard:	2010 ADAAG 40	4.2.4.4 Floor or Ground Surface	
Text:		urface within required maneuvering cleara Changes in level are not permitted. Slope all be permitted.	
Possible Solutions:	Modify exterior of area.	f entrance door to provide level maneuver	ing clearance

**Violation 4 -** There is a 5.5% running slope up to the entrance door.

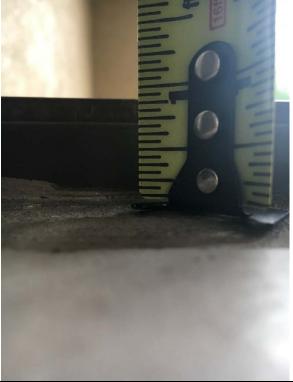
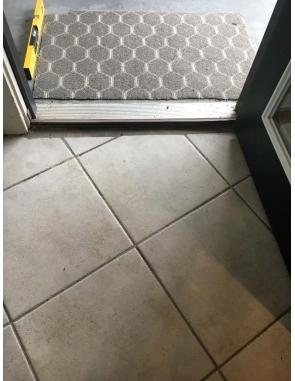
Violation #4 Cost:	\$2,625	Priority Level 4	
Violation #5:	nere is a 3/8" threshold	at the entrance door.	
Standard:	2010 ADAAG 40	4.2.5 Thresholds

Thresholds, if provided at doorways, shall be 1/2 inch (13 mm) high maximum. Raised thresholds and changes in level at doorways shall comply with 302 and 303.

**Violation 5** - There is a 3/8" threshold at the entrance door.

Modify threshold to achieve a change in level no greater than 1/2".

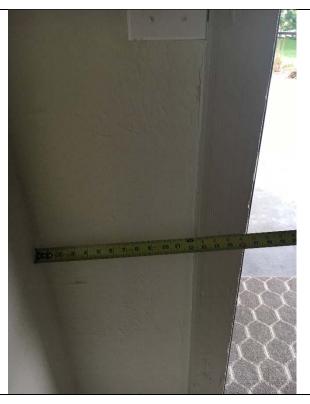
There is only a 16-3/8" maneuvering clearance on the pull side of the entrance door, a minimum of 18" maneuvering clearance is required.

Swinging doors and gates shall have maneuvering clearances complying with Table 404.2.4.1.

**Violation 6 -** There is only a 16-3/8" maneuvering clearance on the pull side of the entrance door, a minimum of 18" maneuvering clearance is required.

Modify door to provide 18" minimum clearance on the pull side of the door.

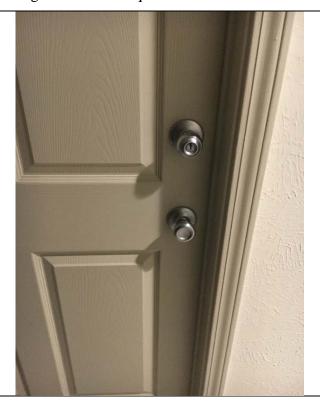
TOWN OF ADDISON BUILDING REPORT				
Facility Information:		Facility Name: Police Substa	tion - Vitruvian	
Facility Contact: Li	sa Pyles	<b>Contact Phone:</b> 972-450-2878	3	
Accessology Inspector In	formation:			
Inspector: Ka	aren Jackson	D	ate: April 19, 2017	
<b>Email:</b> Kj	jackson@accessology.co	om		
Latitude: 32	2.937526	<b>Longitude:</b> -96.849994		
Address: 40	015 Vitruvian Way	City: Addison	County: Dallas	
General Hallway Notes:				
Th	nere are no hallways in the town of	his building. Additionally, this is a lease Addison.	e space and is	
Does this facility have an	y hallways?		No	
Do the doors have compli	ant hardware?		No	
Do the doors have proper	_	ces?	No	
Is the hallway width at le			Yes	
Are visual strobes provid			No	
Are there any protruding	•		No	
Is the signage substantial	iy compilant?		N/A	
Violation #7:	nere are four (4) interior	doors with knob hardware.		
Standard:	2010 ADAAG 404.	.2.7 Door and Gate Hardware.

**Violation 7 -** There are four (4) interior doors with knob hardware.

Text:	Handles, pulls, late shall comply with 3	ches, locks, and other operable parts on 309.4.	doors and gates	
Possible Solutions:	Replace with lever	hardware.		
Violation #7 Cost:	\$1,575	Priority Level 6		
Violation #8:	nere is only a 11" maneuv oor.	vering clearance on the pull side of the	storage room

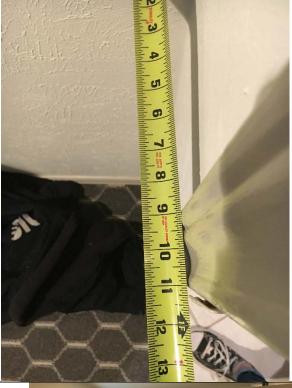
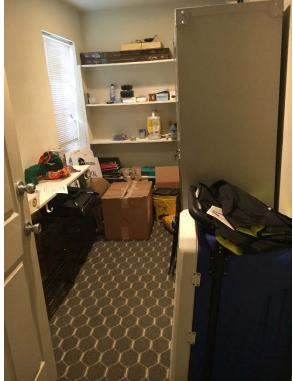
**Violation 8 -** There is only a 11" maneuvering clearance on the pull side of the storage room door.

TOWN OF ADDISON - Police Substation - Vitruvian		
	Hallway - Page 2		
Standard:	404.2.4.1 Swinging Doors and Gates.		
Text:	Swinging doors and gates shall have maneuvering clearances complying with Table 404.2.4.1.		
Possible Solutions:	Modify door to provide 18" minimum clearance on the pull side of the door.		
Violation #8 Cost:	\$2,625 Priority Level 12		
	High Priority 1-4		
Hallway Total	\$4,200 Medium Priority 5-8		
	Low Priority 9-12

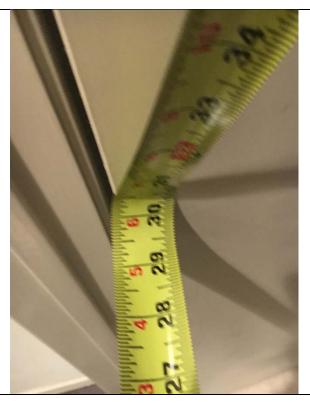
TOWN OF ADDISON BUILDING REPORT				
Facility Information:		Facility Name: Police Substa	tion - Vitruvian	
Facility Contact: List	sa Pyles	<b>Contact Phone:</b> 972-450-2878	3	
Accessology Inspector Inf	formation:			
<b>Inspector:</b> Ka <b>Email:</b> Kj	uren Jackson ackson@accessology.co		<b>Pate:</b> April 19, 2017	
Latitude: 32	.937526	<b>Longitude:</b> -96.849994		
Address: 40	15 Vitruvian Way	City: Addison	County: Dallas	
General Restroom Not <u>es:</u>				
Th	ere is one single-user re	estroom provided in this facility.		
Is the door to the restroor Does the room have the ro Is the water closet substant Does the water closet have Is the lavatory substantial Is the urinal substantially Is the mirror substantially Violation #9:	equired turning radius ntially compliant? e the required clear flo lly compliant? compliant?	g is only 30-1/2" wide.	No Yes No Yes Yes Yes N/A Yes	
Text:	openings of doorwa	ll provide a clear width of 32 inches min ays with swinging doors shall be measu d the stop, with the door open 90 degree	red between the

**Violation 9 -** The restroom door opening is only 30.5" wide.

Possible Solutions:	Modify door to pro	ovide 32" minimum clear width.		
Violation #9 Cost:	\$2,625	Priority Level 4		
Violation #10:	e centerline of the water	r closet is only at 15".

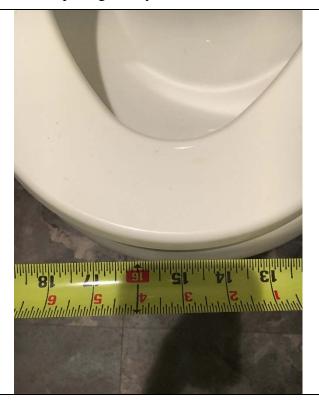
TOWN OF ADDISON - Police Substation - Vitruvian		
	Restrooms - Page 2		
Standard:	2010 ADAAG 604.2 Location		
Text:	The water closet shall be positioned with a wall or partition to the rear and to one side. The centerline of the water closet shall be 16 inches minimum to 18 inchesmaximum from the side wall or partition.		
Possible Solutions:	Relocate water closet to provide 16"-18" centerline.		
Violation #10 Cost:	\$2,625 Priority Level 5		
Violation #III	ne grab bars are mounted at 39" above finished floor to the top of the gripping rface.		
Standard:	2010 ADDAG 609.4 Position of Grab Bars.		
	Grab bars shall be installed in a horizontal position, 33 inches minimum and 36 inches maximum above the finish floor measured to the top of the gripping surface.		
Γext:	and 36 inches maximum above the finish floor measured to the top of the		
	and 36 inches maximum above the finish floor measured to the top of the

**Violation 10 -** The centerline of the water closet is only at 15".

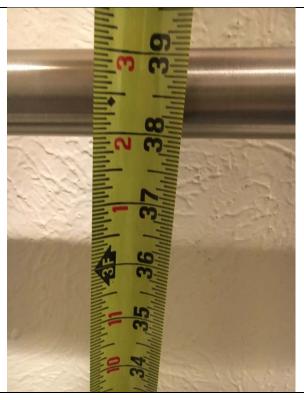
**Violation 11** – The grab bars are mounted at 39" above finished floor to the top of the gripping surface.

Possible Solutions:	and 36 inches maximum above the finish floor measured to the top of the gripping surface.  Remove and reinstall grab bars at 33"-36" to the top of the gripping		
Text: Possible Solutions: Violation #11 Cost:	and 36 inches maximum above the finish floor measured to the top of the gripping surface.  Remove and reinstall grab bars at 33"-36" to the top of the gripping surface.		
Possible Solutions:	and 36 inches maximum above the finish floor measured to the top of the gripping surface.  Remove and reinstall grab bars at 33"-36" to the top of the gripping surface.  \$525  Priority  Level 8

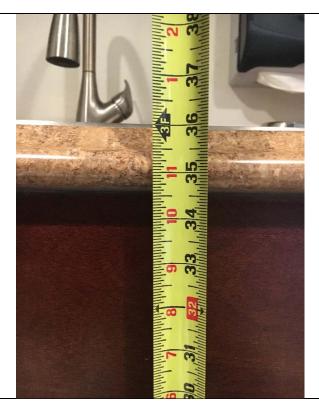
**Violation 12 -** The sink in the break room is at 36" above finished floor to the counter.

TOWN OF ADDISON BUILDING REPORT	
Facility Information:	Facility Name: Police Substa	ntion - Vitruvian
Facility Contact: L	isa Pyles Contact Phone: 972-450-287	8
Accessology Inspector Ir	formation:	
Inspector: K Email: K	aren Jackson I jackson@accessology.com	<b>Date:</b> April 19, 2017
Latitude: 3 Address: 4	2.937526 <b>Longitude:</b> -96.849994 <b>City:</b> Addison	County: Dallas
General Break Room No		
T	he break room provided in this facility does not have a complian	nt sink.
Does the facility have a k Is there a stove or cookto Is there a sink? Is the sink substantially Are the counters at 34" a Violation #12:	op? compliant?	Yes No Yes No No
Standard:	2010 ADAAG Height.	Junier.
Text:	Lavatories and sinks shall be installed with the front of the rim or counter surface 34 inches maximum above the finis ground.	-
Possible Solutions:	Modify sink to provide 34" maximum height.	
Violation #12 Cost:	\$2,100 Priority Level 4

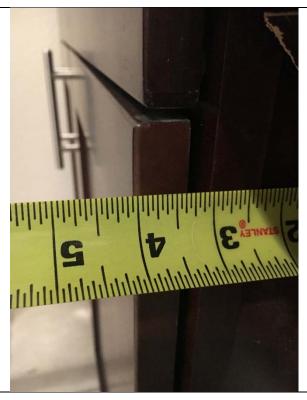
Violation #13.	he knee clearance is only 4" deep at 27" above finished floor when the family 8" is required.	nere a minimum
Standard:	2010 ADAAG 306.3.3 Minimum Required Depth

## **TOWN OF ADDISON - Police Substation - Vitruvian Break Rooms - Page 2** Where knee clearance is required under an element as part of a clear floor space, the knee clearance shall be 11" deep minimum at 9" above the Text: finish floor or ground, and 8" deep minimum at 27" above the finish floor or ground. Modify cabinet apron to achieve required knee clearance. The cost of **Possible Solutions:** compliance is included in Violation #12. Level 4 Violation #13 Cost: \$0 **Priority** High Priority 1-4 Break Rooms Total \$2,100 Medium Priority 5-8 Low Priority 9-12

**Violation 13 -** The knee clearance is only 4" deep at 27" above finished floor where a minimum of 8" is required.
