**TOWN OF ADDISON
BUILDING REPORT**

Facility Information: **Facility Name:** Service Center
Facility Contact: Lisa Pyles **Contact Phone:** 972-450-2878

Accessology Inspector Information:
Inspector: Karen Jackson **Date:** April 17, 2017
Email: Kjackson@accessology.com

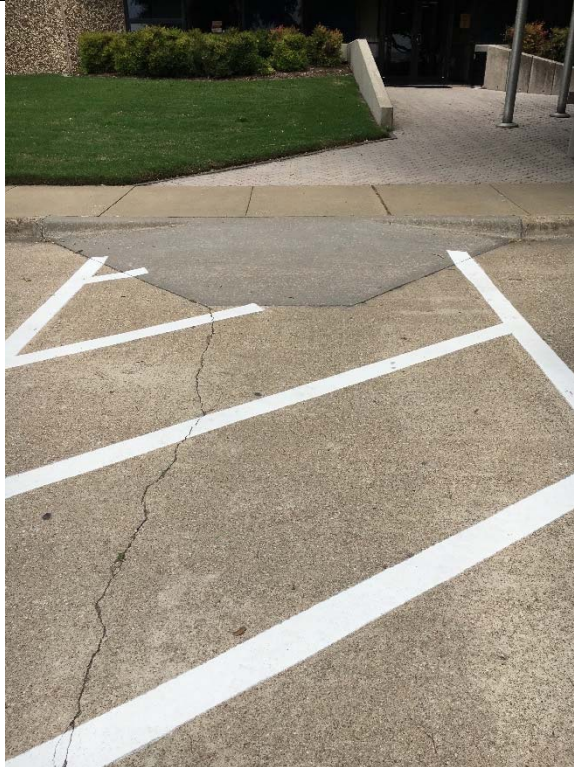
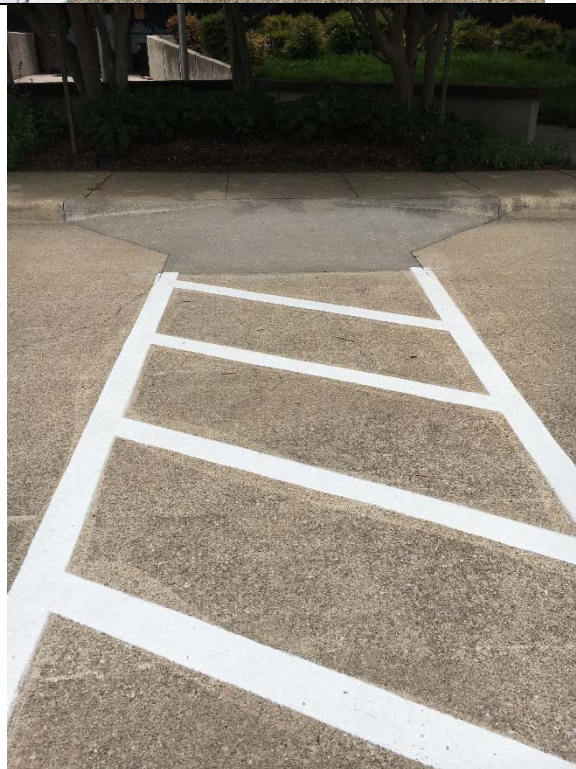
Violation #1: There are built up curb ramps protruding into the access aisles.

Violation 1 - There are built up curb ramps protruding into the access aisles.

Rework the curb ramps so they do not project into the access aisles.

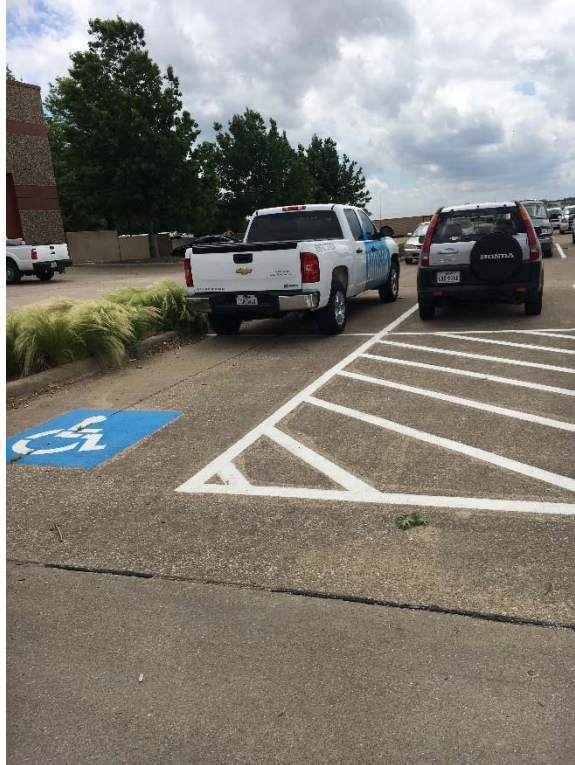
There are 155 parking spaces provided in the employee lot, only 1 accessible space is provided where 6 are required to be provided.

Violation 2 - There are 155 parking spaces provided in the employee lot, only 1 accessible space is provided where 6 are required to be provided.

Add 5 additional accessible parking spaces with access aisles and compliant signage.

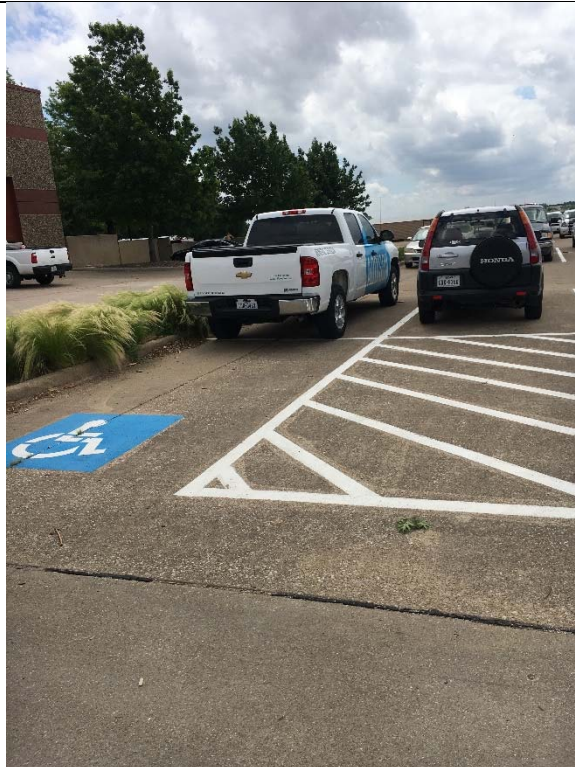
The accessible parking in the employee lot does not have signage provided.

Violation 3 - The accessible parking in the employee lot does not have signage provided.

Add a compliant van accessible sign.

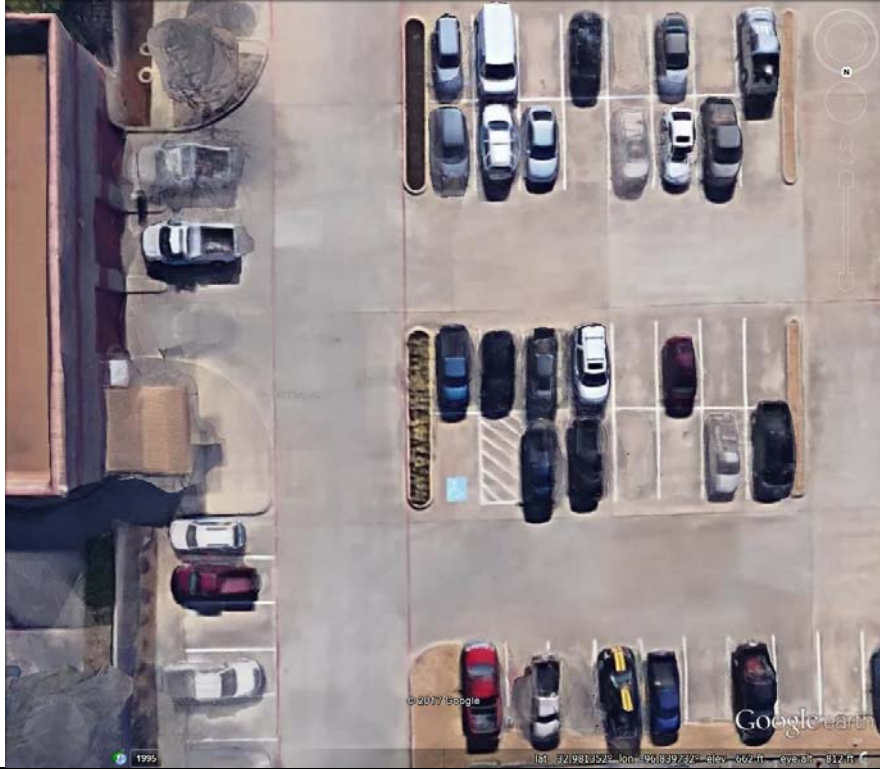
There is not a striped cross walk leading from the accessible parking in the employee lot to the sidewalk.

Violation 4 - There is not a striped cross walk leading from the accessible parking in the employee lot to the sidewalk.

Add a marked crossing from the access aisle to the sidewalk.

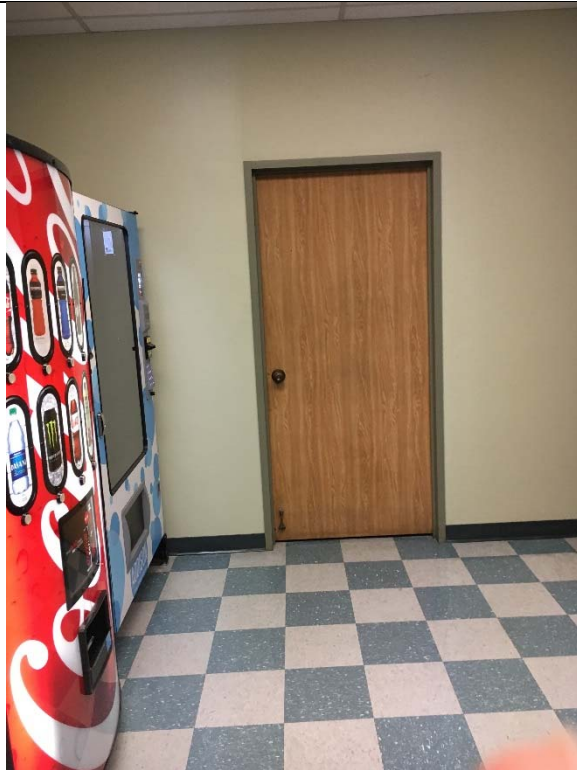
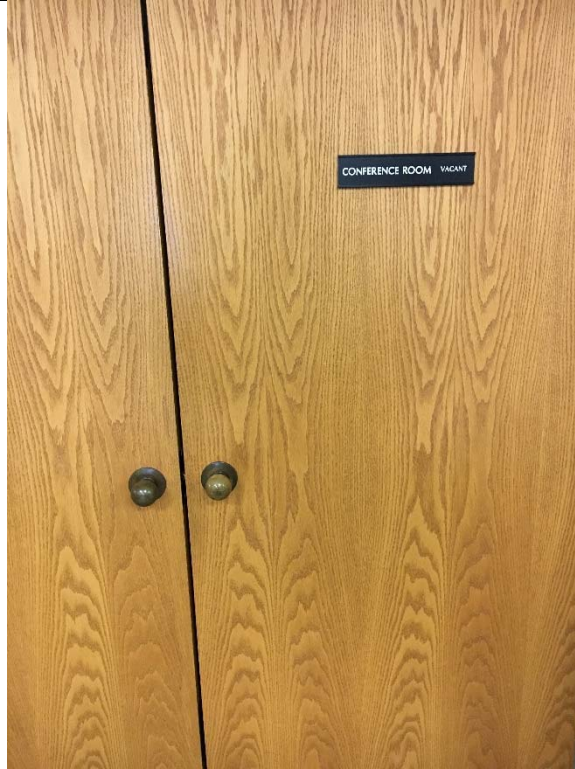
Violation #5: There are approximately 61 door knobs throughout the facility that require grasping and twisting to operate.

Violation 5 - There are approximately 61 door knobs throughout the facility that require grasping and twisting to operate.

Possible Solutions: Replace with lever style door hardware.

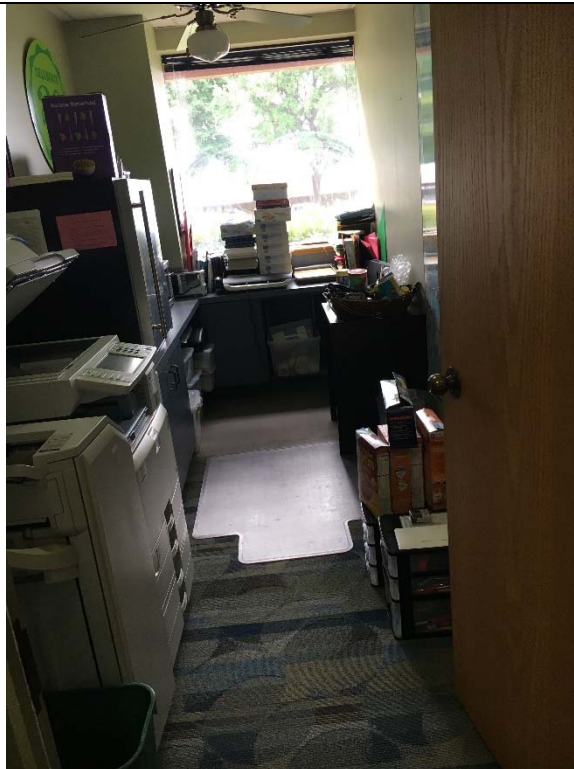
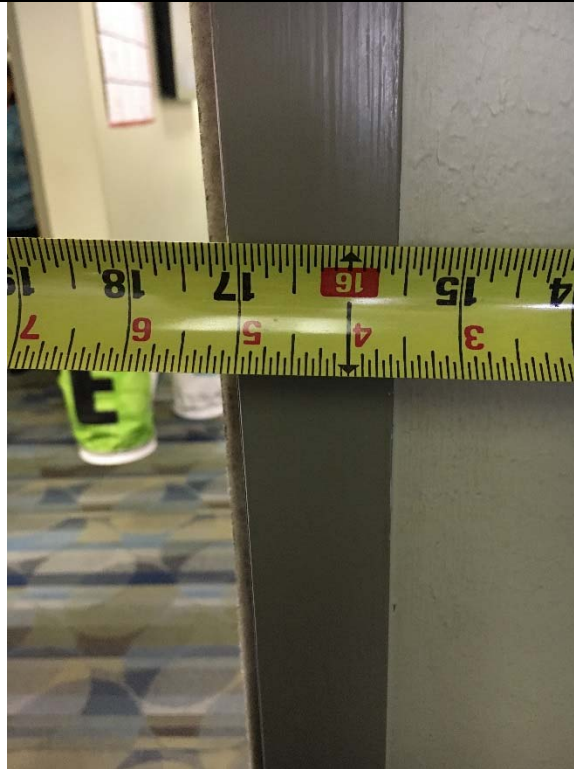
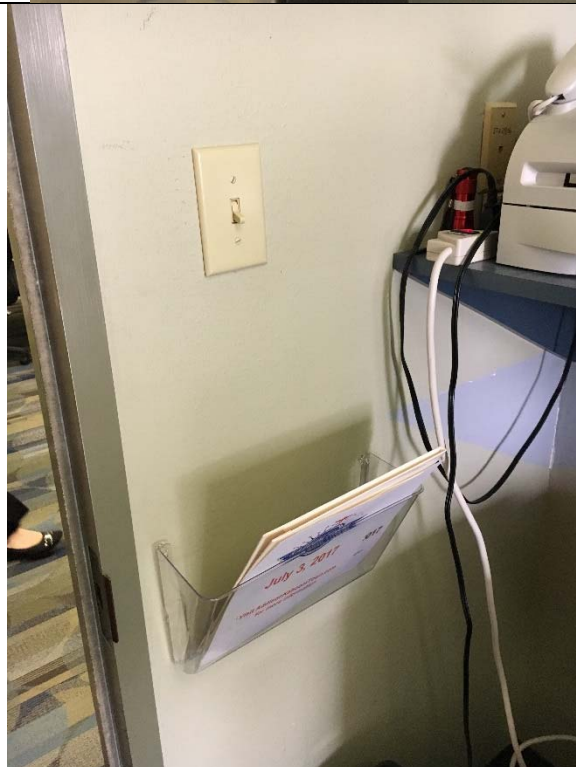
The copy room in the Special Events area only has a 17" maneuvering clearance on the pull side of the door where a minimum of 18" is required.

Violation 6 - The copy room in the Special Events area only has a 17" maneuvering clearance on the pull side of the door where a minimum of 18" is required.

Modify the door to provide 18" minimum clearance on the pull side of the door.

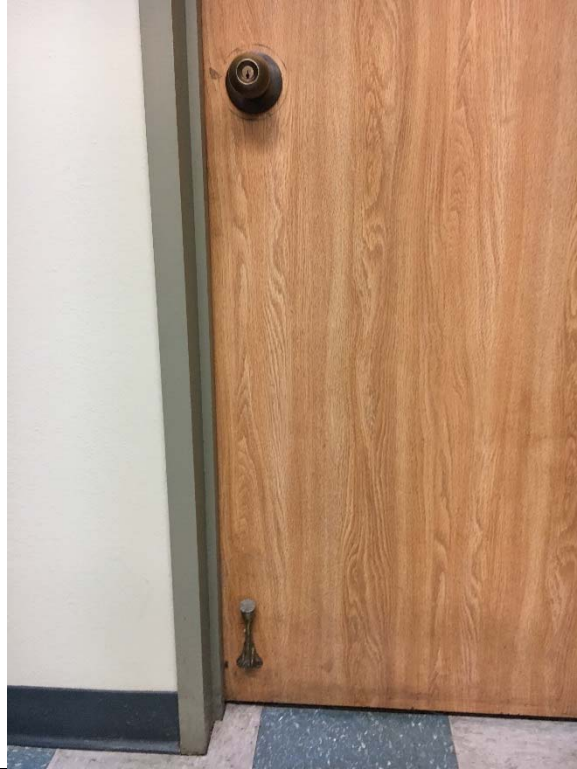
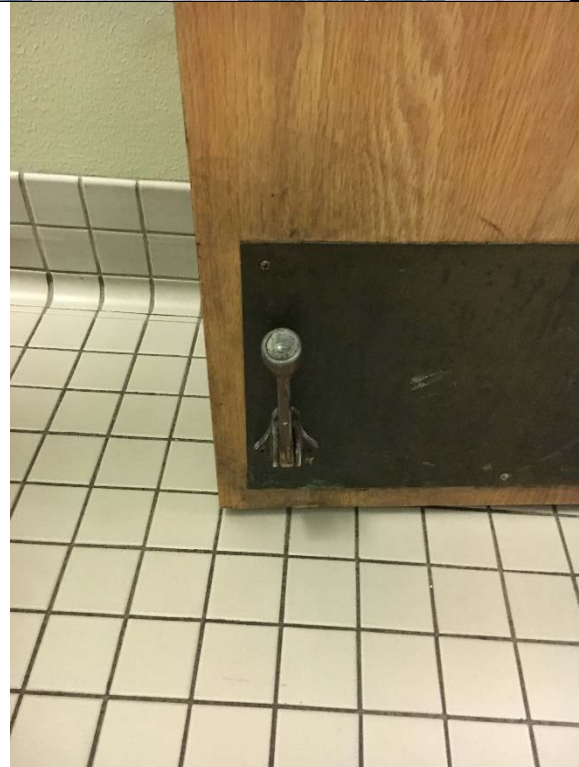
The door in the 1st floor break room and the restrooms serving the break room have fixed door stops and do not have a smooth surface 10" from the bottom of the door.

Violation 7 - The door in the 1st floor break room and the restrooms serving the break room have fixed door stops and do not have a smooth surface 10" from the bottom of the door.

Remove the door stops from the 3 doors.

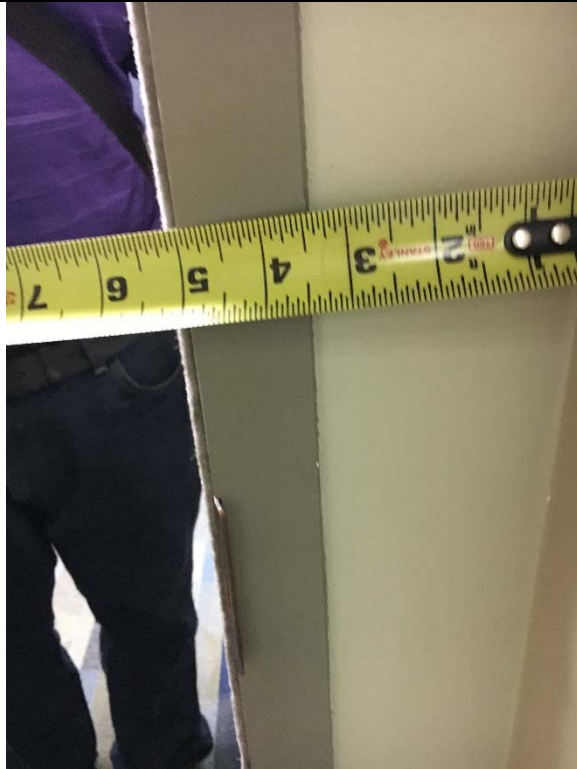
The office door by the service center only has a 5" maneuvering clearance on the pull side of the door where a minimum of 18" is required.

Violation 8 - The office door by the service center only has a 5" maneuvering clearance on the pull side of the door where a minimum of 18" is required.

Modify the door to provide 18" minimum clearance on the pull side of the door.

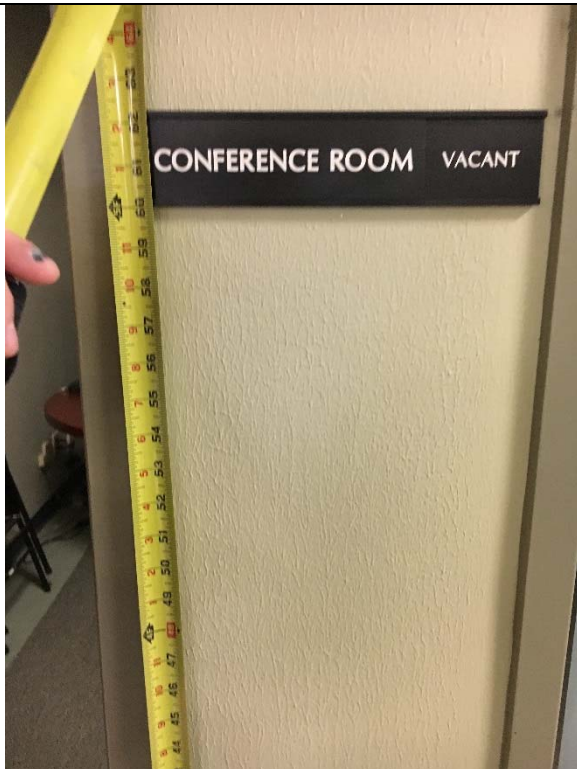
The conference room signage has no Braille or tactile characters.

Violation 9 - The conference room signage has no Braille or tactile characters.

Install compliant signage.

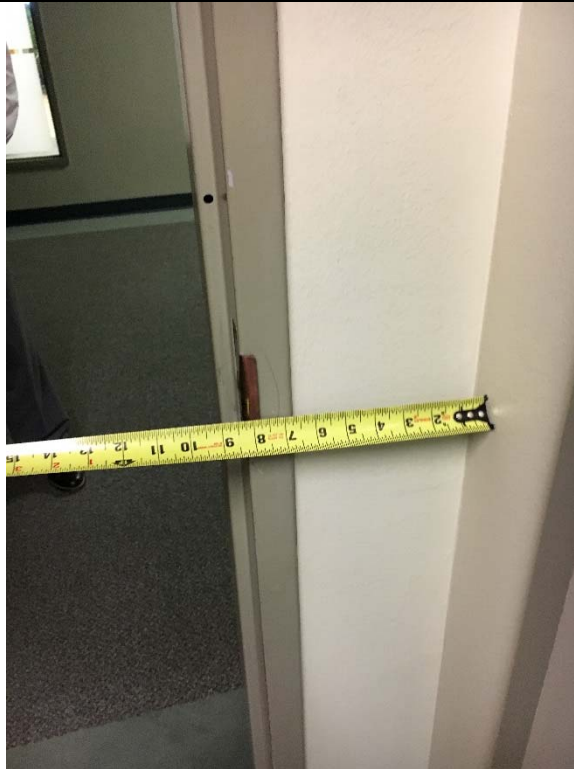
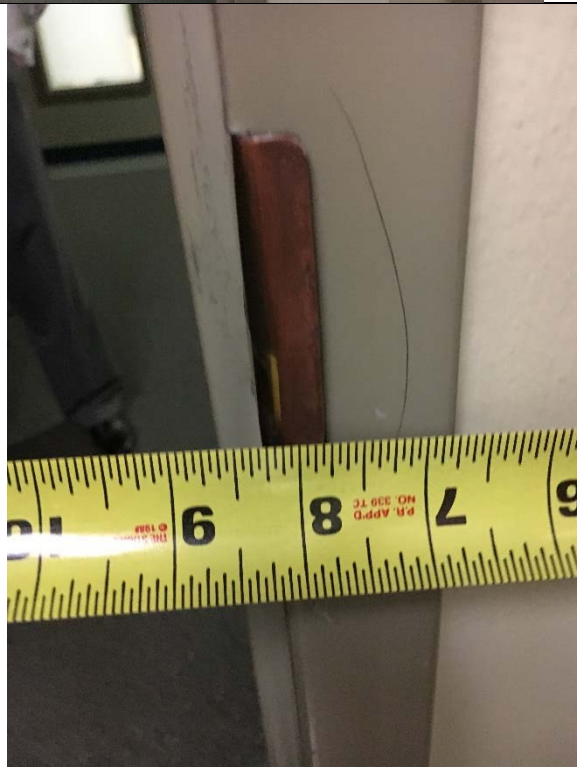
The back exit door in the conference room only has an 8.5" maneuvering clearance on the pull side where a maximum of 18" is required.

Violation 10 - The back exit door in the conference room only has an 8.5" maneuvering clearance on the pull side where a maximum of 18" is required.

Modify the door to provide 18" minimum clearance on the pull side of the door.

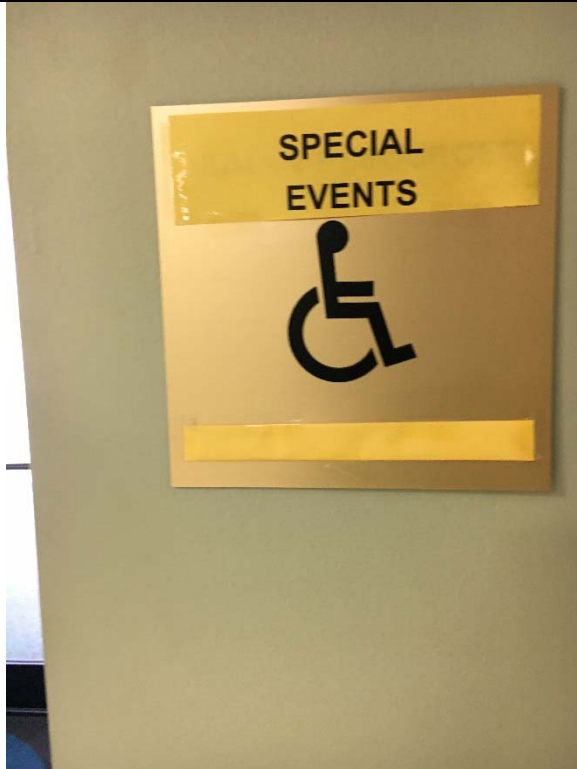
The Special Events signage does not have Braille provided.

Violation 11 - The Special Events signage does not have Braille provided.

Install compliant signage.

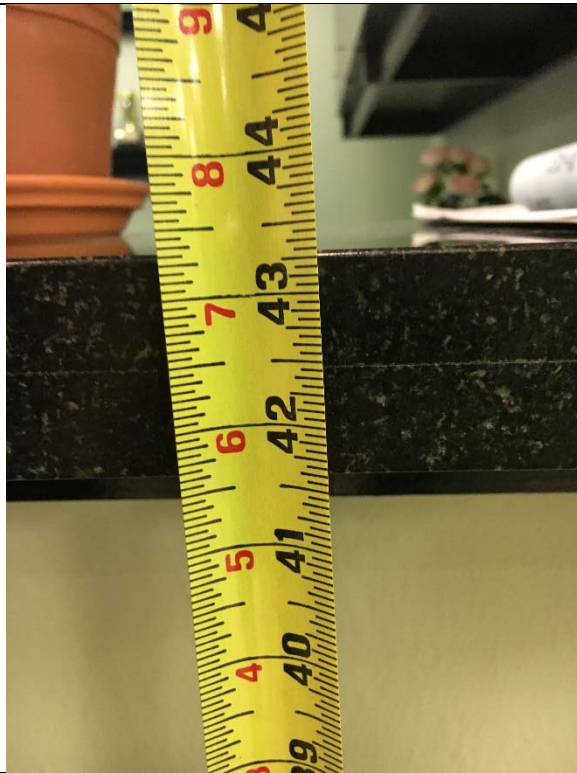
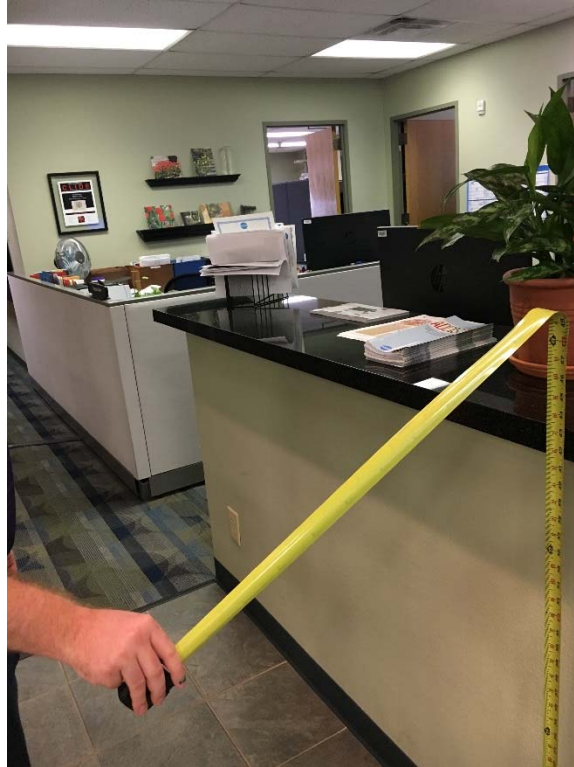
The counter in the front office is mounted at 43-1/4" above finished floor.

Violation 12 - The counter in the front office is mounted at 43-1/4" above finished floor.

Modify counter to provide a 36" length of counter at 36" high.

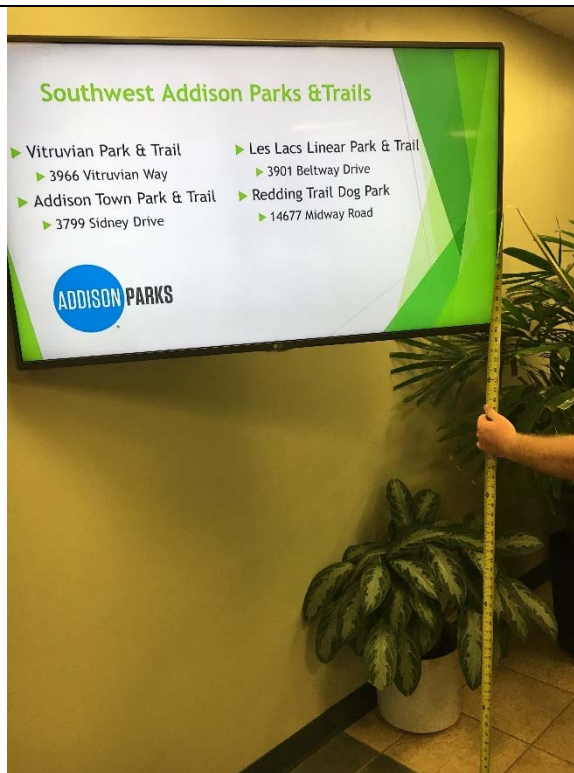
The TV monitor in the front lobby protrudes into the path of travel.

Violation 13 - The TV monitor in the front lobby protrudes into the path of travel.

Relocate TV monitor to a location where it is out of the circulation path or provide a fixed barrier beneath the monitor.

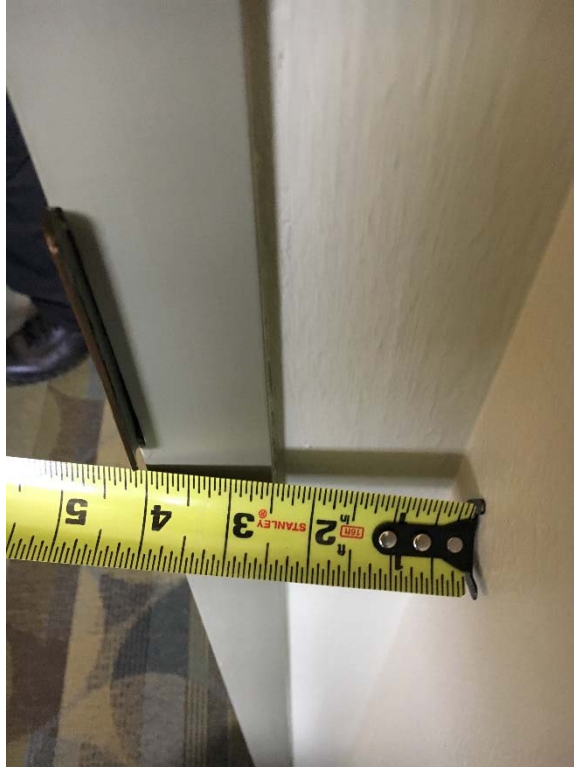
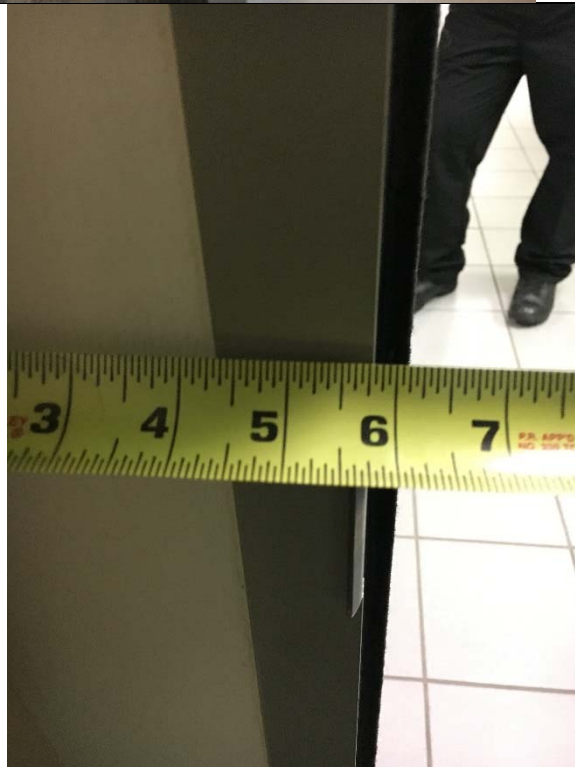
Violation 14 - There are two private offices on the 2nd floor do not have a minimum of 18" maneuvering clearance on the pull side of the doors.

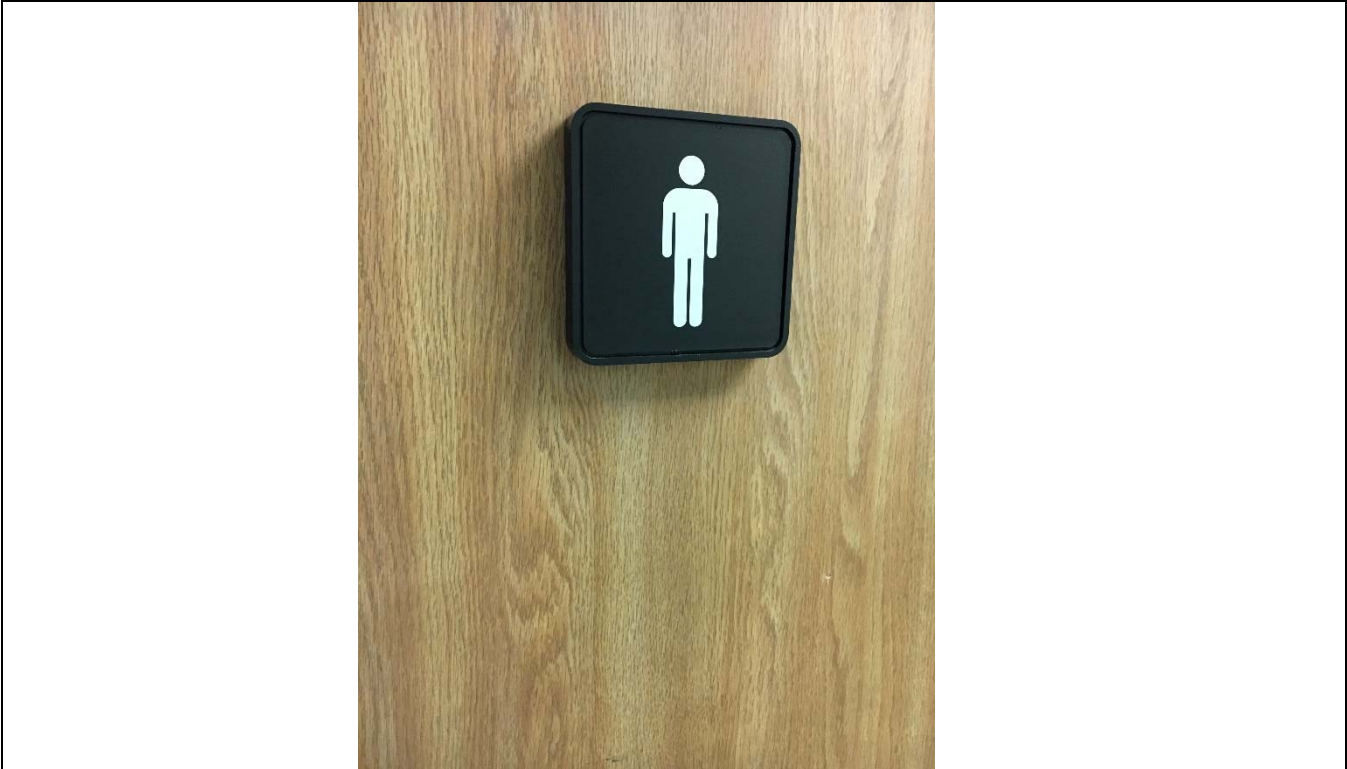
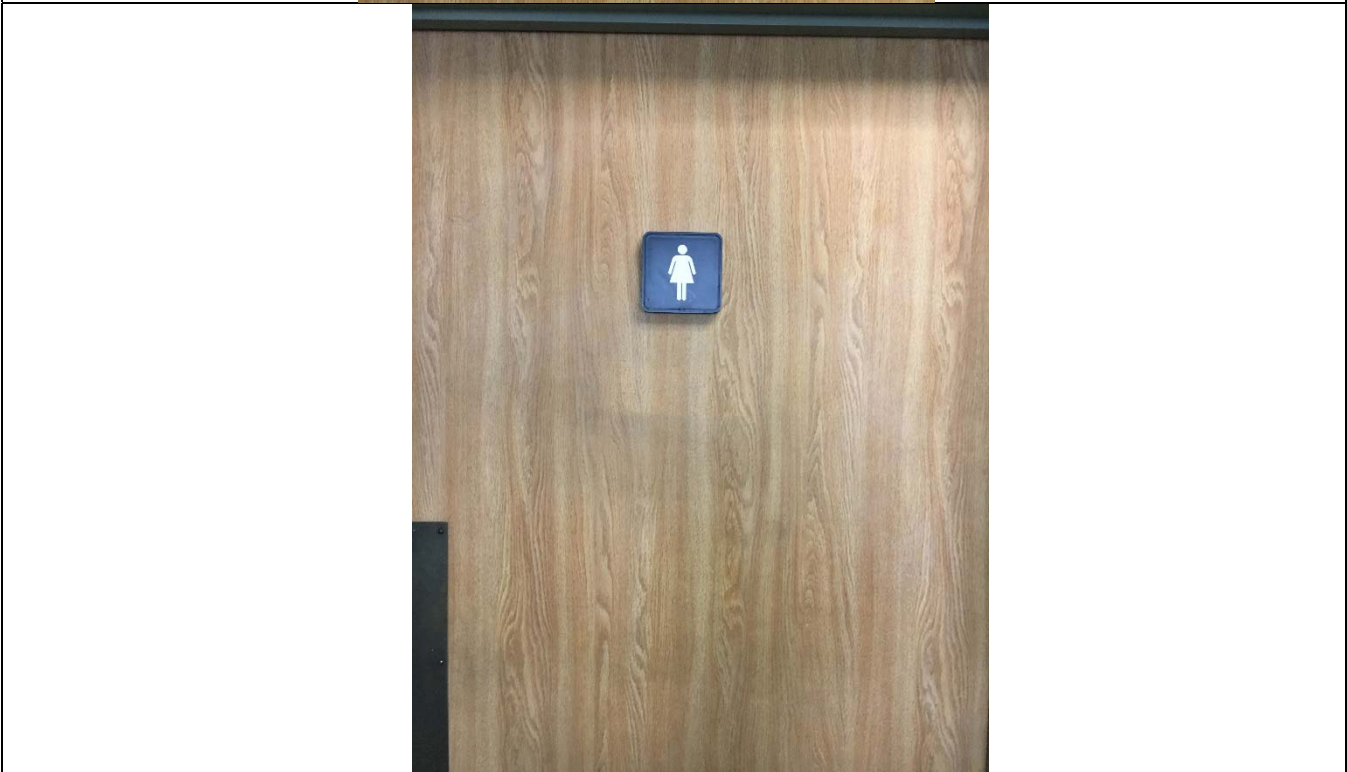
Violation 15 - Breakroom area: Men's and Women's restroom signage is mounted on the door and does not have Braille or tactile characters.

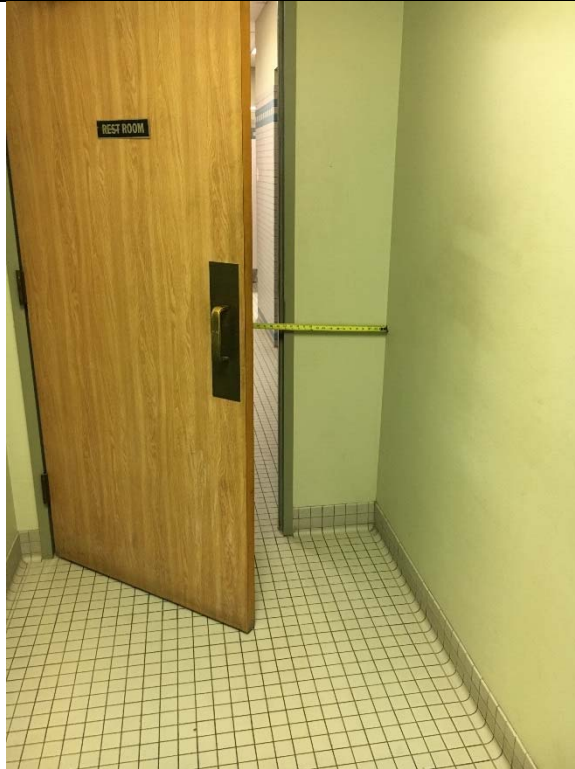
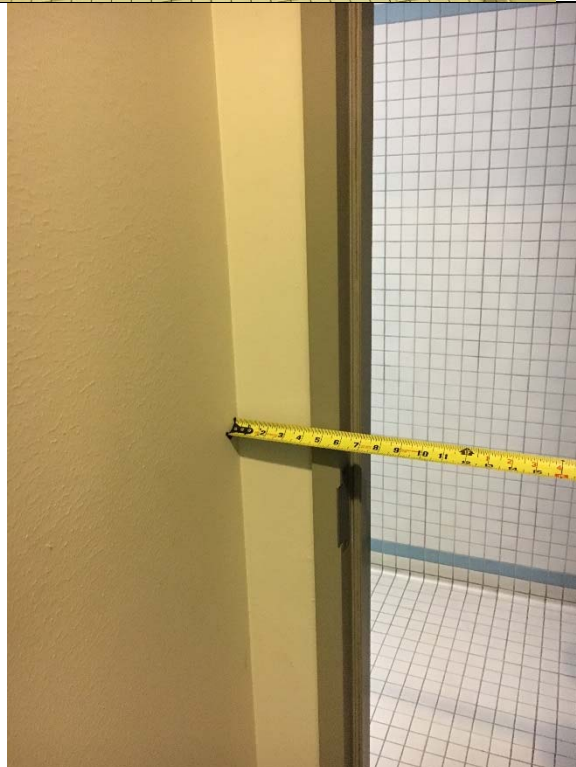
Violation 16 - Breakroom area: The Men's restroom door only has a 5-1/4" maneuvering clearance on the pull side of the outer door and both of the Women's restroom doors only has a 6-1/2" maneuvering clearance on the pull side.

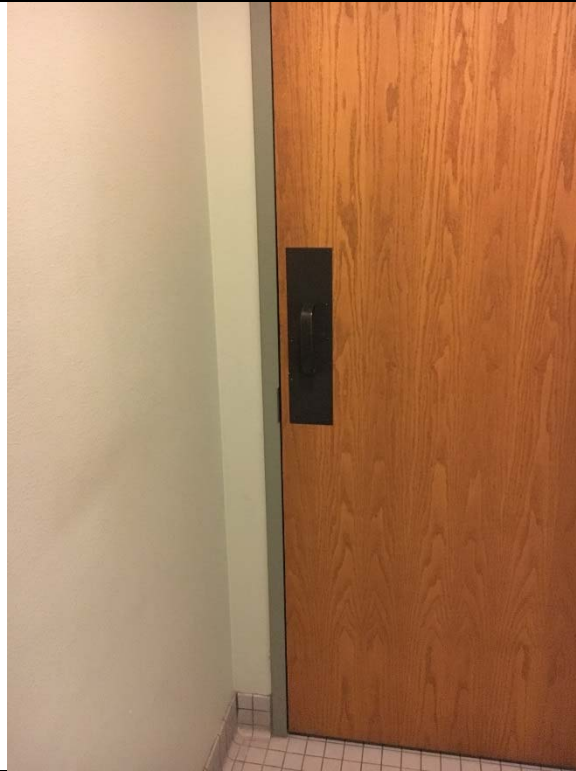
Violation 17 - Breakroom area: Men's and Women's restroom doors require more than 5lbs of pressure to operate.

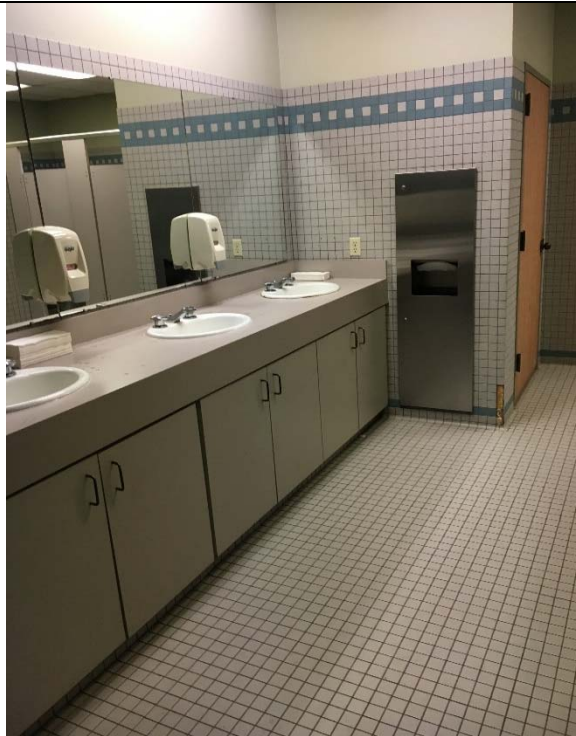
Violation 18 - Breakroom Area: Men's room lavatory does not have the required knee clearance provided and the counter is too high at 36-1/4" above finished floor.

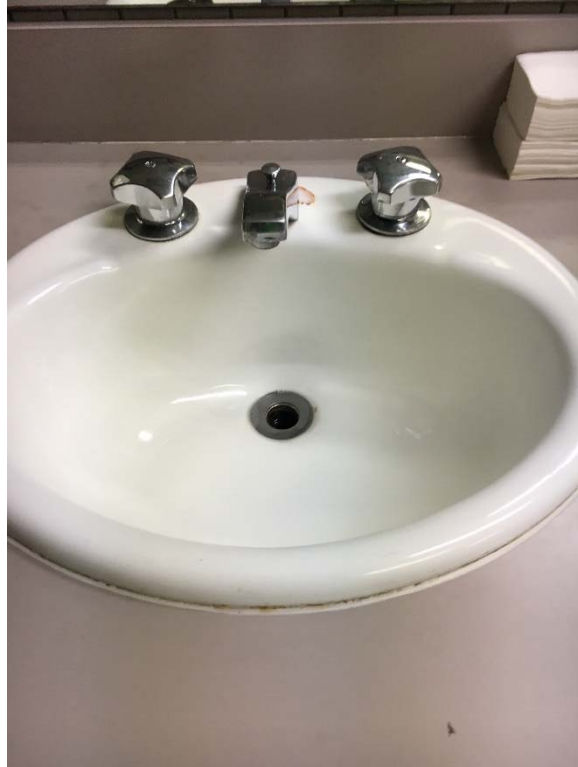
Violation 19 - Breakroom Area: Men's room lavatory faucets require grasping and twisting to operate.

Replace with lever style hardware.

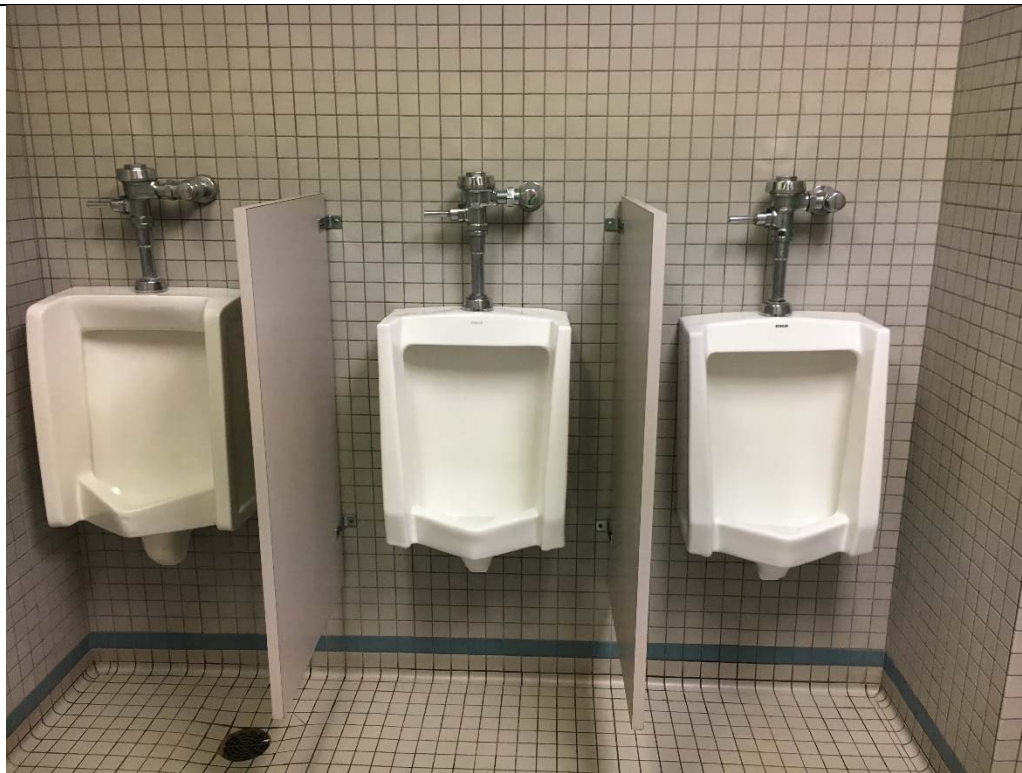
Violation 20 - Breakroom Area: Men's room has 3 urinals and no accessible urinal is provided.

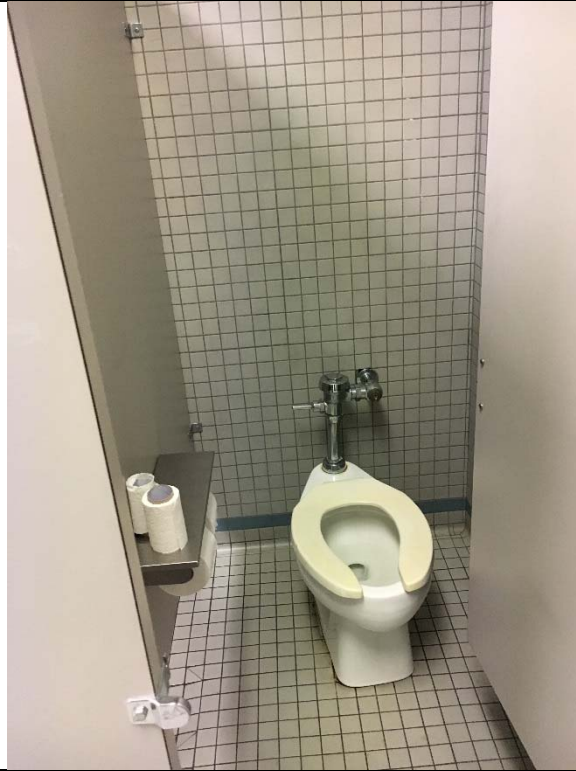
Violation 21 - Breakroom Area: Men's restroom does not have an accessible toilet compartment.

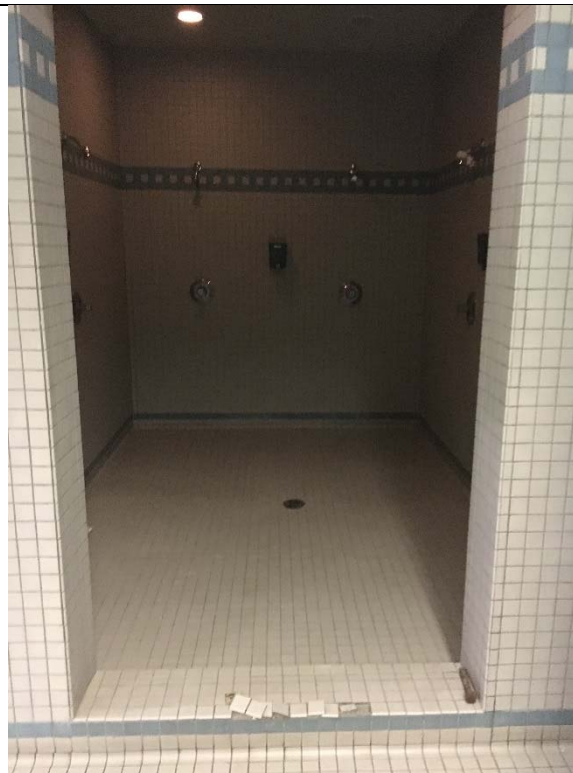
Violation 22 - Breakroom Area: Men's restroom does not have an accessible shower compartment.

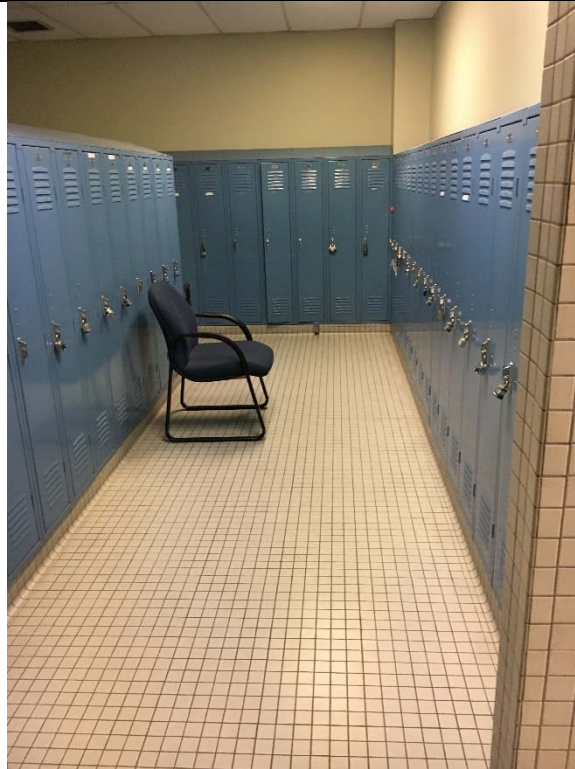
Violation 23 - Breakroom Area: Men's room locker area has no accessible bench.

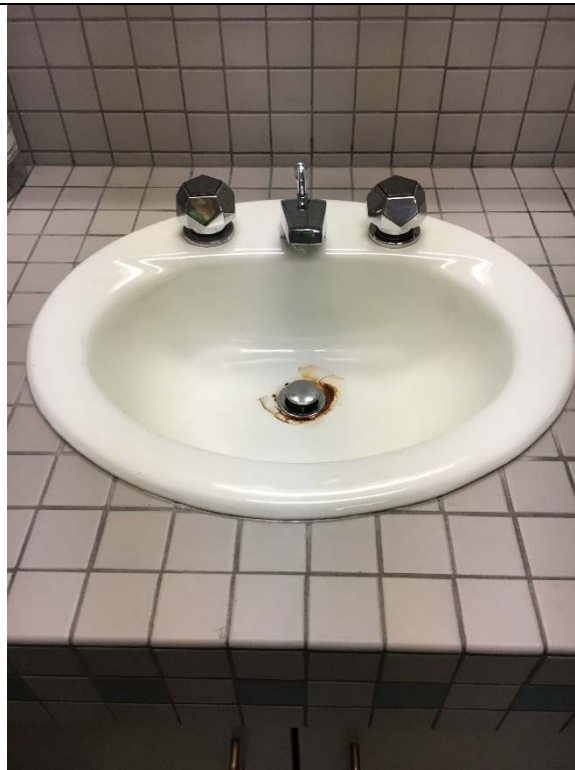
Violation 24 - Breakroom Area: Women's restroom lavatory faucets require grasping and twisting to operate and it does not have the required knee clearance.

Replace with lever style hardware and remove the cabinet below to allow for the required knee clearance.

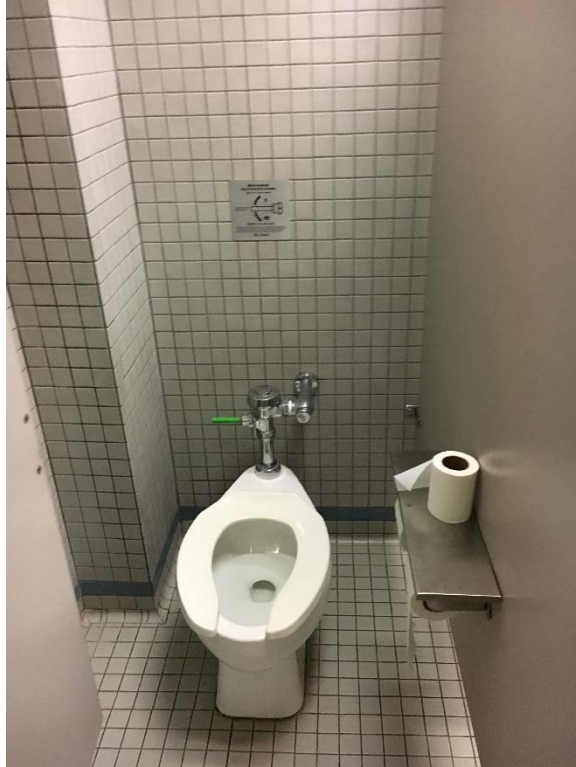
Violation 25 - Breakroom Area: Women's restroom does not have an accessible toilet compartment.

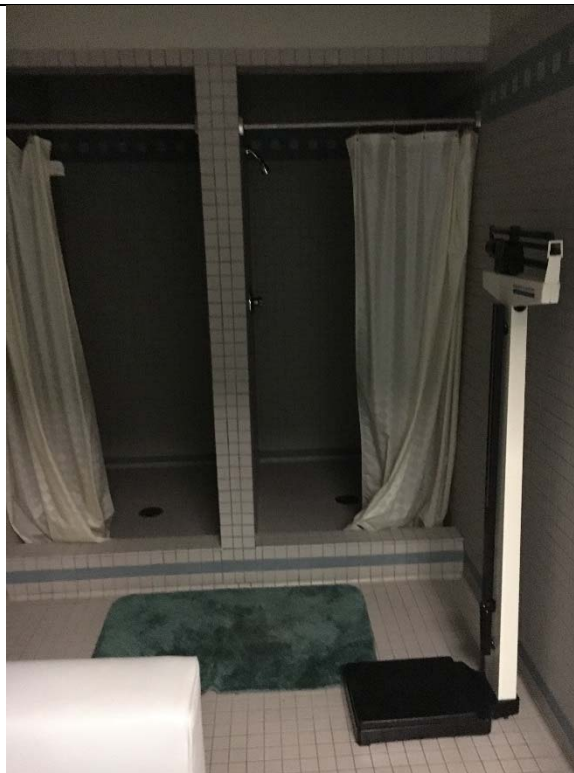
Violation 26 - Breakroom Area: Women's restroom does not have an accessible shower compartment.

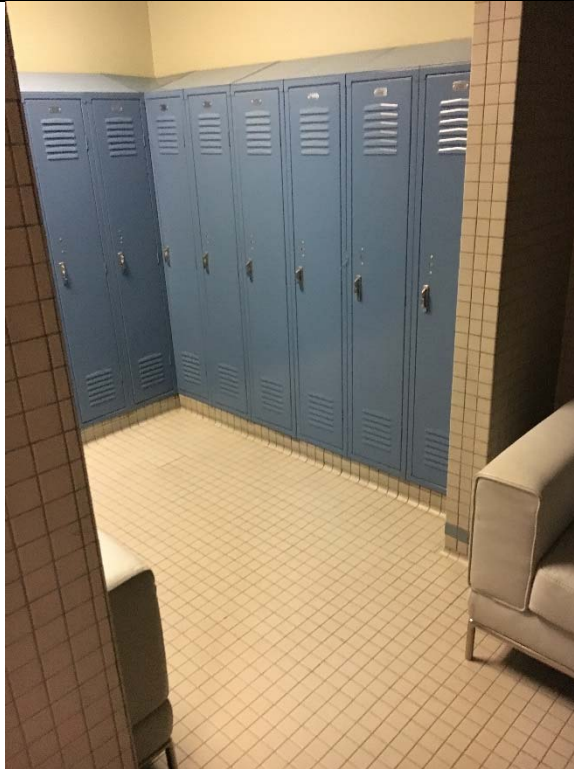
Violation 27 - Breakroom Area: Women's room locker area does not have an accessible bench.

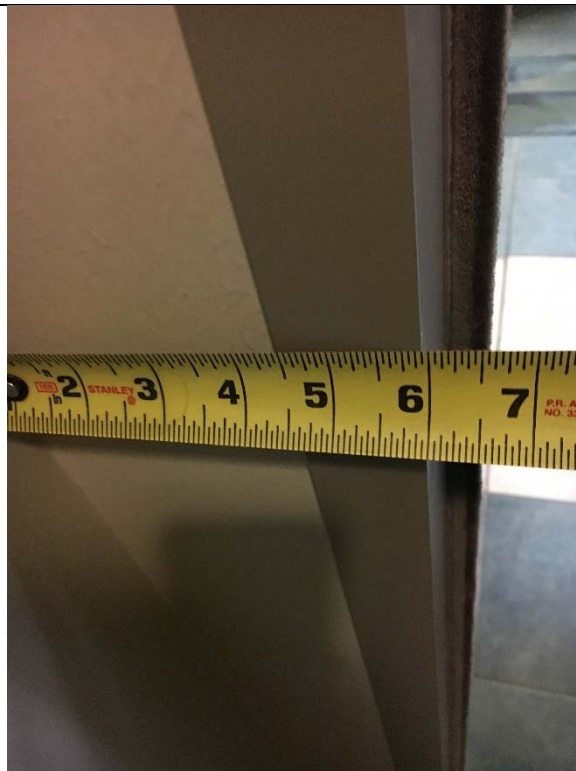
Violation #28: 1st floor lobby: Women's room door only has a 6" maneuvering clearance on the pull side and the door requires more than 5lbs of pressure to operate.

Violation 28 - 1st floor lobby: Women's room door only has a 6" maneuvering clearance on the pull side and the door requires more than 5lbs of pressure to operate.

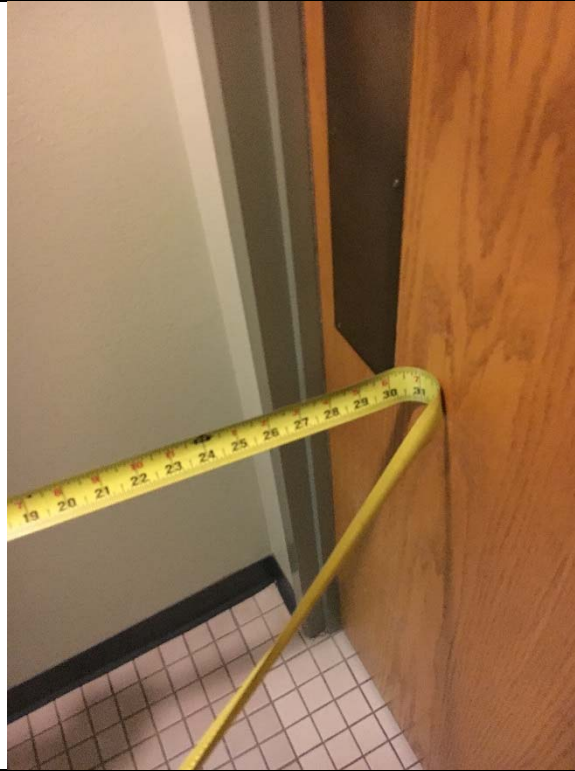
Violation #29: 1st floor lobby: Women's room has 2 doors in a series to enter with only 31" between each door.

Violation 29 - 1st floor lobby: Women's room has 2 doors in a series to enter with only 31" between each door.

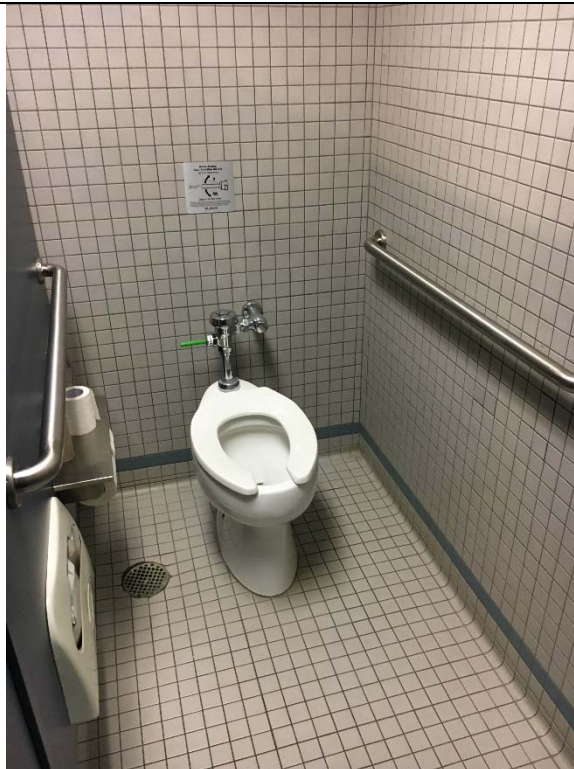
Violation 30 - 1st floor lobby: Women's room does not have an accessible toilet compartment.

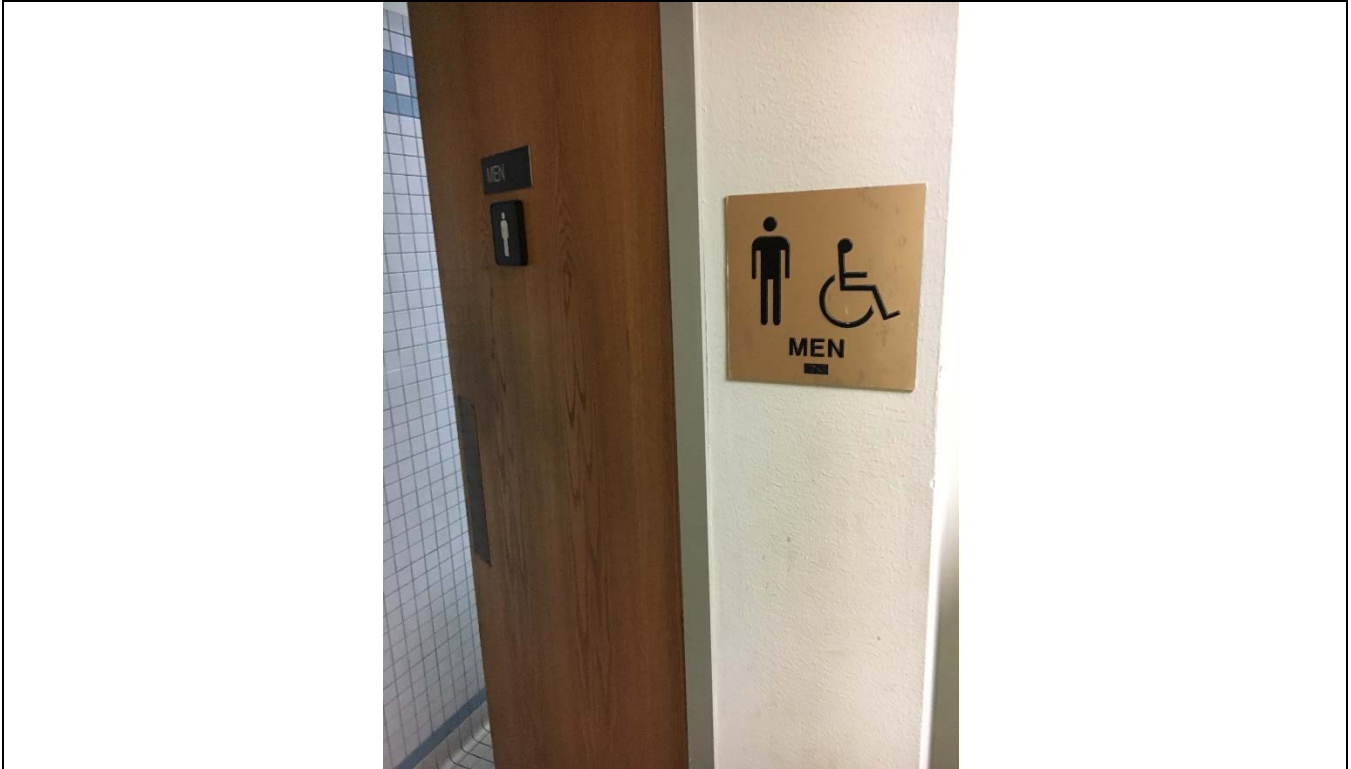
Violation 31 - 1st floor lobby: Men's room signage is mounted on the hinge side of the door.
