**TOWN OF ADDISON
BUILDING REPORT**

Facility Information: **Facility Name:** Service Center
Facility Contact: Lisa Pyles **Contact Phone:** 972-450-2878

Accessology Inspector Information:
Inspector: Karen Jackson **Date:** April 17, 2017
Email: Kjackson@accessology.com

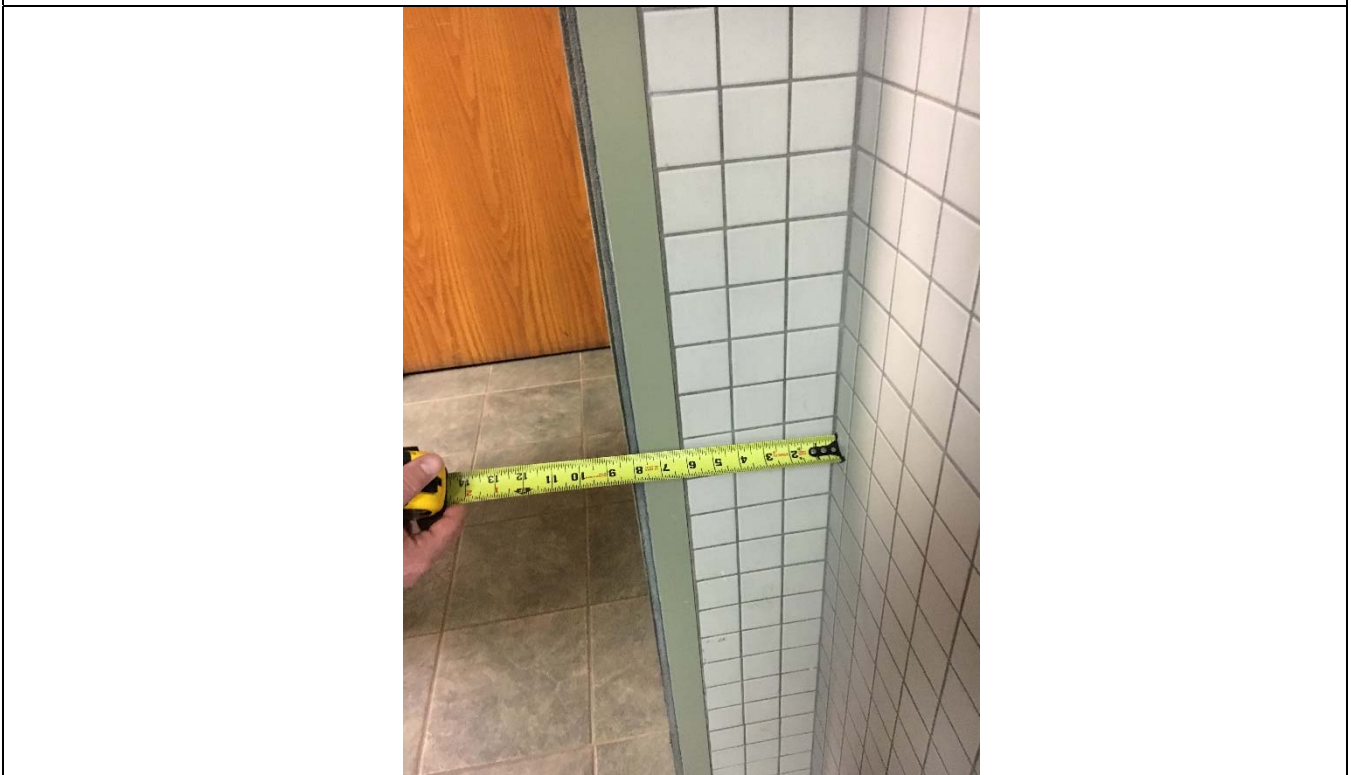
Violation 32 - 1st floor lobby: Men's restroom door only has 8" maneuvering clearance on the pull side and the door requires more than 5lbs of pressure to operate.

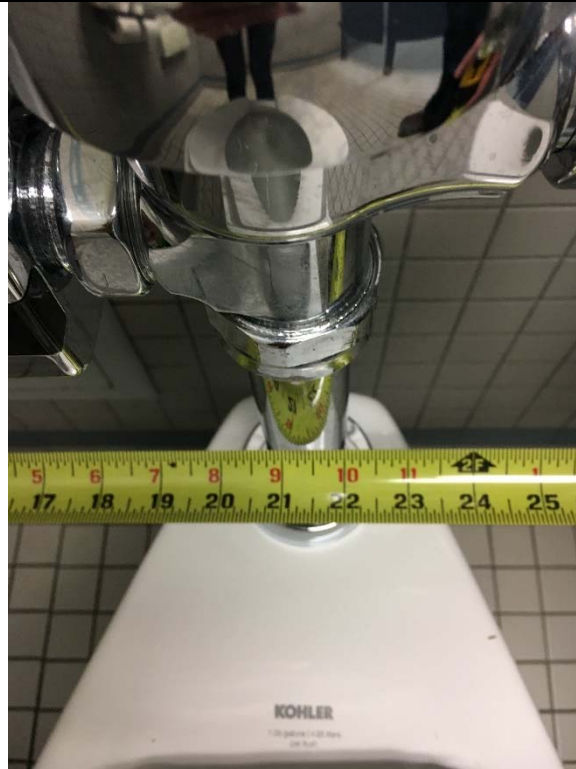
Violation 33 - 1st floor lobby: Men's room water closet in accessible stall is 21-1/2" to its centerline.

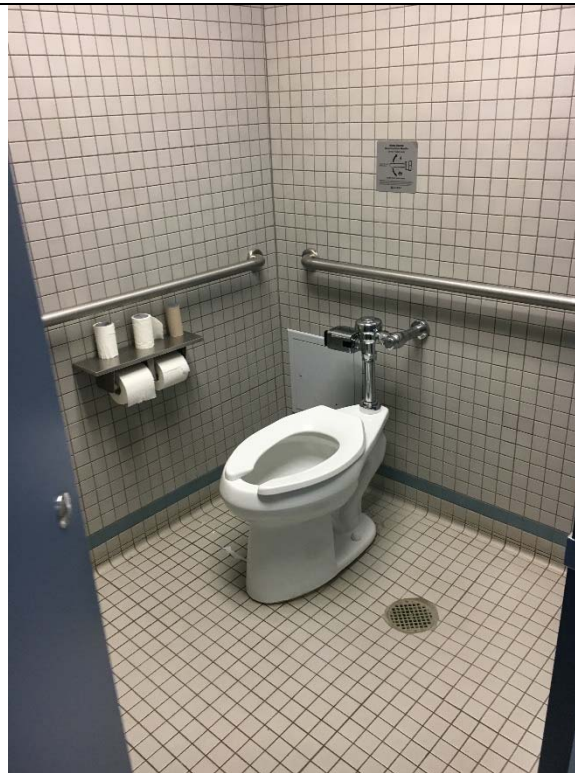
Violation 34 - 1st floor lobby: Men's restroom accessible toilet compartment is only 51-1/2" deep.

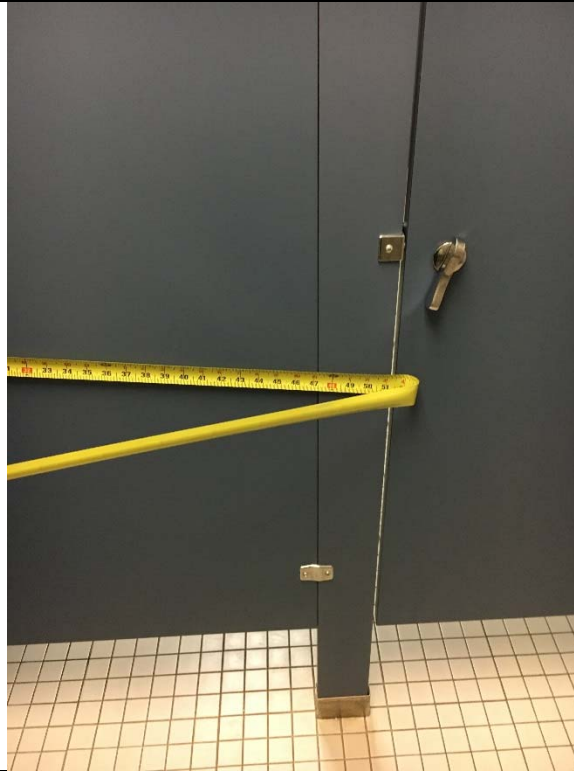
Violation 35 - 1st floor lobby: Men's restroom stall door swings into the stall and only has a 30" wide opening.

Replace stall partition with a 36" wide door with outward swinding door.

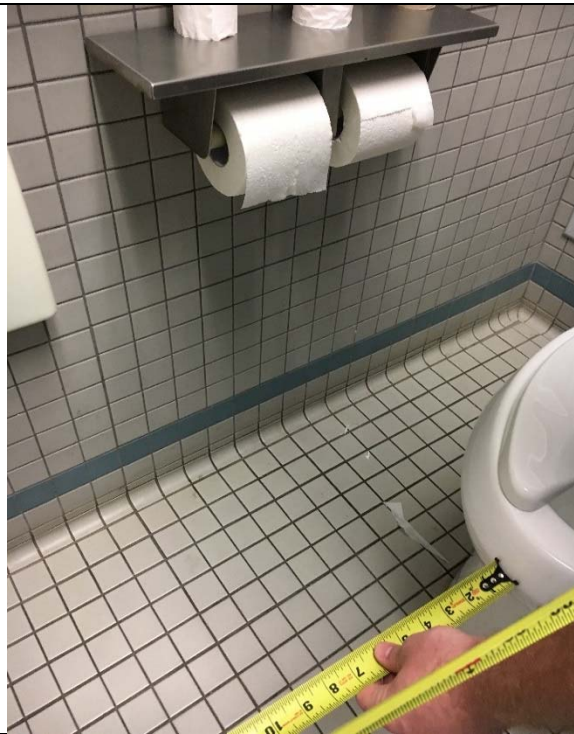
Violation 36 - 1st floor lobby: Men's restroom toilet paper dispenser is mounted too close to the back wall.

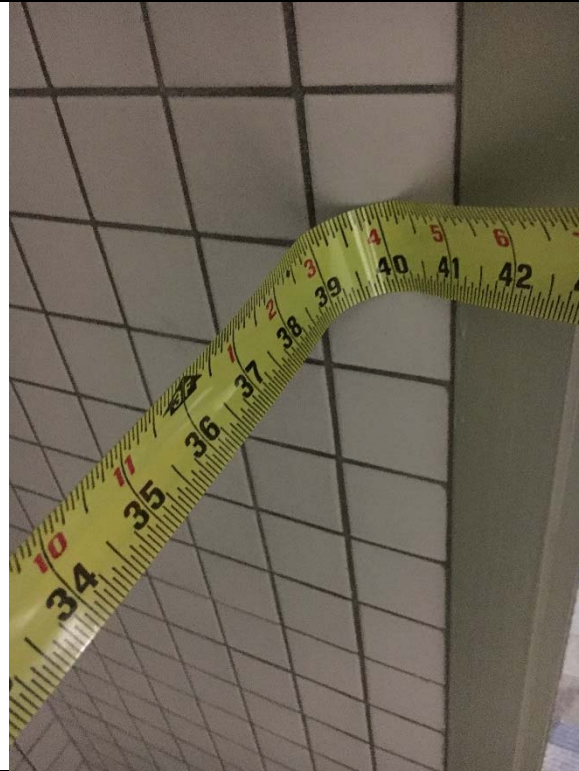
Violation #37: 2nd floor: Men's restroom entrance door maneuvering clearance is only 40" deep where a minimum of 48" is required.

Violation 37 - 2nd floor: Men's restroom entrance door maneuvering clearance is only 40" deep where a minimum of 48" is required.

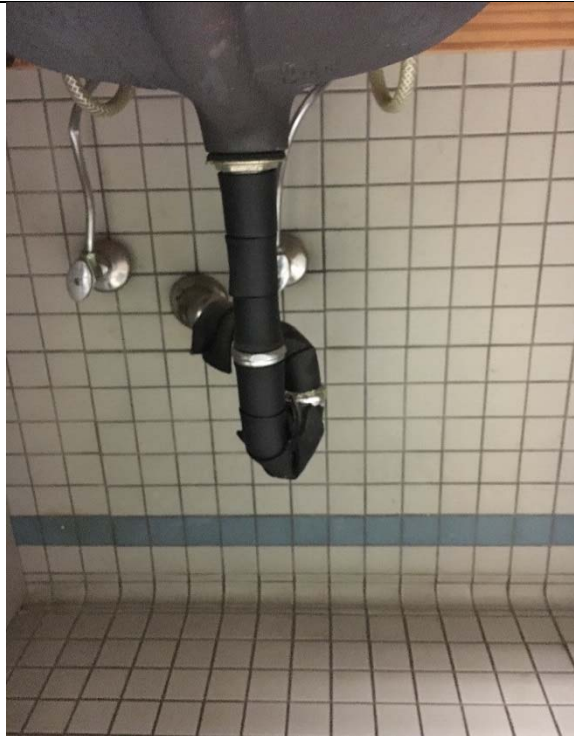
Violation #38: 2nd floor: Men's room lavatory pipes are not properly protected against contact. Pipes are currently wrapped in electrical tape.

Violation 38 - 2nd floor: Men's room lavatory pipes are not properly protected against contact. Pipes are currently wrapped in electrical tape.

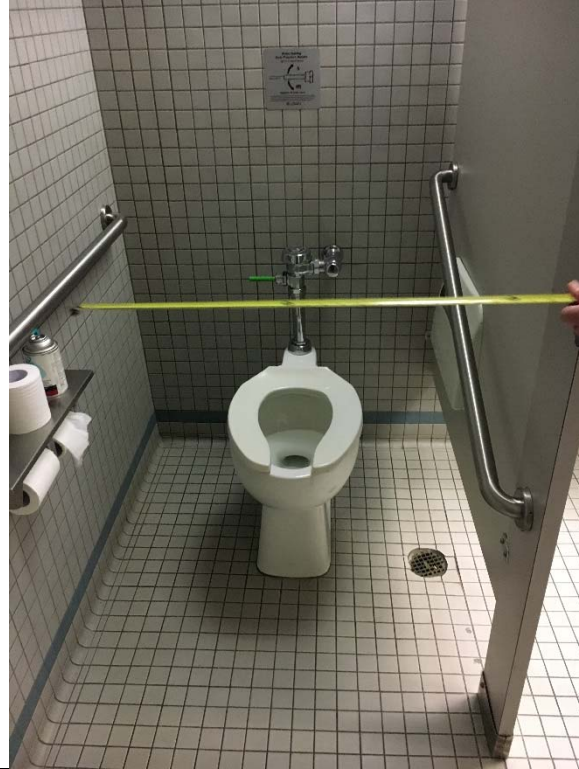
Violation #39: 2nd floor: Men's restroom does not have an accessible toilet compartment.

Violation 39 - 2nd floor: Men's restroom does not have an accessible toilet compartment.

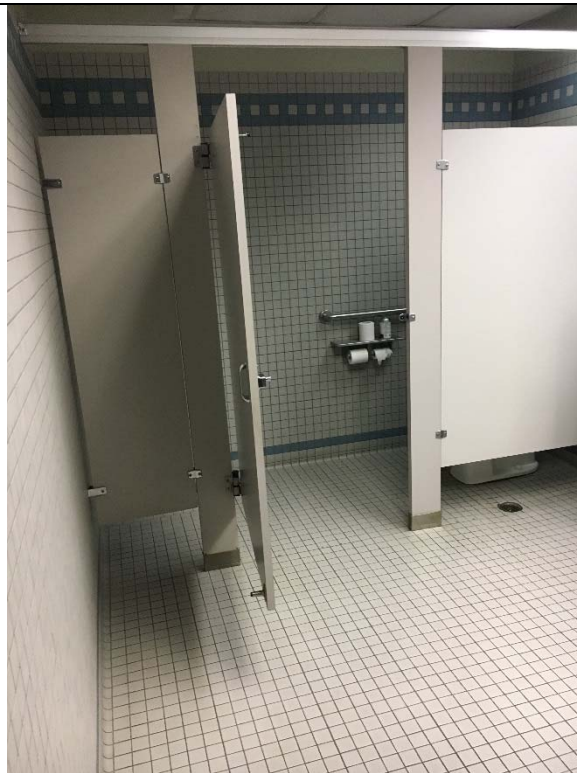
Violation #40: 2nd floor: Men's restroom accessible toilet compartment door is not self-closing.

Violation 40 - 2nd floor: Men's restroom accessible toilet compartment door is not self-closing.

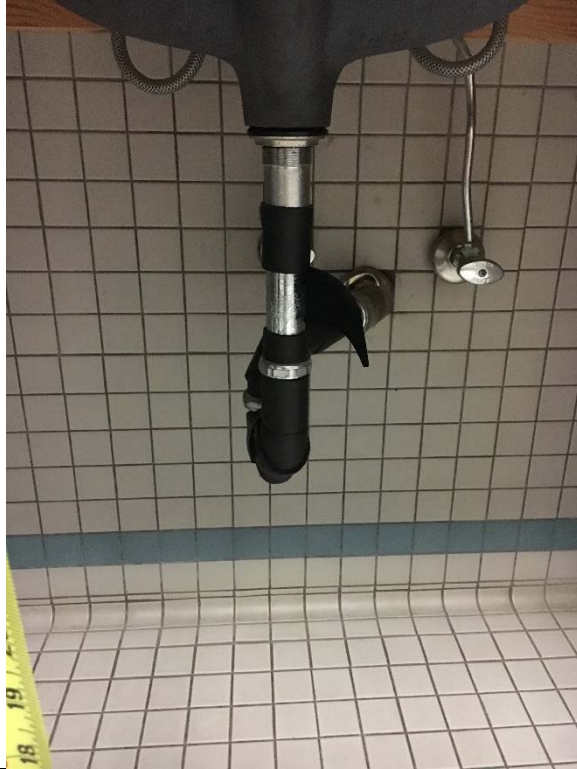
Violation #41: 2nd floor: Women's restroom lavatory pipes are not protected against contact.

Violation 41 - 2nd floor: Women's restroom lavatory pipes are not protected against contact.

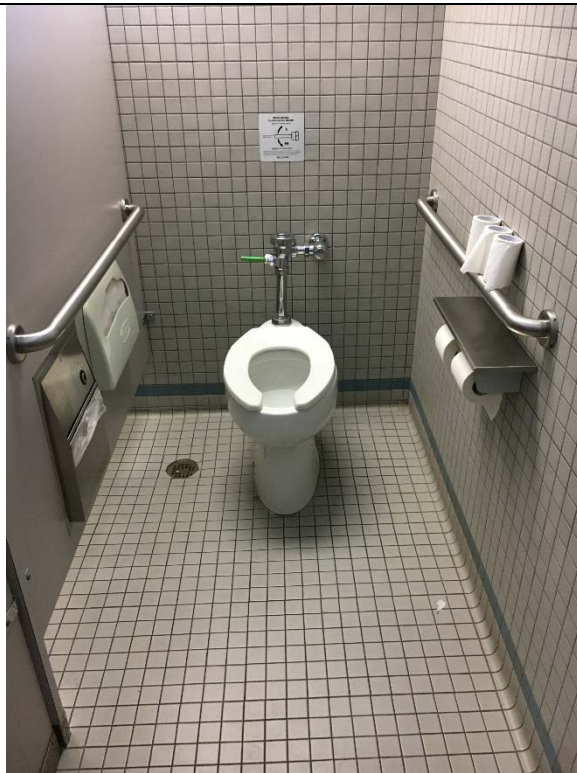
Violation #42: 2nd floor: Women's restroom does not have an accessible toilet compartment.

Violation 42 - 2nd floor: Women's restroom does not have an accessible toilet compartment.

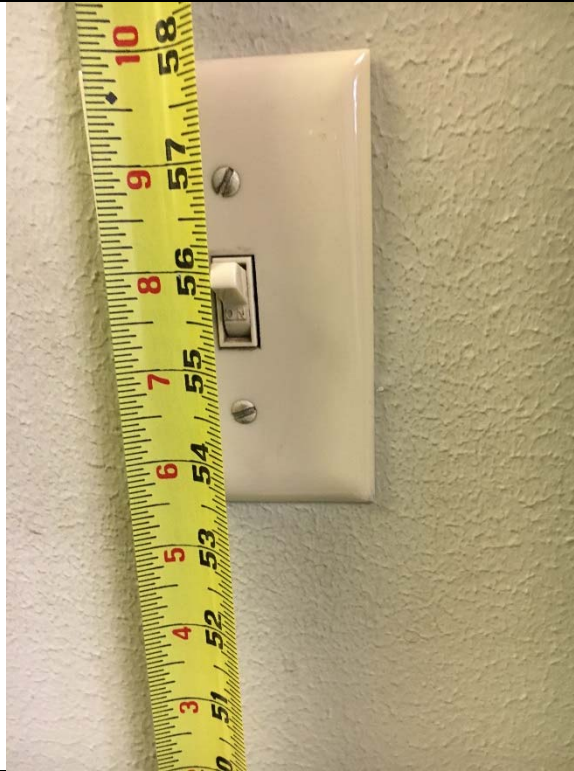
Violation #43: The light switch in the Men's restroom on the first floor by the break rooms is mounted at 56" where a maximum of 48" is allowed.

Violation 43 - The light switch in the Men's restroom on the first floor by the break rooms is mounted at 56" where a maximum of 48" is allowed.

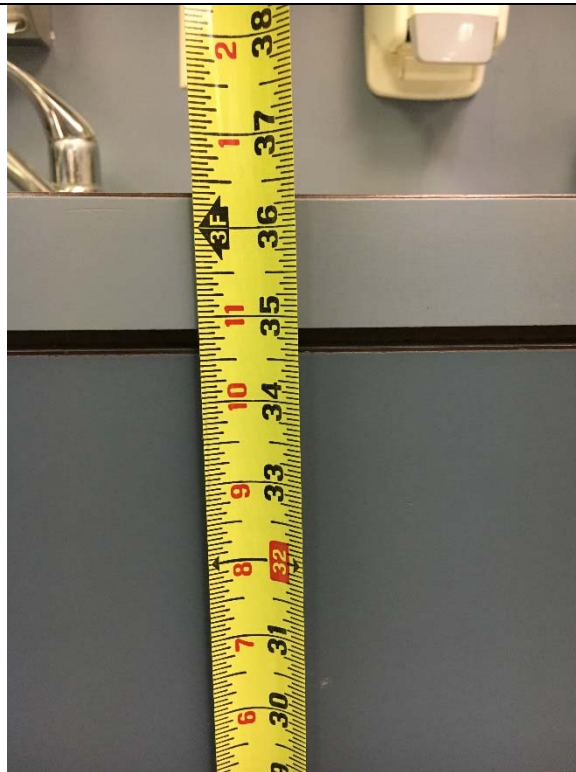
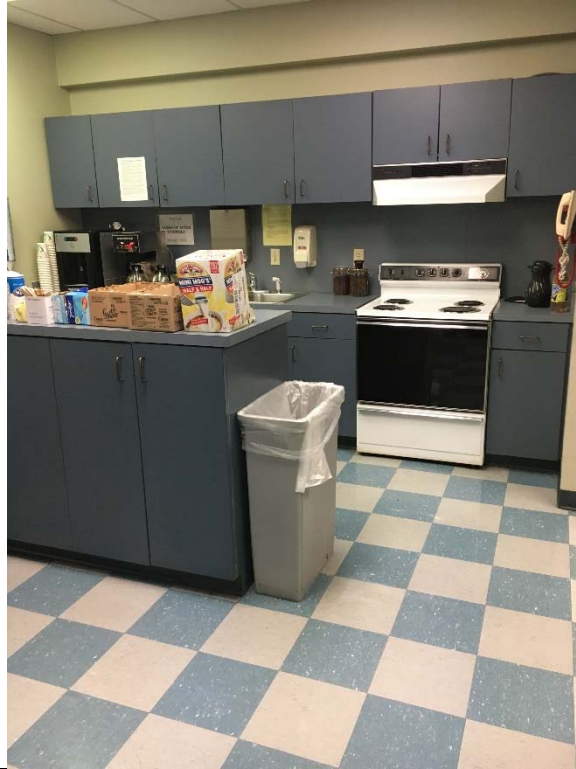
Violation #44: The break room sink on the 1st floor is at 36-5/16" above finished floor where 34" maximum is required.

Violation 44 - The counter/sink in the 1st floor break room is at 36 5/16" above finished floor.

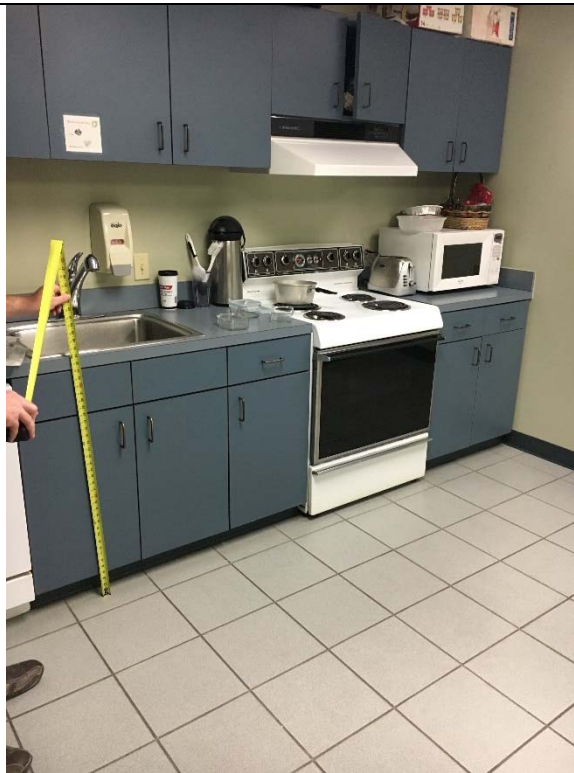
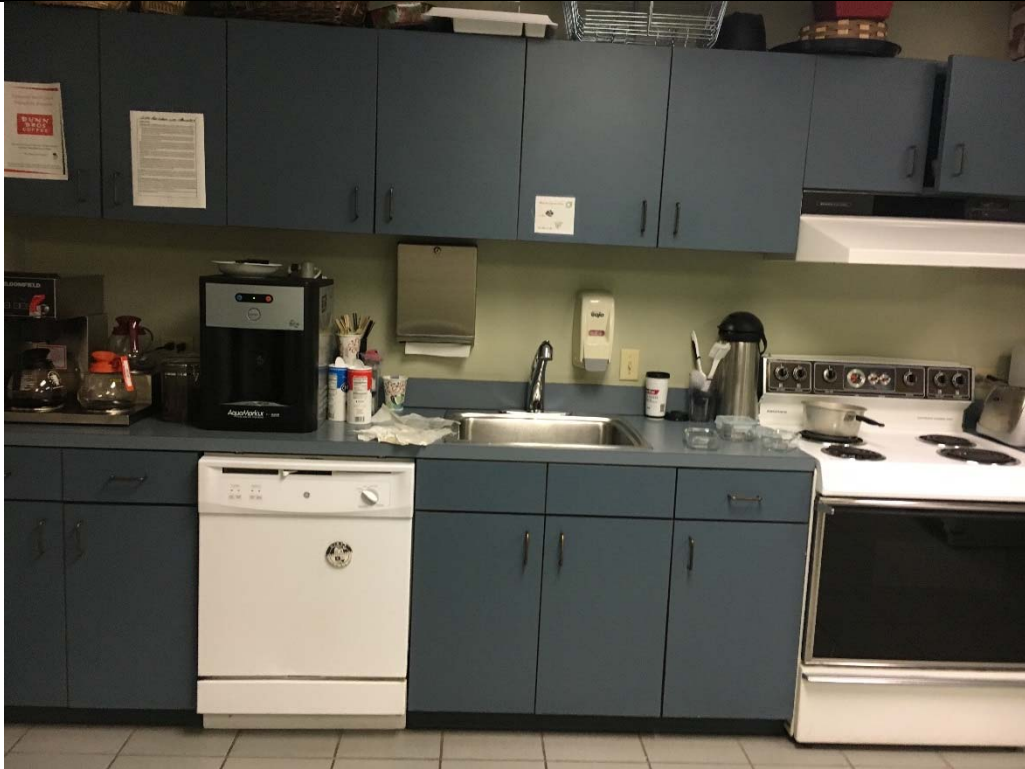
Violation #45: The 2nd floor break room sink is at 36" above finished floor where a maximum of 34" is required.

Violation 45 - The counter/sink in the 2nd floor break room is at 36" above finished floor.

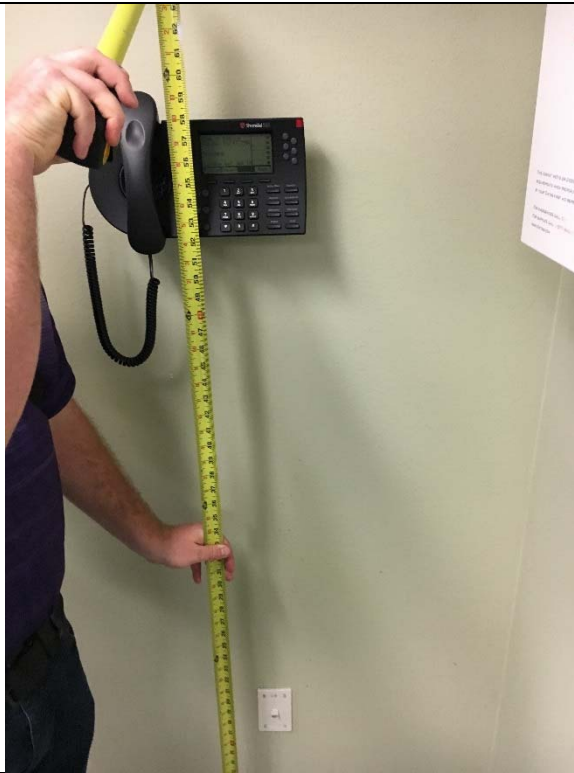
Violation 46 - The phone provided in the break room on the 2nd floor is mounted at 56" to the highest operable part.

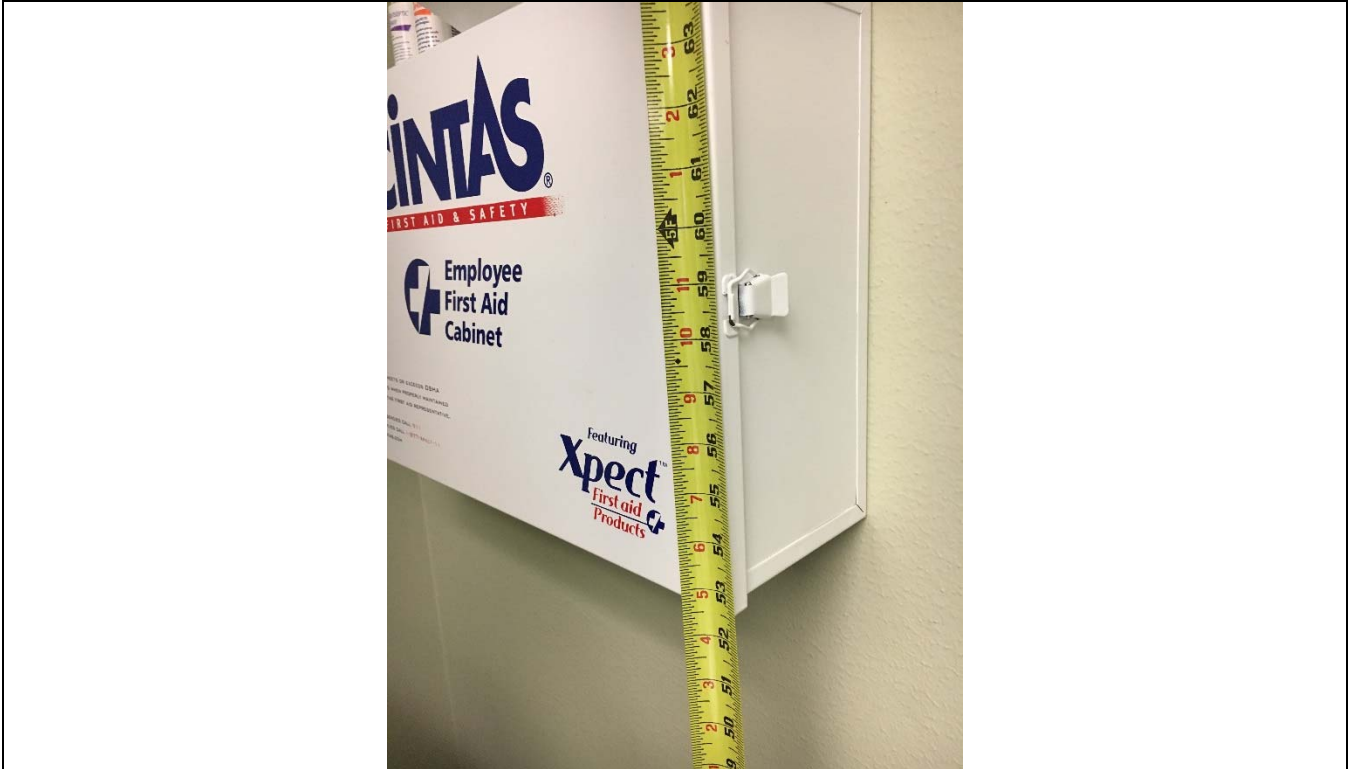
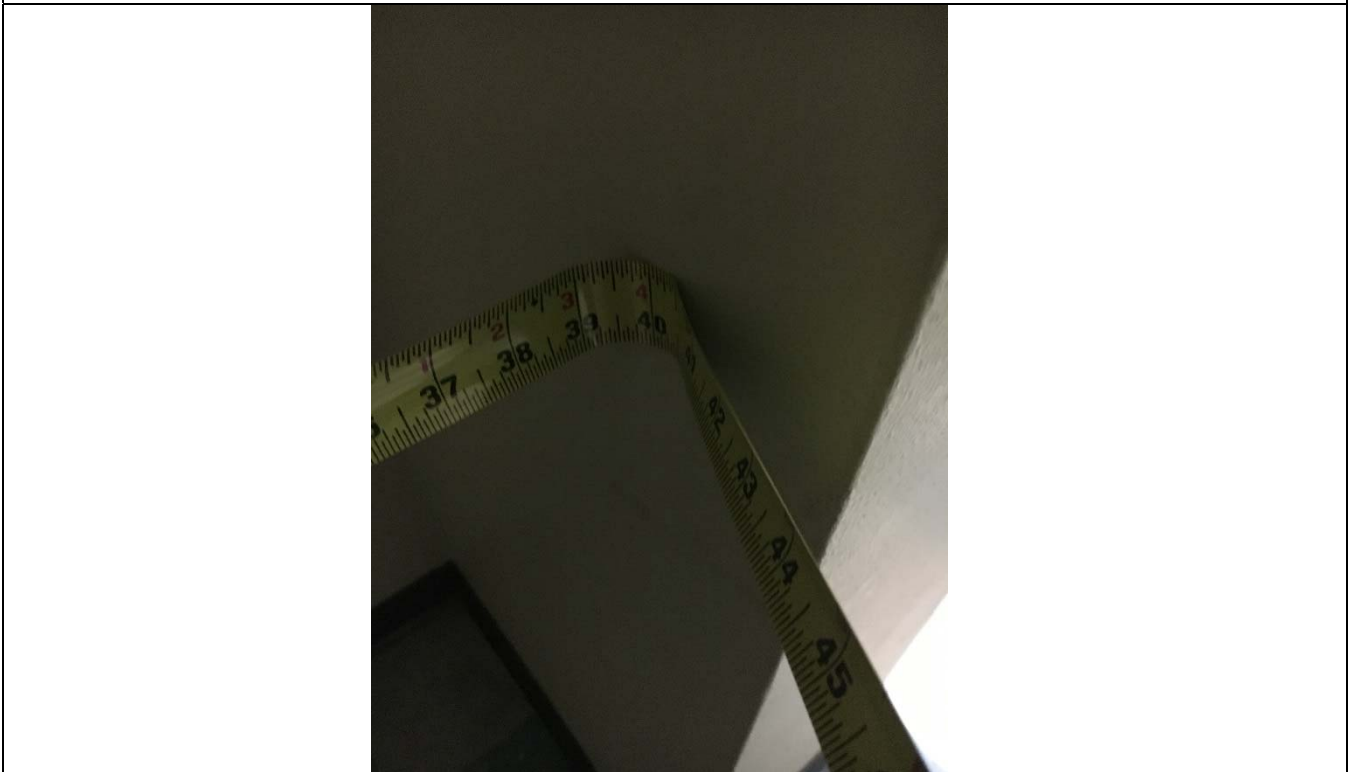
Violation 47 - The first aid box mounted on the wall in the 2nd floor break room is mounted with the operable part at 58.5" above finished floor.

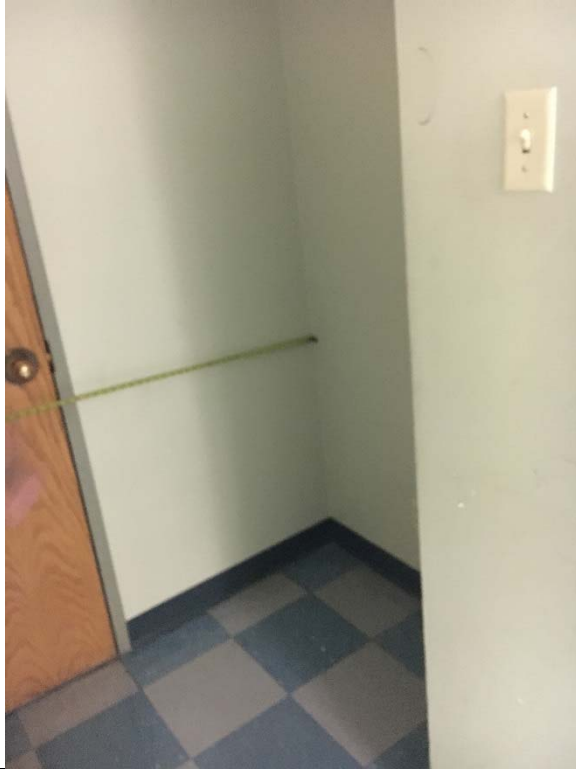
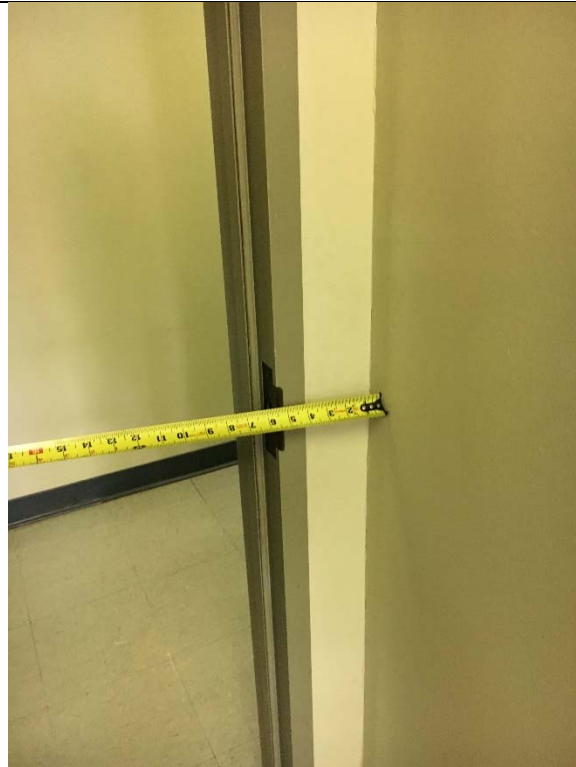
Violation #48: The door leaving the breakroom on the 1st floor into the hallway has a 40" deep maneuvering clearance on the pull side where 60" minimum is required.

Violation 48 - The door leaving the breakroom on the 1st floor into the hallway has a 40" deep maneuvering clearance on the pull side where 60" minimum is required.

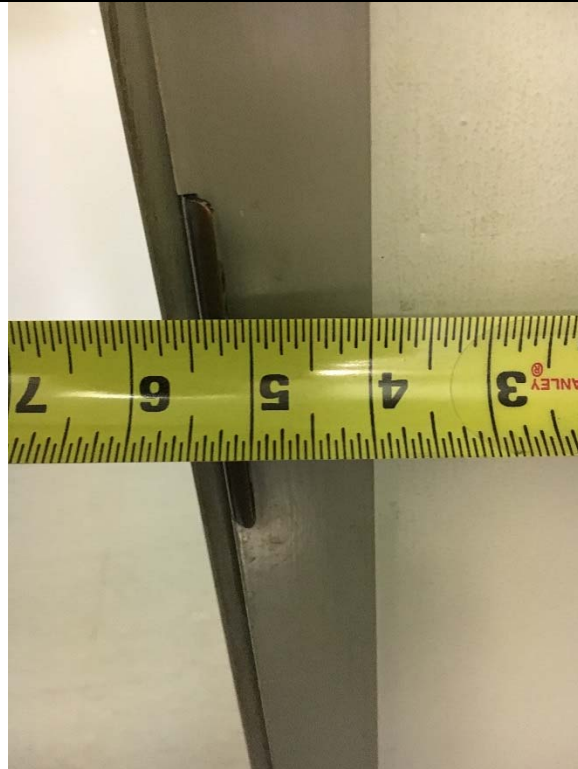
Violation #49: There is only a 6.5" maneuvering clearance on the pull side of the door exiting the first floor break room, a minimum of 18" is required.

Violation 49 - There is only a 6.5" maneuvering clearance on the pull side of the door exiting the first floor break room, a minimum of 18" is required.

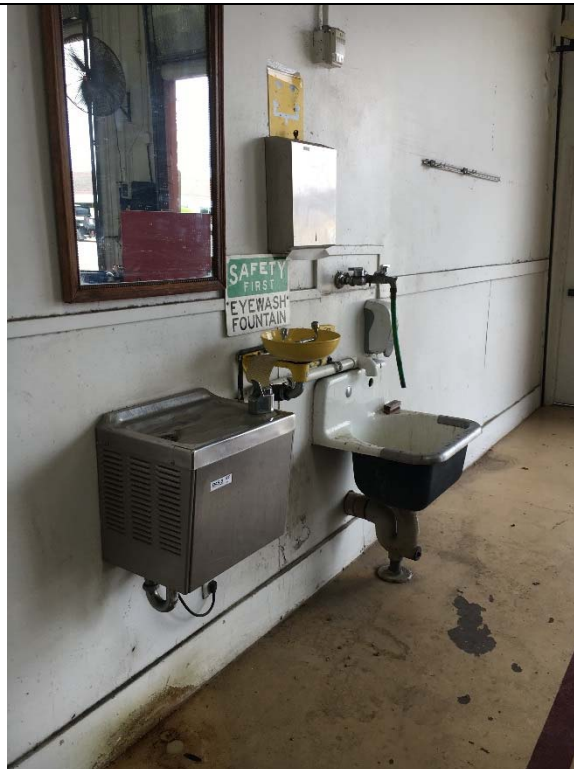
Violation 50 - There is one drinking fountain provided in the shop area but it is not an accessible unit.

51	Remove existing drinking fountain and install new Hi/Low drinking fountain unit.	Level 7	\$5,250.00
52	Install a fully accessible picnic table unit.	Level 12	\$2,415.00

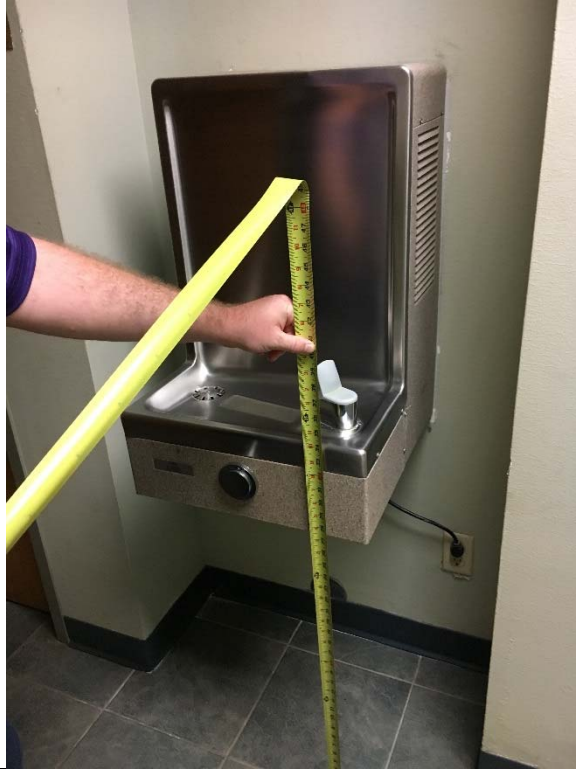
Violation 51 - There is only one drinking fountain provided in the front lobby area, two are required.

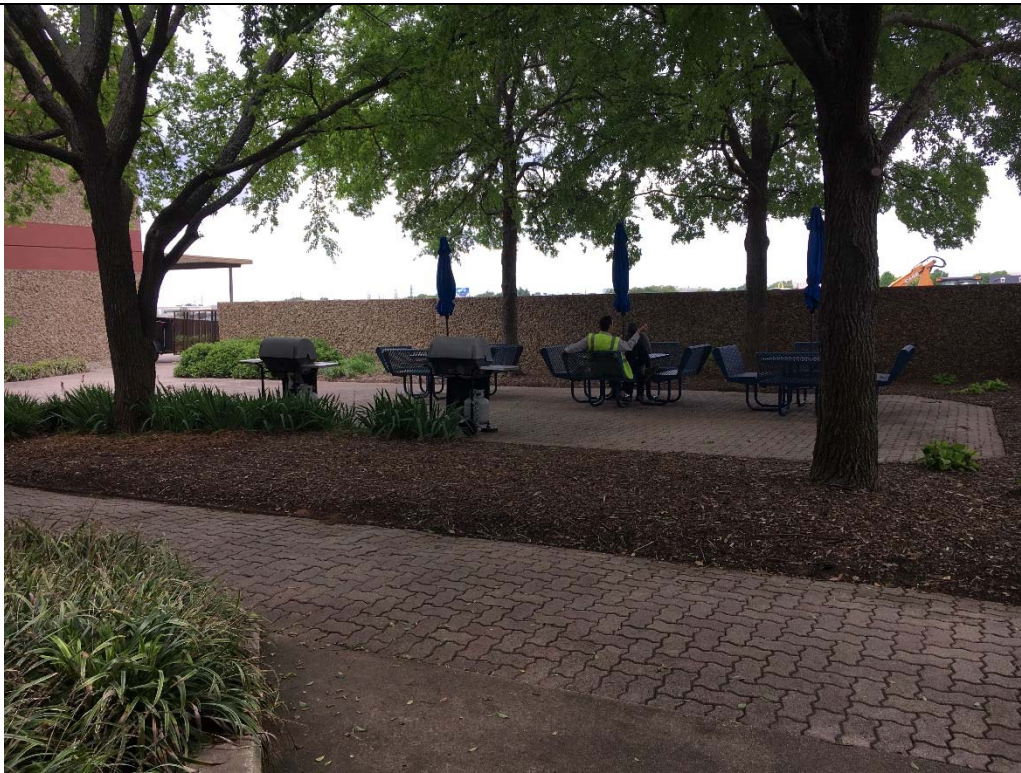
Violation 52 - The outdoor seating area does not have any accessible picnic tables provided.
