TOW	N OF ADDISON	
BUIL	DING REPORT	
Facility Information:	Facility Name: Theatre Centr	re
Facility Contact: Lisa Pyles	Contact Phone: 972-450-2878	3
Accessology Inspector Information:		
Inspector: Karen Jackson Email: Kjackson@accessology.com	D	Pate: April 19, 2017
Latitude: 32.961853	Longitude: -96.828709	
Address: 15650 Addison Road	City: Addison	County: Dallas
The parking evaluated on this re Additionally, there is an employ Total Parking Spaces: Employee Lot Total Accessible Parking Spaces: Number of van accessible spaces: Is the accessible parking substantially compliant?	port is shared with the Conference ee parking lot provided.	27 0 0 N/A
Total Parking Spaces: Public Parking Total Accessible Parking Spaces: Number of van accessible spaces: Is the accessible parking substantially compliant?		159 6 2 No
Violation #1: There are no accessible parking	spaces provided in the employee [parking lot.

Summary Sheet for Theatre Centre

Theatre Centre

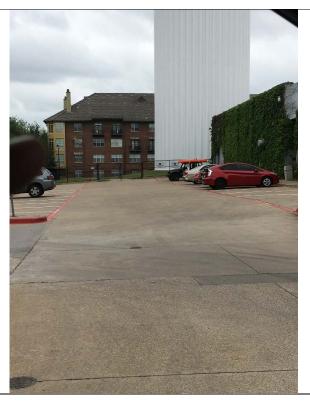
Standard: 2010 ADAAG 502 Park	sing Spaces

Car and van parking spaces shall comply with (502 Parking Spaces). Where parking spaces are marked with lines, width measurements of parking spaces and access aisles shall be made from the centerline of the markings.

Violation 1 - There are no accessible parking spaces provided in the employee parking lot.

Add two (2) accessible parking spaces, one being van accessible with an access aisle and compliant signage.

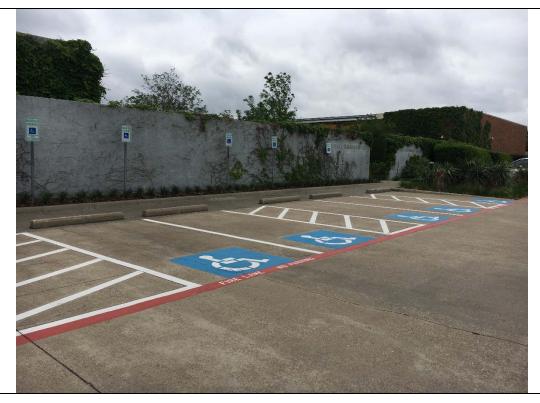
In the public parking lot, two of the accessible parking spaces are not a minimum of 96" wide: The third space is 92-1/2" wide and the fifth space is 93" wide.

Car parking spaces shall be 96" wide minimum and van parking spaces shall be 132" wide minimum, shall be marked to define the width, and shall have an adjacent access aisle complying with 502.3.

Violation 2 - Two of the accessible parking spaces are not a minimum of 96" wide: The third space is 92-1/2" wide and the fifth space is 93" wide.

Restripe spaces to achieve a minimum of 96" wide car parking spaces while maintaining the 11' wide van accessible space.

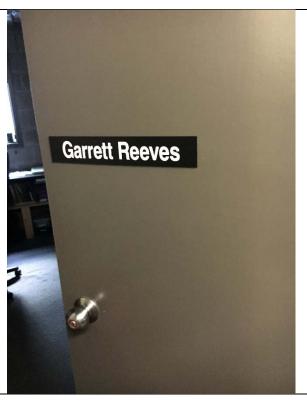
Violation 3 - There are approximately 35 doors throughout the facility that have door knob style hardware requiring grasping and twisting to operate.

Possible Solutions:	Replace all existing kr	nob hardware with lever type hardware	re.
Violation #3 Cost:	\$13,781	Priority Level 5

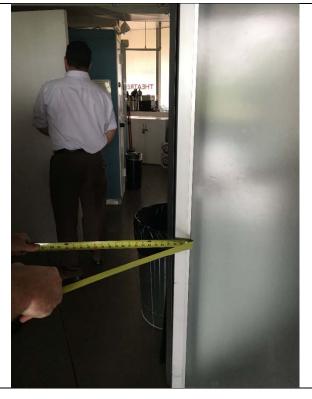
Violation #4: Access into the ticket booth is only 28" wide where 32" minimum is required.

Standard: 2010 ADAAG 404.2.3 Clear Width.

Door openings shall provide a clear width of 32" minimum. Clear openings of doorways with swinging doors shall be measured between the face of the door and the stop, with the door open 90 degrees.

Violation 4 - Access into the ticket booth is only 28" wide.

Possible Solutions: Modify door into ticket booth to provide 32" minimum clear width.

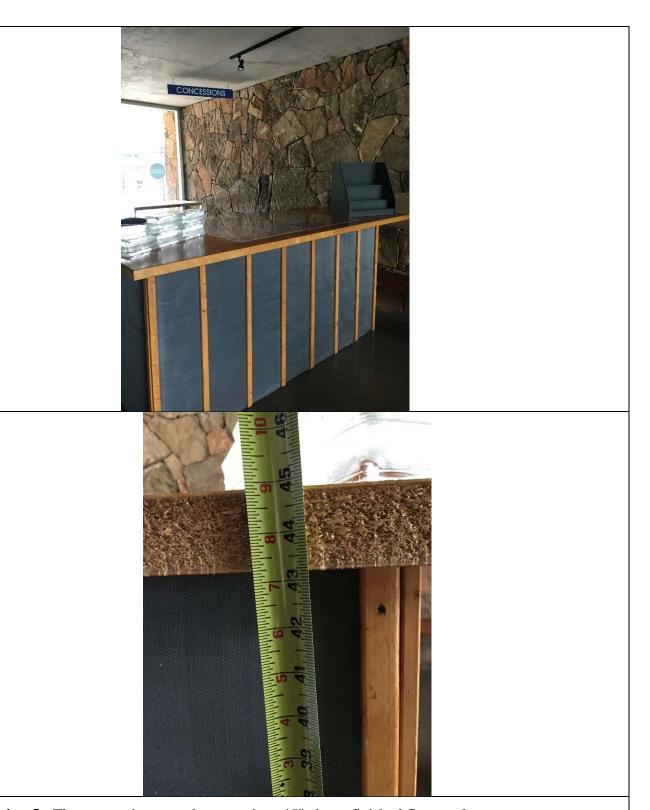
Violation #5: The concessions stand counter is at 45" above finished floor to the counter.

Standard: 2010 ADAAG 904.4.1 Parallel Approach.

A portion of the counter surface that is 36" long minimum and 36" high maximum above the finish floor shall be provided. A clear floor space complying with 305 shall be positioned for a parallel approach adjacent to the 36" minimum length of counter.

Violation 5 - The concessions stand counter is at 45" above finished floor to the counter.

Possible Solutions: Modify counter to provide a 36" high and 36" long portion.

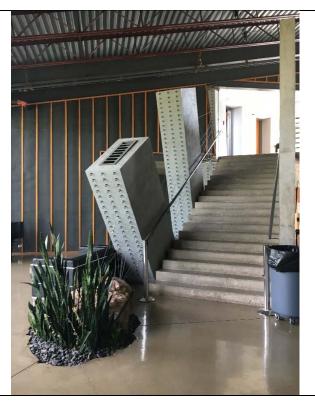
Violation #6: There is no accessible route to the 2nd floor of the building.

Standard: 2010 ADAAG 206.2.3 Multi-Story Buildings and Facilities.

At least one accessible route shall connect each story and mezzanine in multi-story buildings and facilities.

Violation 6 - There is no accessible route to the 2nd floor of the building.

Install an elevator to provide access to the amenities on the 2nd floor.

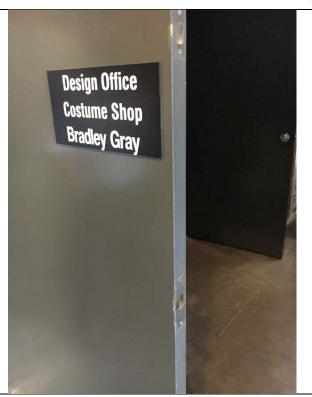
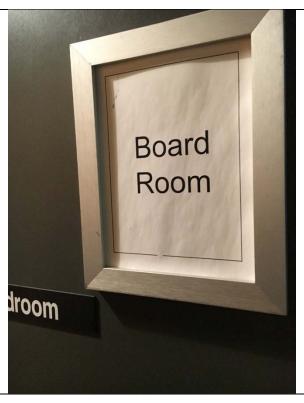
There are approximately 15 permanent signs throughout the building that are mounted in the incorrect location and do not have Braille or tactile characters.

2010 ADAAG 703.1 General.

Signs shall comply with 703. Where both visual and tactile characters are required, either one sign with both visual and tactile characters, or two separate signs, one with visual, and one with tactile characters, shall be provided.

Violation 7 - There are approximately 15 permanent signs throughout the building that are not compliant.

Replace with compliant signage on the hinge side of the doors.

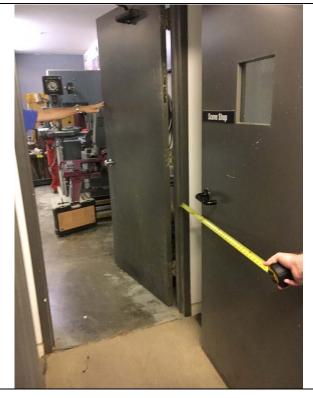
The scene shop has 2 doors in a series with only 13-1/2" between doors.

2010 ADAAG 404.2.6 Doors in Series and Gates in Series.

The distance between two hinged or pivoted doors in series and gates in series shall be 48" minimum plus the width of doors or gates swinging into the space.

Violation 8 - The scene shop has 2 doors in a series with only 13-1/2" between doors.

TOWN OF ADDISON - Theatre Centre Hallway - Page 4	
Hallway - Page 4	
Possible Solutions: Remove one of the doors to alleviate doors in series condition.	
Violation #8 Cost: \$2,625 Priority Level 6	
Multiple doors throughout the Theatre (3 offices, board room, crew restroom, Violation #9: Theatre staff only area and the scene shop) do not have the minimum 18" maneuvering clearance on the pull side.	
Standard: 2010 ADAAG 404.2.4.1 Swinging Doors and Gates.	
Text: Swinging doors and gates shall have maneuvering clearances complying with Table 404.2.4.1.	ıg
Possible Solutions: Modify doors to provide 18" minimum clearance.	
Violation #9 Cost: \$18,375 Priority Level 7	
High Priority 1-4	
Hallway Total \$201,469 Medium Priority 5-8	}
Low Priority 9-12	_

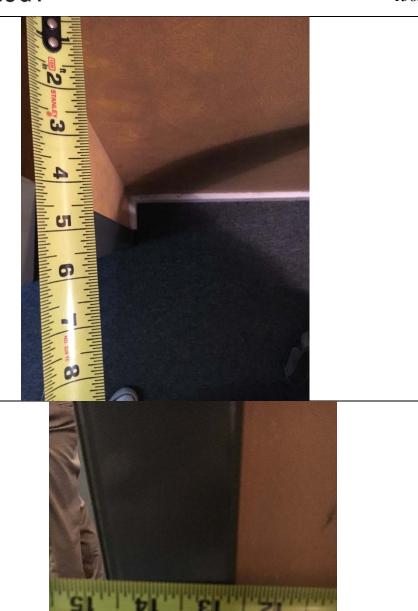
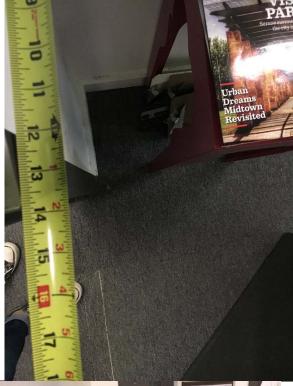
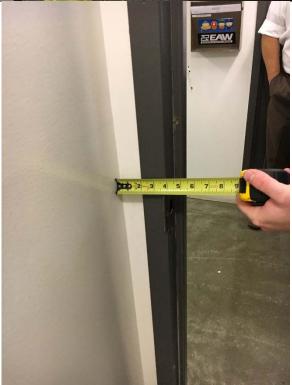
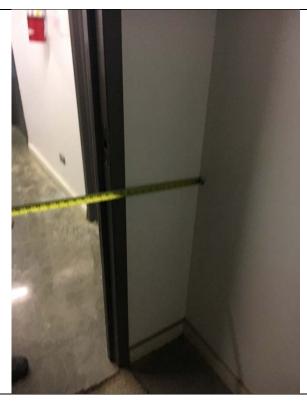
Violation 9 - Multiple doors throughout the theater (3 offices, board room, crew restroom, theater staff only area and the scene shop) do not have the minimum 18" maneuvering clearance on the pull side.

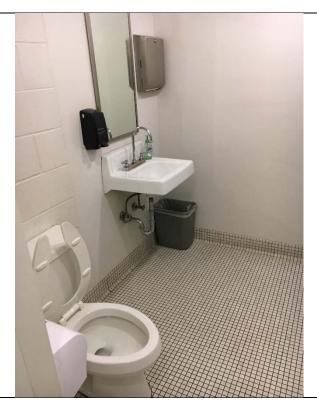
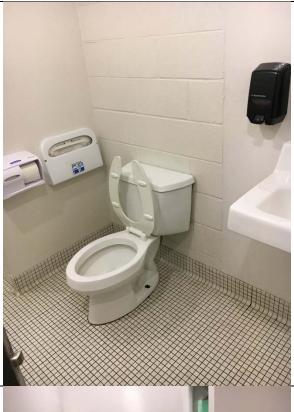
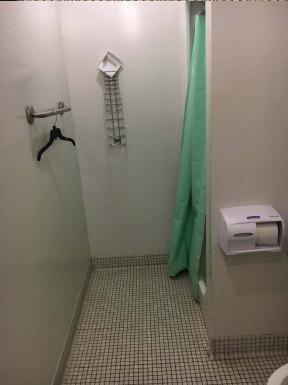
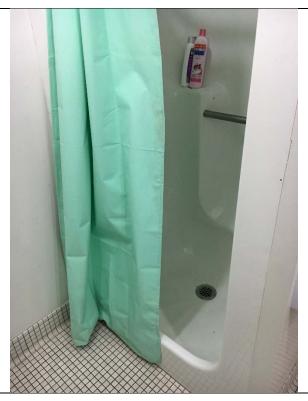
$\begin{tabular}{ll} \textbf{Violation 10 -} The crew shower room is too small and is not fully compliant. \end{tabular}$

Possible Solutions:	Modify room to prodispensers.	ovide accessible water closet, shower stall, l	lavatory and
Violation #10 Cost:	\$10,500	Priority Level 4]

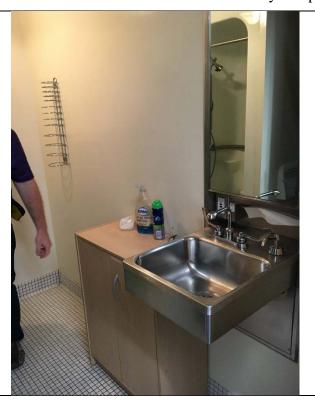
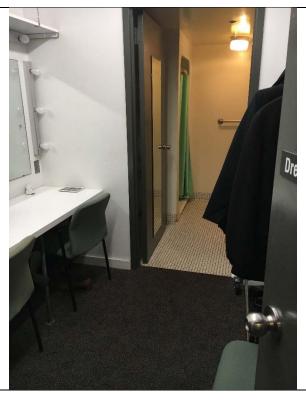
Dressing room #5 is noted to be the accessible dressing room. There is a restroom with a shower provided that is too small and is not fully accessible.

Standard: 2010 ADAAG 222.1 General.

Where dressing rooms, fitting rooms, or locker rooms are provided, at least 5 percent, but no fewer than one, of each type of use in each cluster provided shall comply with 803.

Violation 11 - Dressing room #5 is noted to be the accessible dressing room. There is a restroom with a shower provided that is too small and is not fully accessible.

Possible Solutions: Modify dressing room to provide fully accessible restroom/shower facilities.

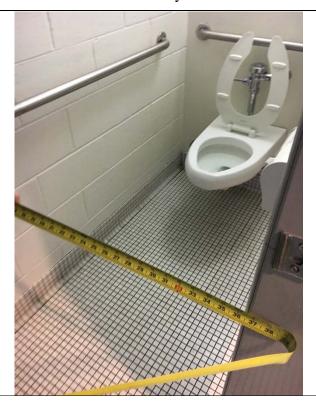
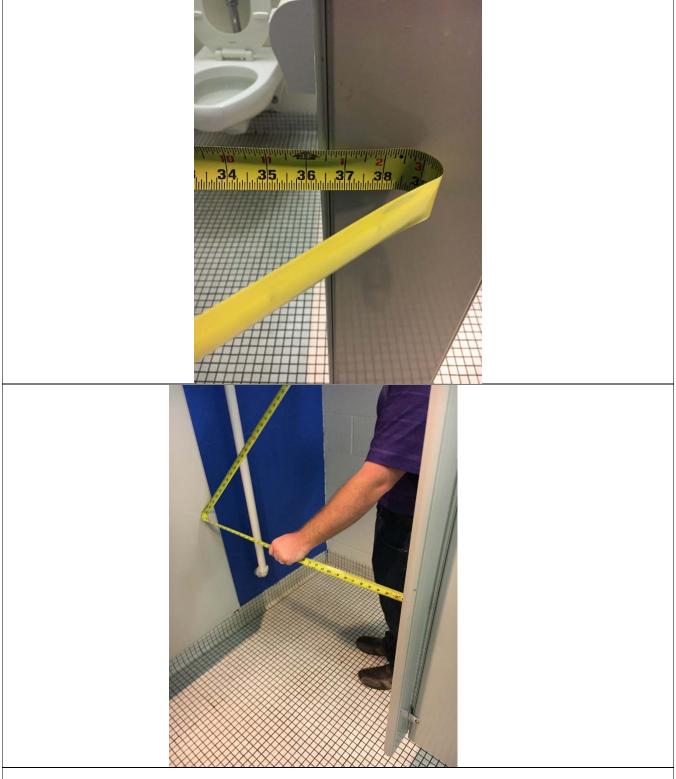
Violation #12: Men's Restroom - Accessible stall is only 36.5" wide.

Standard: 2010 ADAAG 604.8.1.1 Size.

Wheelchair accessible compartments shall be 60" wide minimum measured perpendicular to the side wall, and 56" deep minimum for wall hung water closets and 59" deep minimum for floor mounted water closets measured perpendicular to the rear wall.

Violation 12 - Men's Restroom - Accessible stall is only 36.5" wide.

Possible Solutions: Modify restroom to provide an fully accessible stall.

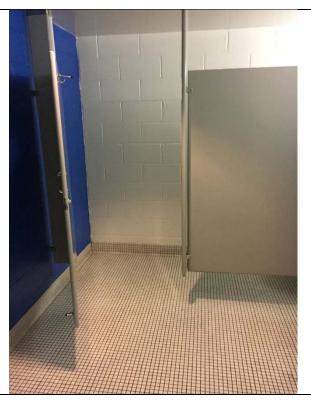
Violation #13: Men's Room - Stall door is not self-closing.

Standard: 2010 ADAAG 604.8.1.2 Doors.

Violation 13 - Men's Room - Stall door is not self-closing.

Text:	The door shall be self-closing.
Possible Solutions:	Install a self-closing mechanism on the stall door.

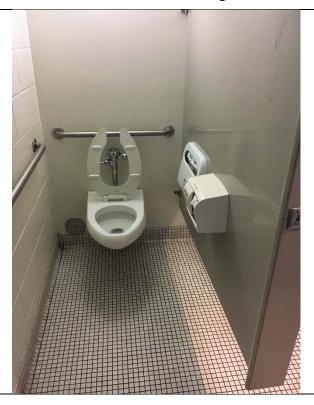
Men's Room - Flush control is on the closed side of the stall.

Standard: 2010 ADAAG 604.6 Flush Controls.

Text: Flush controls shall be located on the open side of the water closet.

Violation 14 - Men's Room - Flush control is on the closed side of the stall.

Possible Solutions: Replace flush valve to the open side of the water closet.

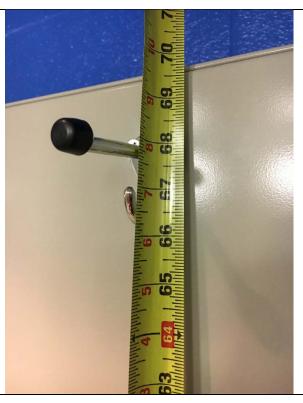
Violation #15: Men's Restroom - Coat hook is mounted at 66.5" above finished floor.

Standard: 2010 ADAAG 308.2.1 Unobstructed Front Reach. 2010 ADAAG 308.3.1 Unobstructed Side Reach

Where a forward or side reach is unobstructed, the high forward and side reaches shall be 48" maximum and the low forward and side reach shall be 15" minimum above the finish floor or ground.

Violation 15 - Men's Restroom - Coat hook is mounted at 66.5" above finished floor.

Possible Solutions: Install a coat hook that is no higher than 48" above finished floor.

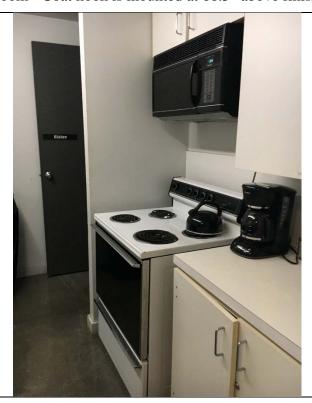
Violation 16 - The microwave provided is mounted above the stove and out of reach.

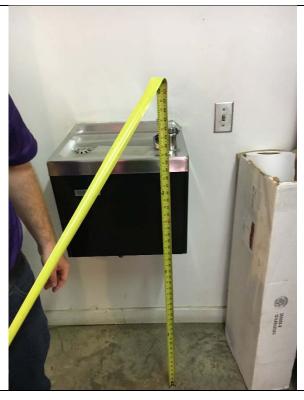
Violation 17 - The drinking fountain provided in the employee is for standing persons only and has no knee clearance and requires grasping and twisting to operate.

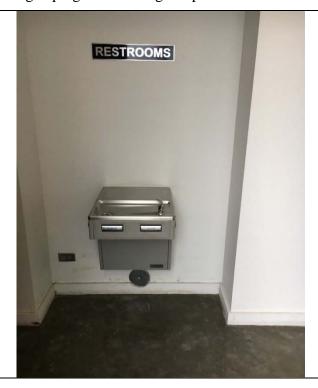
Standard:	2010 ADAAG 211.2 Min	imum Number.

Violation 18 - There is only one drinking fountain provided on the second floor, two are required.

TOWN OF ADDISON - Theatre Centre Miscellaneous - Page 2
Text:	No fewer than two drinking fountains shall be provided. One drinking fountain shall comply with 602.1 through 602.6 and one drinking fountain shall comply with 602.7.
Possible Solutions:	Install new Hi/Low drinking fountain.
Violation #18 Cost:	\$5,250 Priority Level 5
	High Priority 1-4
Miscellaneous Total	\$10,500 Medium Priority 5-8
	Low Priority 9-12
