| | | TOWN OF ADDISON BUILDING REPORT | |
| Facility Information: | | Facility Name: Town Hall | |
| Latitude: Address: | 32.952568 5300 Beltline Road | Longitude: -96.81562 City: Addison | County: Dallas |

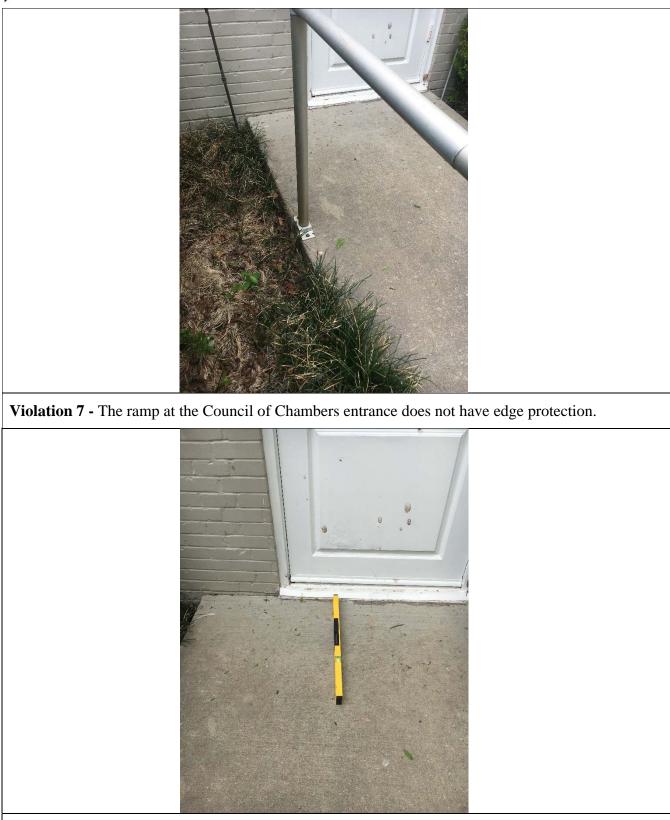
| | TOWN OF ADDISON - Town Hall Entrance - Page 2 |
|---|---|
| Violation #8: | The landing at the entrance to the Council of Chambers has a 10.5% running slope. |

Violation 8 - The landing at the entrance to the Council of Chambers has a 10.5% running slope.

| | TOWN OF ADDISON - Town Hall Entrance - Page 2 |
|---|---|
| Possible Solutions: | Remove and repour the landing to a achieve a level landing with slopes n greater than 2% in all directions. Price included in Violation #6. |

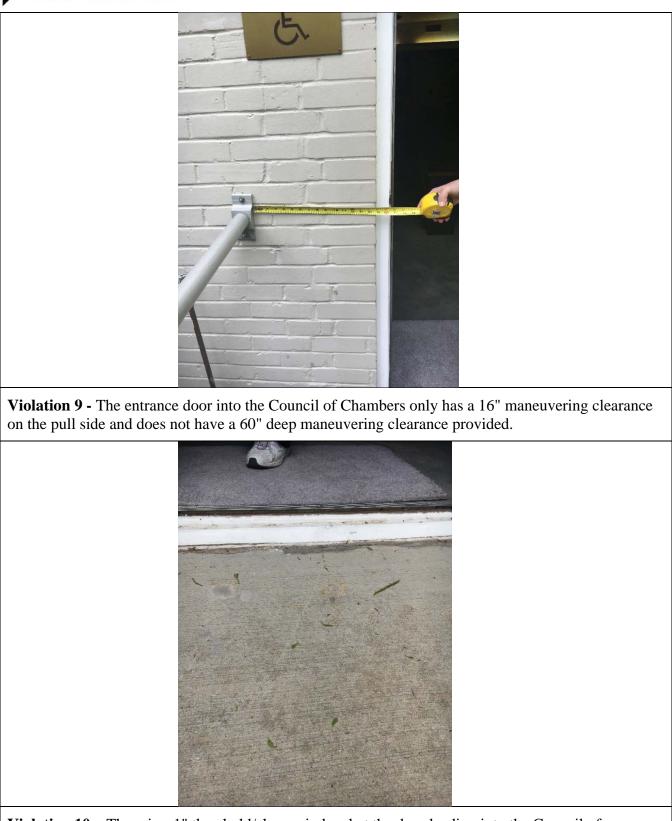
| | TOWN OF ADDISON - Town Hall |
|---|---|
| Violation #10: | There is a 1" threshold/change in level at the door leading into the Council of Chambers. |

Violation 10 – There is a 1" threshold/change in level at the door leading into the Council of Chambers.

| | TOWN OF ADDISON - Town Hall |
|---|---|
| Possible Solutions: | Modify entrance door threshold to 3/4" maximum with 1:2 bevel. |

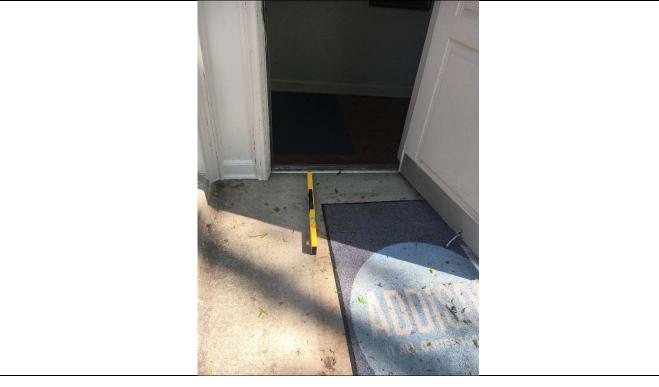
| | TOWN OF ADDISON - Town Hall |
|---|---|
| Violation #11: | The back middle entrance that leads to the restrooms has an 8% running slope at the landing. |

Violation 11 - The middle entrance at the back that leads to the restrooms has an 8% running slope at the landing. Additionally, the floor mat at the door is not secured to the ground.

| | TOWN OF ADDISON - Town Hall |
|---|---|
| Possible Solutions: | Remove and repour the landing to a achieve a level landing with a slope no greater than 2% in all directions. |

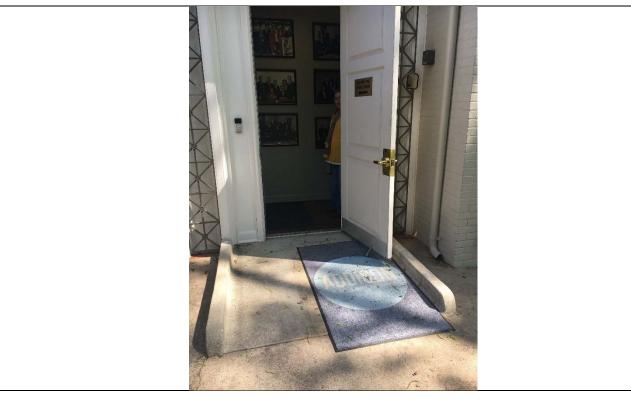
| | TOWN OF ADDISON - Town Hall Entropse Page 4 |
|---|--|
| Violation #12: | The back middle entrance door does not have a minimum of 18" on the pull side. |

Violation 12 - The back middle entrance door does not have a minimum of 18" on the pull side.

| | TOWN OF ADDISON - Town Hall Entropse Page 4 |
|---|--|
| Possible Solutions: | Widen the landing to provided a minimum of 18" on the pull side or provide an automatic door opener. Additionally, ensure the depth of the maneuvering clearance is a minimum of 60" deep. Price included in Violation #11. |

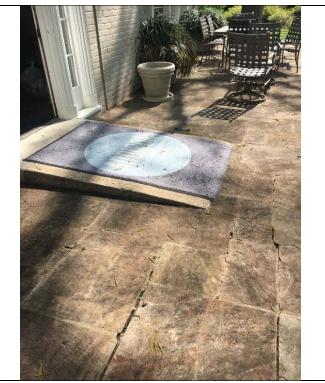
| | TOWN OF ADDISON - Town Hall Entropse Page 4 |
|---|--|
| Violation #13: | The far right entrance at the back is ramped to the entrance and does not have a level landing. |

Violation 13 - The far right entrance at the back is ramped to the entrance and does not have a level landing.

| | TOWN OF ADDISON - Town Hall Entropse Page 4 |
|---|--|
| Possible Solutions: | Widen the landing to provided a minimum of 18" on the pull side or provide an automatic door opener. Additionally, ensure the depth of the maneuvering clearance is a minimum of 60" deep. |

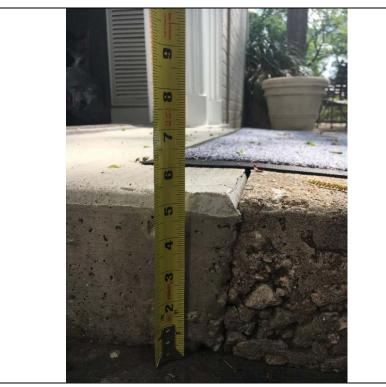
Violation 14 - The ramp up to the far right back entrance has a 5-3/8" drop off with no edge protection.

| | TOWN OF ADDISON - Town Hall |
|---|--|
| Possible Solutions: | Provide edge protection. |

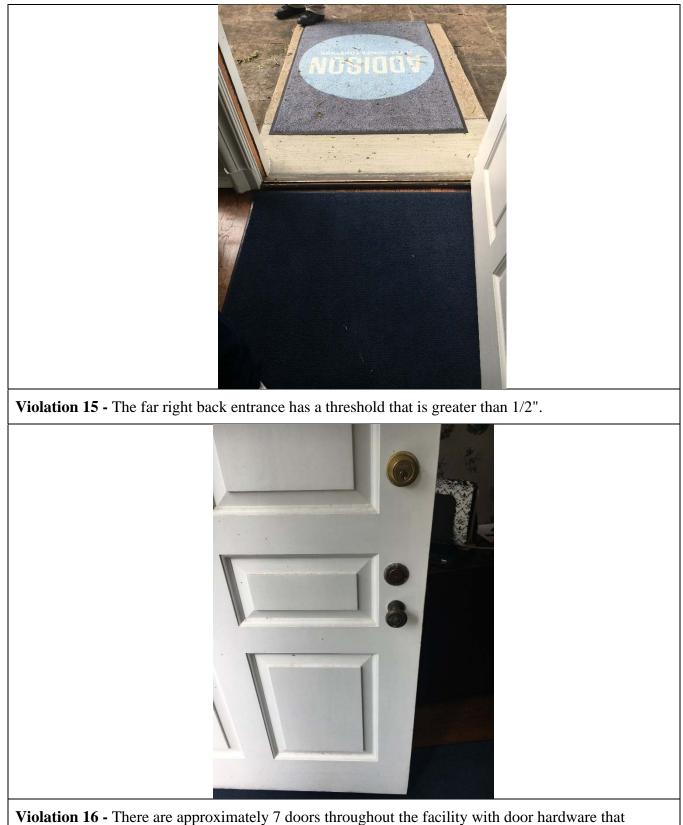
| | | N OF ADDISON LDING REPORT | |
|---|---|---|---|
| Violation #16. | e are approximately 7 doors ires grasping and twisting to | is throughout the facility with door looperate. | hardware that |

Violation 16 - There are approximately 7 doors throughout the facility with door har requires grasping and twisting to operate.

| | | N OF ADDISON LDING REPORT | |
|---|---|---|---|
| Possible Solutions: | Replace entrance door ha | ardware with lever type hardware. | |

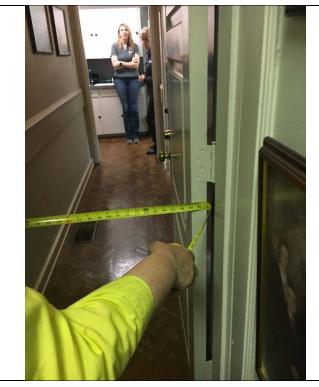
| | TOWN OF ADDISON - Town Hall |
|---|---|
| Violation #17: | Doorways throughout the facility have openings that range from 28"-31" wide openings. |

Violation 17 - Doorways throughout the facility have openings that range from 28"-31" wide openings.

| | TOWN OF ADDISON - Town Hall |
|---|---|
| Possible Solutions: | Remove door frames to provide a minimum opening of 32". |

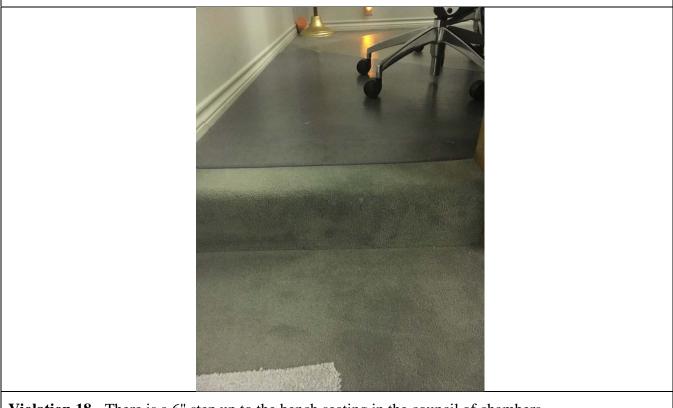
| | TOWN OF ADDISON - Town Hall |
|---|---|
| Violation #18: | There is a 6" step up to the bench seating in the council of chambers. |

Violation 18 - There is a 6" step up to the bench seating in the council of chambers.

| | TOWN OF ADDISON - Town Hall |
|---|---|
| Possible Solutions: | Provide access to the bench seating area. |

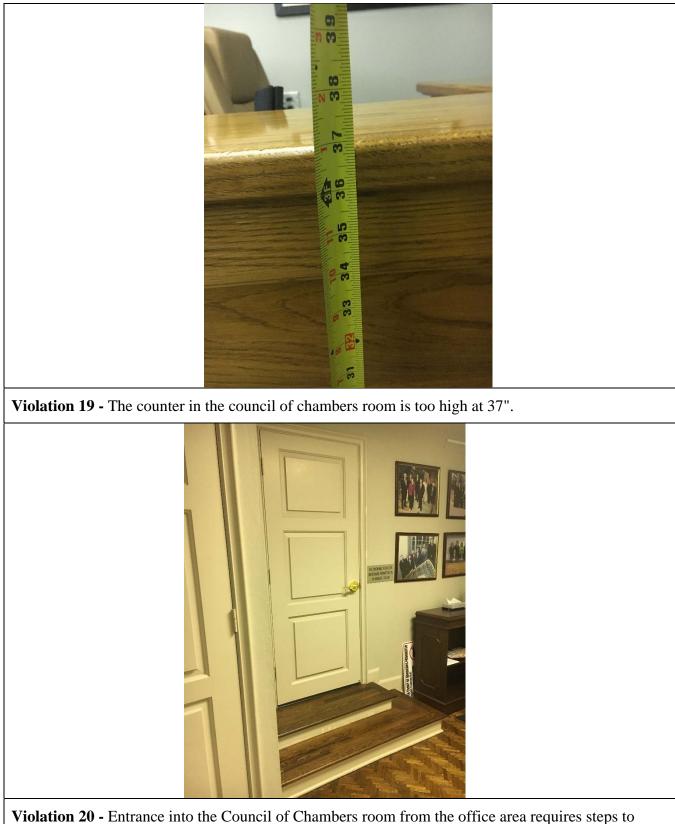
| | TOWN OF ADDISON - Town Hall | |
|---|--|--|
| Violation #20: | Entrance into the Council of Chambers room from the office area requires steps to enter the room. | |

Violation 20 - Entrance into the Council of Chambers room from the office area requires st enter the room.

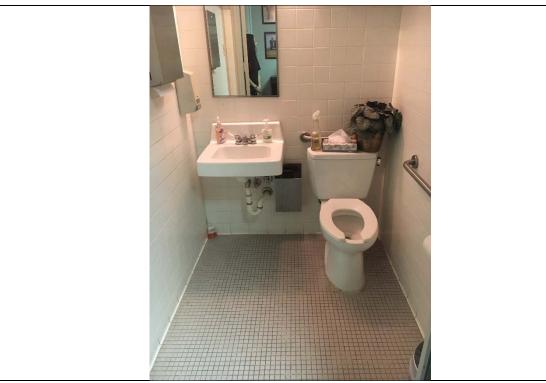
| TOWN OF ADDISON BUILDING REPORT | | | | |
|--|--|---|---|--|
| Violation $\#/1$ | omen's Room: Room is onl accommodate a wheelchair | ly 56" wide by 65-1/2" deep and is no r turning space. | ot large enough | |

Violation 21 - Women's Room: Room is only 56" wide by 65-1/2" deep and is not large enough to accommodate a wheelchair turning space.

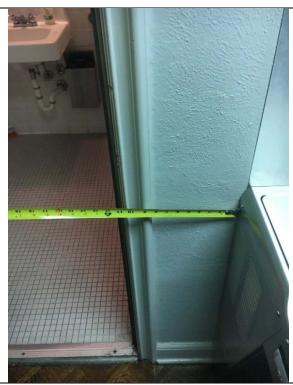
| | TOWN OF ADDISON - Town Hall |
|---|---|
| Violation #22: | Women's Room: There is only a 10-1/2" maneuvering clearance provided on the pull side of the door. |

Violation 22 - Women's Room: There is only a 10-1/2" maneuvering clearance provided on the pull side of the door.

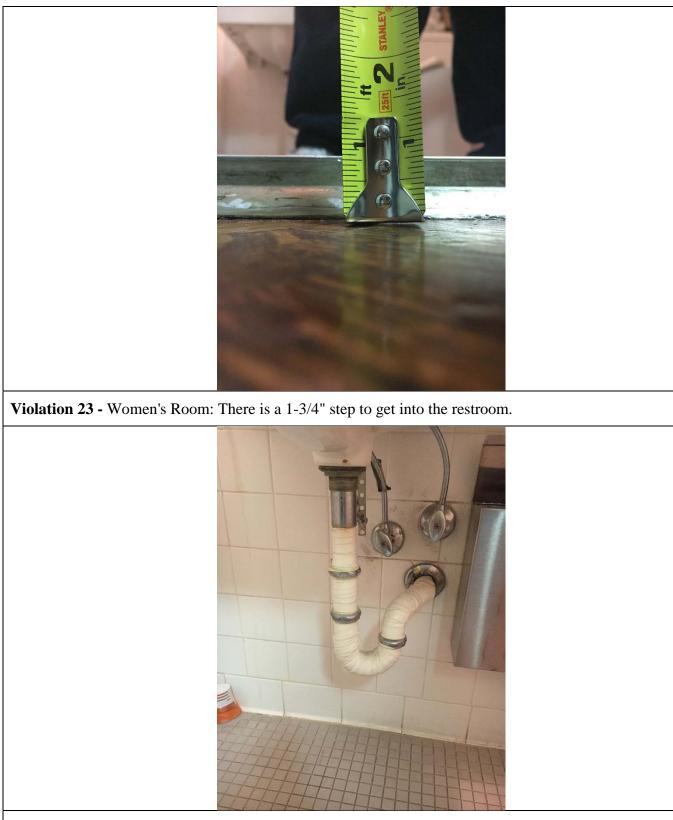
| | TOWN OF ADDISON - Town Hall |
|---|---|
| Violation #24: | Women's Room: Lavatory pipes and controls are not protected against contact. |

Violation 24 - Women's Room: Lavatory pipes and controls are not protected against contact.

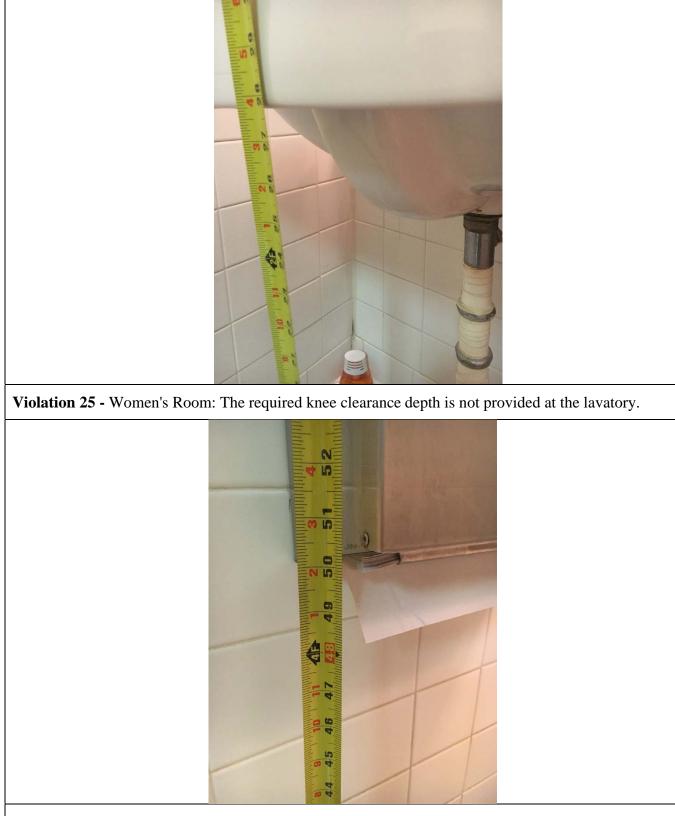
Violation 26 - Women's Room: The operation portion of the paper towel dispenser is at 50" above finished floor.

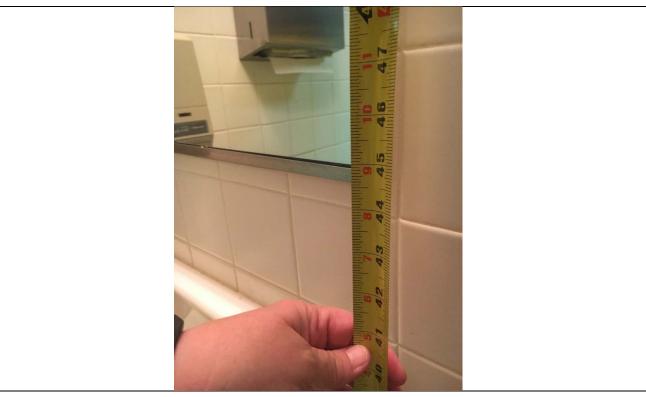
| | TOWN OF ADDISON - Town Hall |
|---|---|
| Violation #27: | Women's Room: Mirror is at 45" to the bottom of the reflective surface. |

Violation 27 - Women's Room: Mirror is at 45" to the bottom of the reflective surface.

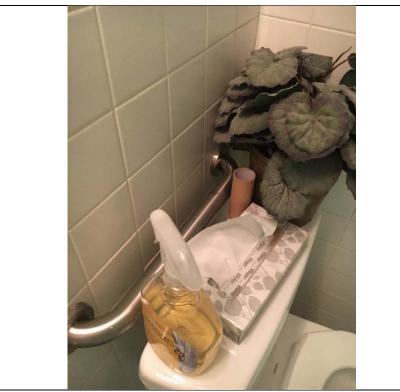
| | TOWN OF ADDISON - Town Hall |
|---|---|
| Violation #28: | Women's Room: The side grab bar has over a 2" space between the grab bar and the wall. The rear grab bar is only 12" long. |

Violation 28 - Women's Room: The side grab bar has over a 2" space between the grab bar and the wall. The rear grab bar is only 12" long.

| | TOWN OF ADDISON - Town Hall |
|---|--|
| Possible Solutions: | Reposition side grab bar and replace rear grab bar with a 36" long grab bar. |

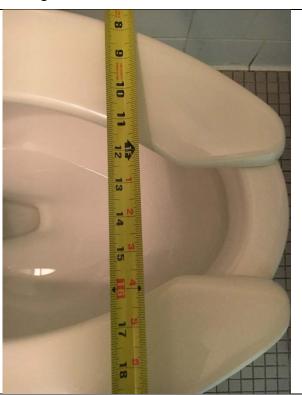
| | TOWN OF ADDISON - Town Hall |
|---|--|
| Violation #29: | Women's Room: Water closet centerline is at 14" where 16"-18" is required. |

Violation 29 - Women's Room: Water closet centerline is at 14".

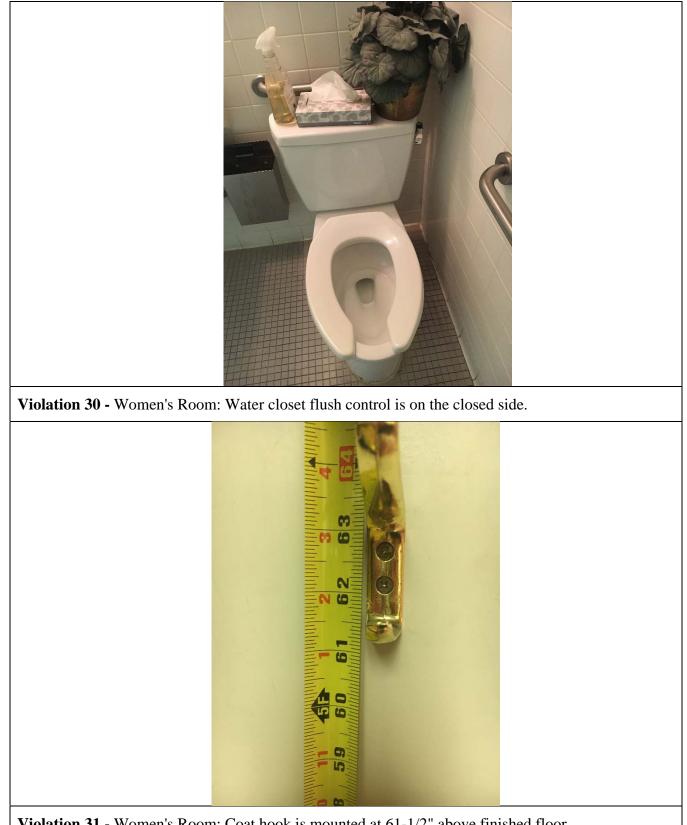
Violation 31 - Women's Room: Coat hook is mounted at 61-1/2" above finished floor.

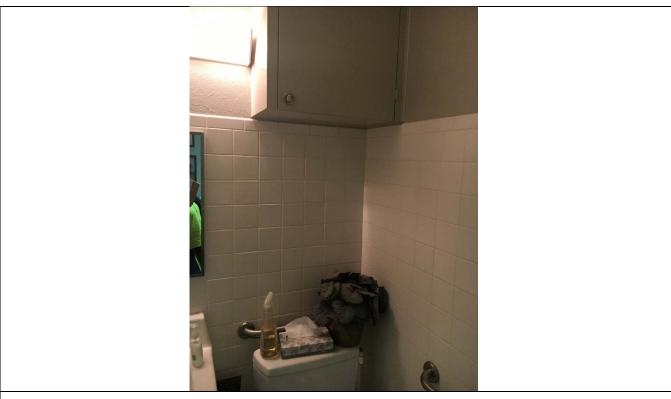
| | TOWN OF ADDISON - Town Hall | | |
|---|---|--|--|
| Violation #32: | Women's Room: Cabinet provided over the water closet is an overhead protrusion. | | |

Violation 32 - Women's Room: Cabinet provided over the water closet is an overhead protrusion.

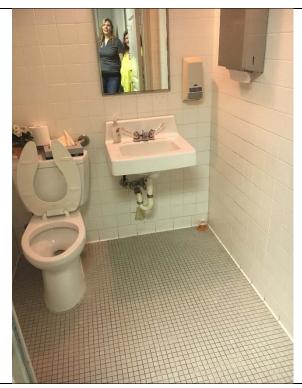
| | TOWN OF ADDISON - Town Hall | | |
|---|---|--|--|
| Violation #32 Cost: Violation #33: | \$525PriorityLevel 8Men's Room: Room is only 56" wide by 65-1/2" deep and is not large enough to accommodate a wheelchair turning space. | | |

Violation 33 - Men's Room: Room is only 56" wide by 65-1/2" deep and is not large enough to accommodate a wheelchair turning space.

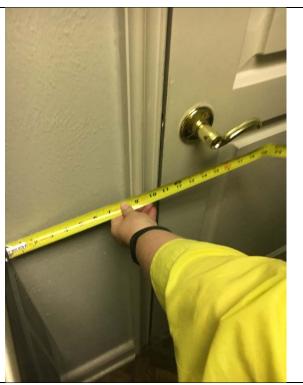
| | TOWN OF ADDISON - Town Hall |
|---|--|
| Violation #34: | Men's Room: There is only an 11" maneuvering clearance provided on the pull side of the door. |

Violation 34 - Men's Room: There is only an 11" maneuvering clearance provided on the pull side of the door.

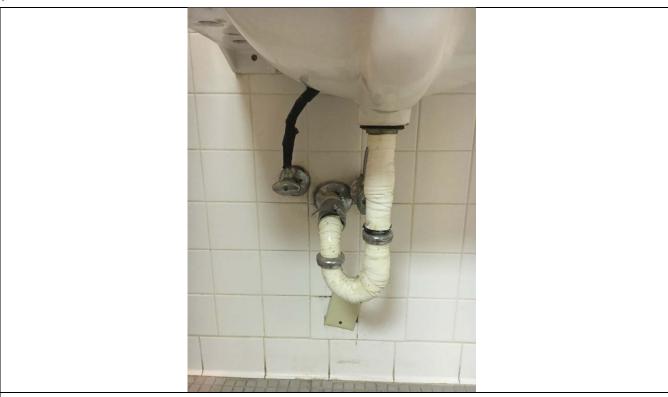
| | TOWN OF ADDISON - Town Hall |
|---|---|
| Violation #36: | Men's Room: Lavatory pipes and controls are not protected against contact. |

Violation 36 - Men's Room: Lavatory pipes and controls are not protected against contact.

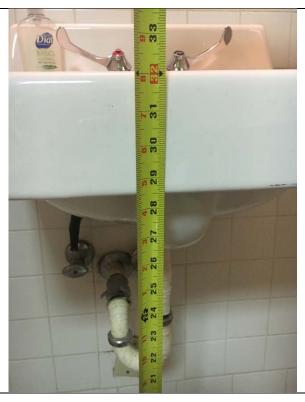
| | TOWN OF ADDISON - Town Hall |
|---|---|
| Violation #37: | Men's Room: The required knee clearance depth is not provided at the lavatory. |

Violation 37 - Men's Room: The required knee clearance depth is not provided at the lavatory.

| | TOWN OF ADDISON - Town Hall |
|---|---|
| Possible Solutions: | Replace lavatory. |

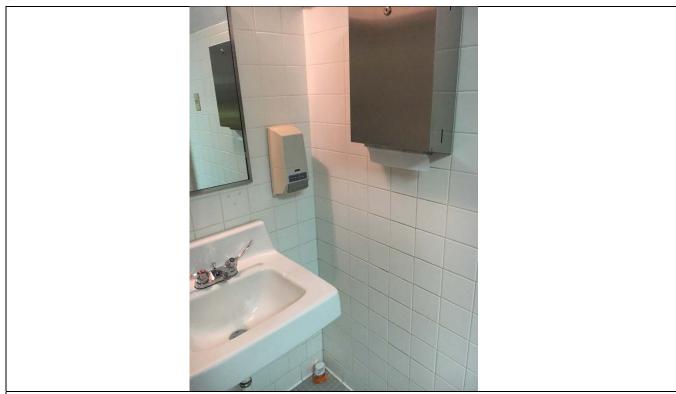
| | TOWN OF ADDISON - Town Hall |
|---|---|
| Violation #38. | Men's Room: The operation portion of the paper towel dispenser is at 50" above inished floor. |

Violation 38 - Men's Room: The operation portion of the paper towel dispenser is at 50" above finished floor.

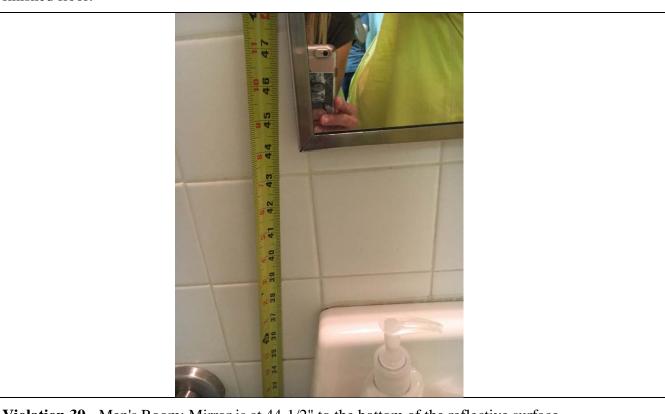
| | TOWN OF ADDISON - Town Hall | | |
|---|---|--|--|
| Violation #39: | Men's Room: Mirror is at 44-1/2" to the bottom of the reflective surface. | | |

Violation 39 - Men's Room: Mirror is at 44-1/2" to the bottom of the reflective surface.

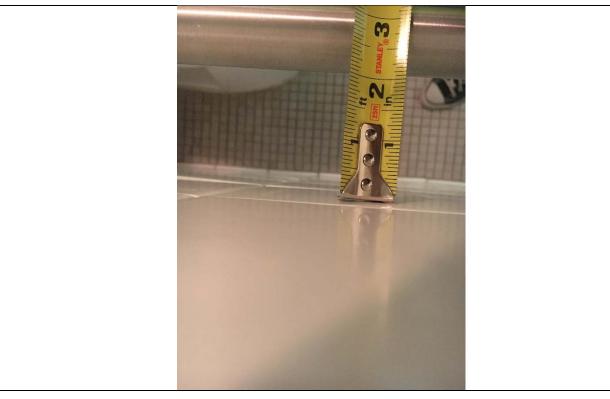
Violation 40 - Men's Room: The side grab bar has over a 2" space between the grab bar and the wall. The rear grab bar is only 12" long.

| | TOWN OF ADDISON - Town Hall | | |
|---|---|--|--|
| Possible Solutions: | Reposition side grab bar and replace rear grab bar with a 36" long grab bar. | | |

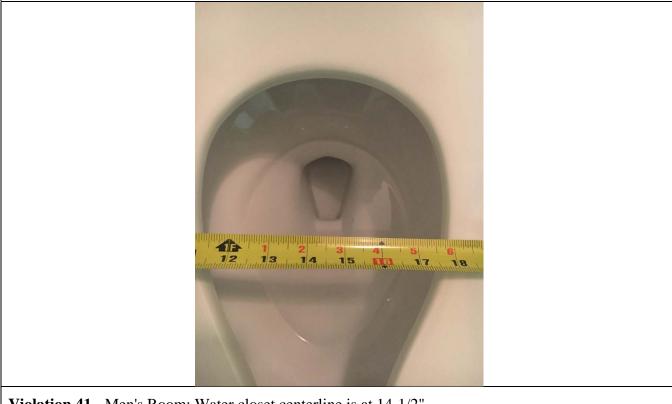
| | TOWN OF ADDISON - Town Hall | | |
|---|---|--|--|
| Violation #41: | Men's Room: Water closet centerline is at 14-1/2". | | |

Violation 41 - Men's Room: Water closet centerline is at 14-1/2".

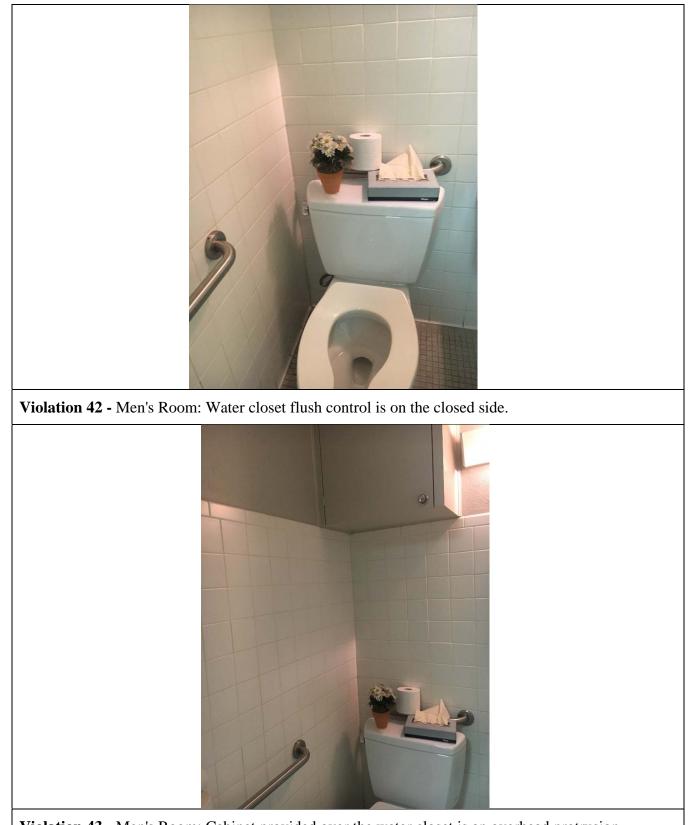
| | TOWN OF ADDISON - Town Hall | | | |
|---|---|--|--|--|
| Violation #43: | Men's Room: Cabinet provided over the water closet is an overhead protrusion. | | | |

Violation 43 - Men's Room: Cabinet provided over the water closet is an overhead protrusion.

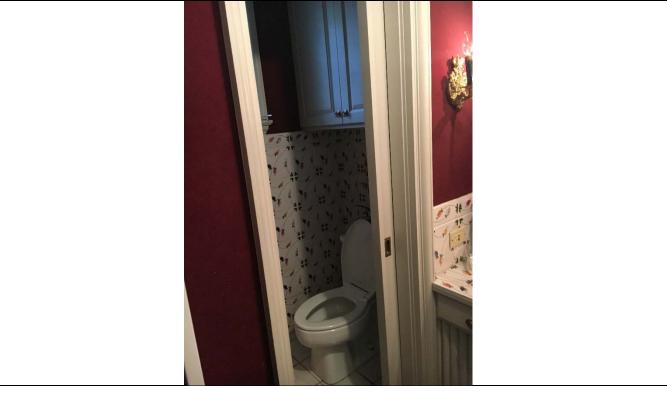
| | TOWN OF ADDISON - Town Hall | | | |
|---|---|--|--|--|
| Violation #44: | The small restroom at the front of the building has no accessible features. | | | |

Violation 44 – The small restroom at the front of the building has no accessible features.

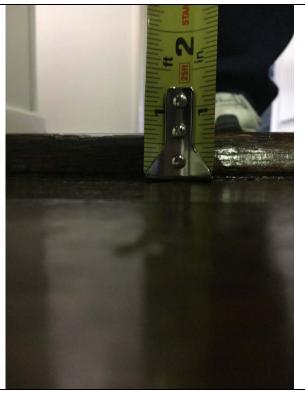
| TOWN OF ADDISON | | | | | |
|---|---|---|---|---|--|
| Violation #45: There | e is a 5/8" step to get into the | e break room. | | | |

Violation 45 - There is a 5/8" step to get into the break room.

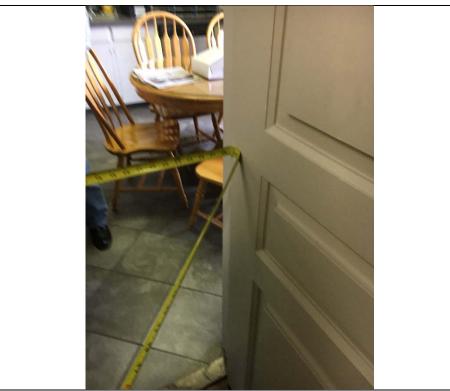
| TOWN OF ADDISON | | | | | |
|---|---|---|---|---|--|
| Violation #46: The c | loor width leading into the b | preak room is only 29" wide. | | | |

Violation 46 - The door width leading into the break room is only 29" wide.

| | TOWN OF ADDISON - Town Hall |
|---|--|
| Possible Solutions: | Replace door to achieve 32" minimum clear width. |

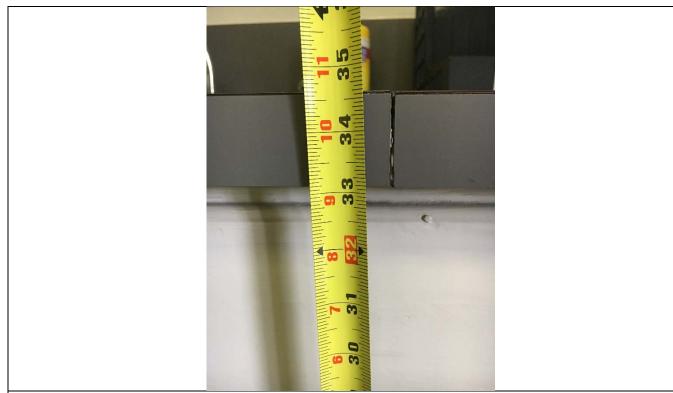
Violation 47 - Break room sink is 34-9/16" high with no knee clearance, where 34" maximum is required.
