**TOWN OF ADDISON
BUILDING REPORT**

Facility Information: **Facility Name:** Tree House
Facility Contact: Lisa Pyles **Contact Phone:** 972-450-2878

Accessology Inspector Information:
Inspector: Karen Jackson **Date:** April 4, 2016
Email: Kjackson@accessology.com

Latitude: 32.947856 **Longitude:** -96.84084
Address: 14681 Midway Road, #200 **City:** Addison **County:** Dallas

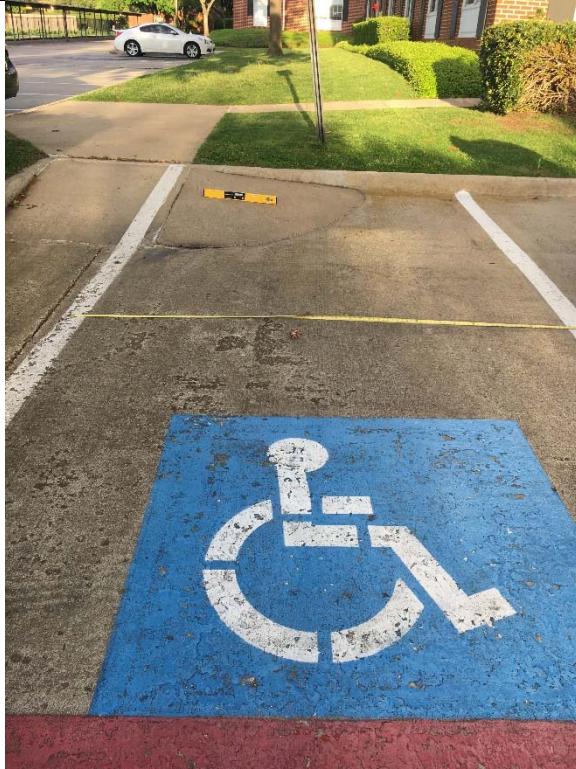
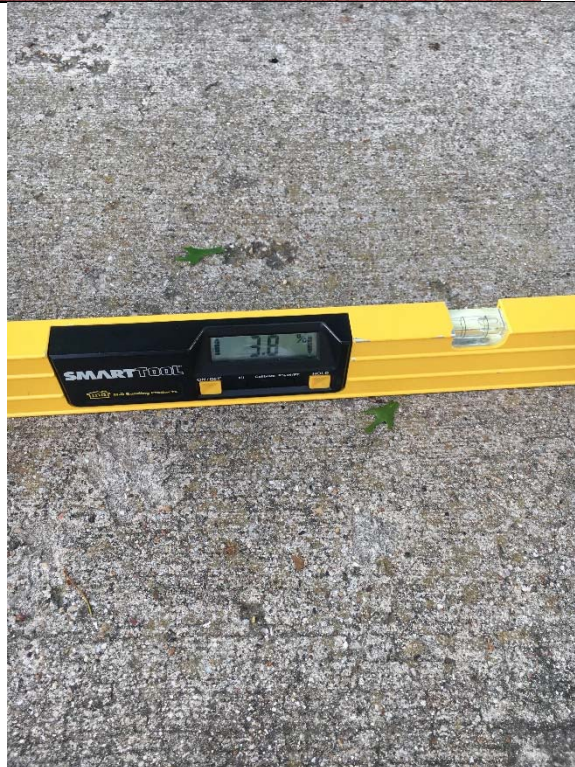
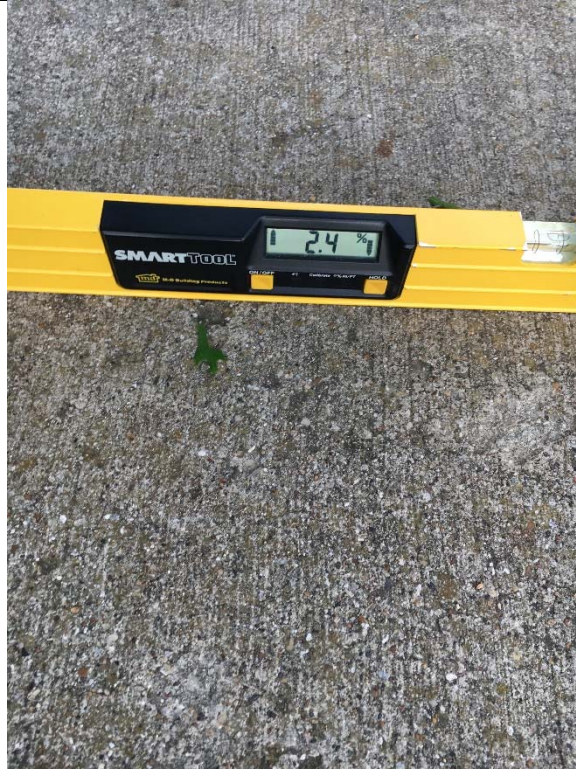
Violation #1: The accessible parking space has a running slope of 3.8% and a cross slope of 2.4%.

Violation 1 - The accessible parking space has a running slope of 3.8% and a cross slope of 2.4%.

Relocate accessible parking. Ensure slopes are no greater than 2% in all directions.

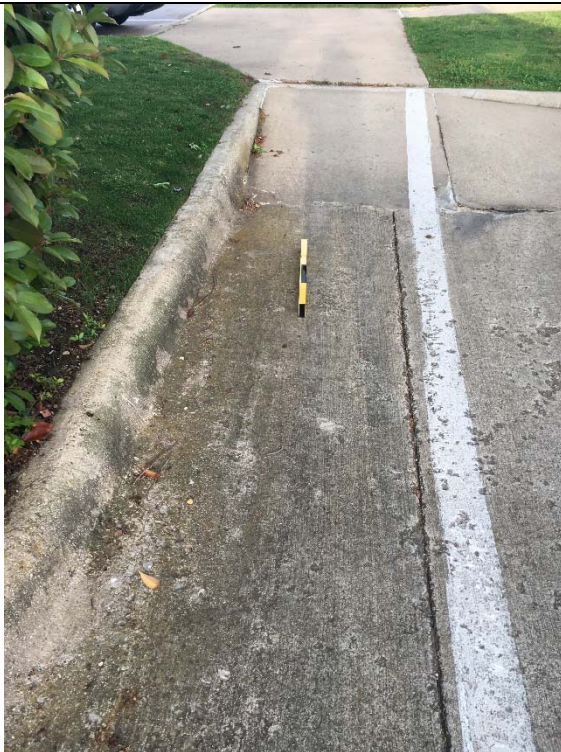
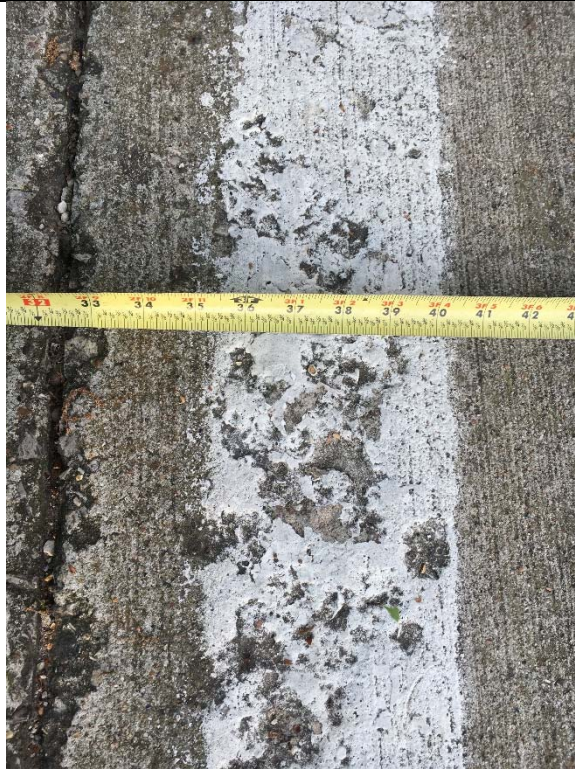
The access aisle is only 38" wide and has a built up curb ramp in it.

Violation 2 - The access aisle is only 38" wide and has a built up curb ramp in it.

Add compliant access aisles that fully complies with 502.3 with slopes no greater than 2% in all directions.

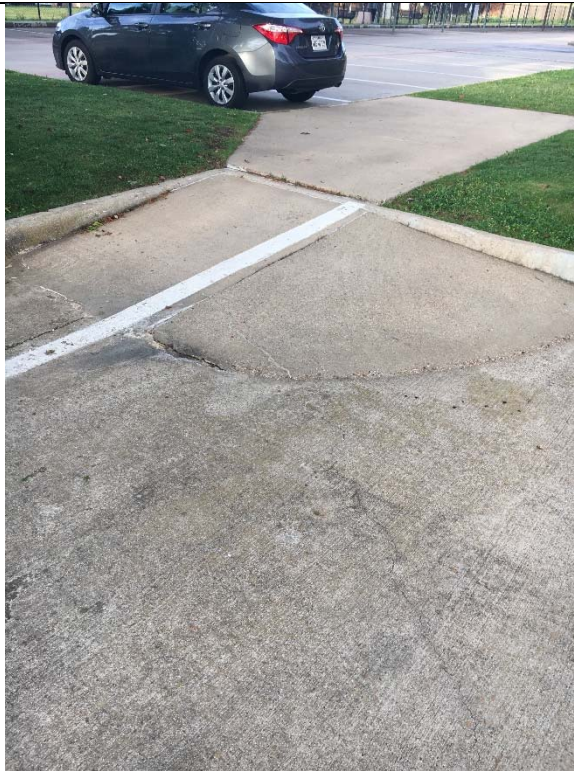
The curb ramp provided projects into the access aisle and the accessible parking space and has a running slope of 11.4%.

Violation 3 - The curb ramp provided projects into the access aisle and the accessible parking space and has a running slope of 11.4%.

When parking is reworked, install a compliant curb ramp complying with sections 405 and 406.

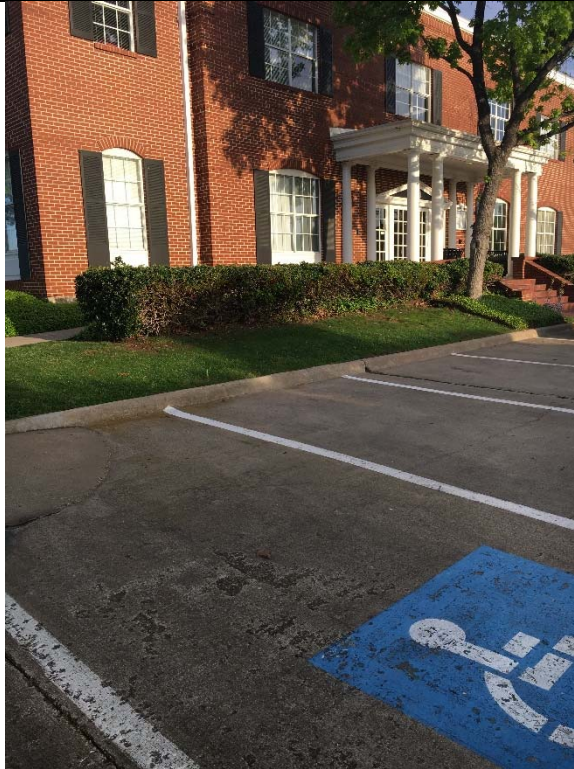
There is only 1 accessible parking space provided and 3 are required.

Violation 4: - There is only 1 accessible parking space provided, with the parking count, 3 are required.

Add two parking spaces and ensure one is van accessible with compliant signage. Two of the accessible parking spaces can share an access aisle.

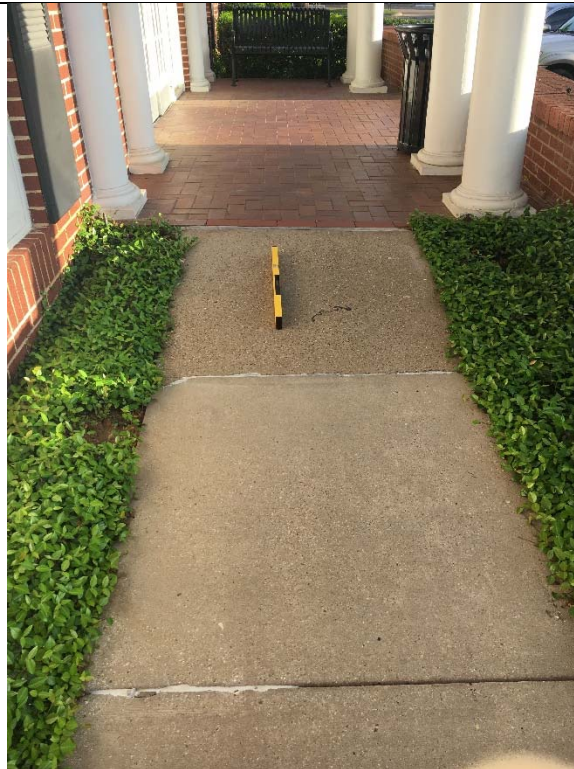
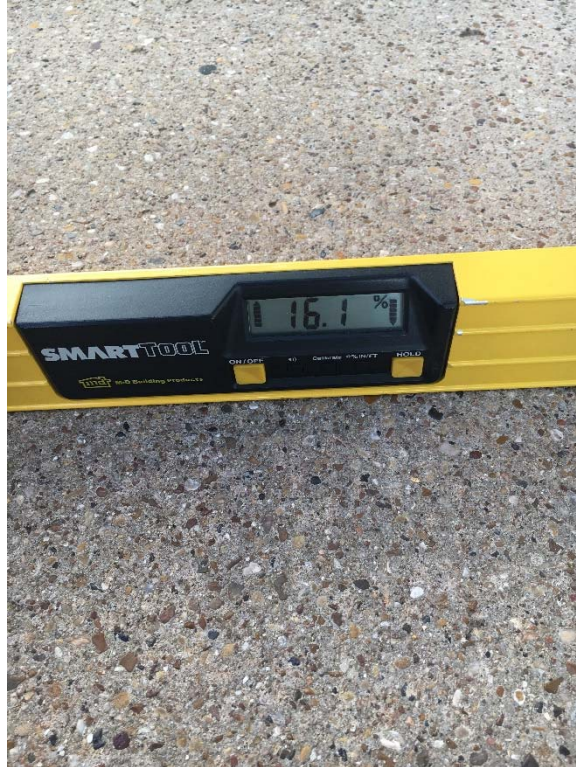
There is a 5'-0" ramped area where the sidewalk meets the brick pavers that has a running slope of 16.1%.

Violation 5 - There is a 5'-0" ramped area where the sidewalk meets the brick pavers that has a running slope of 16.1%.

Remove portion of the sidewalk leading up to the brick porch and extend the slope to provide a sidewalk with a running slope of less than 5%.

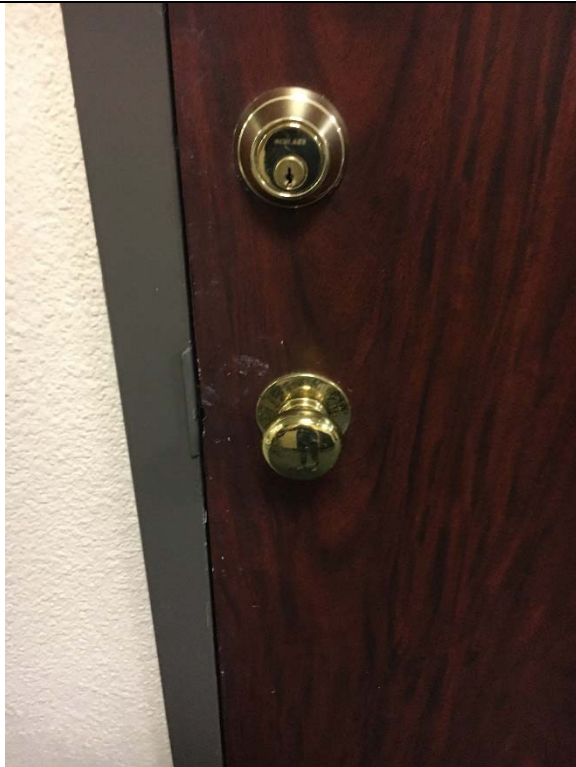
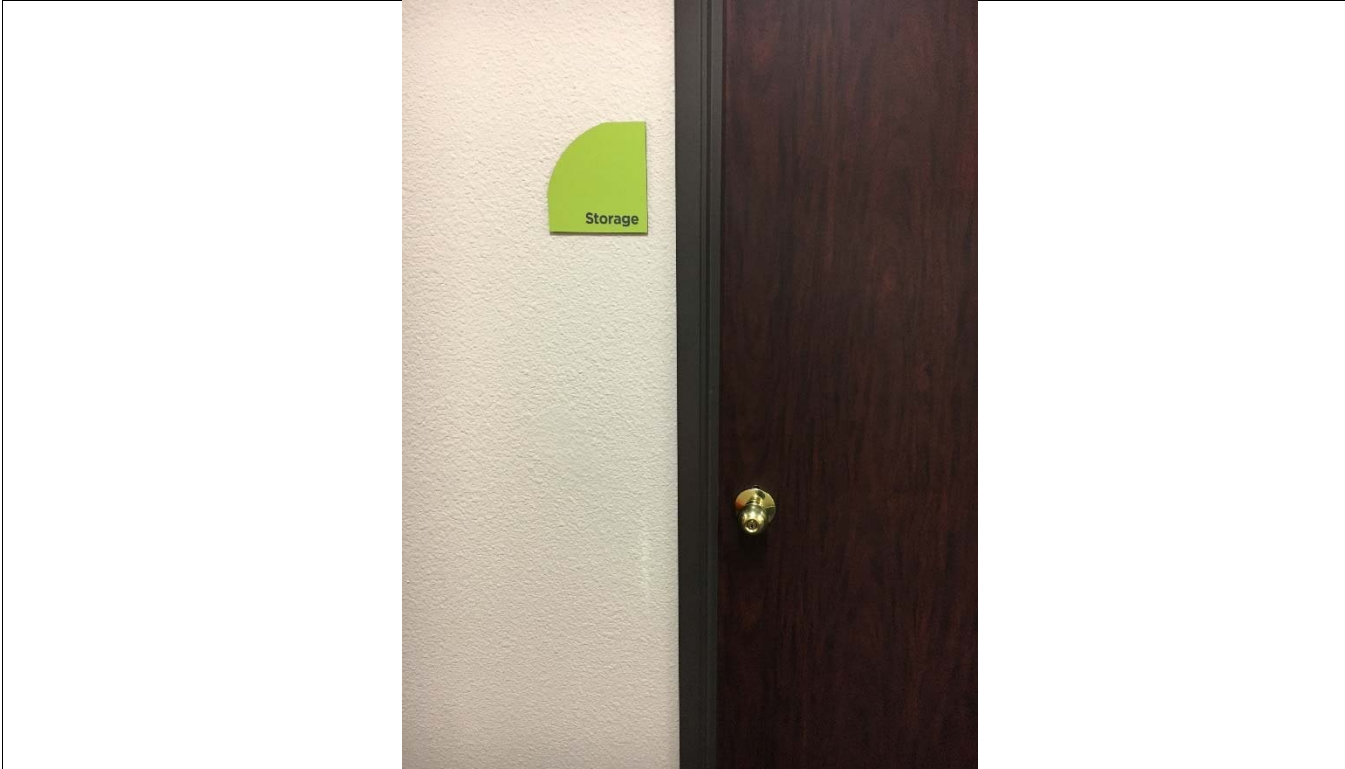
The supply and storage rooms in the main hallway have knob door hardware.

Violation 6 - The supply and storage rooms in the main hallway have knob door hardware.

Replace door hardware with lever type hardware that does not require tight grasping or twisting to operate.

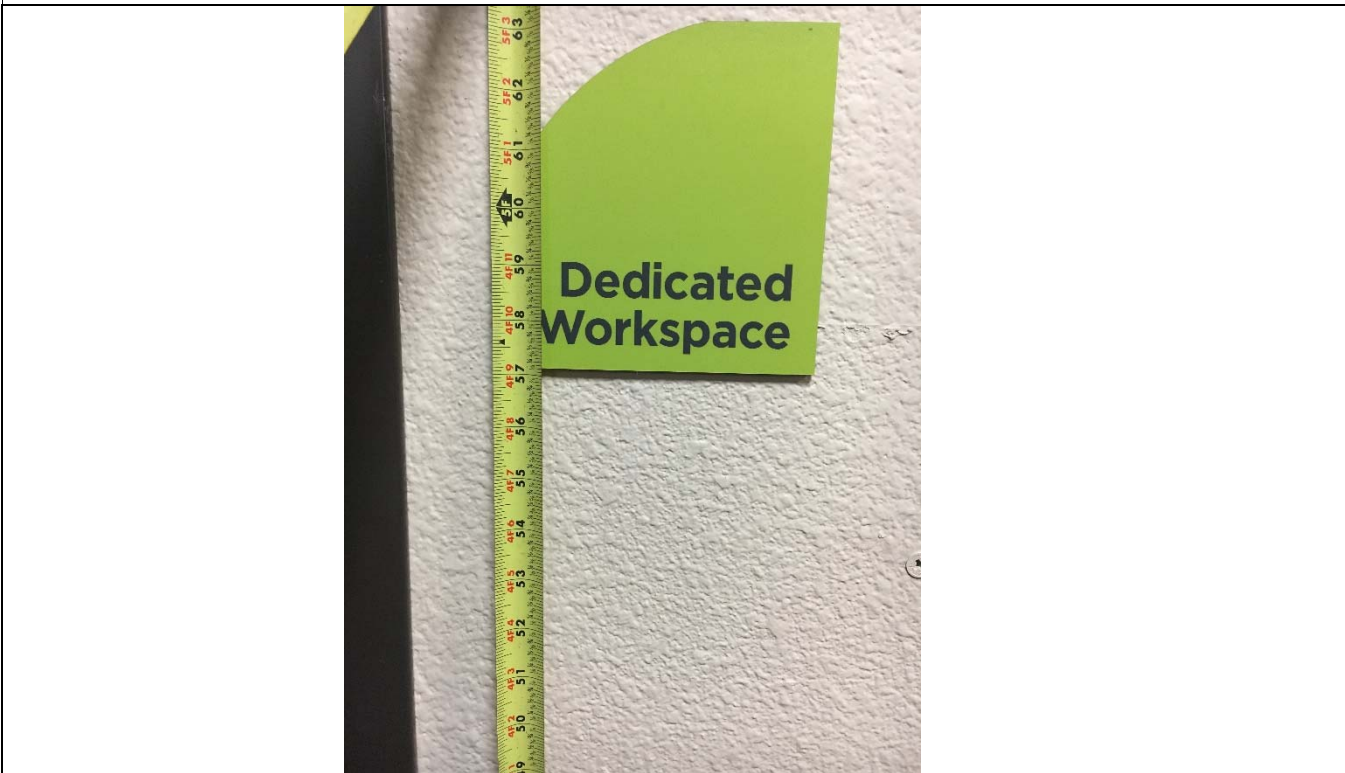
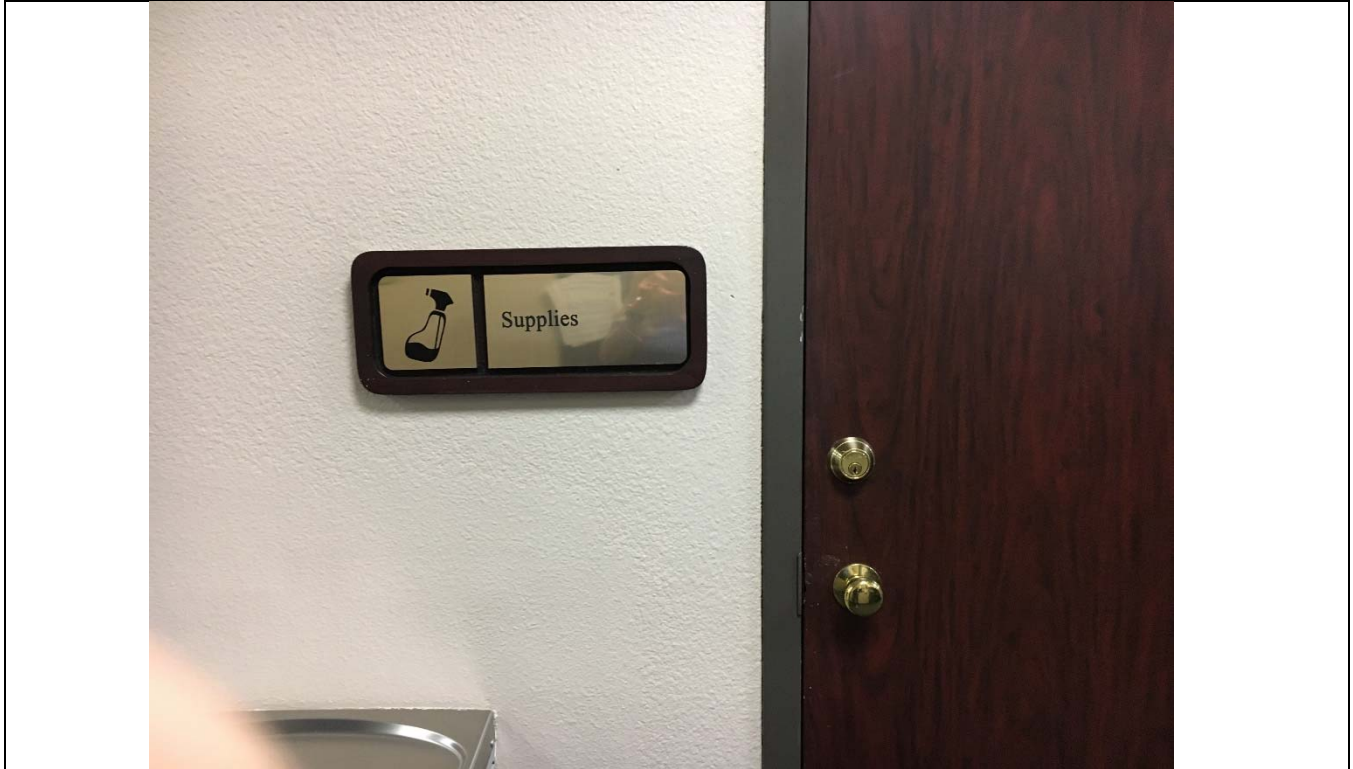
There are 11 green room designation signs with no Braille or tactile characters. The Men's, Women's, storage and supply signage have no Braille or tactile characters and are not properly mounted.

Violation 7 - There are 11 green room designation signs with no Braille or tactile characters. The Men's, Women's, storage and supply signage have no Braille or tactile characters and are not properly mounted.

Replace all room signs.

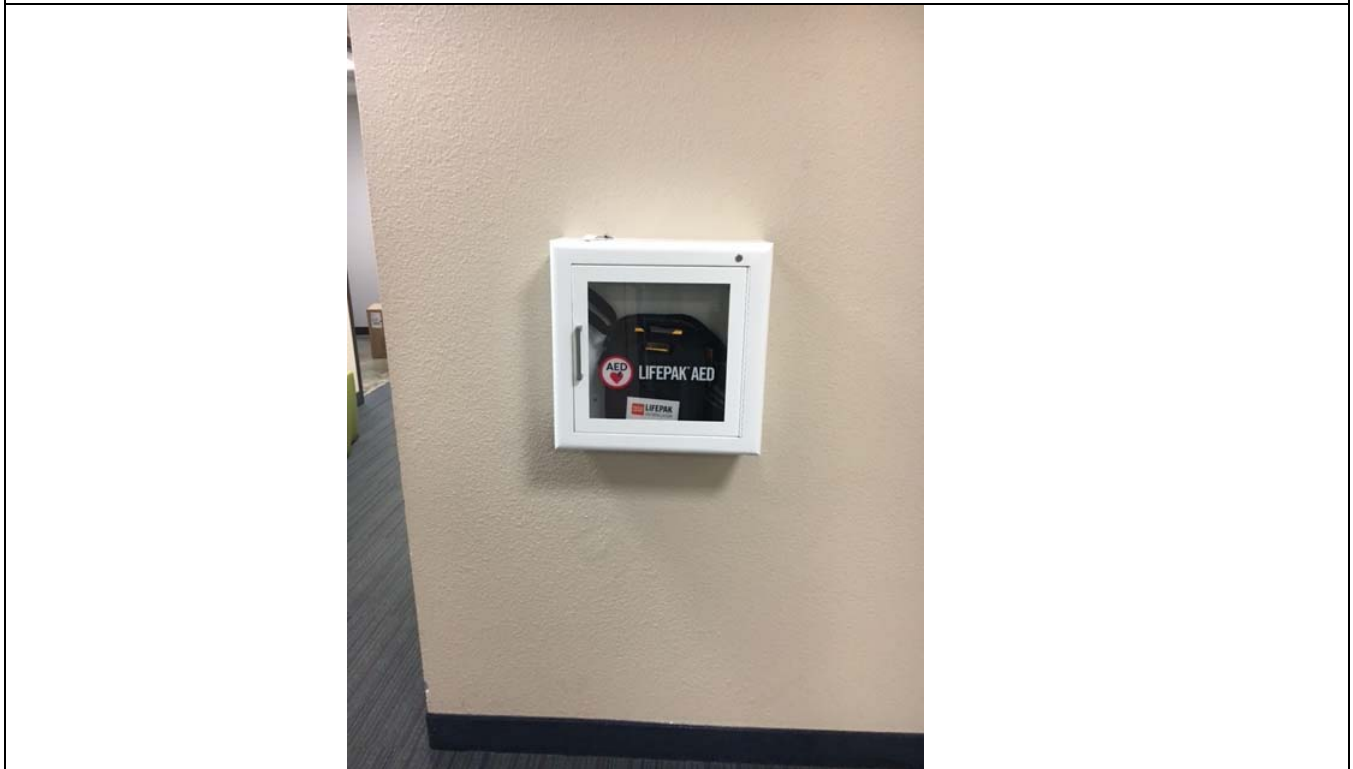
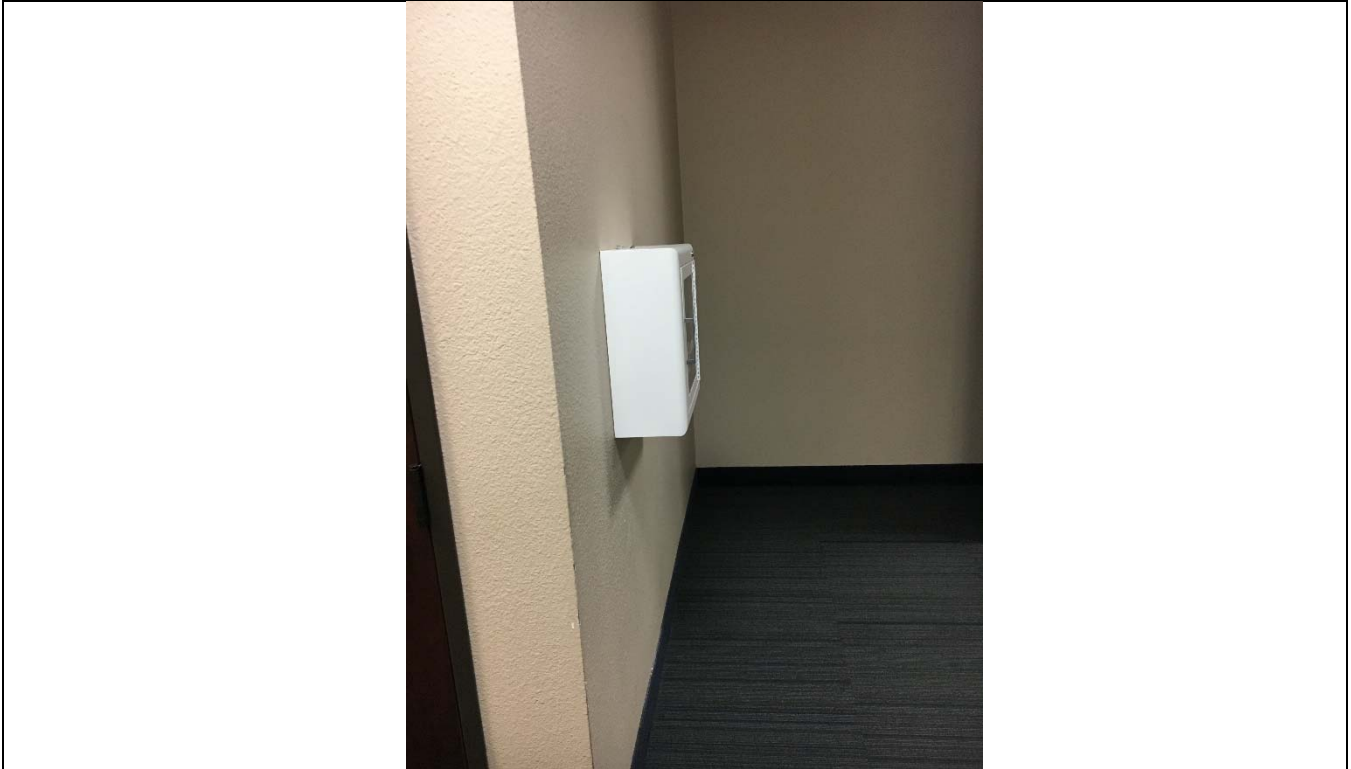
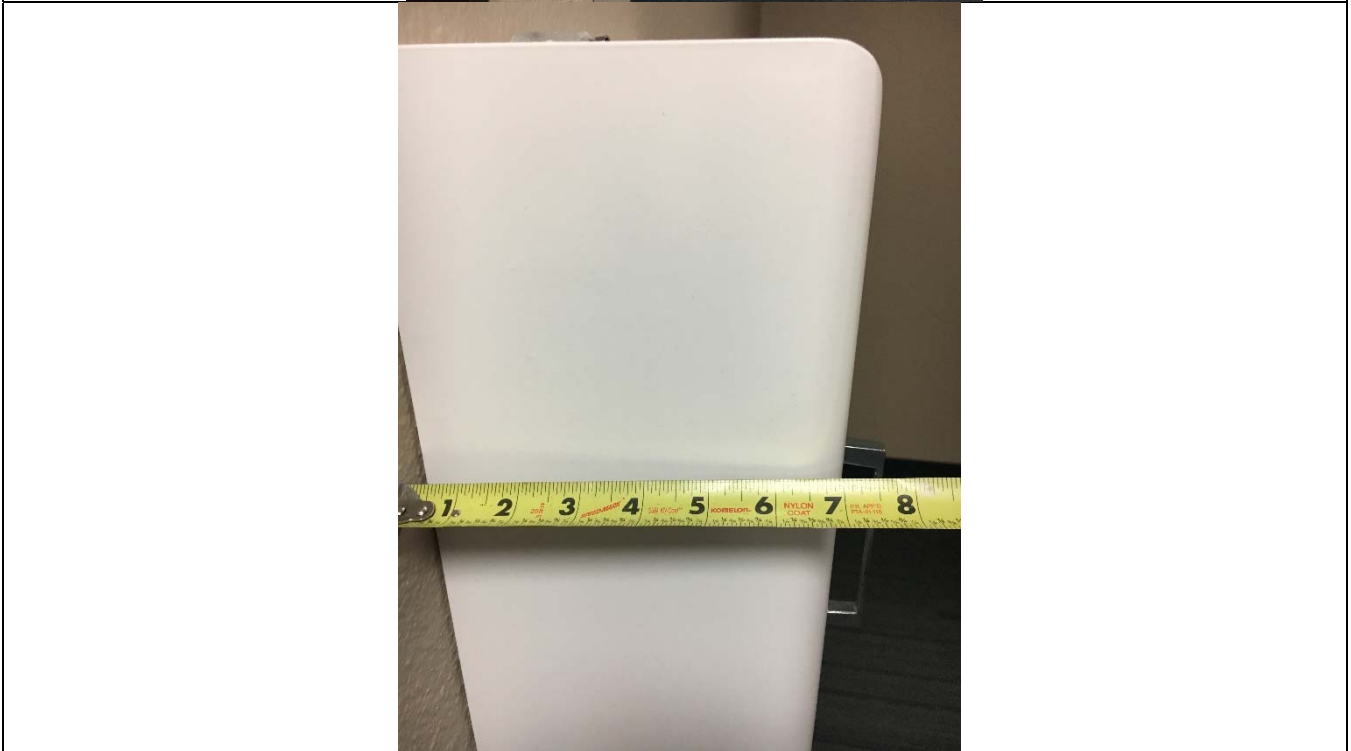
The Lifepak AED box in the hallway is a protruding object protruding out 7" into the walkway at 37-5/16" above finished floor.

Violation 8 - The Lifepak AED box in the hallway is a protruding object protruding out 7" into the walkway at 37-5/16" above finished floor.

Relocate the AED box to a location where it does not protrude into the path of travel.

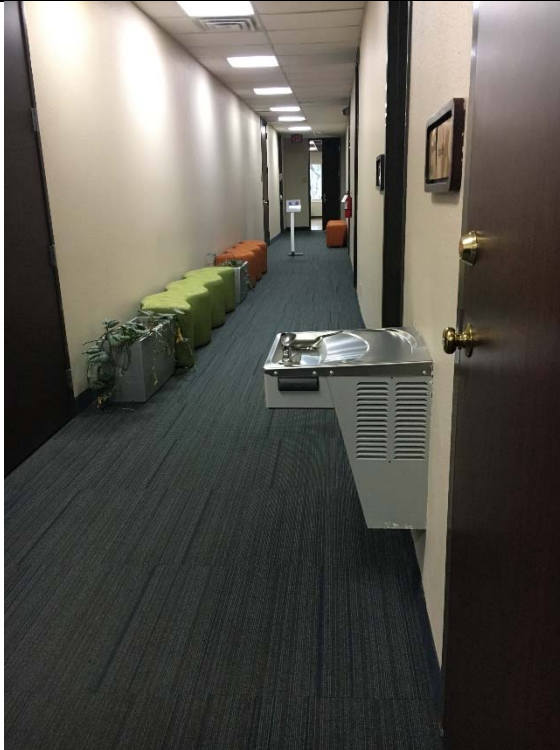
The drinking fountain in the hallway protrudes more than 4" into the path of travel at 28" above finished floor.

Violation 9 - The drinking fountain in the hallway protrudes more than 4" into the path of travel at 28" above finished floor.

Install new hi/lo compliant drinking fountain in a compliant location. Price included under violation #9.

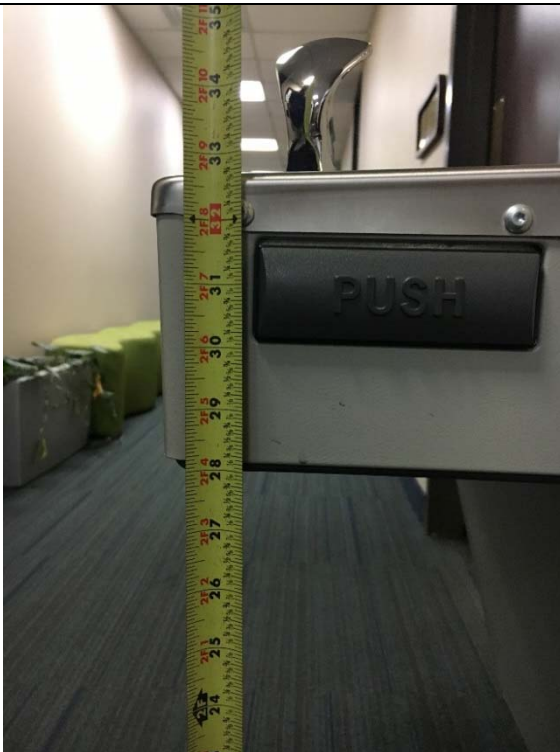
There is only one drinking fountain provided at accessible height. Two are required, one is required to be provided for standing persons.

Violation 10- There is only one drinking fountain provided at accessible height. Two are required, one is required to be provided for standing persons.

Install a unit for standing persons.

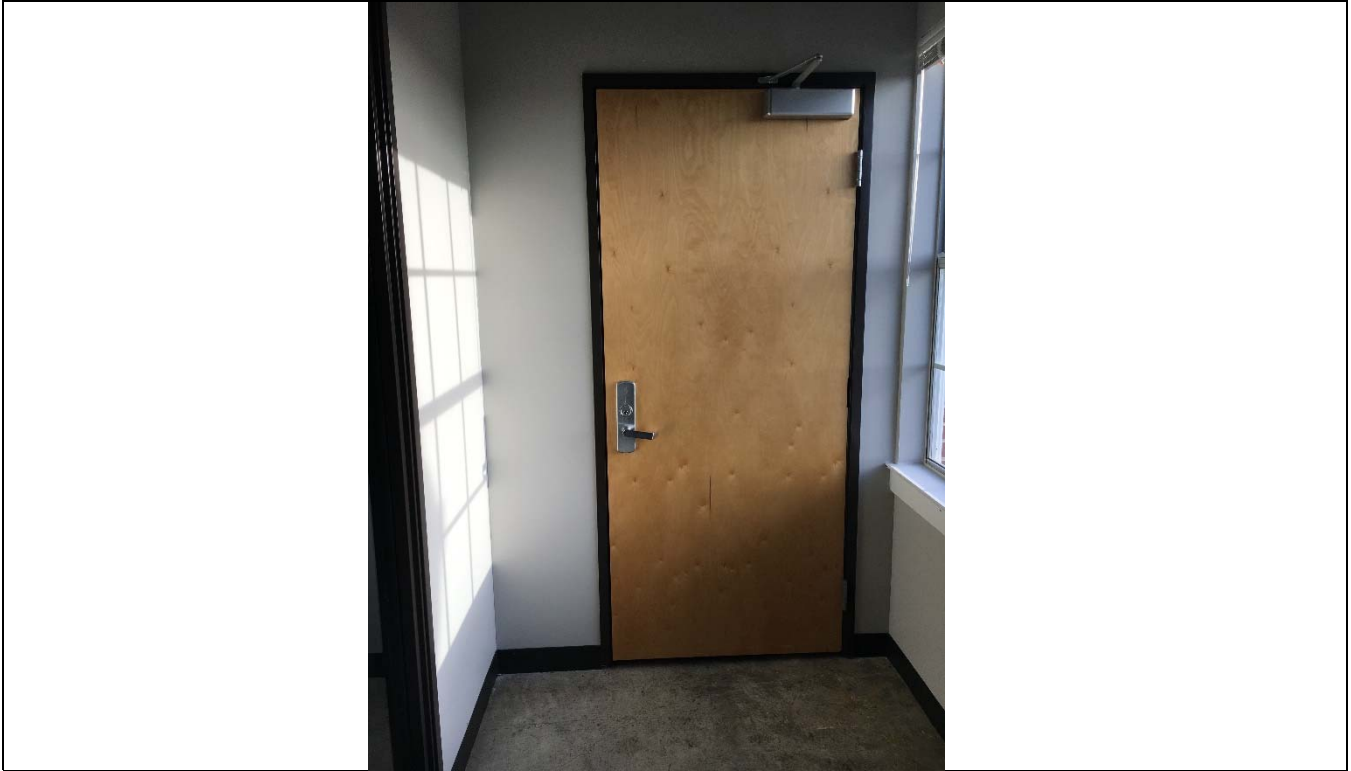
Interior hallway door only has 16" maneuvering clearance on the pull side.

Violation 11 - Interior hallway door only has 16" maneuvering clearance on the pull side.

Modify door to provide 18" clearance.

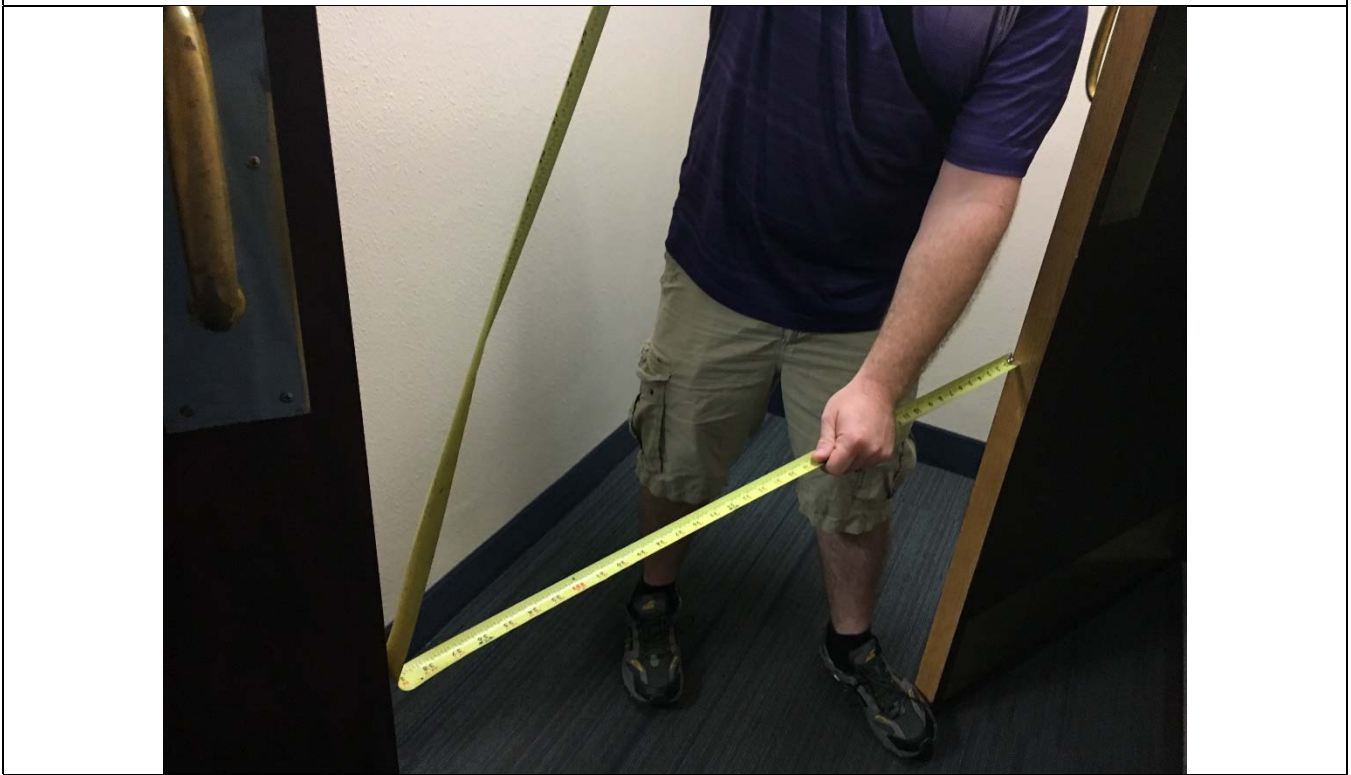
The Women's restroom maneuvering clearance between two doors in a series is only 39" between doors.

Violation 12 - The Women's restroom maneuvering clearance between two doors in a series is only 39" between doors.

Remove one of the doors to alleviate the doors in series condition.

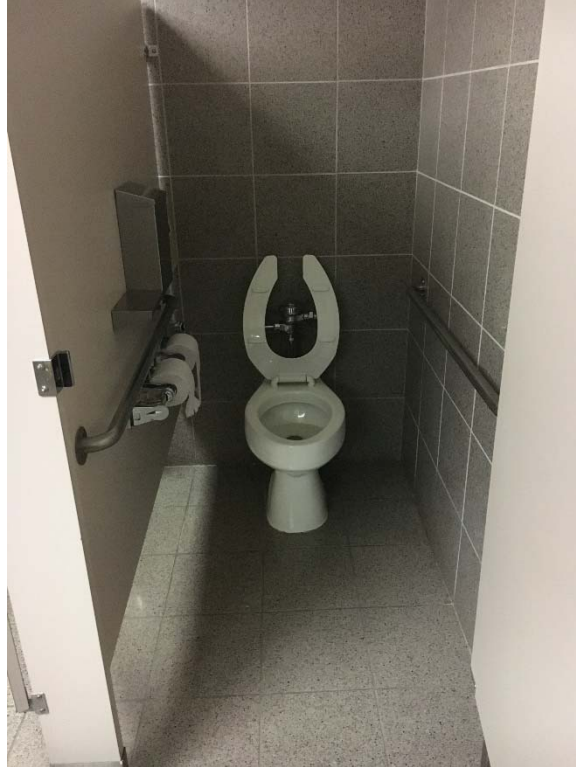
There is no accessible stall provided in the Women's restroom.

Violation 13 - There is no accessible stall provided in the Women's restroom.

Remodel toilet room to provide a fully compliant stall.

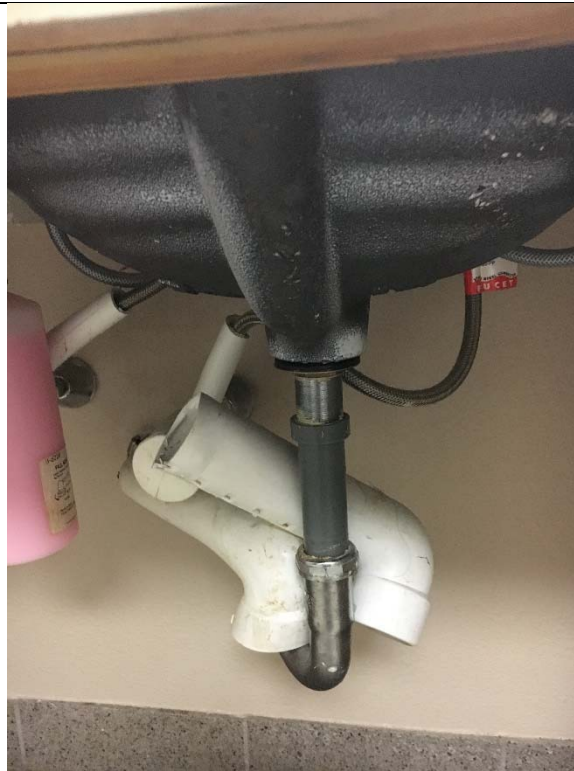
Women's restroom lavatory pipes are not wrapped.

Violation 14 - Women's restroom lavatory pipes are not wrapped.

Provide protection at the exposed drains and water lines under the lavatory.

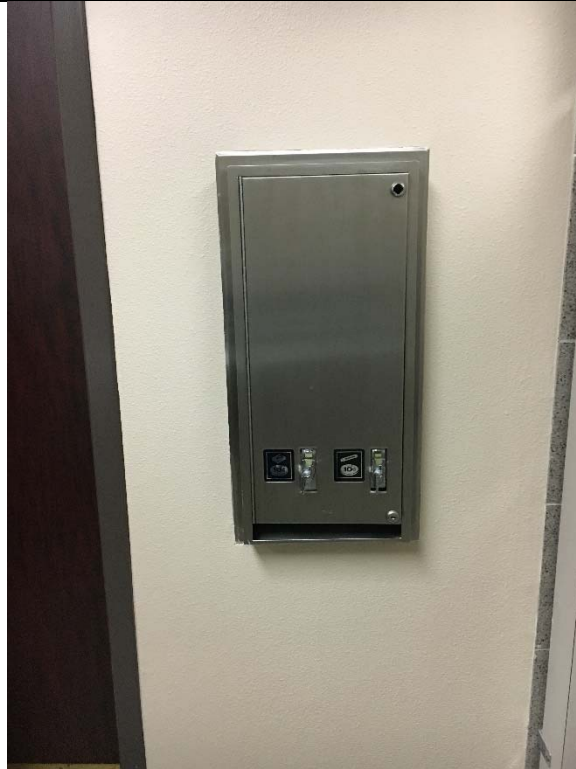
The feminine product dispenser provided in the Women's restroom requires tight grasping and twisting to operate.

Violation 15 - The feminine product dispenser provided in the Women's restroom requires tight grasping and twisting to operate.

Remove or replace with a dispenser that does not require grasping or twisting to operate.

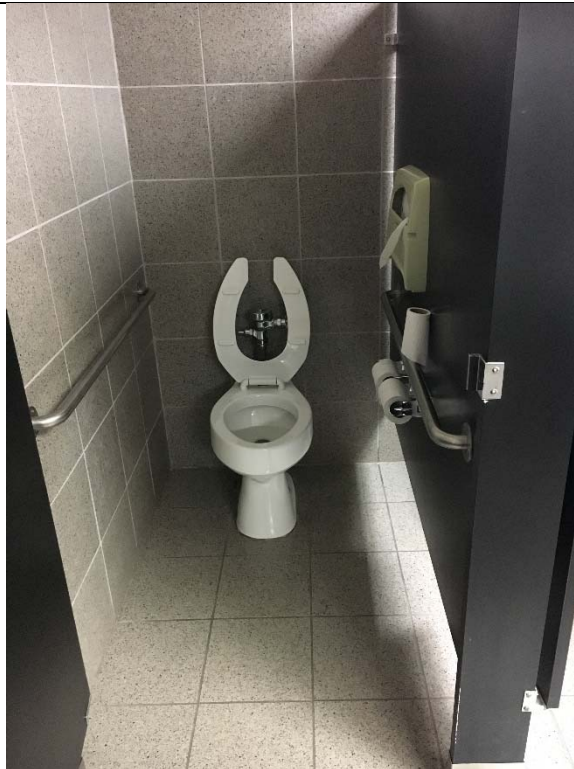
There is no accessible stall provided in the Men's restroom.

Violation 16 - There is no accessible stall provided in the Men's restroom.

Remodel toilet room to provide a fully compliant stall.

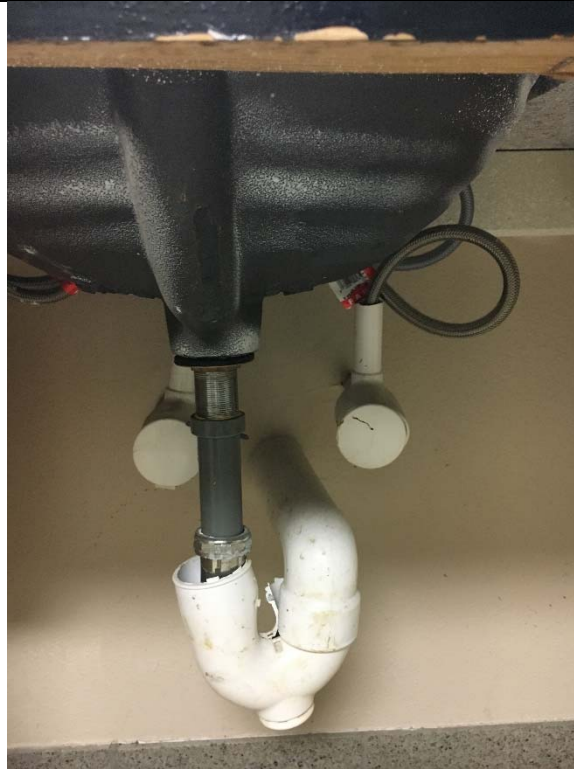
Men's restroom lavatory pipes are not wrapped.

Violation 17 - Men's restroom lavatory pipes are not wrapped.

Provide protection at the exposed drains and water lines under the lavatory.

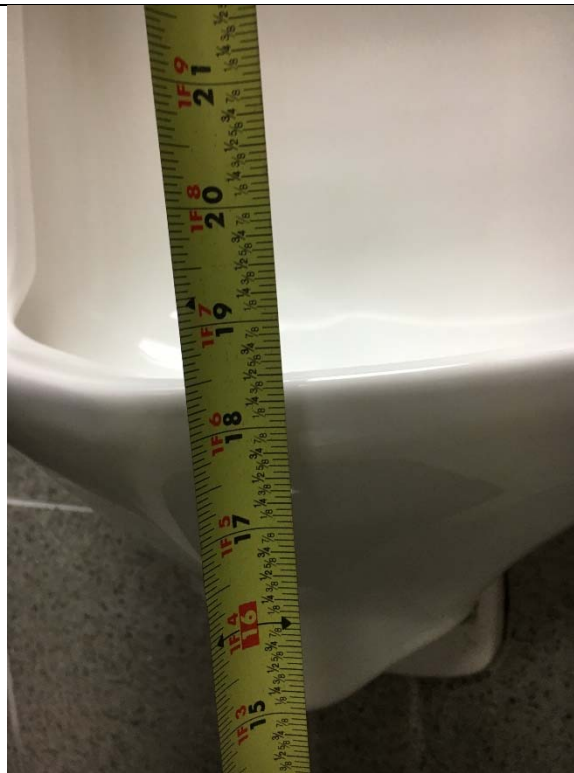
Men's restroom accessible urinal is mounted at 18-1/2" to the rim where a maximum of 17" is required.

Violation 18 - Men's restroom accessible urinal is mounted at 18-1/2" to the rim where a maximum of 17" is required.

Lower the urinal to 17" to the rim.

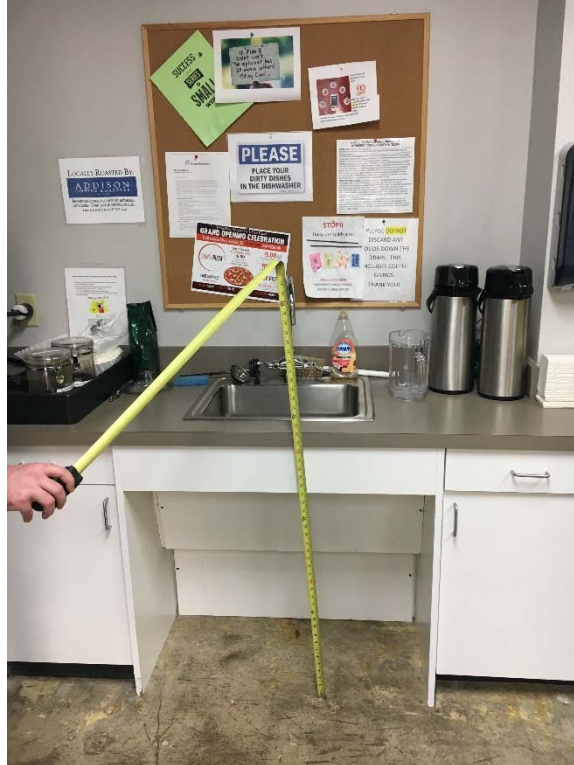
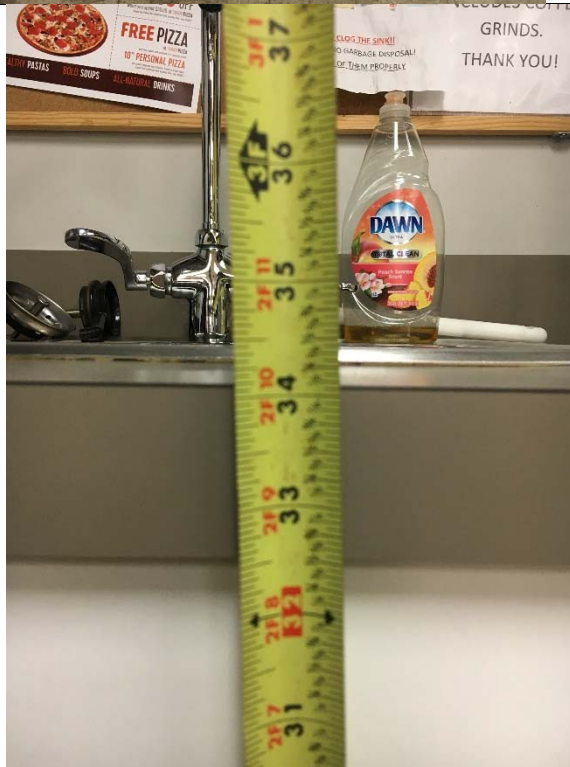
Violation #18: The sink in the break room is at 34-3/4" to the top of the counter where 34" maximum is required.

Violation 19 - The sink in the break room is at 34-3/4" to the top of the counter where 34" maximum is required.

Possible Solutions: Modify sink to provide 34" maximum height.
