Client: Town of Addison Date: 1/2/18
 Program: ADA Self-Evaluation and Transition Plan Prepared By: CMP
 KHA No.: 063543021 Checked By: EPE

Corridor: Proton Rd GPS ID: 260
 Project Name: Intersection of Proton Dr and driveway (Lat. 32.9459; Long. -96.8395)
 Town: Addison

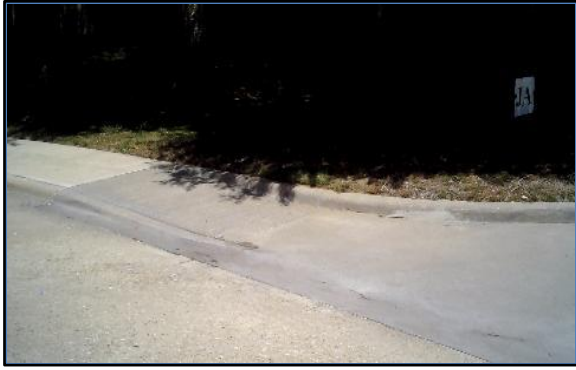
Ramp 1A

Curb Ramp Issues	Curb Ramp ID ('2' or '1' in ramp label indicates no existing ramp)		Possible Solutions
	1A	2A	
Curb ramp does not exist and is needed			Remove and replace curb ramp
Curb ramp does not land in crosswalk			
No 4' x 4' clear space at base of curb ramp			
Curbed side is not 90° or has traversable adjacent surface			
Flare cross slope is greater than 10%			
Curb ramp running slope is greater than 8.3%			
Blended transition running slope is greater than 5%			
Cut-thru ramp running slope is greater than 5%			
Curb ramp cross slope is greater than 2%		X	
Cut-thru ramp cross slope is greater than 2%			
Curb ramp width is less than 48"			For intersection, commercial driveway, and park ramps, install color truncated domes
Cut-thru ramp width is less than 60"			
Permanent obstruction (>0.25") in curb ramp/landing/flares			
Temporary obstruction (>0.25") in curb ramp/landing/flares			
No textured surface at base of curb ramp	X	X

No color contrast at base of curb ramp	X	X	
Landing area does not exist and is needed			
Landing area is less than 5' x 5' or slopes greater than 2%	X	X	
Curb ramp transition onto roadway is greater than 0.25"			
Counter slope of the gutter or street at the foot of the curb ramp is greater than 5%			
Ponding occurs at base of curb ramp			Remove and replace landing area
