RFI

RFI #: 135
 Dates: 5/31/2012
 Job: EB-02 Keller Springs Lofts
 Phone: 877-777-5115

Subject: Slab at Club Poured Short

Drawing: S2.11, S2.13, A9.1
 Cost Impact: None
 Spec Section:
 Schedule Impact: None

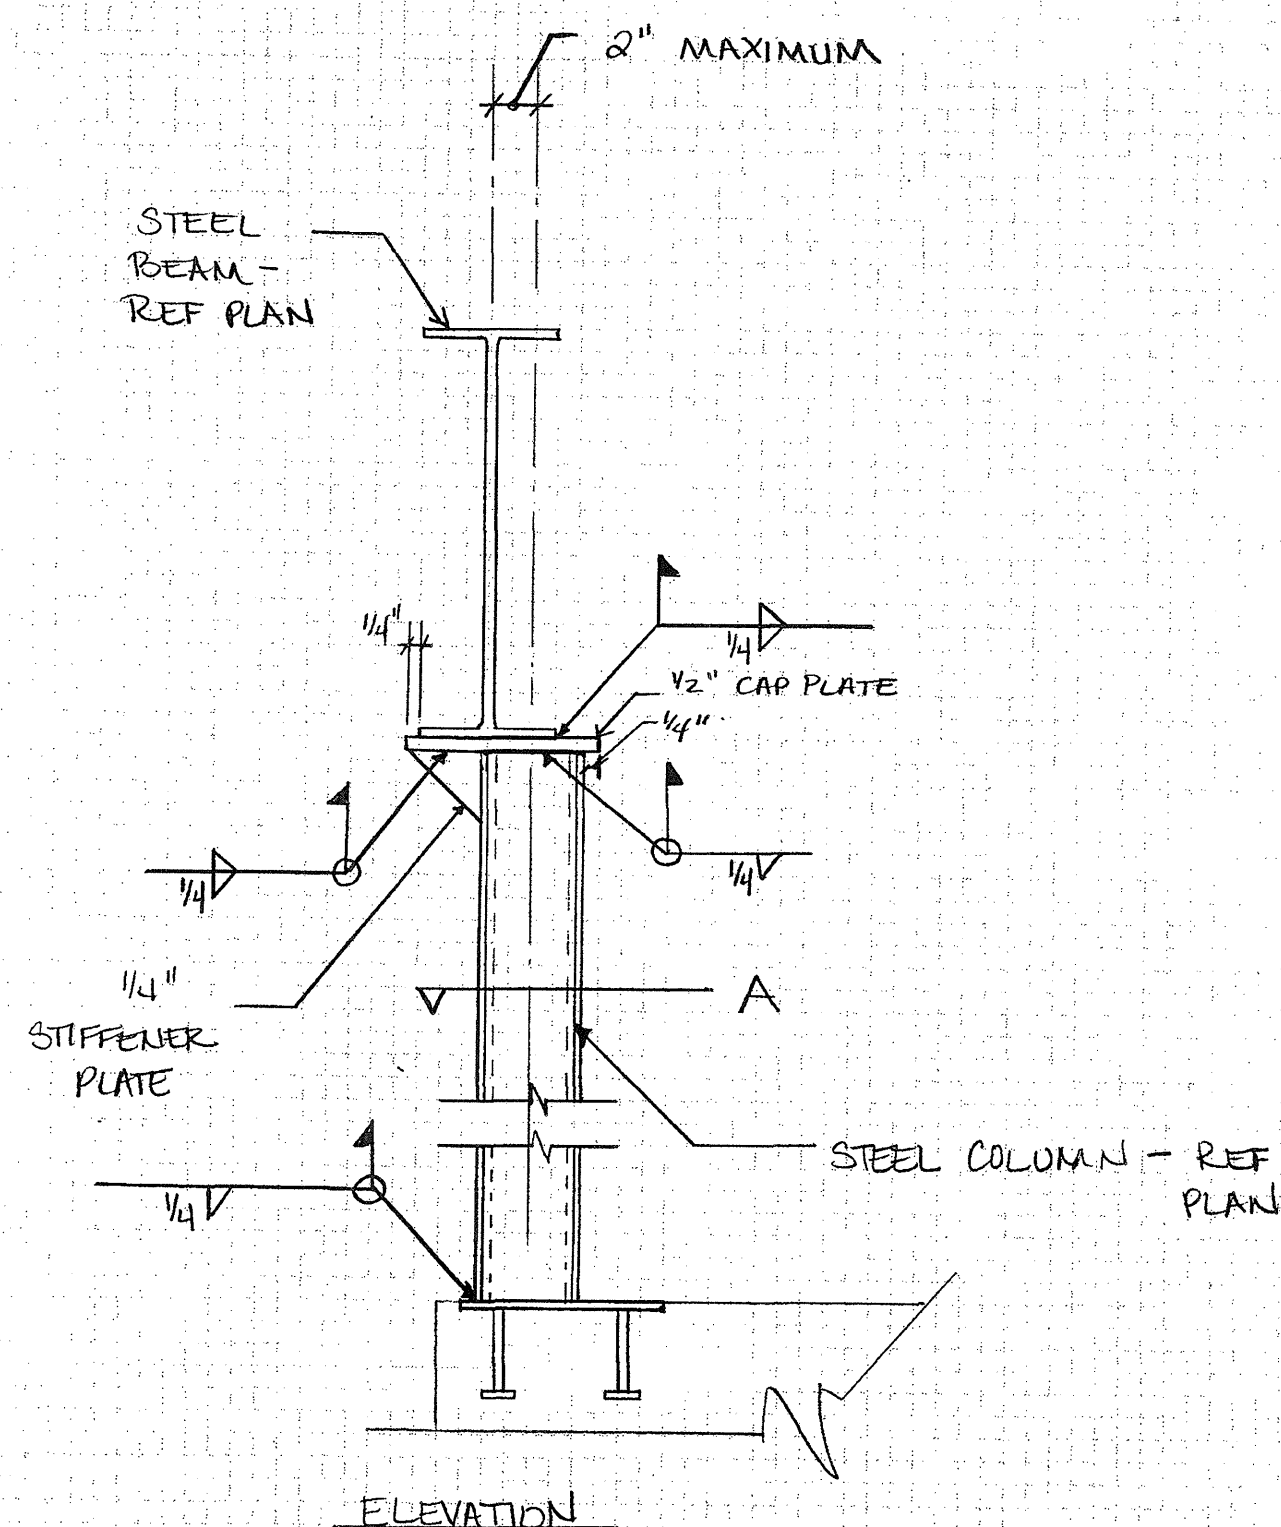
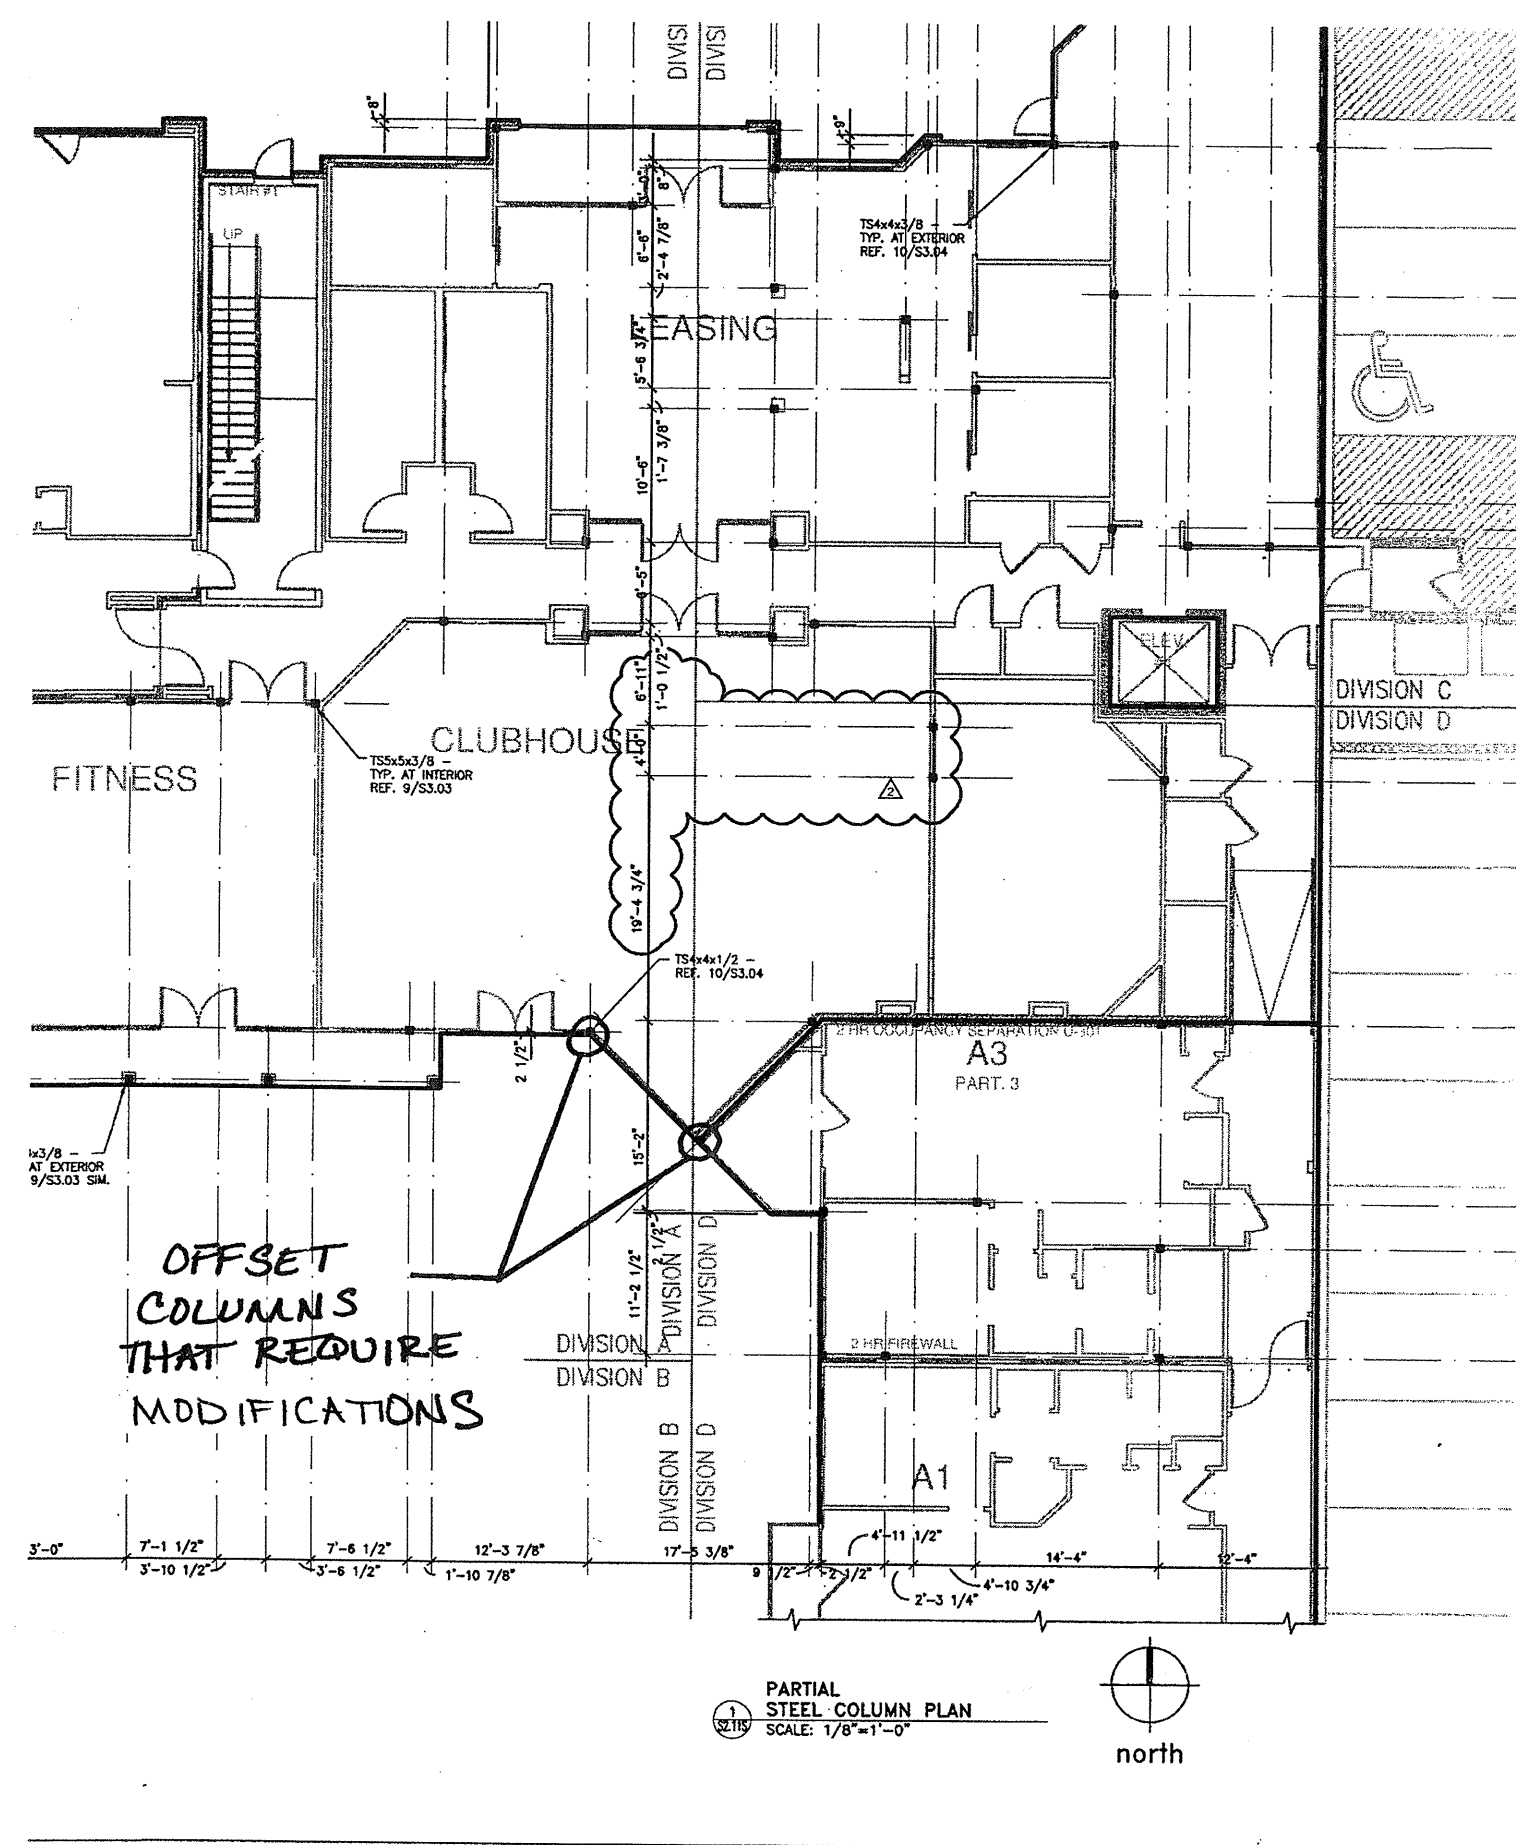
Request: Date Required: 6/8/2012
 On the courtyard side of the Club, where the 45 degree angle is, the concrete slab form board was about 2 inches short right in the angle. Please provide a fix for the following:
 1. How can the steel beam be positioned to carry the exterior wall of the floors above?
 2. How can the slab be repaired so that we have the correct dimensions for the exterior wall of the clubhouse?

Response:
 Per the conference call on May 30, 2012, the beams will remain in the current locations indicated on the drawings and modifications made per the attached sketches. The columns will be attached to the embed plates at their current locations. The maximum offset of the column from its intended location on the structural drawings is two (2) inches. If this limit cannot be maintained with the current locations of the embeds, contact PPO for additional remedial recommendations.
