RFI

RFI #: 117
 Date: 5/15/2012
 Job: EB-02 Keller Springs Lofts
 Phone: 877-777-5115

Subject: Structural Repair Needed at Step From Pour 3 to Pour 5

Subject: Slab Overpour at Pour #1

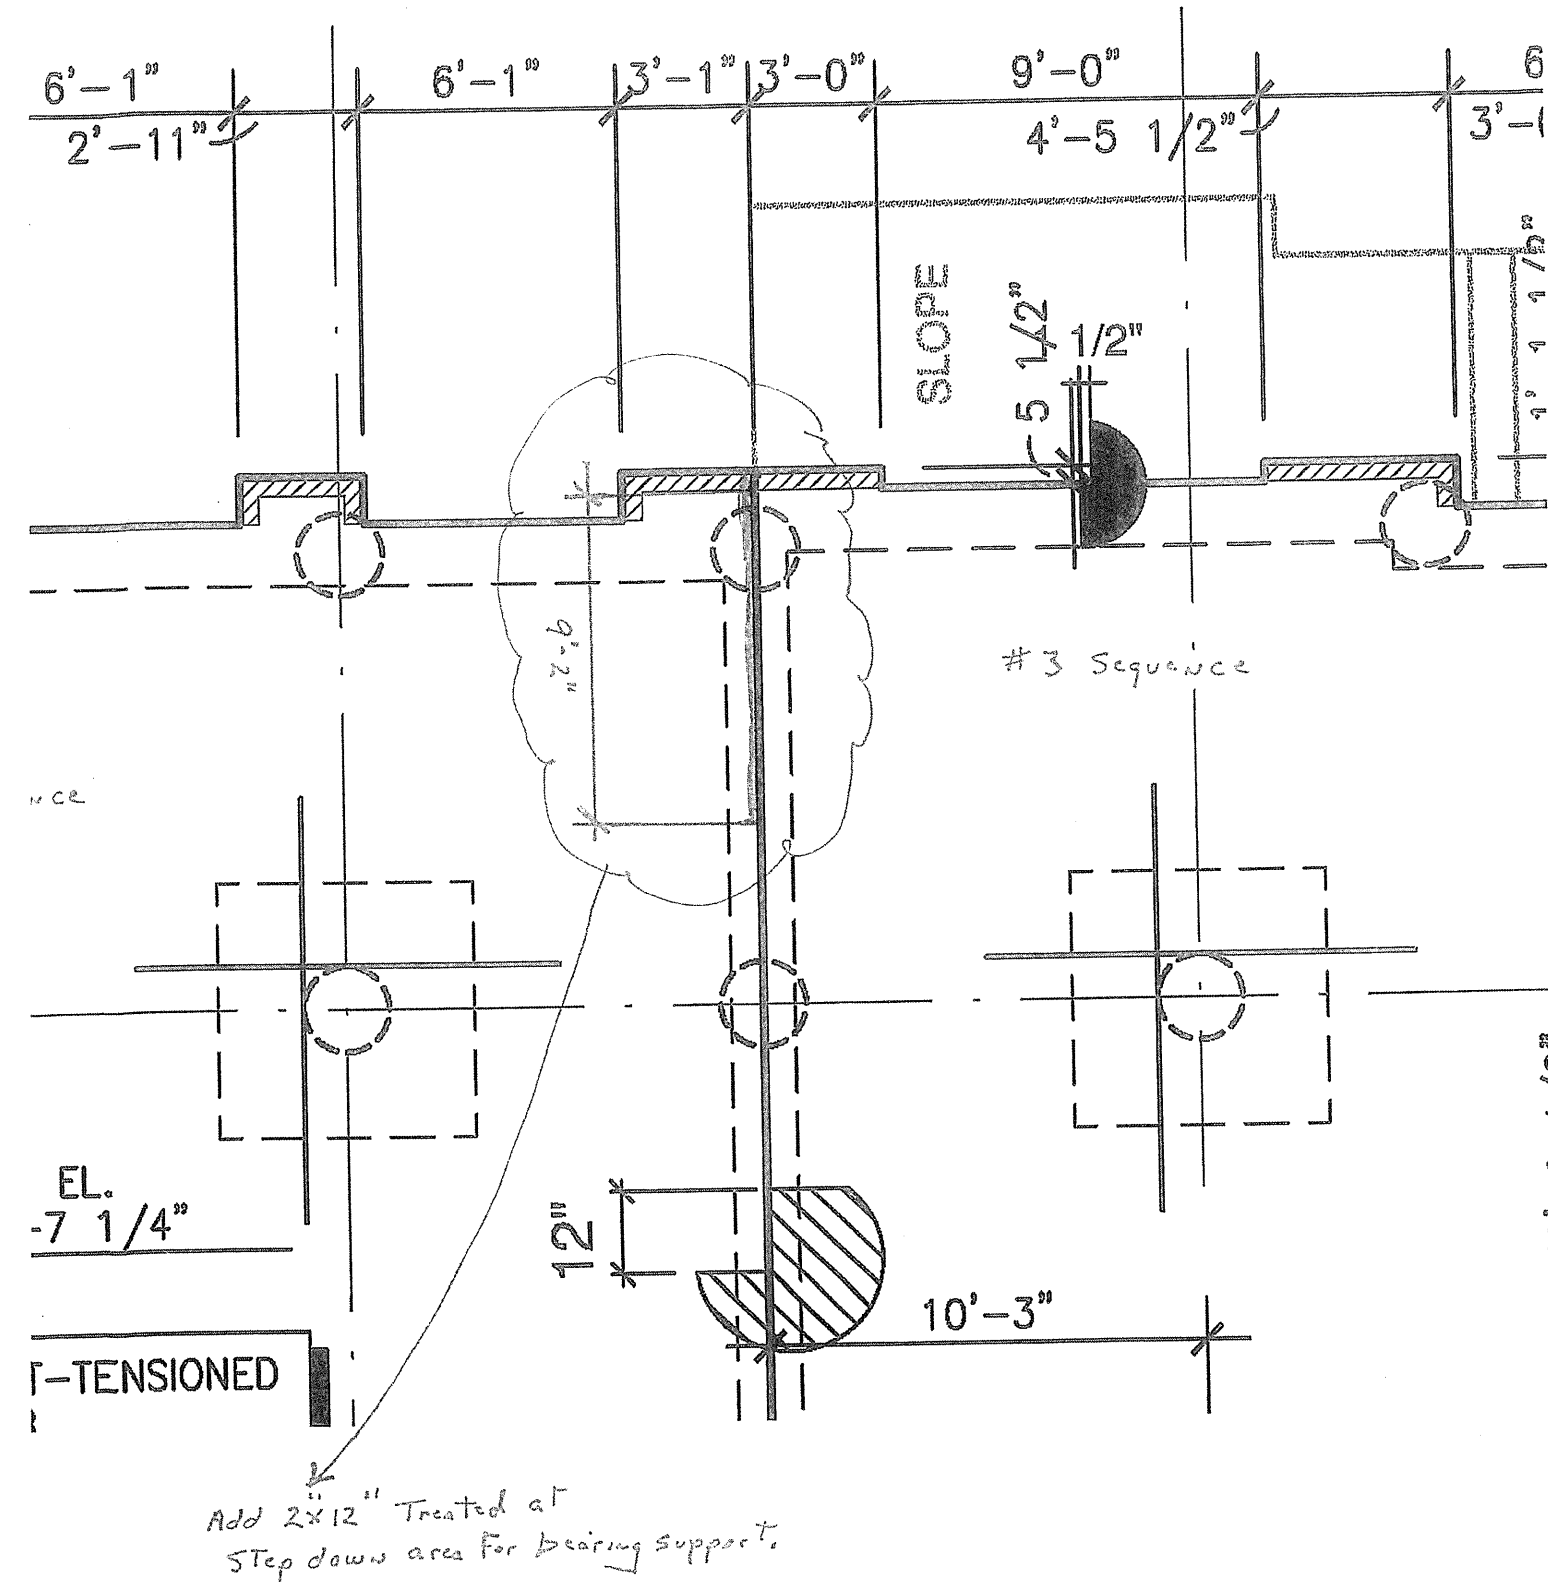
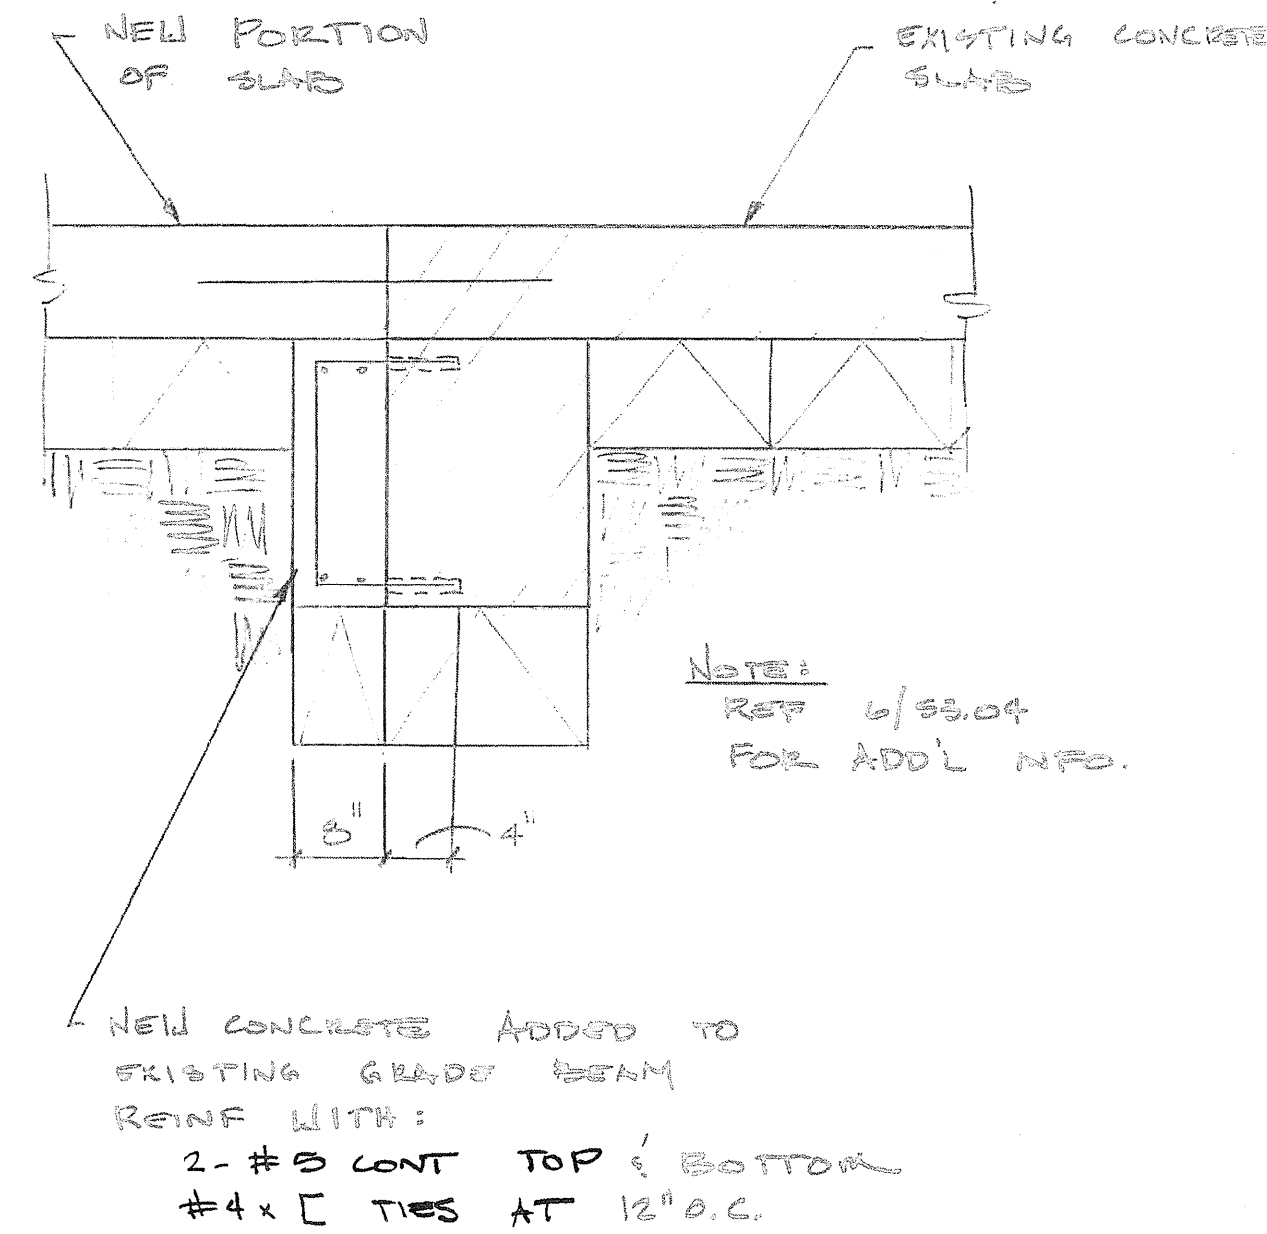
PARKIN PERKINS OLSEN Project: KELLER SPRINGS PPO No: 39155
 CONSULTING ENGINEERING, INC. Date: 5/30/12
 Subject: RFI - 131 Calc'd By: _____ Chkd By: _____ Sht: 1 of 1

Request: Date Required: 6/5/2012
 The slab at the northeast corner of Pour #1 was overpoured to cover the entire gradebeam instead of half of it. Please provide method to repair.

Response:
 Please see attached sketch for PPO's suggested solution.
 Architect to verify that the presence of this cold joint inside the unit is acceptable.

BGO is in concurrence with PPO's structural detail. Please do not oversize the holes for the dowels. Provide Greenstreak Swellstop Waterstop (<http://www.greenstreak.com/Div3/Waterstops/swellstop.asp>) or approval equal in the joint,
 WK 06/04/2012
