CONTINUED ON MAP 13

CONTINUED ON MAP 15

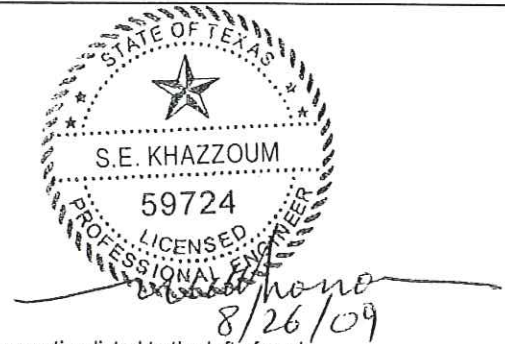
Enter a rating for each element of each component. The rating should equal or exceed the minimum rating listed to the left of each element. Component Ratings should equal the lowest rating of any element of the component. Fully supportive comments are to be made hereon or on attachments for all ratings of 7 or below.

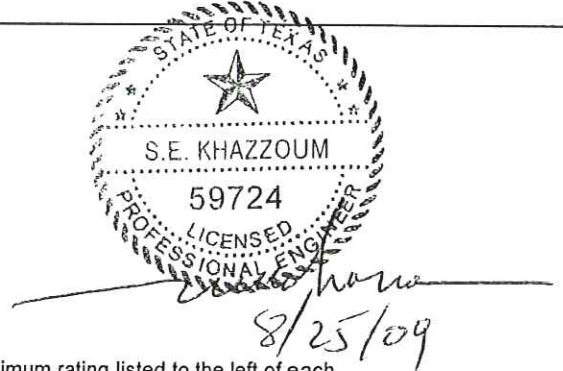
Enter a rating for each element of each component. The rating should equal or exceed the minimum rating listed to the left of each element. Component Ratings should equal the lowest rating of any element of the component. Fully supportive comments are to be made hereon or on attachments for all ratings of 7 or below.

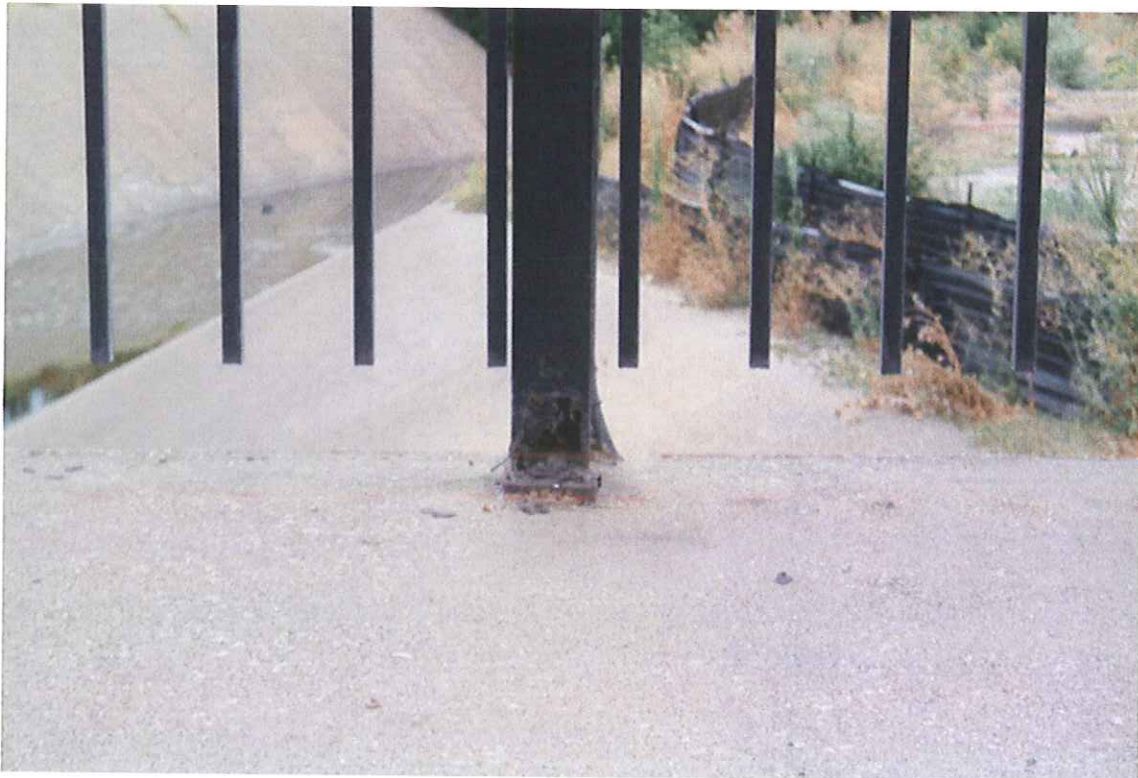
CORRODED BOTTOM OF RAIL POST ON WEST SIDE OF BRIDGE LOOKING EAST
