BSI LIMITED DEMOLITION | RENOVATION ASBESTOS SURVEY FINAL REPORT

ADDISON ATHLETIC CLUB
3900 BELTWAY DRIVE
ADDISON, TX 75001

BSI PROJECT NO:
2018-1566

BSI Project No. | 2018-1566
Limited Asbestos Demolition | Renovation Survey Report
Addison Athletic Club
3900 Beltway Drive
Addison, TX 75001

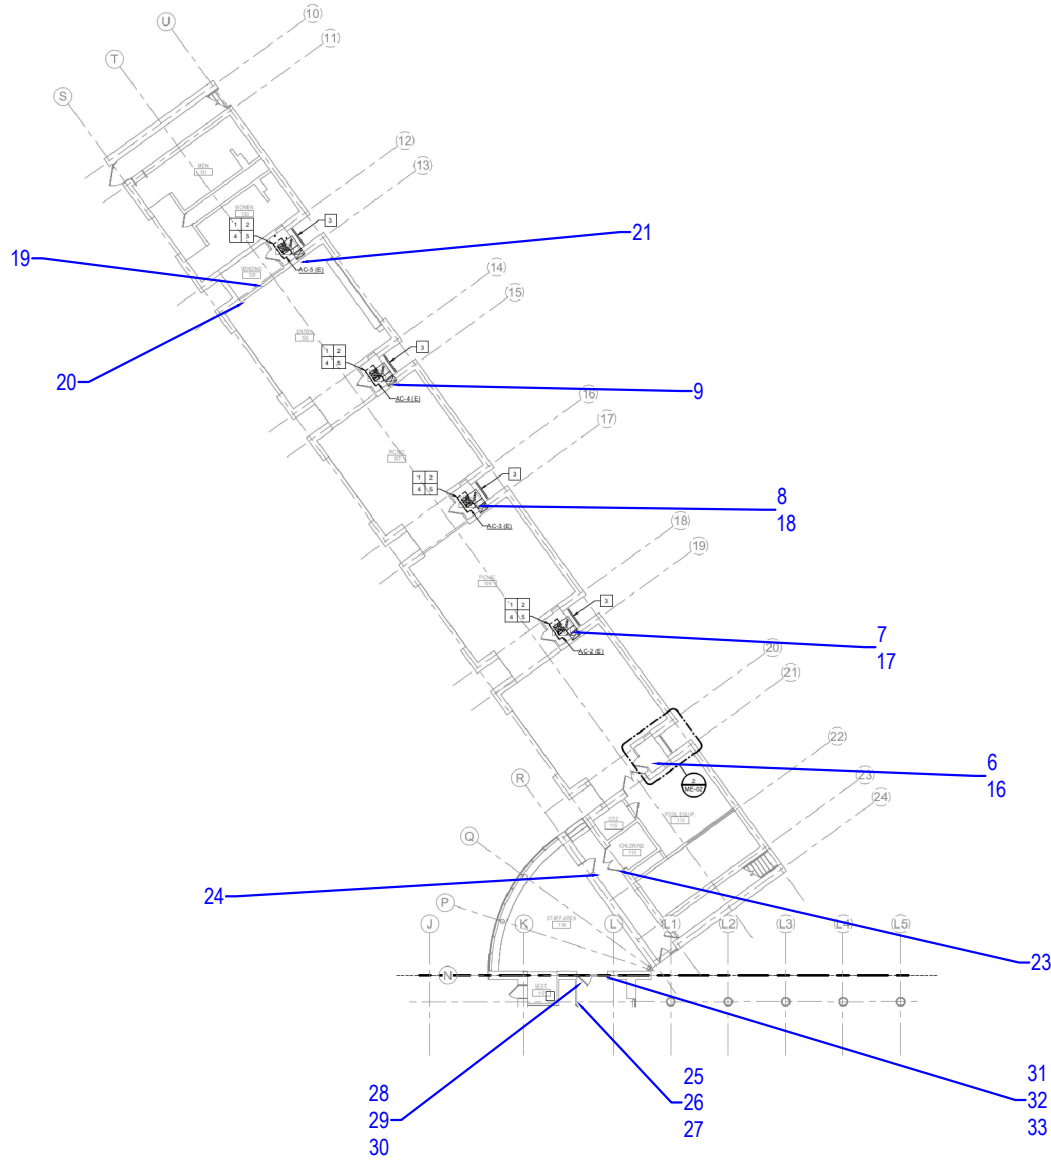
Figure 2

LOCATION OF
SURVEY SAMPLES

Location of
Bulk Sample

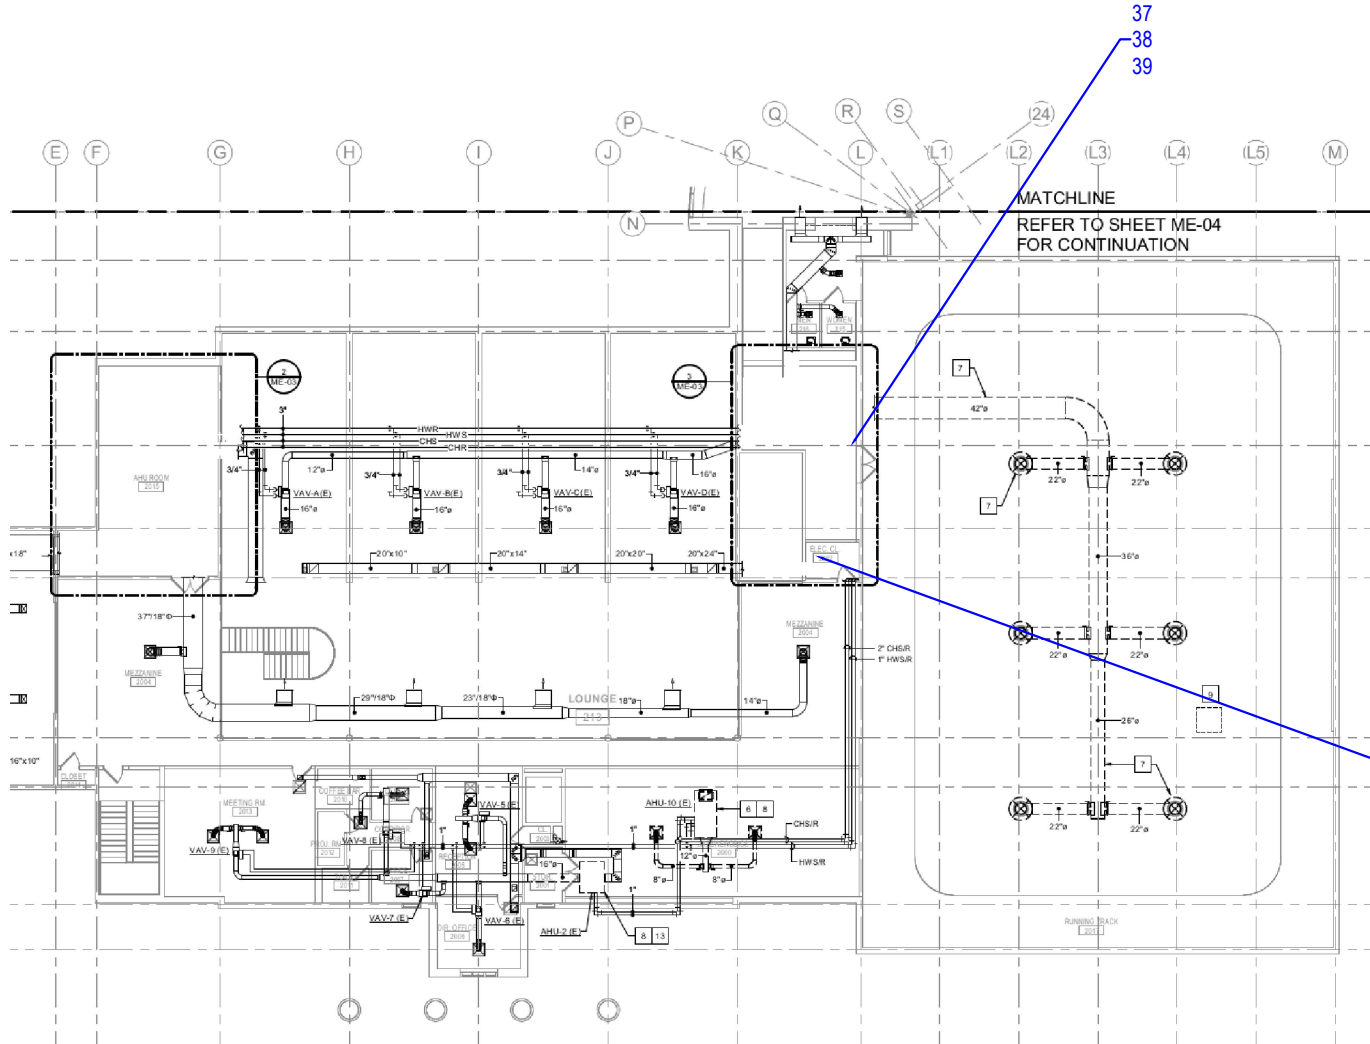
Figure 3

LOCATION OF
SURVEY SAMPLES

Location of
Bulk Sample
