**FY 2003 OFF-SYSTEM BRIDGE INVENTORY,
INSPECTION AND APPRAISAL PROGRAM**

DALLAS DISTRICT

CITY OF ADDISON

**2003 OFF-SYSTEM BRIDGE INVENTORY, INSPECTION
AND APPRAISAL PROGRAM
TxDOT DALLAS DISTRICT
CITY OF ADDISON**

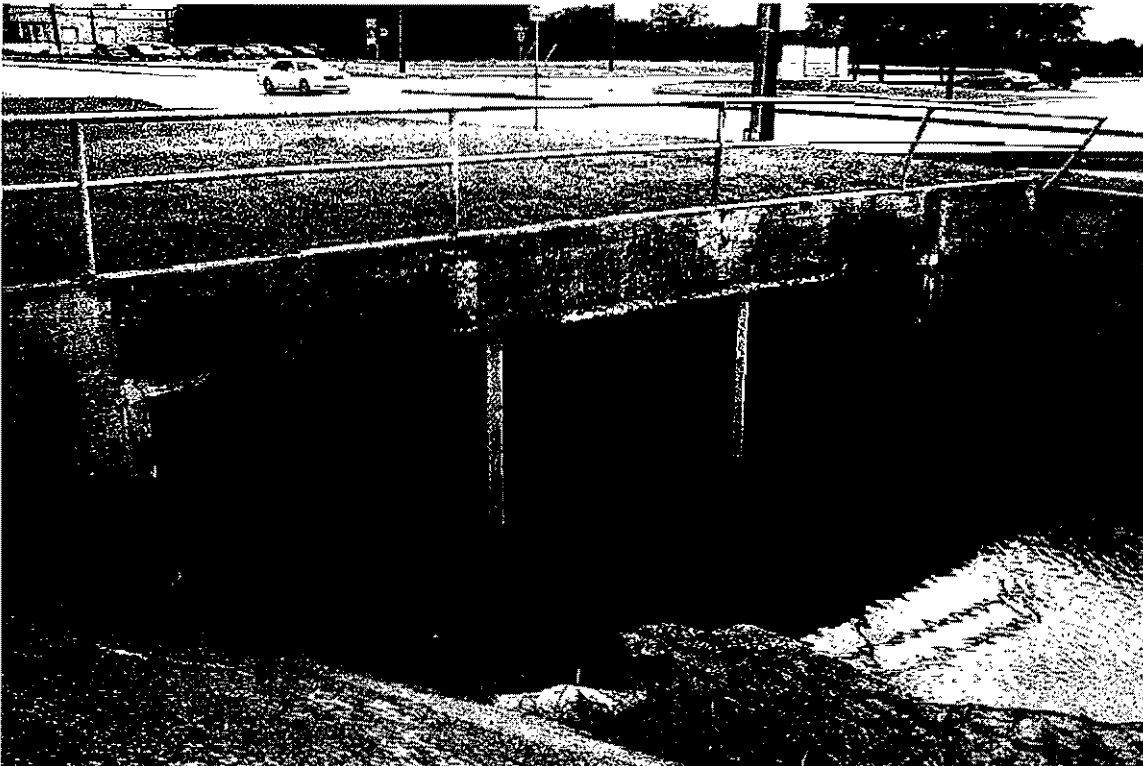
NEG. 493

SIDE ELEVATION - LOOKING SOUTHWEST

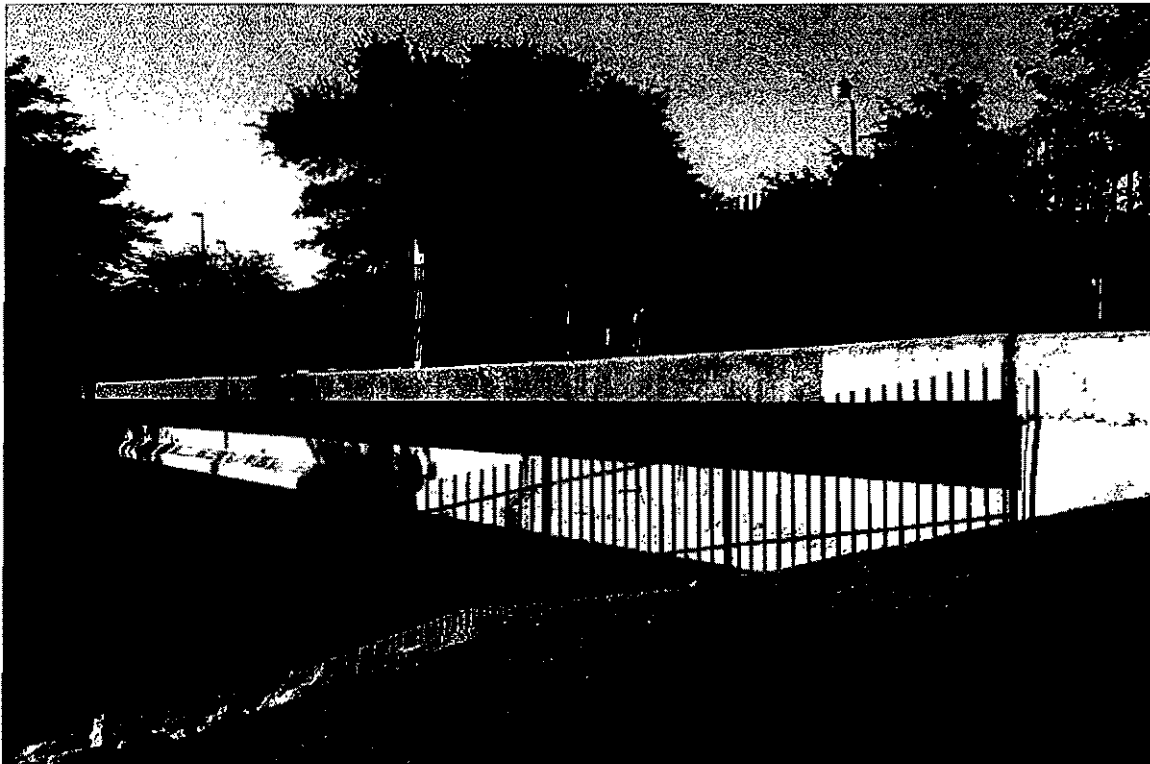
NEG. 174

SIDE ELEVATION - LOOKING NORTHEAST
