**Re: Addison Road from Beltline to Keller-Springs**

**REPORT OF  
PAVEMENT INVESTIGATION  
FOR  
ADDISON ROAD  
FROM BELTLINE ROAD TO KELLER-SPRINGS ROAD  
ADDISON, TEXAS**

15 January 1999  
Job No. H9812

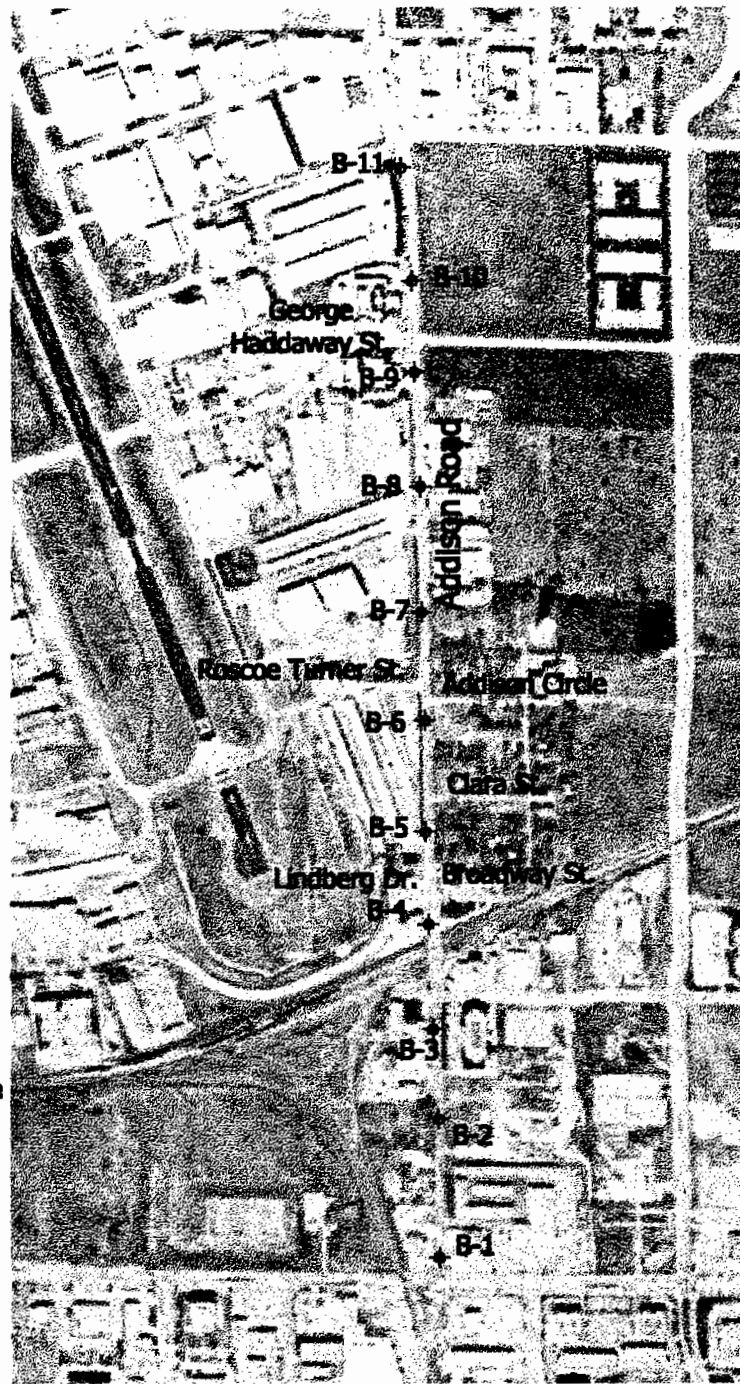
<b>Plan of Borings</b> Addison Road from Beltline Road to Keller-Springs Road		<b>Haston Associates</b>	
		<b>Sheet 1</b>	
Drawn by JSH	Scale: As Shown		
Date 02-Nov-98	Job No. H9812

Subsurface materials and conditions were explored 6 November 1998 by means of eleven borings located approximately as shown on attached Sheet 1. The borings were advanced through the pavement with an auger and then Shelby-tube samplers were used to obtain relatively undisturbed samples. The samples were labeled, sealed in moisture-proof containers, and transported to the laboratory for further examination and analysis.

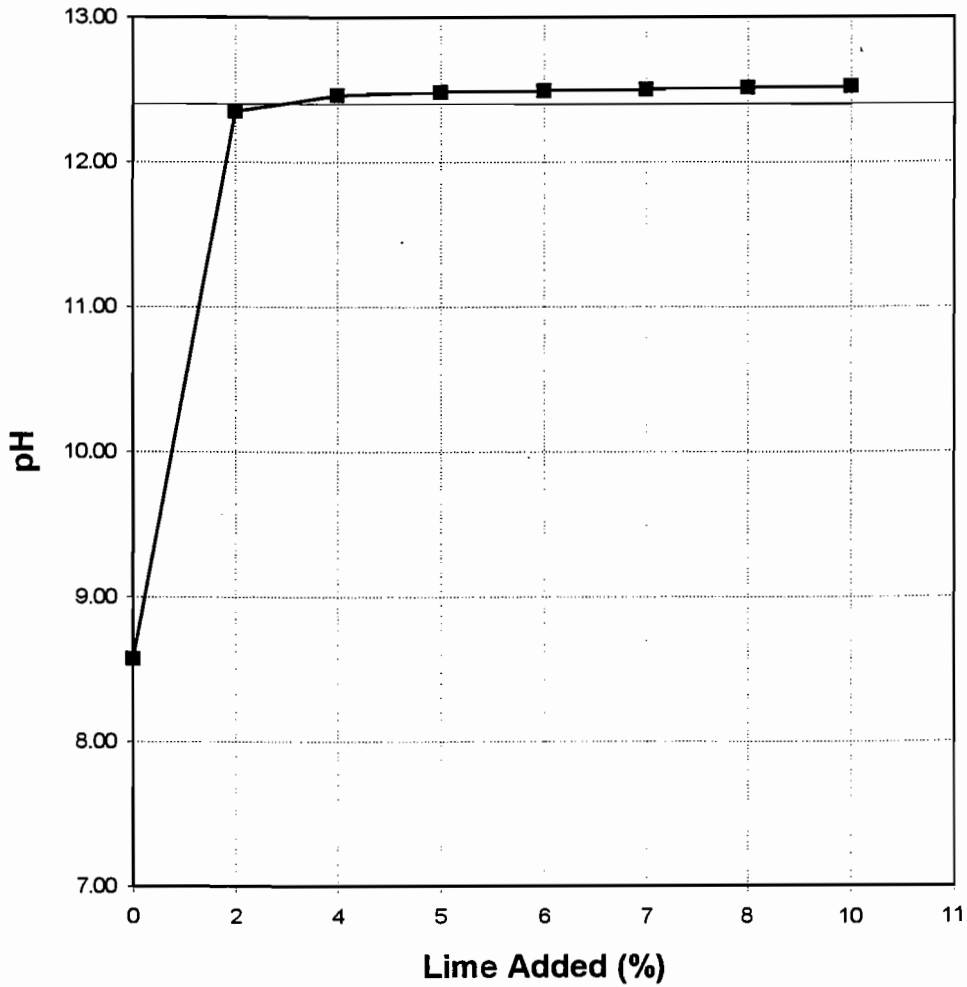
Boring #1 @ 1.5-3.0' - Dark brown clay

Lime Added (%)	pH
0	8.57
2	12.35
4	12.46
5	12.48
6	12.49
7	12.50
8	12.51
10	12.52

In our opinion, lime stabilization of the subgrade soils is the best method of providing a durable non-pumping subbase at this site. The recommended application rate for hydrated lime is 7 percent, or 30 pounds per square yard for a 6-inch compacted thickness<sup>3</sup>.

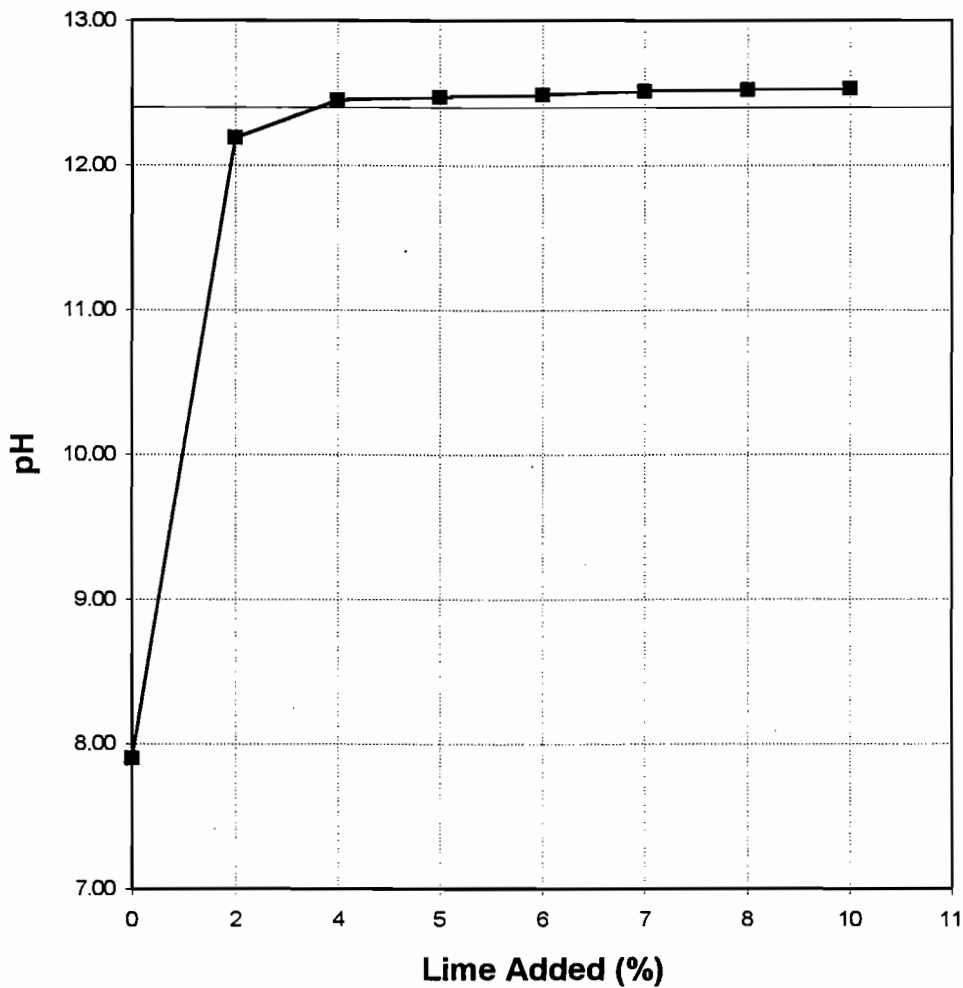
Boring #4 @ 1.5-3.0' - Dark brown clay

Lime Added (%)	pH
0	7.90
2	12.19
4	12.45
5	12.47
6	12.49
7	12.51
8	12.52
10	12.53

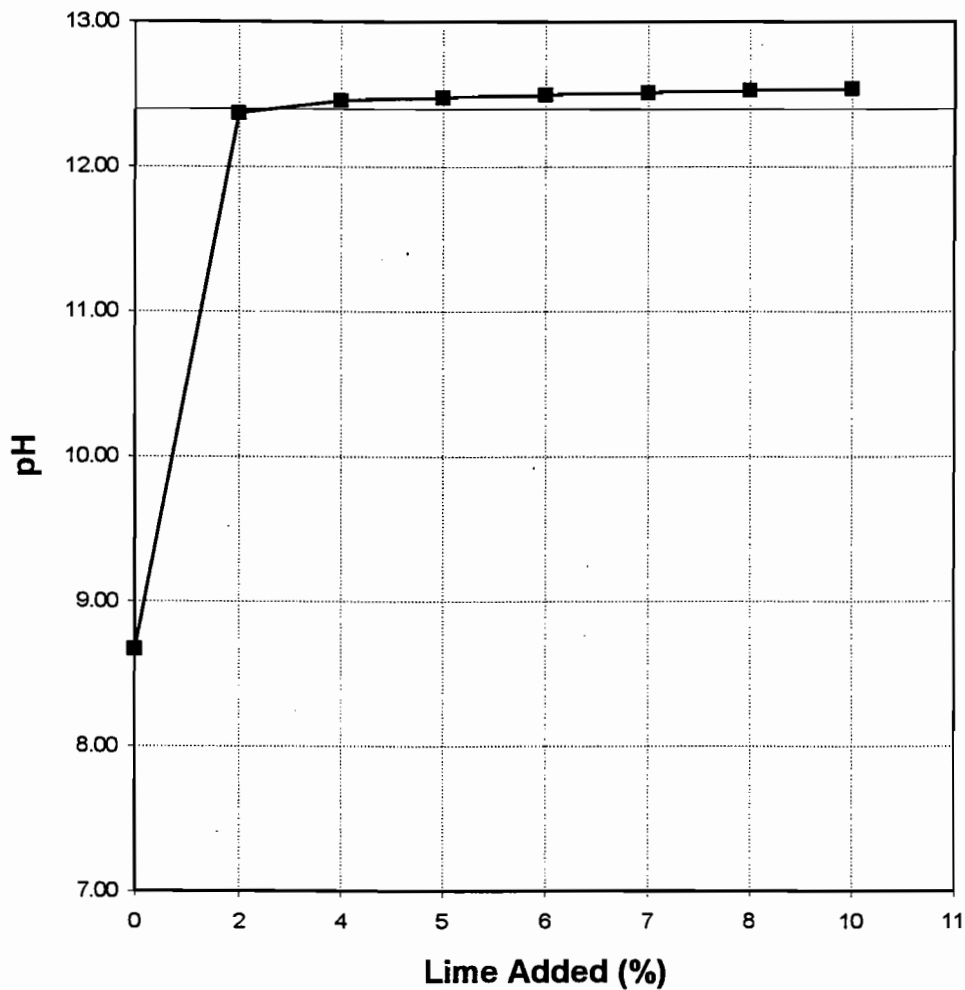
Boring #8 @ 0-1.5' - Dark brown clay

Lime Added (%)	pH
0	8.67
2	12.37
4	12.46
5	12.48
6	12.50
7	12.51
8	12.53
10	12.54
