arapato Rd Drainage Meeting 8-12-99 Drainage Issues Inlet not puking up water water flowing across entersection Hydroplaning / Brakery @ intersuction Jeling in wenter Birdbaths Trugation reurrance Huitt Zollers: It appears that Cos Stope is not adequate 3" NS 6" median note - could that have Chused the problems? Col Bell will take Shots Next week for delivery -Averyze elivations and then look at

RE: Arapaho Road - Addison, Texas

Re: Arapaho Road

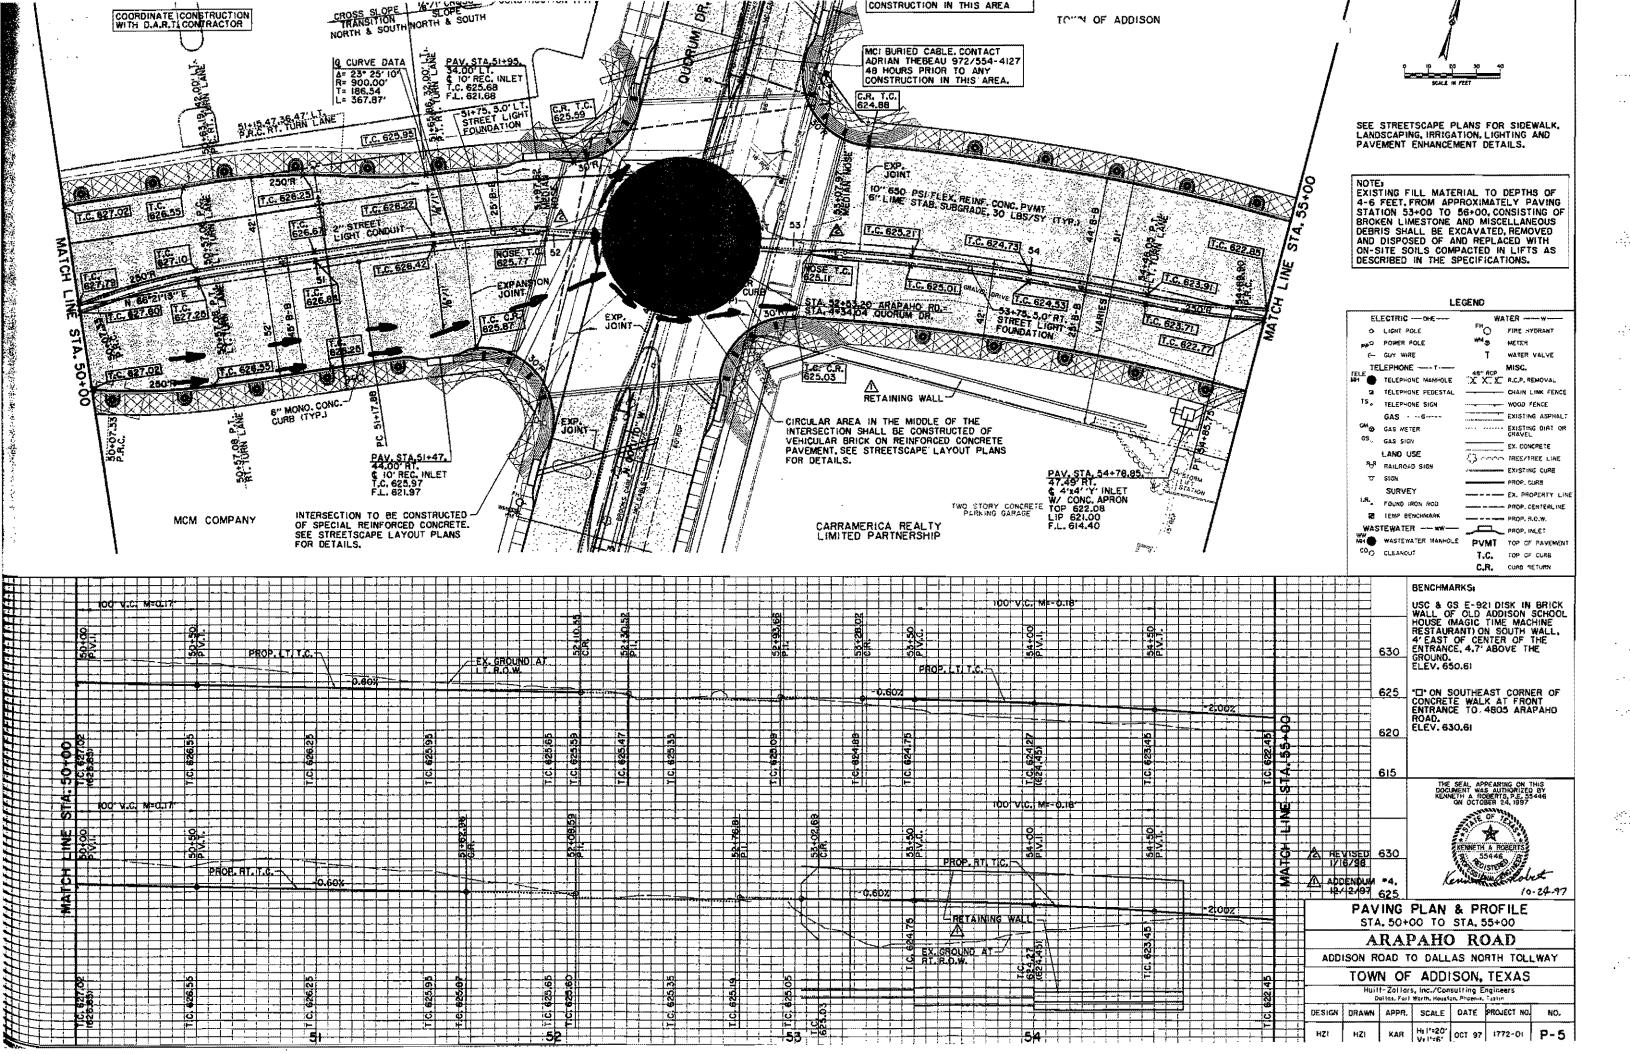
As you stated this morning, on Friday the phone company had pumped water out of a trench or manhole and it was draining along the gutter in question. The amount of water running down the street was just enough to delineate the drainage pattern and highlight the problem. The water was draining along the south gutter and the pavement joint between the east bound right thru lane and the right turn lane with an apparent high and dry spot in the right turn lane. As the water neared the inlet at paving station 51+47, it began to drain in a northeasterly direction towards the center of the circle in the Arapaho Road / Quorum Drive intersection. When the water reached the outer edge of the brick pavers, the water split and drained to the north and east around the brick circle. The easterly flow eventually crossed the intersection and rejoined the south gutter. The northerly flow crossed the centerline of Arapaho Road and continued around the circle in a northeasterly direction. I have enclosed a copy of Paving Sheet P-5 with the drainage patterns that I observed marked in blue.

Arapaho Road was designed with a 1/8" per foot cross slope in this area. Water should not be draining away from the curb and certainly not across the ridgeline at the centerline of Arapaho Road. In this area the water should be draining along the south curb and across the Quorum Drive intersection in the valley gutter. Based on my observations, it appears the intersection is built too flat. Further investigation by the Contractor regarding "As Built" elevations on the pavement should be initiated. After the investigation, alternative solutions can be evaluated.
