BRIDGE SUMMARY SHEET

District: 18 County: 057 Bridge # 8042-18-003 Inspection Date: 6-17-98

Location: Midway Rd Over Hutton Branch

Description: 3- M.B.C.

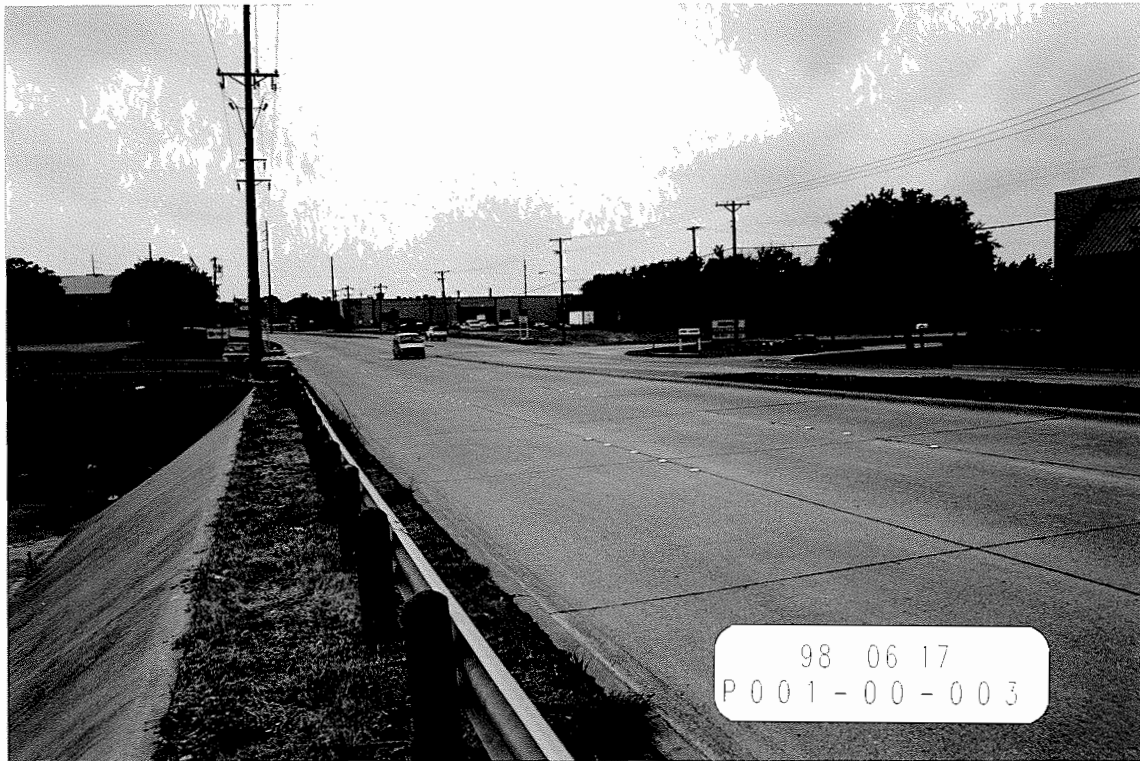
Neg. 23 View 1

Roadway Over Bridge
Looking South

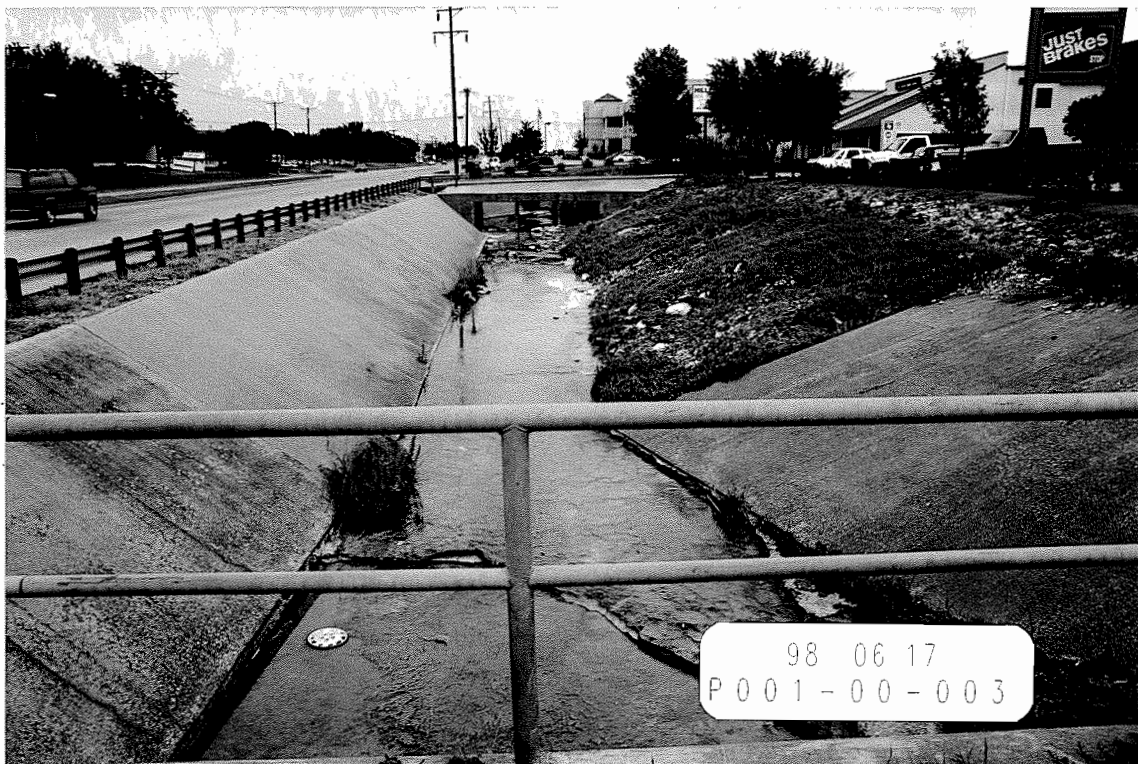
Neg. 24 View 2

Upstream View
Looking North

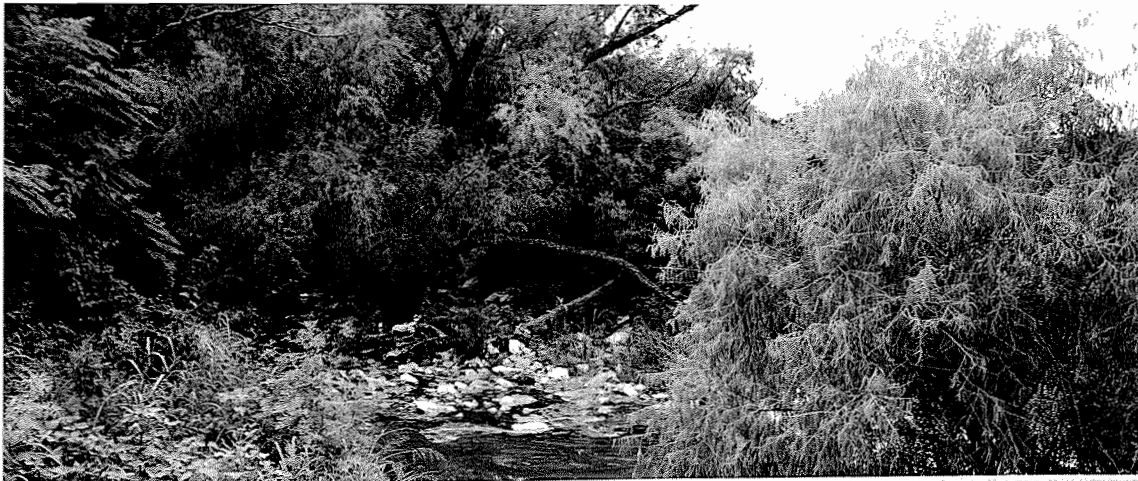
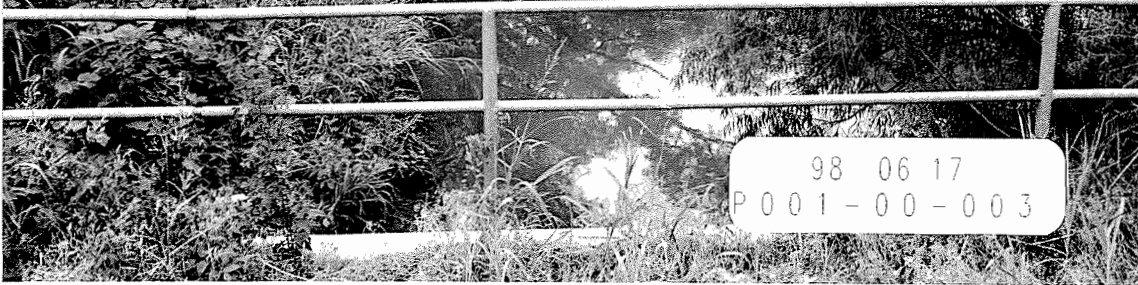
Neg. 25 View 3

Comments: 1. Vegetation & silt downstream end.

1. Water ponding downstream end.

Downstream View
Looking South

Repair damaged pedestrian railing at N. intake.
Remove vegetation down stream end.

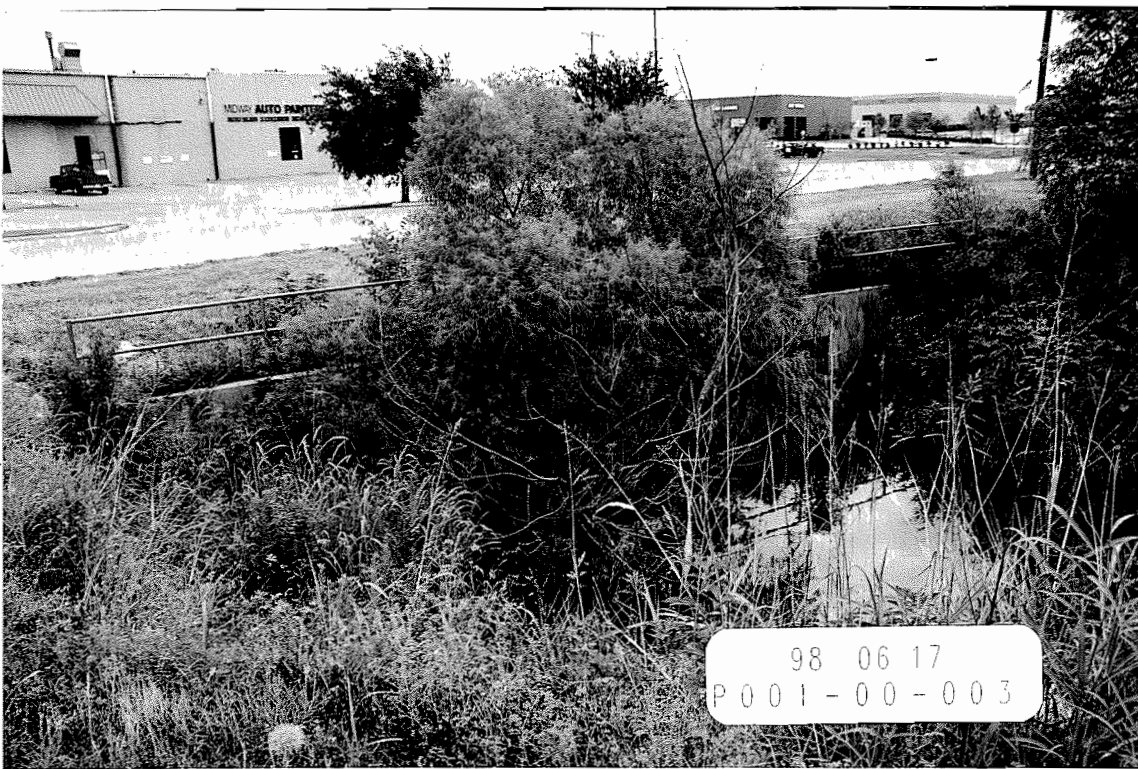
Neg. 26 View 4

Elevation
Looking Northeast

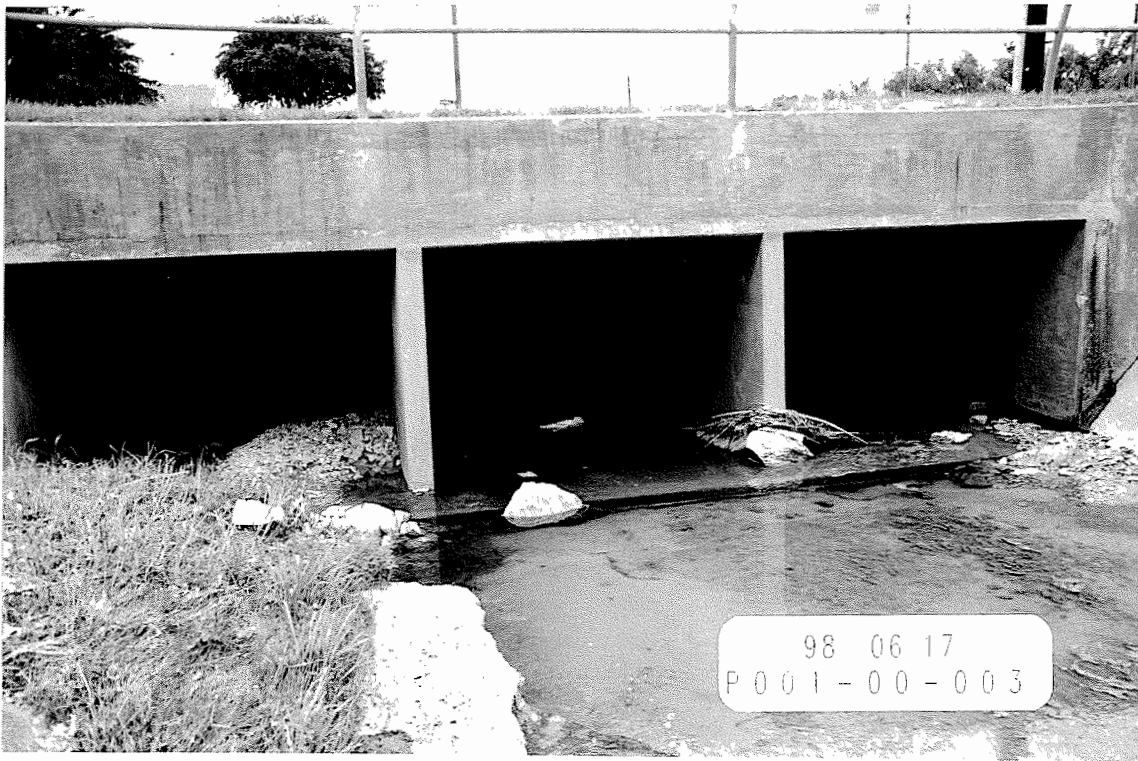
Neg. 27 View 5

Superstructure

Looking South

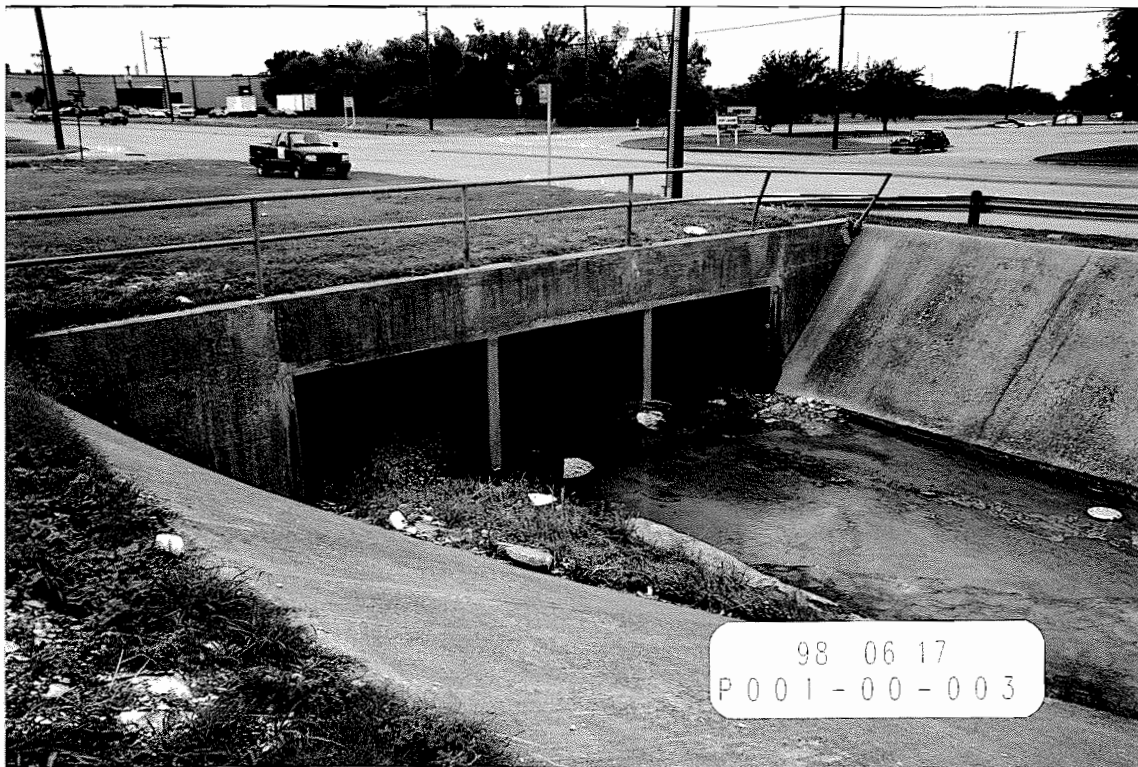
Neg. 28 View 6

Stream

Looking Southwest
