RFI

RFI #: 78
 Date: 3/16/2012
 Job: EB-02 Keller Springs Lofts
 Phone: 877-777-5115

Subject: Raising piers on north wall

Subject: Structural Repair Needed at Step From Pour 3 to Pour 5

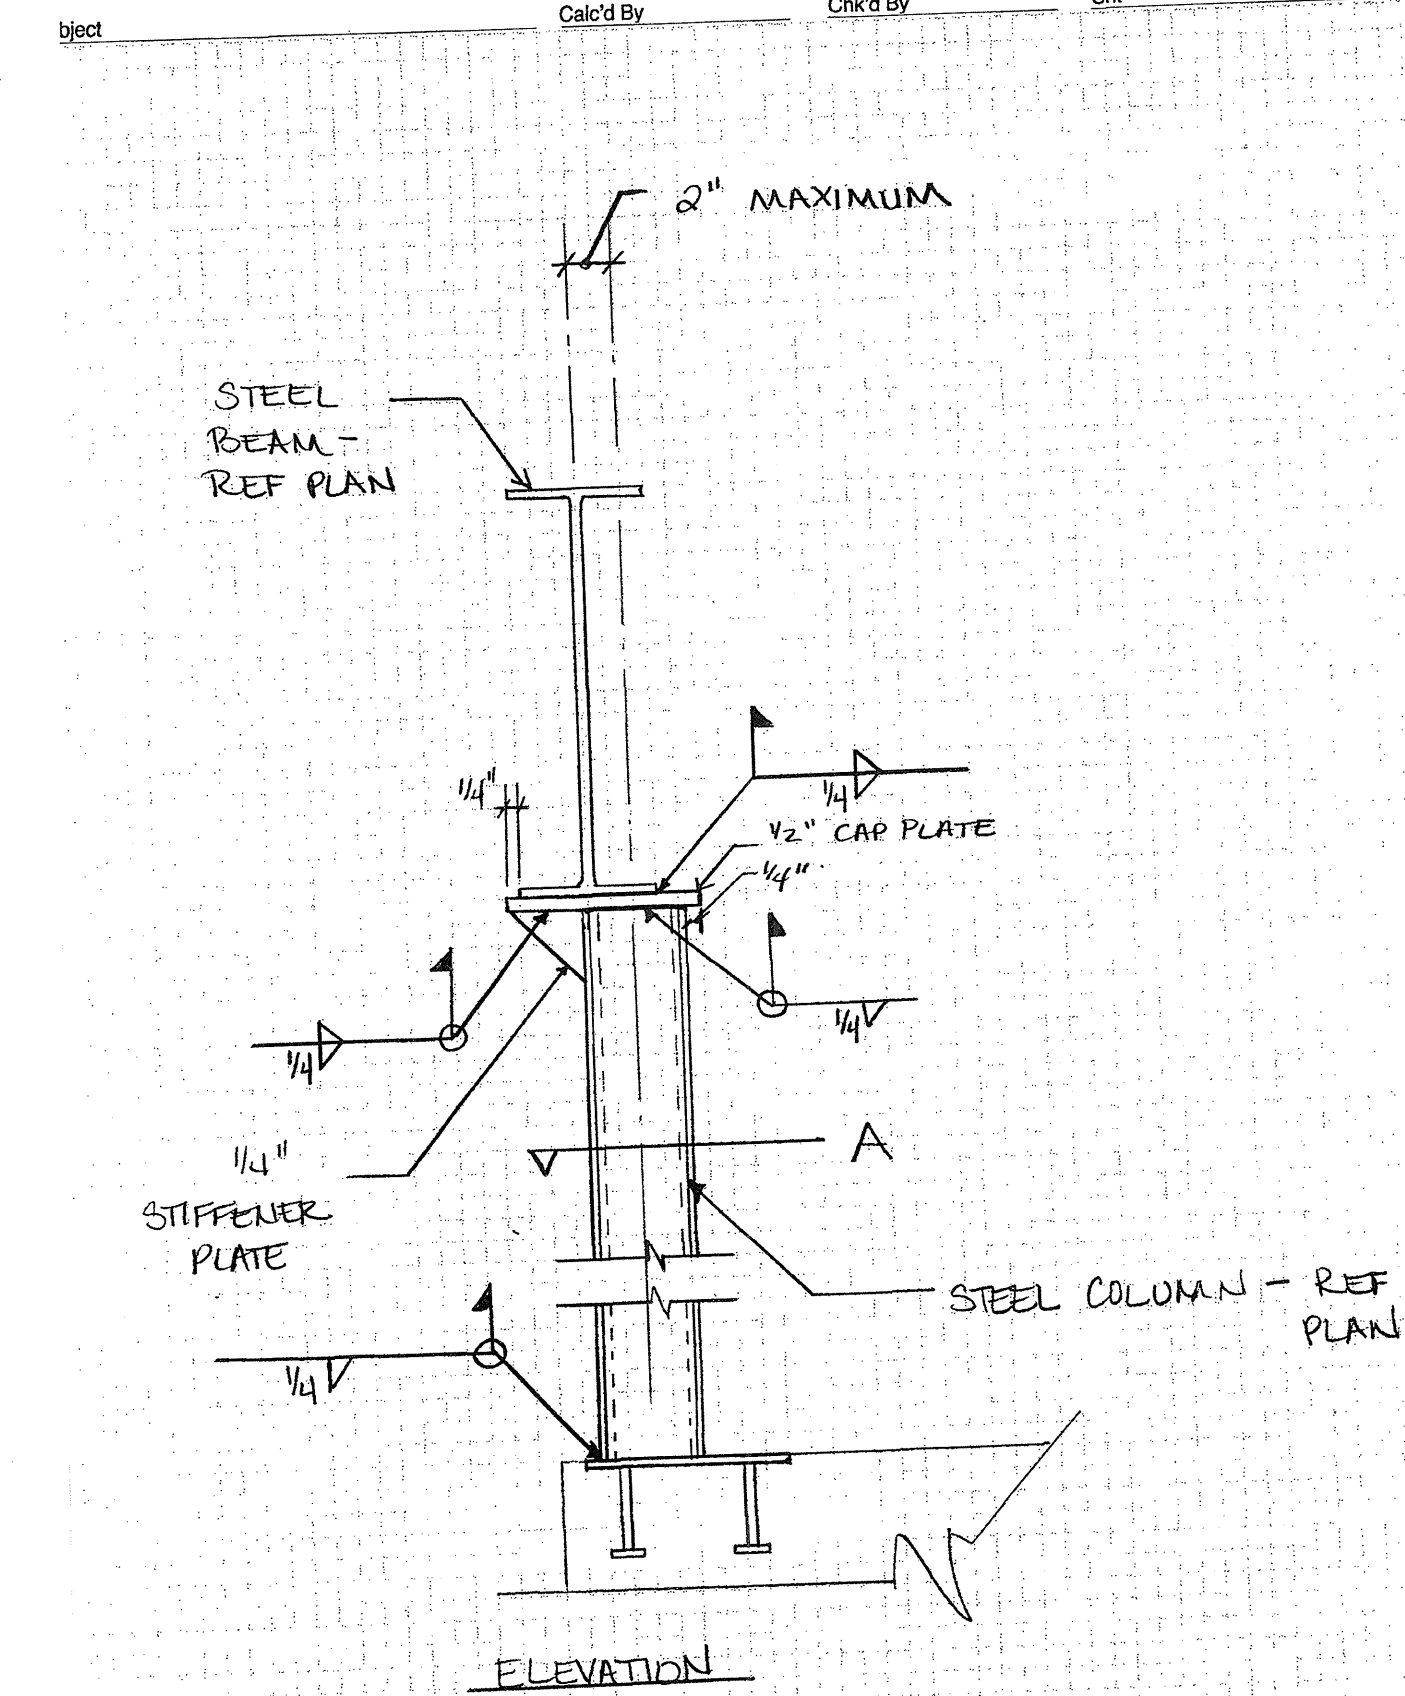
Subject: Slab at Club Poured Short

Request:
 On the courtyard side of the Club, where the 45 degree angle is, the concrete slab form board was about 2 inches short right in the angle. Please provide a fix for the following:
 1. How can the steel beam be positioned to carry the exterior wall of the floors above?
 2. How can the slab be repaired so that we have the correct dimensions for the exterior wall of the clubhouse?

Response:
 Per the conference call on May 30, 2012, the beams will remain in the current locations indicated on the drawings and modifications made per the attached sketches. The columns will be attached to the embed plates at their current locations. The maximum offset of the column from its intended location on the structural drawings is two (2) inches. If this limit cannot be maintained with the current locations of the embeds, contact PPO for additional remedial recommendations.
