**ADDISON AIRPORT
BUILDING REPORT**

Facility Information: **Facility Name:** 4736 Airport Parkway
Facility Contact: Lisa Pyles **Contact Phone:** 972-450-2878

Accessology Inspector Information:
Inspector: Karen Jackson **Date:** April 17, 2017
Email: Kjackson@accessology.com

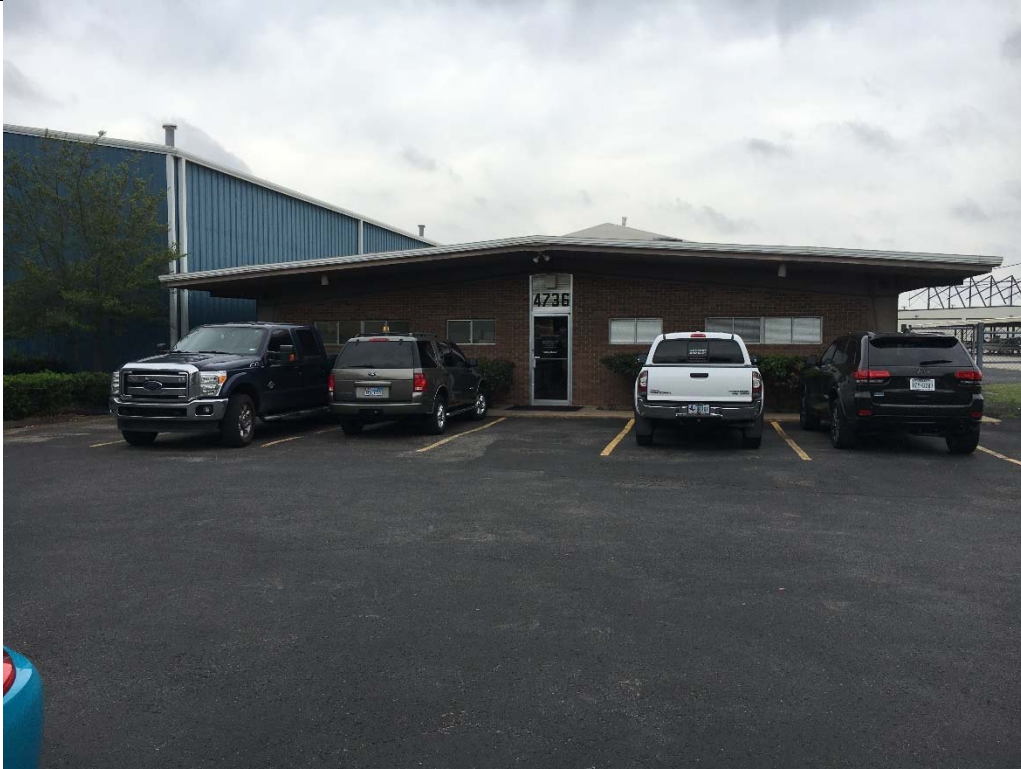
Violation #1: No accessible parking spaces are provided. One accessible parking space is required and it must be van accessible.

Standard: 2010 ADAAG 208.1 General.

Violation 1 - There are no accessible parking spaces provided.

Provide one van accessible space with required access aisle and signage.

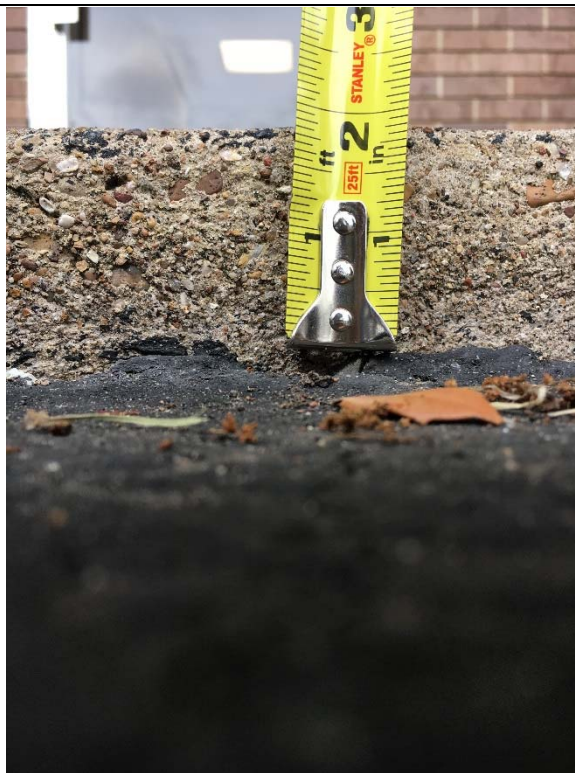
Violation #2: There is a 1-13/16" change in level at the main entrance of the building.

Standard: 2010 ADAAG 303.2 Vertical.

Violation 2 - There is a 1-13/16" step to get to the main entrance of the building.

Possible Solutions: Remove change in level at main entrance to the building.

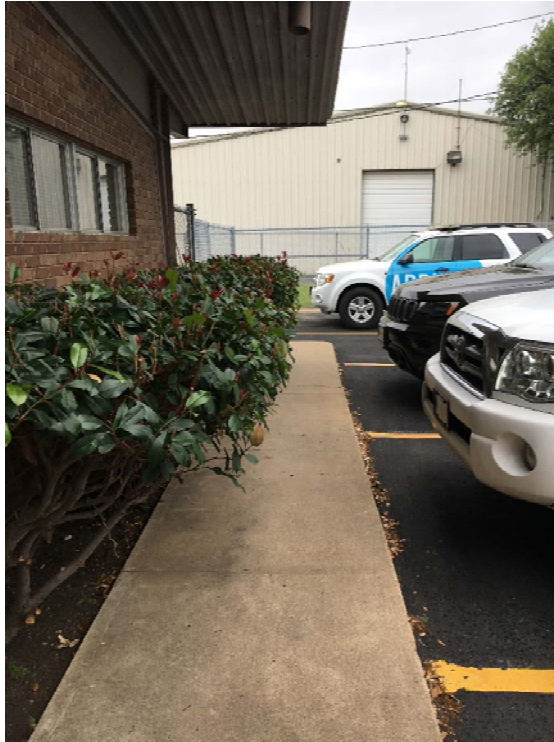
Violation #3: The bushes next to the sidewalk along the front of the building protrude into the walkway and reduce the clear width of the path of travel below 36".

Standard: 2010 ADAAG 403.5.1 Clear Width

Violation 3 - Bushes provided next to the sidewalk along the front of the building protrude into the walkway and reduce the width of the path of travel.

Maintain bushes along the sidewalk to provide 36" minimum clear route.

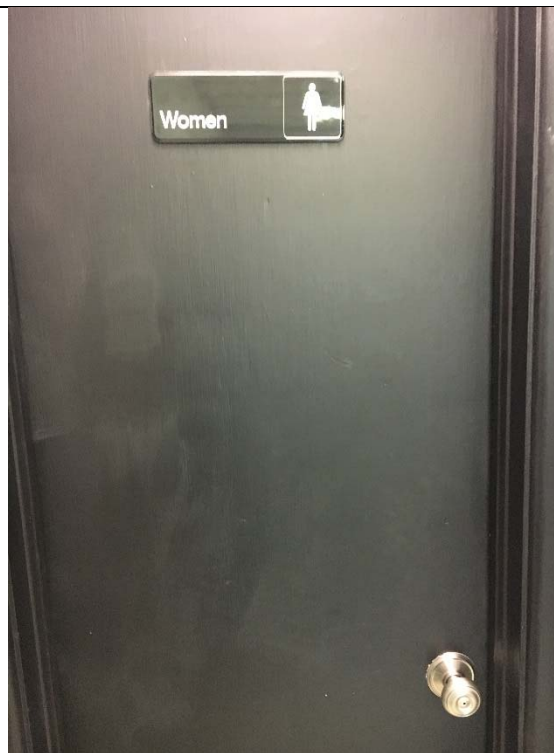
There are 6 doors in the facility that have door hardware that requires grasping and twisting to operate.

2010 ADAAG 404.2.7 Door and Gate Hardware.

Violation 4 - There are 6 doors in the facility that have door hardware that requires grasping and twisting to operate.

Replace all knob hardware with lever hardware that doesn't require tight grasping or twisting to operate.

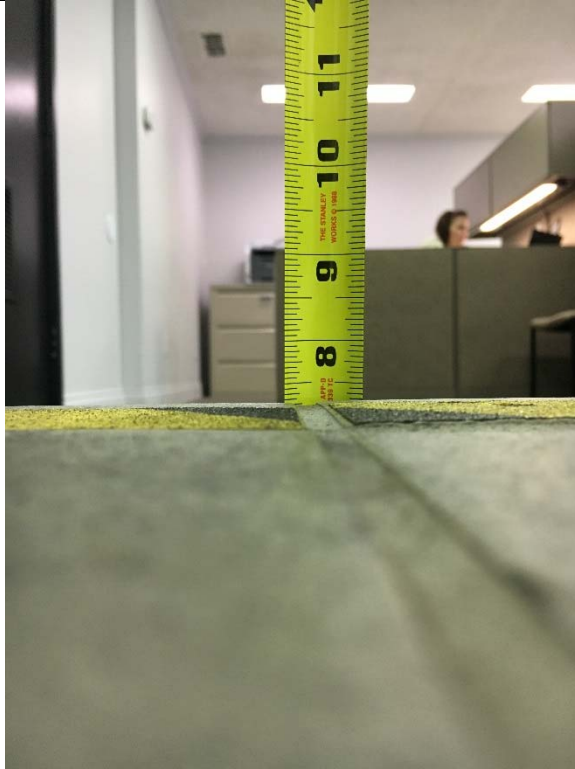
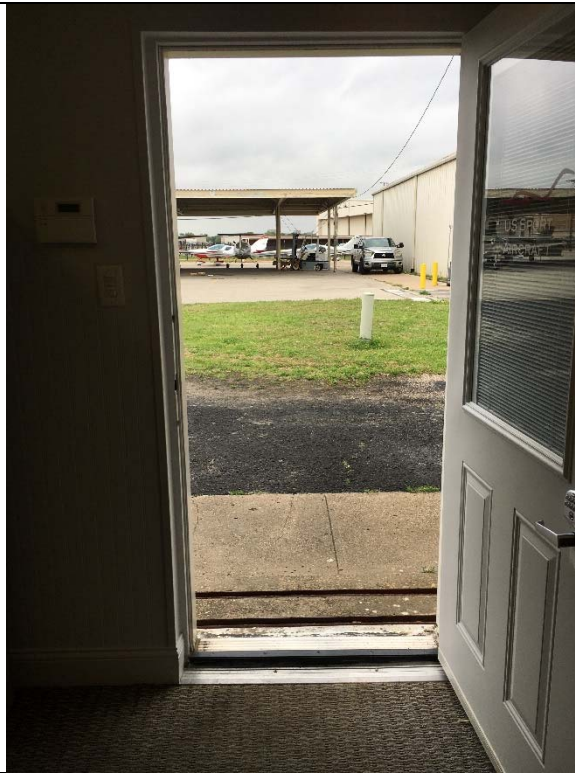
The route leading into the Testing Center requires a 7-5/16" step down to enter.

2010 ADAAG 303.2 Vertical.

Violation 5 - The route leading into the Testing Center requires a 7-5/16" step down to enter.

The change in level could be accomplished by installation of a ramp or platform lift. Relocating the functions of the Testing Center to an accessible facility is also acceptable.

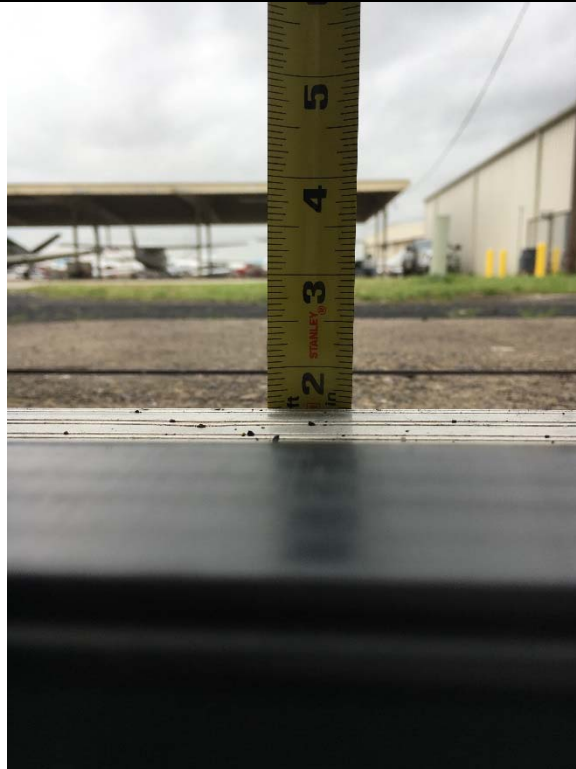
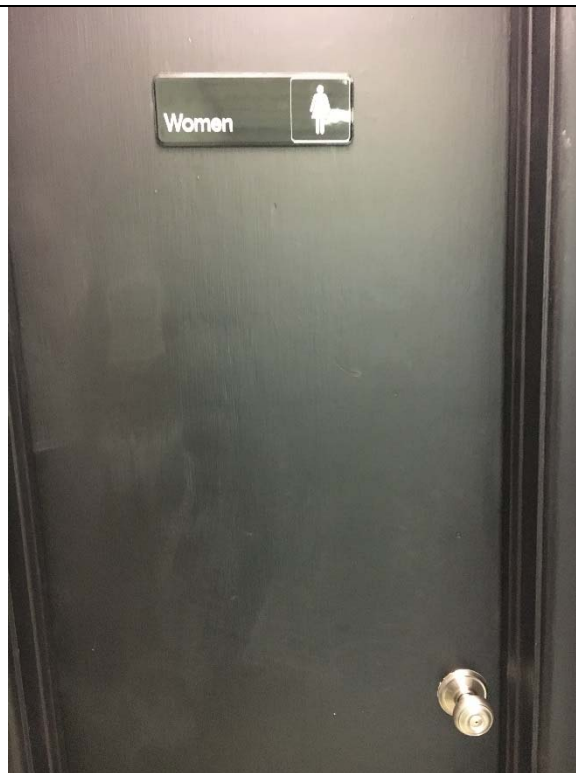
The exterior exit door from the Testing Center has a 1-1/2" step down.

2010 ADAAG 303.2 Vertical.

Violation 6 - The route leading outside from the Testing Center has a 1-1/2" step down.

Modify door and threshold to be flush with outside surfaces.

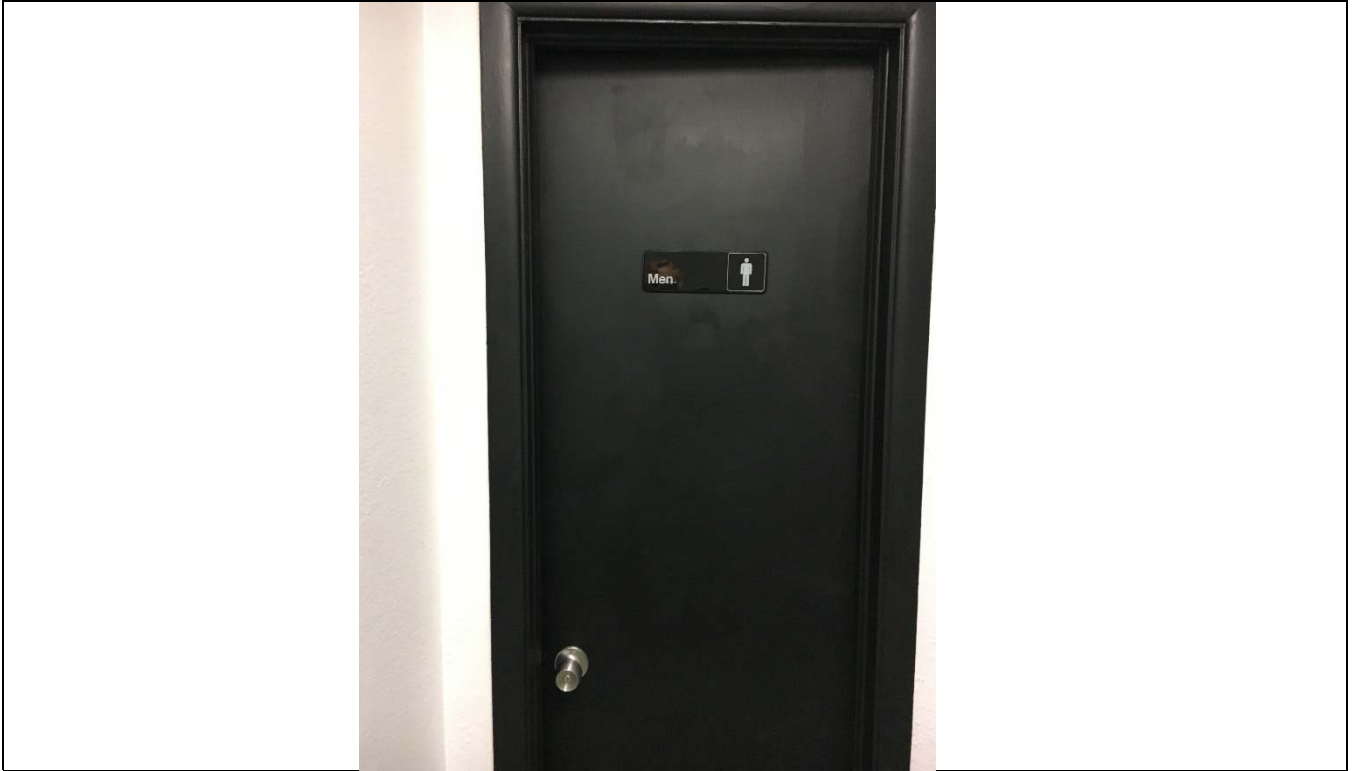
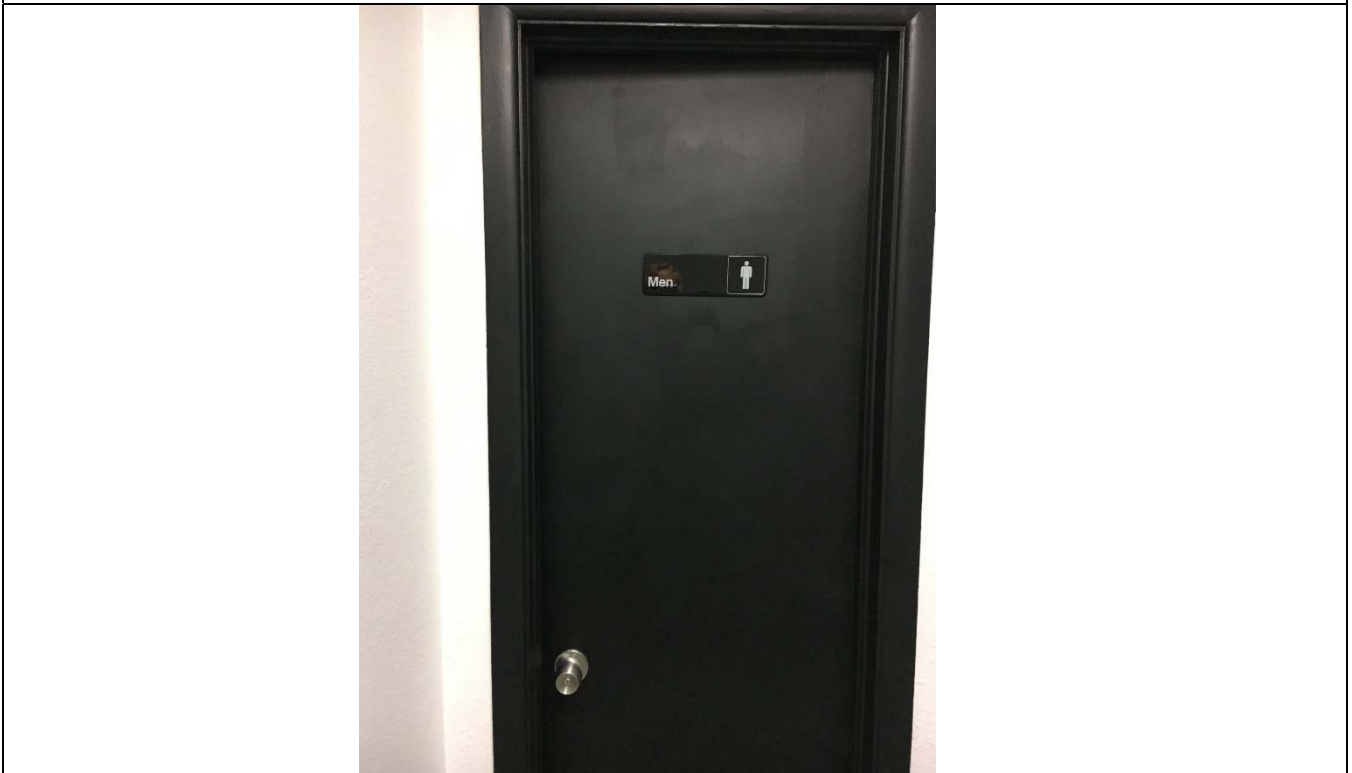
Men's and Women's Restrooms: Signage is mounted on the doors and does not have tactile characters and Braille.

2010 ADAAG 703.1 General

Violation 7 - Men's and Women's Restrooms: Signage is mounted on the door.

Install compliant signage at the men's and women's restroom doors.

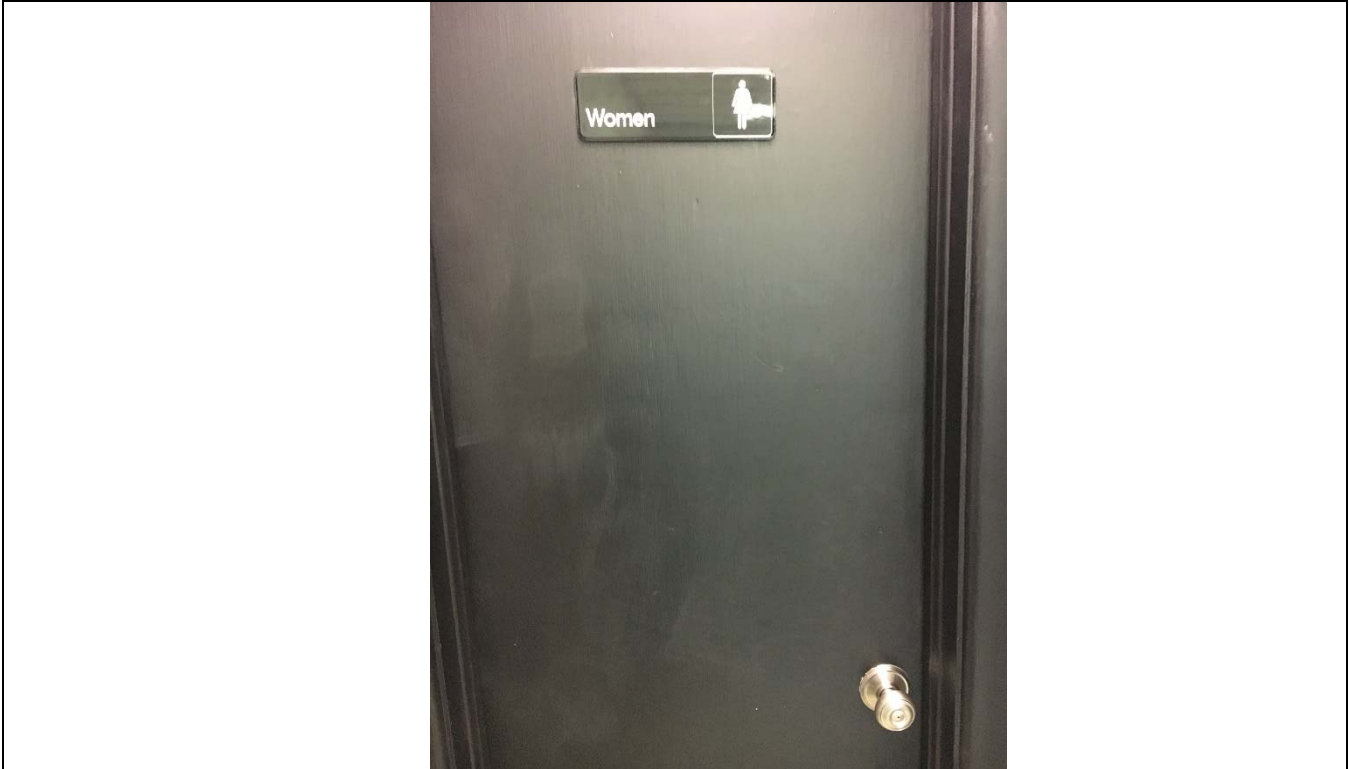
Men's and Women's Restrooms: Door hardware requires grasping and twisting to operate.

2010 ADAAG 404.2.7 Door and Gate Hardware.

Violation 8 - Men's and Women's Restrooms: Door hardware requires grasping and twisting to operate.

Replace knob hardware with lever style door hardware.

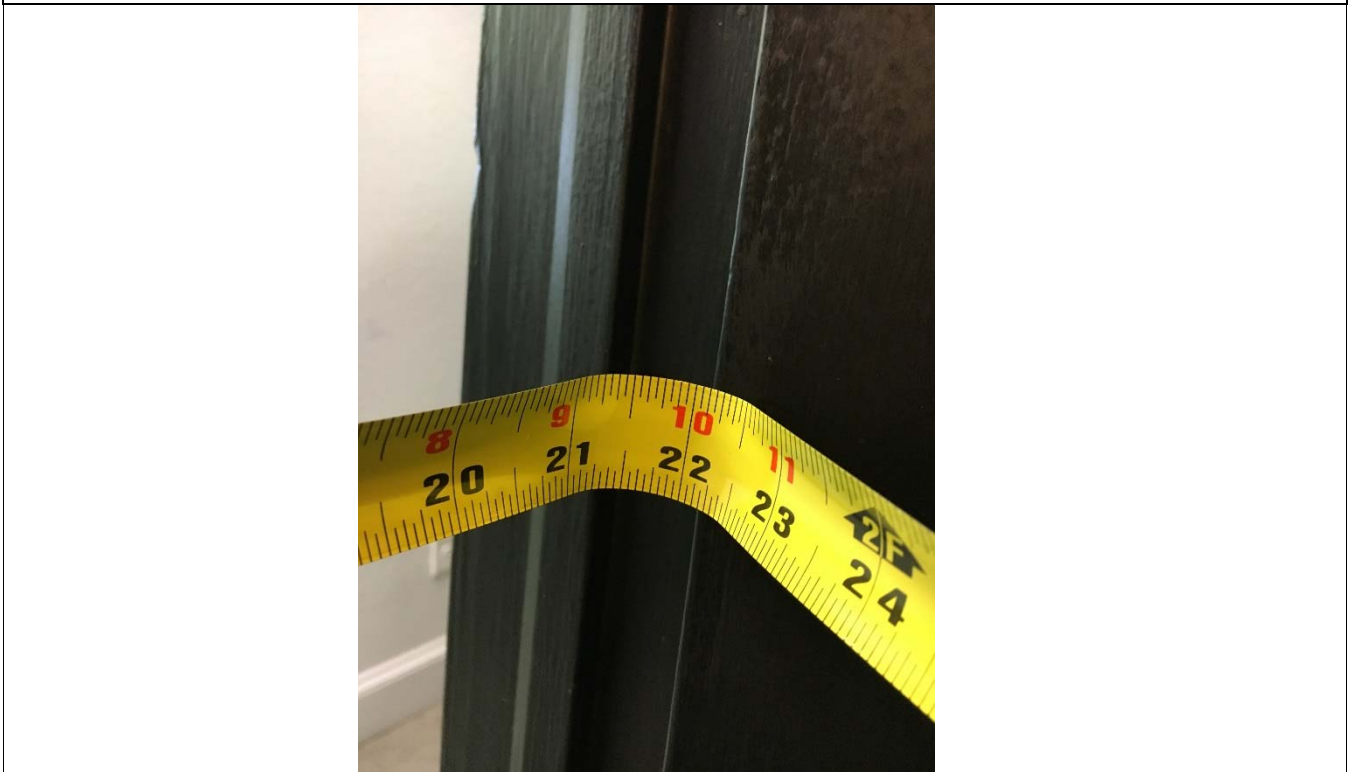
Men's and Women's Restrooms: Doors are only 22" wide and do not provide the required 32" minimum clear width.

2010 ADAAG 404.2.3 Door and Gate Clear Width.

Violation 9 - Men's and Women's Restrooms: Doors are only 22" wide.

Replace doors to achieve 32" minimum clear width and reverse swing of the doors outward.

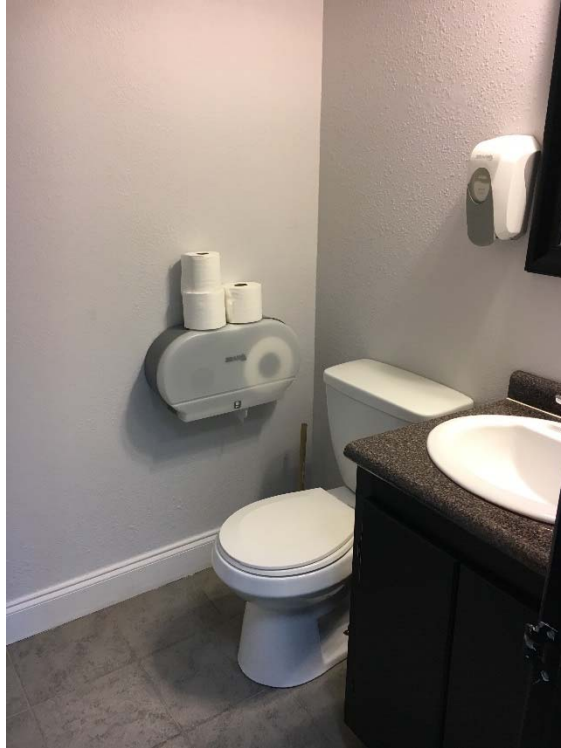
The Women's single user restroom is not large enough to accommodate a wheelchair turning space and the required clear floor spaces for accessible fixtures.

2010 ADAAG 213.2 Toilet Rooms and Bathing Rooms.

Violation 10 - The Women's single user restrooms is not large enough to accommodate a wheelchair turning space.

Enlarge restroom to accommodate accessible water closet and lavatory and wheelchair turning space.

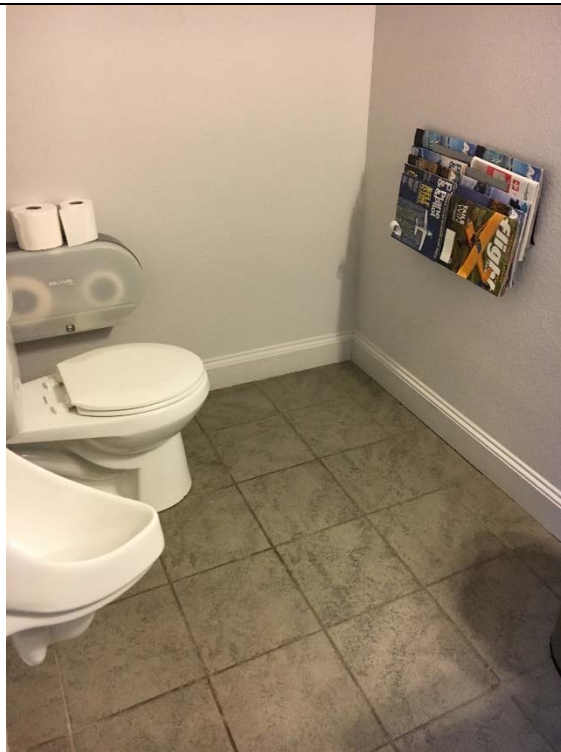
The Men's single user restroom is not large enough to accommodate a wheelchair turning space and the required clear floor spaces for accessible fixtures.

2010 ADAAG 213.2 Toilet Rooms and Bathing Rooms.

Violation 11 - The Men's single user restrooms is not large enough to accommodate a wheelchair turning space.

Enlarge restroom to accommodate accessible water closet and lavatory and wheelchair turning space.

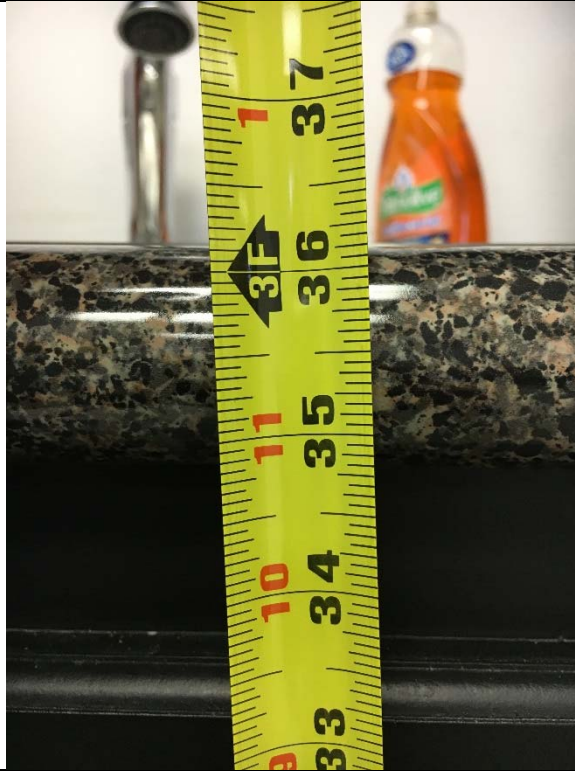
Violation #12: The sink in the breakroom is 36" above finished floor where 34" maximum is required.

Standard: 2010 ADAAG 606.3 Height.

Violation 12 - The counter in the breakroom is at 36" above finished floor.

Possible Solutions: Modify sink to provide 34" maximum height.
