**TOWN OF ADDISON
BUILDING REPORT**

Facility Information: **Facility Name:** Addison Circle Park Pavilion
Facility Contact: Lisa Pyles **Contact Phone:** 972-450-2878

Accessology Inspector Information:
Inspector: Karen Jackson **Date:** April 21, 2017
Email: Kjackson@accessology.com

Latitude: 32.960824 **Longitude:** -96.827594
Address: 4790 Addison Circle Drive **City:** Addison **County:** Dallas

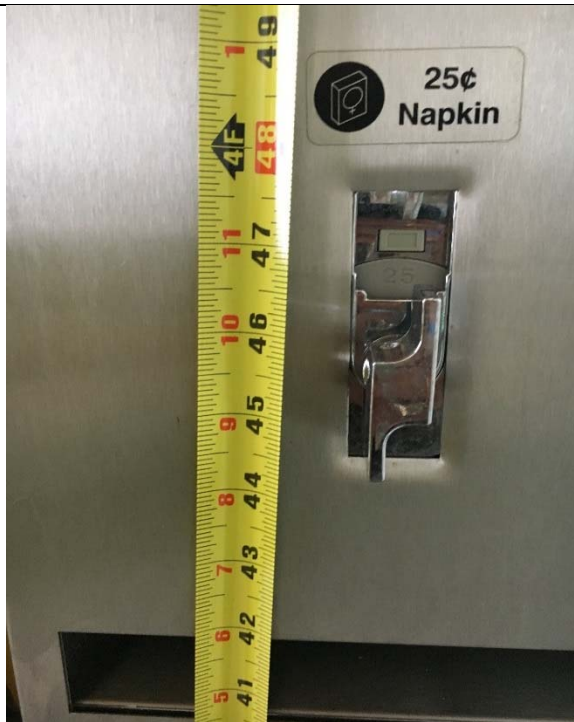
The feminine product dispenser in the Women's restroom requires grasping and twisting to operate.

2010 ADAAG 309.4 Operation.

Operable parts shall be operable with one hand and shall not require tight grasping, pinching, or twisting of the wrist. The force required to activate operable parts shall be 5 pounds (22.2 N) maximum.

Violation 2: The feminine product dispenser in the Women's restroom requires grasping and twisting to operate.

Replace dispenser with unit that does not required tight grasping or twisting to operate.

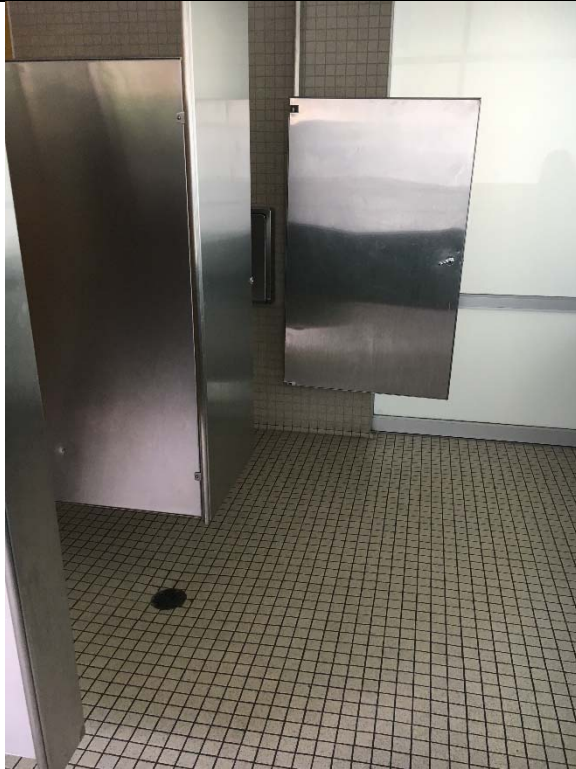
The accessible toilet compartment door in the Men's restroom is not self-closing.

2010 ADAAG 604.8.1.2 Doors.

The door shall be self-closing.

Violation 3: The accessible toilet compartment door in the Men's restroom is not self-closing.

Install self-closing hinge on stall door.

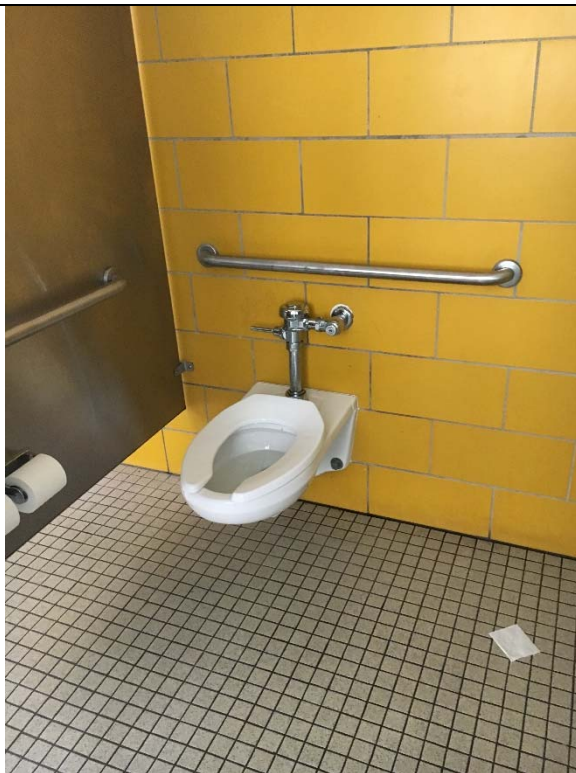
The flush control in the accessible toilet compartment in the Men's restroom is on the closed side.

2010 ADAAG 604.6 Flush Controls.

Text: Flush controls shall be located on the open side of the water closet.

Violation 4: The flush control in the accessible toilet compartment in the Men's restroom is on the closed side.

Possible Solutions: Relocate flush control to open side of water closet.

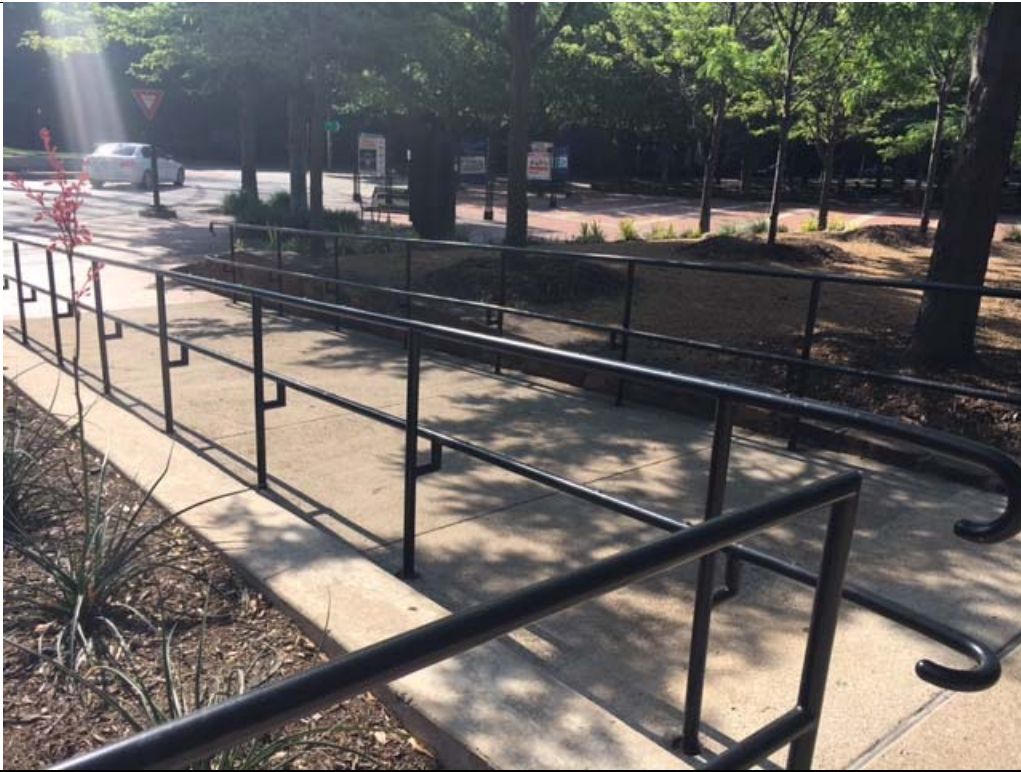
The ramp leading to the pavilion area has a running slope of 8.8%.

2010 ADAAG 405.2 Slope.

Ramp runs shall have a running slope not steeper than 1:12.

Violation 5: The ramp leading to the pavilion area has a running slope of 8.8%.

Modify or replace ramp to achieve 8.33% maximum running slope.
