Client: Town of Addison Date: 1/2/18
 Program: ADA Self-Evaluation and Transition Plan Prepared By: CMP
 KHA No.: 063543021 Checked By: EPE

Corridor : Quorum Dr GPS ID: 113
 Project Name: Intersection of Quorum Dr and driveway (Lat. 32.9668; Long. -96.8257)
 Town: Addison

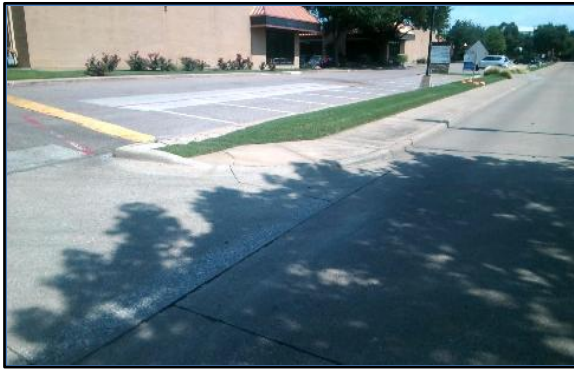
Curb Ramp Issues	Curb Ramp ID ('z' or 'l' in ramp label indicates no existing ramp)		Possible Solutions
	1z	4z	
Curb ramp does not exist and is needed	X	X	Install curb ramp; if median improvement, see shapefile
Curb ramp does not land in crosswalk			
No 4' x 4' clear space at base of curb ramp			
Curbed side is not 90° or has traversable adjacent surface			
Flare cross slope is greater than 10%			
Curb ramp running slope is greater than 8.3%			
Blended transition running slope is greater than 5%			
Cut-thru ramp running slope is greater than 5%			
Curb ramp cross slope is greater than 2%			
Cut-thru ramp cross slope is greater than 2%			
Curb ramp width is less than 48"			
Cut-thru ramp width is less than 60"			
Permanent obstruction (>0.25") in curb ramp/landing/flares			
Temporary obstruction (>0.25") in curb ramp/landing/flares			
No textured surface at base of curb ramp			
No color contrast at base of curb ramp

Corner 1 No Ramp (1z)

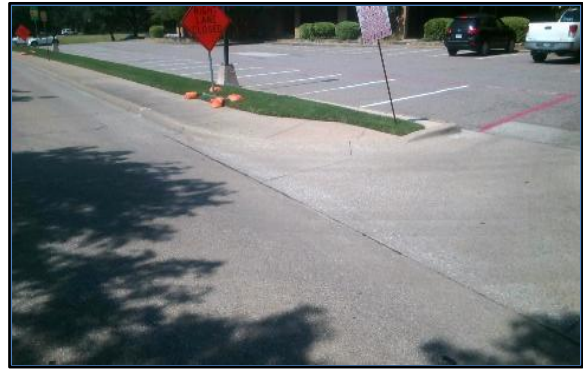
Corner 4 No Ramp (4z)
