Client: Town of Addison Date: 1/2/18  
 Program: ADA Self-Evaluation and Transition Plan Prepared By: CMP  
 KHA No.: 063543021 Checked By: EPE

Corridor : Addison Rd GPS ID: 162  
 Project Name: Intersection of Addison Rd and driveway (Lat. 32.9555; Long. -96.8298)  
 Town: Addison

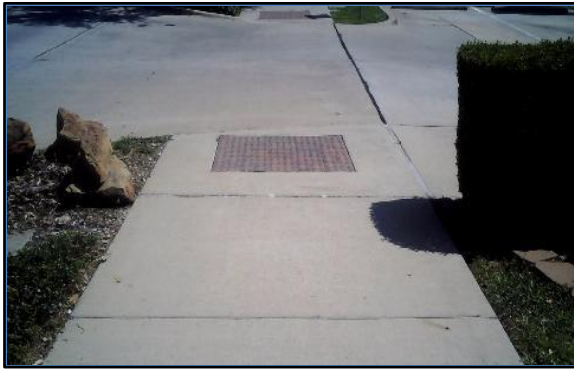
Ramp 1A

Curb Ramp Issues	Curb Ramp ID ('2' or '1' in ramp label indicates no existing ramp)		Possible Solutions
	1A	4A	
Curb ramp does not exist and is needed			
Curb ramp does not land in crosswalk			
No 4' x 4' clear space at base of curb ramp			
Curbed side is not 90° or has traversable adjacent surface			
Flare cross slope is greater than 10%			
Curb ramp running slope is greater than 8.3%			
Blended transition running slope is greater than 5%			
Cut-thru ramp running slope is greater than 5%			
Curb ramp cross slope is greater than 2%			
Cut-thru ramp cross slope is greater than 2%			
Curb ramp width is less than 48"			
Cut-thru ramp width is less than 60"			
Permanent obstruction (>0.25") in curb ramp/landing/flares			
Temporary obstruction (>0.25") in curb ramp/landing/flares			
No textured surface at base of curb ramp			
No color contrast at base of curb ramp			
Landing area does not exist and is needed

Landing area is less than 5' x 5' or slopes greater than 2%		X	Remove and replace landing area
Curb ramp transition onto roadway is greater than 0.25"		X	Fix curb ramp transition
Counter slope of the gutter or street at the foot of the curb ramp is greater than 5%			
Ponding occurs at base of curb ramp
