Client: Town of Addison Date: 1/2/18  
 Program: ADA Self-Evaluation and Transition Plan Prepared By: CMP  
 KHA No.: 063543021 Checked By: EPE

Corridor : Addison Rd GPS ID: 163  
 Project Name: Intersection of Addison Rd and driveway (Lat. 32.9554; Long. -96.8298)  
 Town: Addison

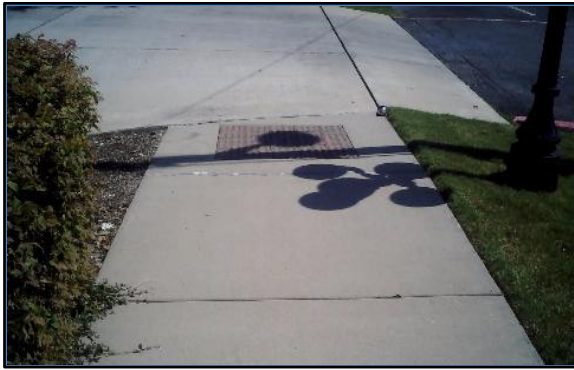
Ramp 1A

Landing area is less than 5' x 5' or slopes greater than 2%			
Curb ramp transition onto roadway is greater than 0.25"	X	X	Fix curb ramp transition
Counter slope of the gutter or street at the foot of the curb ramp is greater than 5%			
Ponding occurs at base of curb ramp
