Client: Town of Addison Date: 1/2/18
 Program: ADA Self-Evaluation and Transition Plan Prepared By: CMP
 KHA No.: 063543021 Checked By: EPE

Corridor : Addison Rd GPS ID: 166
 Project Name: Intersection of Addison Rd and driveway (Lat. 32.9548; Long. -96.8298)
 Town: Addison

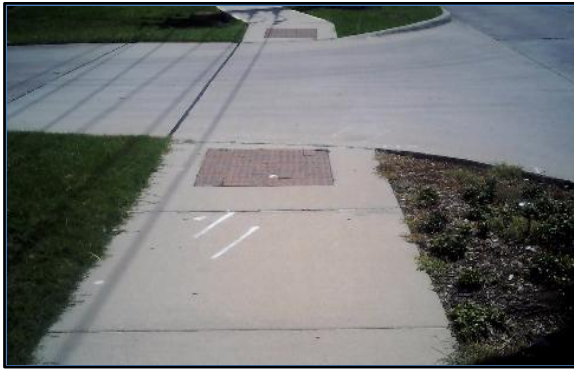
Ramp 2A

Curb Ramp Issues	Curb Ramp ID ('2' or '1' in ramp label indicates no existing ramp)		Possible Solutions
	2A	3A	
Curb ramp does not exist and is needed			Remove and replace curb ramp
Curb ramp does not land in crosswalk			
No 4' x 4' clear space at base of curb ramp			
Curbed side is not 90° or has traversable adjacent surface			
Flare cross slope is greater than 10%			
Curb ramp running slope is greater than 8.3%			
Blended transition running slope is greater than 5%			
Cut-thru ramp running slope is greater than 5%			
Curb ramp cross slope is greater than 2%		X	
Cut-thru ramp cross slope is greater than 2%			
Curb ramp width is less than 48"			
Cut-thru ramp width is less than 60"			
Permanent obstruction (>0.25") in curb ramp/landing/flares			
Temporary obstruction (>0.25") in curb ramp/landing/flares			
No textured surface at base of curb ramp			Fix curb ramp transition
No color contrast at base of curb ramp

Landing area does not exist and is needed			
Landing area is less than 5' x 5' or slopes greater than 2%			
Curb ramp transition onto roadway is greater than 0.25'		X	
Counter slope of the gutter or street at the foot of the curb ramp is greater than 5%			
Ponding occurs at base of curb ramp
