Client: Town of Addison Date: 1/2/18
 Program: ADA Self-Evaluation and Transition Plan Prepared By: CMP
 KHA No.: 063543021 Checked By: EPE

Corridor : Belt Line Rd GPS ID: 177
 Project Name: Intersection of Belt Line Rd and driveway (Lat. 32.9541; Long. -96.8363)
 Town: Addison

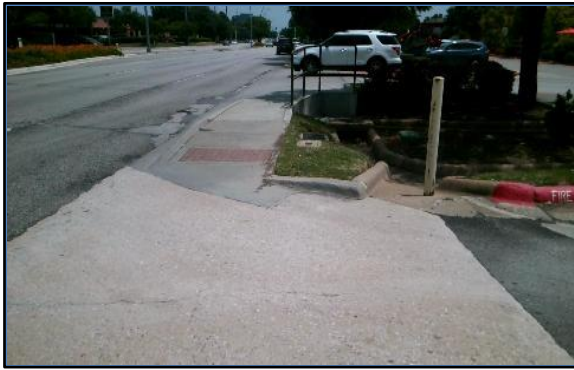
Ramp 3A

Curb Ramp Issues	Curb Ramp ID ('2' or '1' in ramp label indicates no existing ramp)		Possible Solutions
	3A	4A	
Curb ramp does not exist and is needed			Remove and replace curb ramp
Curb ramp does not land in crosswalk			
No 4' x 4' clear space at base of curb ramp			
Curbed side is not 90° or has traversable adjacent surface			
Flare cross slope is greater than 10%			
Curb ramp running slope is greater than 8.3%			
Blended transition running slope is greater than 5%			
Cut-thru ramp running slope is greater than 5%			
Curb ramp cross slope is greater than 2%	X		
Cut-thru ramp cross slope is greater than 2%			
Curb ramp width is less than 48"			
Cut-thru ramp width is less than 60"			
Permanent obstruction (>0.25") in curb ramp/landing/flares	X		
Temporary obstruction (>0.25") in curb ramp/landing/flares			
No textured surface at base of curb ramp			Fix curb ramp transition
No color contrast at base of curb ramp

Landing area does not exist and is needed			Fix ponding
Landing area is less than 5' x 5' or slopes greater than 2%			
Curb ramp transition onto roadway is greater than 0.25'		X	
Counter slope of the gutter or street at the foot of the curb ramp is greater than 5%			
Ponding occurs at base of curb ramp	X
