Client: Town of Addison Date: 1/2/18
 Program: ADA Self-Evaluation and Transition Plan Prepared By: CMP
 KHA No.: 063543021 Checked By: EPE

Corridor : Belt Line Rd GPS ID: 178
 Project Name: Intersection of Belt Line Rd and driveway (Lat. 32.9541; Long. -96.8361)
 Town: Addison

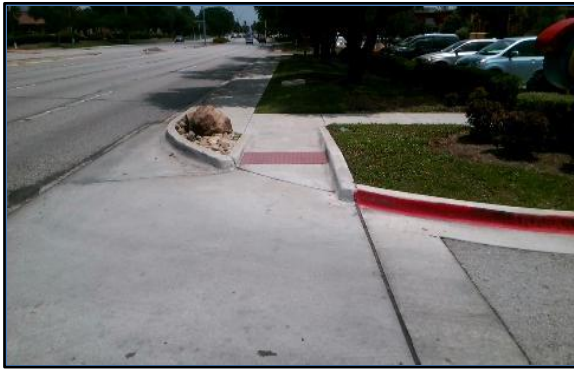
Ramp 3A

Curb Ramp Issues	Curb Ramp ID ('2' or '1' in ramp label indicates no existing ramp)		Possible Solutions
	3A	4A	
Curb ramp does not exist and is needed			Remove and replace landing area Fix curb ramp transition
Curb ramp does not land in crosswalk			
No 4' x 4' clear space at base of curb ramp			
Curbed side is not 90° or has traversable adjacent surface			
Flare cross slope is greater than 10%			
Curb ramp running slope is greater than 8.3%			
Blended transition running slope is greater than 5%			
Cut-thru ramp running slope is greater than 5%			
Curb ramp cross slope is greater than 2%			
Cut-thru ramp cross slope is greater than 2%			
Curb ramp width is less than 48"			
Cut-thru ramp width is less than 60"			
Permanent obstruction (>0.25") in curb ramp/landing/flares			
Temporary obstruction (>0.25") in curb ramp/landing/flares			
No textured surface at base of curb ramp			
No color contrast at base of curb ramp

Landing area does not exist and is needed			
Landing area is less than 5' x 5' or slopes greater than 2%		X	
Curb ramp transition onto roadway is greater than 0.25"	X		
Counter slope of the gutter or street at the foot of the curb ramp is greater than 5%			
Ponding occurs at base of curb ramp
