Client: Town of Addison Date: 1/2/18
 Program: ADA Self-Evaluation and Transition Plan Prepared By: CMP
 KHA No.: 063543021 Checked By: EPE

Corridor : Belt Line Rd GPS ID: 196
 Project Name: Intersection of Belt Line Rd and driveway (Lat. 32.9541; Long. -96.8249)
 Town: Addison

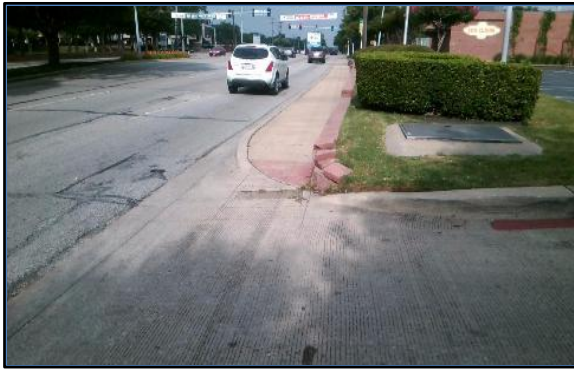
Ramp 1A

Curb Ramp Issues	Curb Ramp ID ('2' or '1' in ramp label indicates no existing ramp)		Possible Solutions
	1A	2A	
Curb ramp does not exist and is needed			Remove and replace curb ramp
Curb ramp does not land in crosswalk			
No 4' x 4' clear space at base of curb ramp			
Curbed side is not 90° or has traversable adjacent surface			
Flare cross slope is greater than 10%			
Curb ramp running slope is greater than 8.3%			
Blended transition running slope is greater than 5%			
Cut-thru ramp running slope is greater than 5%			
Curb ramp cross slope is greater than 2%			
Cut-thru ramp cross slope is greater than 2%			
Curb ramp width is less than 48"	X		For intersection, commercial driveway, and park ramps, install
Cut-thru ramp width is less than 60"			
Permanent obstruction (>0.25') in curb ramp/landing/flares	X		
Temporary obstruction (>0.25') in curb ramp/landing/flares			
No textured surface at base of curb ramp	X	X

No color contrast at base of curb ramp			
Landing area does not exist and is needed			
Landing area is less than 5' x 5' or slopes greater than 2%	X		
Curb ramp transition onto roadway is greater than 0.25'	X	X	
Counter slope of the gutter or street at the foot of the curb ramp is greater than 5%			
Ponding occurs at base of curb ramp	X		Fix ponding
