Client: Town of Addison Date: 1/2/18
 Program: ADA Self-Evaluation and Transition Plan Prepared By: CMP
 KHA No.: 063543021 Checked By: EPE

Corridor : Belt Line Rd GPS ID: 179
 Project Name: Intersection of Belt Line Rd and driveway (Lat. 32.9542; Long. -96.8360)
 Town: Addison

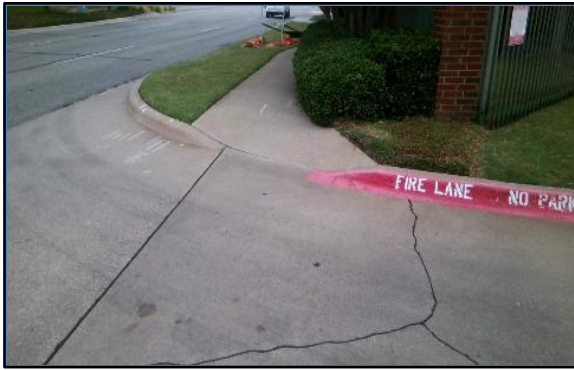
Ramp 1A

Curb Ramp Issues	Curb Ramp ID ('2' or '1' in ramp label indicates no existing ramp)		Possible Solutions
	1A	2A	
Curb ramp does not exist and is needed			Remove and replace curb ramp
Curb ramp does not land in crosswalk			
No 4' x 4' clear space at base of curb ramp			
Curbed side is not 90° or has traversable adjacent surface			
Flare cross slope is greater than 10%	X	X	
Curb ramp running slope is greater than 8.3%	X		
Blended transition running slope is greater than 5%			
Cut-thru ramp running slope is greater than 5%			
Curb ramp cross slope is greater than 2%	X		
Cut-thru ramp cross slope is greater than 2%			
Curb ramp width is less than 48"			For intersection, commercial driveway, and park ramps, install color truncated domes
Cut-thru ramp width is less than 60"			
Permanent obstruction (>0.25") in curb ramp/landing/flares			
Temporary obstruction (>0.25") in curb ramp/landing/flares			
No textured surface at base of curb ramp	X	X

No color contrast at base of curb ramp	X	X	
Landing area does not exist and is needed			
Landing area is less than 5' x 5' or slopes greater than 2%	X	X	
Curb ramp transition onto roadway is greater than 0.25"	X	X	
Counter slope of the gutter or street at the foot of the curb ramp is greater than 5%			
Ponding occurs at base of curb ramp		X	Fix ponding
