Client: Town of Addison Date: 1/2/18
 Program: ADA Self-Evaluation and Transition Plan Prepared By: CMP
 KHA No.: 063543021 Checked By: EPE

Corridor : Quorum Dr GPS ID: 205
 Project Name: Intersection of Quorum Dr and driveway (Lat. 32.9513; Long. -96.8252)
 Town: Addison

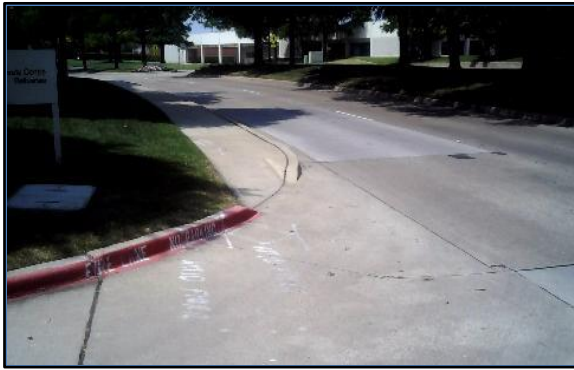
Ramp 1A

Curb Ramp Issues	Curb Ramp ID ('z' or 'l' in ramp label indicates no existing ramp)		Possible Solutions
	1A	4A	
Curb ramp does not exist and is needed			Remove and replace curb ramp
Curb ramp does not land in crosswalk			
No 4' x 4' clear space at base of curb ramp			
Curbed side is not 90° or has traversable adjacent surface		X	
Flare cross slope is greater than 10%			
Curb ramp running slope is greater than 8.3%	X		
Blended transition running slope is greater than 5%			
Cut-thru ramp running slope is greater than 5%			
Curb ramp cross slope is greater than 2%	X	X	
Cut-thru ramp cross slope is greater than 2%			
Curb ramp width is less than 48"	X	X	For intersection, commercial driveway, and park ramps, install color truncated domes
Cut-thru ramp width is less than 60"			
Permanent obstruction (>0.25") in curb ramp/landing/flares		X	
Temporary obstruction (>0.25") in curb ramp/landing/flares			
No textured surface at base of curb ramp	X	X

No color contrast at base of curb ramp	X	X	
Landing area does not exist and is needed			
Landing area is less than 5' x 5' or slopes greater than 2%	X	X	
Curb ramp transition onto roadway is greater than 0.25'			
Counter slope of the gutter or street at the foot of the curb ramp is greater than 5%			
Ponding occurs at base of curb ramp			Remove and replace landing area

Item No.	Item Description	Quantity	Unit	Unit Price	Item Cost
TxDOT 110-6001	EXCAVATION (ROADWAY)	0	CY	\$ 10.00	\$ -
TxDOT 529-6002	CONC CURB (TY II)	0	LF	\$ 15.00	\$ -
TxDOT 531-6001	CONC SIDEWALKS (4")	0	SY	\$ 45.00	\$ -
TxDOT 531	CURB RAMPS	2	EA	\$ 1,500.00	\$ 3,000.00
TxDOT 5003-6002	RETROFIT DET WARN SURF (CAST IN PLACE)	0	SF	\$ 50.00	\$ -
TxDOT 104-6015	REMOVING CONC (SIDEWALKS)	21	SY	\$ 9.00	\$ 189.00
TxDOT 677	ELIM EXT PAVE MRK & MRKS	0	LF	\$ 2.80	\$ -
TxDOT 666/678	REFL PAV MRK PREP TY I & TY II (W) 24" (SLD)	0	LF	\$ 8.50	\$ -
---	REPAVE ROADWAY	0	LS	\$ 5,000.00	\$ -
---	FIX PONDING	0	LS	\$ 2,000.00	\$ -
---	FIX CURB RAMP TRANSITION	0	LS	\$ 2,000.00	\$ -
---	MEDIAN NOSE MODIFICATION	0	LS	\$ 5,000.00	\$ -
---	REMOVE TEMPORARY OBSTRUCTION	0	LS	\$ 500.00	\$ -
---	FIX CURB RAMP COUNTER SLOPE	0	LS	\$ 2,000.00	\$ -
