Client: Town of Addison Date: 1/2/18
 Program: ADA Self-Evaluation and Transition Plan Prepared By: CMP
 KHA No.: 063543021 Checked By: EPE

Corridor : Quorum Dr GPS ID: 215
 Project Name: Intersection of Quorum Dr and Landmark PI (west)
 Town: Addison

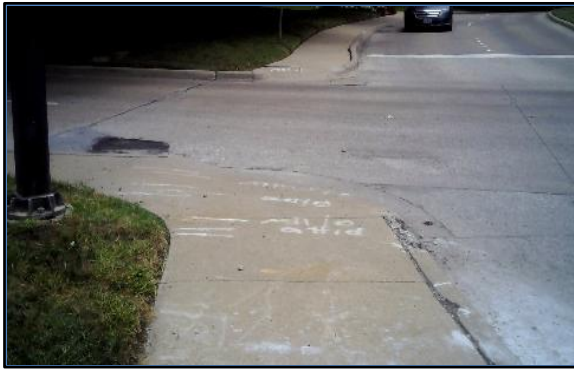
Ramp 1A

| Curb Ramp Issues | Curb Ramp ID ('z' or 'l' in ramp label indicates no existing ramp) | | | | Possible Solutions |
|---|---|---|---|---|---|
| Flare cross slope is greater than 10% | X | X | | | |
| Curb ramp running slope is greater than 8.3% | X | X | | | |
| Permanent obstruction (>0.25") in curb ramp/landing/flares | | X | | | For intersection, commercial driveway, and park ramps, install color truncated domes |
| No textured surface at base of curb ramp | X | X | | | Remove and replace landing area |
| No color contrast at base of curb ramp | X | X | | | |
| Landing area is less than 5' x 5' or slopes greater than 2% | X | X | | | |

| Curb Ramp Issues | Curb Ramp ID ('z' or 'l' in ramp label indicates no existing ramp) | | | | Possible Solutions |
|---|---|---|---|---|---|
| No 4' x 4' clear space at base of curb ramp | | | | | Remove and replace curb ramp |
| Landing area does not exist and is needed | | | | | Fix curb ramp transition |

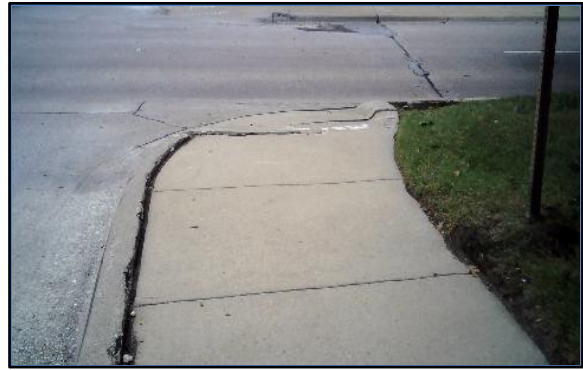
Ramp 2A

| Curb Ramp Issues | Curb Ramp ID ('z' or 'l' in ramp label indicates no existing ramp) | | | | Possible Solutions |
|---|---|---|---|---|---|
| Curb ramp transition onto roadway is greater than 0.25" | | X | | | |

| Item No. | Item Description | Quantity | Unit | Unit Price | Item Cost |
|---|---|---|---|---|---|
| --- | FIX CURB RAMP TRANSITION | 1 | LS | \$ 2,000.00 | \$ 2,000.00 |

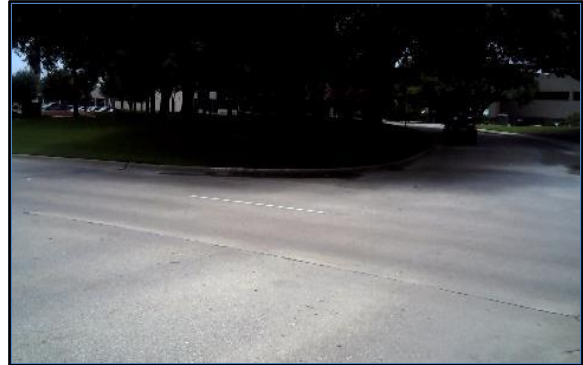
Corner 4 No Ramp (4z)

| Curb Ramp Issues | Curb Ramp ID ('z' or 'l' in ramp label indicates no existing ramp) | | | | Possible Solutions |
|---|---|---|---|---|---|
| Curb ramp does not exist and is needed | | | | X | Install curb ramp; if median improvement, see shapefile |

| Item No. | Item Description | Quantity | Unit | Unit Price | Item Cost |
|---|---|---|---|---|---|
| TxDOT 531 | CURB RAMPS | 4 | EA | \$ 1,500.00 | \$ 6,000.00 |
