Client: Town of Addison Date: 1/2/18
 Program: ADA Self-Evaluation and Transition Plan Prepared By: CMP
 KHA No.: 063543021 Checked By: EPE

Corridor : Brookwood Ln GPS ID: 281
 Project Name: Intersection of Brookwood Ln and Dove Ct
 Town: Addison

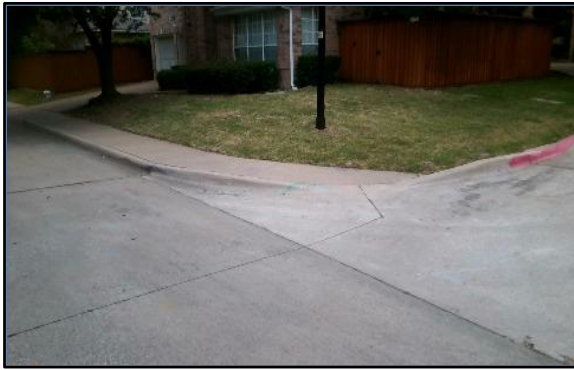
Ramp 1A

| Curb Ramp Issues | Curb Ramp ID ('z' or 'l' in ramp label indicates no existing ramp) | | | | Possible Solutions |
|---|--|---|---|---|--|
| | 1A | 2A | 3z | 4z | |
| Curbed side is not 90° or has traversable adjacent surface | | X | | | |
| Flare cross slope is greater than 10% | | X | | | |
| Curb ramp running slope is greater than 8.3% | X | X | | | |
| Curb ramp cross slope is greater than 2% | X | X | | | |
| Permanent obstruction (>0.25") in curb ramp/landing/flares | X | X | | | |
| Temporary obstruction (>0.25") in curb ramp/landing/flares | X | X | | | Fix curb ramp transition |
| No textured surface at base of curb ramp | X | X | | | |
| No color contrast at base of curb ramp | X | X | | | Fix curb ramp counter slope |
| Landing area does not exist and is needed | X | X | | | |
| Landing area is less than 5' x 5' or slopes greater than 2% | X | X | | | Fix curb ramp counter slope |
| Curb ramp transition onto roadway is greater than 0.25" | X | X | | | |
| Counter slope of the gutter or street at the foot of the curb ramp is greater than 5% | X | X | | | |

| Item No. | Item Description | Quantity | Unit | Unit Price | Item Cost |
|---|--|---|---|---|---|
| --- | FIX CURB RAMP TRANSITION | 2 | LS | \$ 2,000.00 | \$ 4,000.00 |
| --- | FIX CURB RAMP COUNTER SLOPE | 2 | LS | \$ 2,000.00 | \$ 4,000.00 |

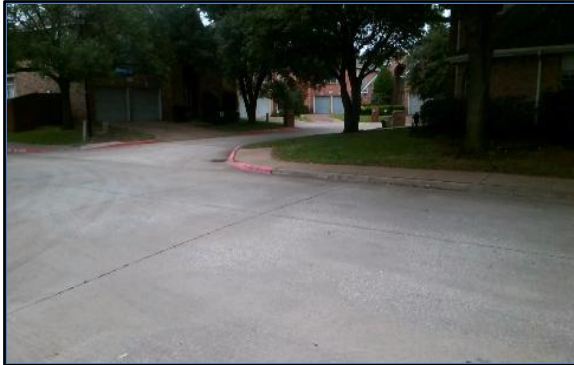
Corner 3 No Ramp (3z)

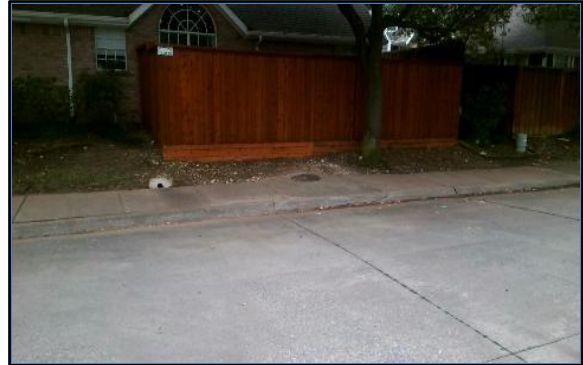
| Curb Ramp Issues | Curb Ramp ID ('z' or 'l' in ramp label indicates no existing ramp) | | | | Possible Solutions |
|---|--|---|---|---|--|
| Curb ramp does not exist and is needed | | | | X | Install curb ramp; if median improvement, see shapefile |

Corner 4 No Ramp (4z)

| Item No. | Item Description | Quantity | Unit | Unit Price | Item Cost |
|---|--|---|---|---|---|
| TxDOT 531 | CURB RAMPS | 5 | EA | \$ 1,500.00 | \$ 7,500.00 |
