Client: Town of Addison Date: 1/2/18  
 Program: ADA Self-Evaluation and Transition Plan Prepared By: CMP  
 KHA No.: 063543021 Checked By: EPE

Corridor: Spring Valley Rd GPS ID: 295  
 Project Name: Intersection of Spring Valley Rd and driveway (Lat. 32.9399; Long. -96.8549)  
 Town: Addison

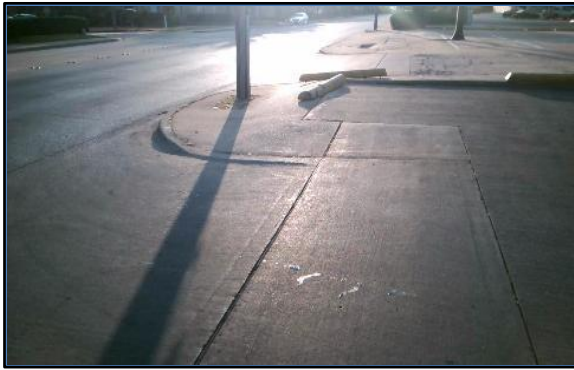
Curb Ramp Issues	Curb Ramp ID ('z' or 'l' in ramp label indicates no existing ramp)		Possible Solutions
	3z	4z	
Curb ramp does not exist and is needed	X		Install curb ramp; if median improvement, see shapefile
Curb ramp does not land in crosswalk			
No 4' x 4' clear space at base of curb ramp			
Curbed side is not 90° or has traversable adjacent surface			
Flare cross slope is greater than 10%			
Curb ramp running slope is greater than 8.3%			
Blended transition running slope is greater than 5%			
Cut-thru ramp running slope is greater than 5%			
Curb ramp cross slope is greater than 2%			
Cut-thru ramp cross slope is greater than 2%			
Curb ramp width is less than 48"			
Cut-thru ramp width is less than 60"			
Permanent obstruction (>0.25") in curb ramp/landing/flares			
Temporary obstruction (>0.25") in curb ramp/landing/flares			
No textured surface at base of curb ramp			
No color contrast at base of curb ramp

Corner 3 No Ramp (3z)

Item No.	Item Description	Quantity	Unit	Unit Price	Item Cost
TxDOT 110-6001	EXCAVATION (ROADWAY)	0	CY	\$ 10.00	\$ -
TxDOT 529-6002	CONC CURB (TY II)	0	LF	\$ 15.00	\$ -
TxDOT 531-6001	CONC SIDEWALKS (4")	0	SY	\$ 45.00	\$ -
TxDOT 531	CURB RAMPS	1	EA	\$ 1,500.00	\$ 1,500.00
TxDOT 5003-6002	RETROFIT DET WARN SURF (CAST IN PLACE)	0	SF	\$ 50.00	\$ -
TxDOT 104-6015	REMOVING CONC (SIDEWALKS)	0	SY	\$ 9.00	\$ -
TxDOT 677	ELIM EXT PAVE MRK & MRKS	0	LF	\$ 2.80	\$ -
TxDOT 666/678	REFL PAV MRK PREP TY I & TY II (W) 24" (SLD)	0	LF	\$ 8.50	\$ -
---	REPAVE ROADWAY	0	LS	\$ 5,000.00	\$ -
---	FIX PONDING	0	LS	\$ 2,000.00	\$ -
---	FIX CURB RAMP TRANSITION	0	LS	\$ 2,000.00	\$ -
---	MEDIAN NOSE MODIFICATION	0	LS	\$ 5,000.00	\$ -
---	REMOVE TEMPORARY OBSTRUCTION	0	LS	\$ 500.00	\$ -
---	FIX CURB RAMP COUNTER SLOPE	0	LS	\$ 2,000.00	\$ -

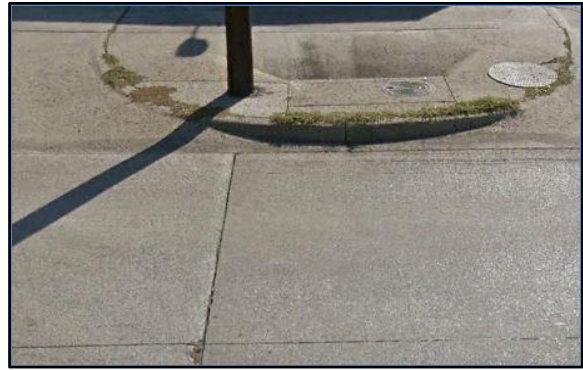
Corner 4 No Ramp (4z)
